Subject: Water Testing for Lead

Allis Elementary School

4201 Buckeye Rd.

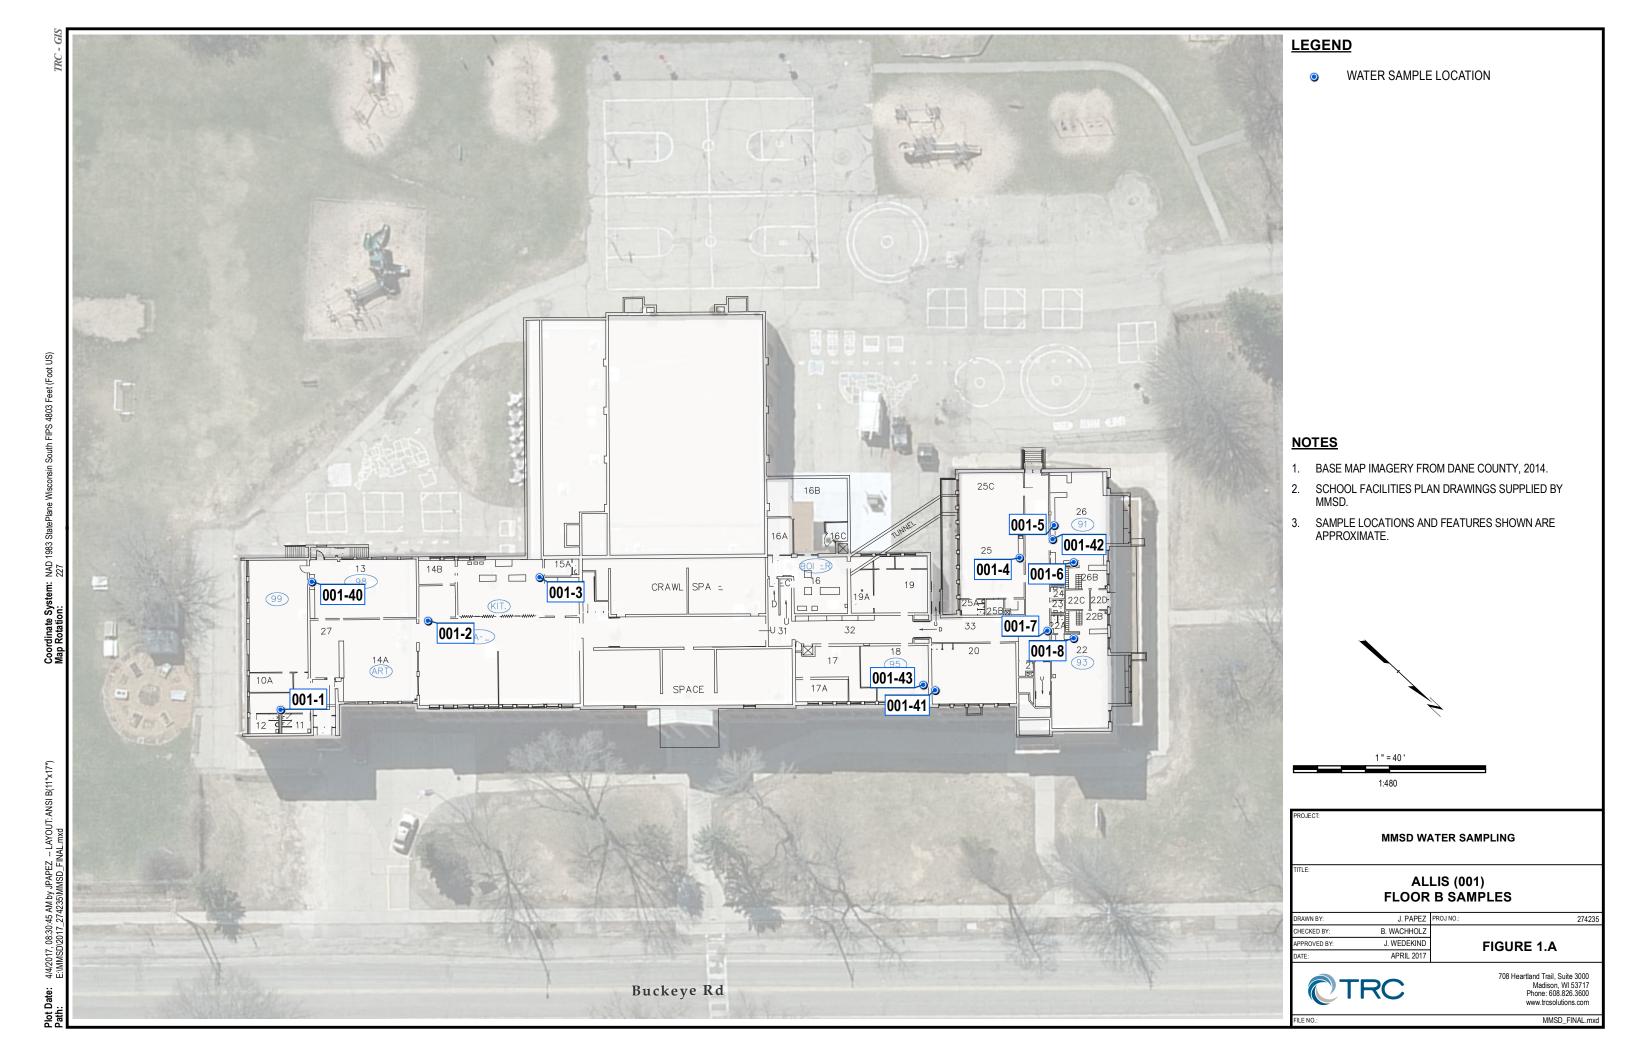
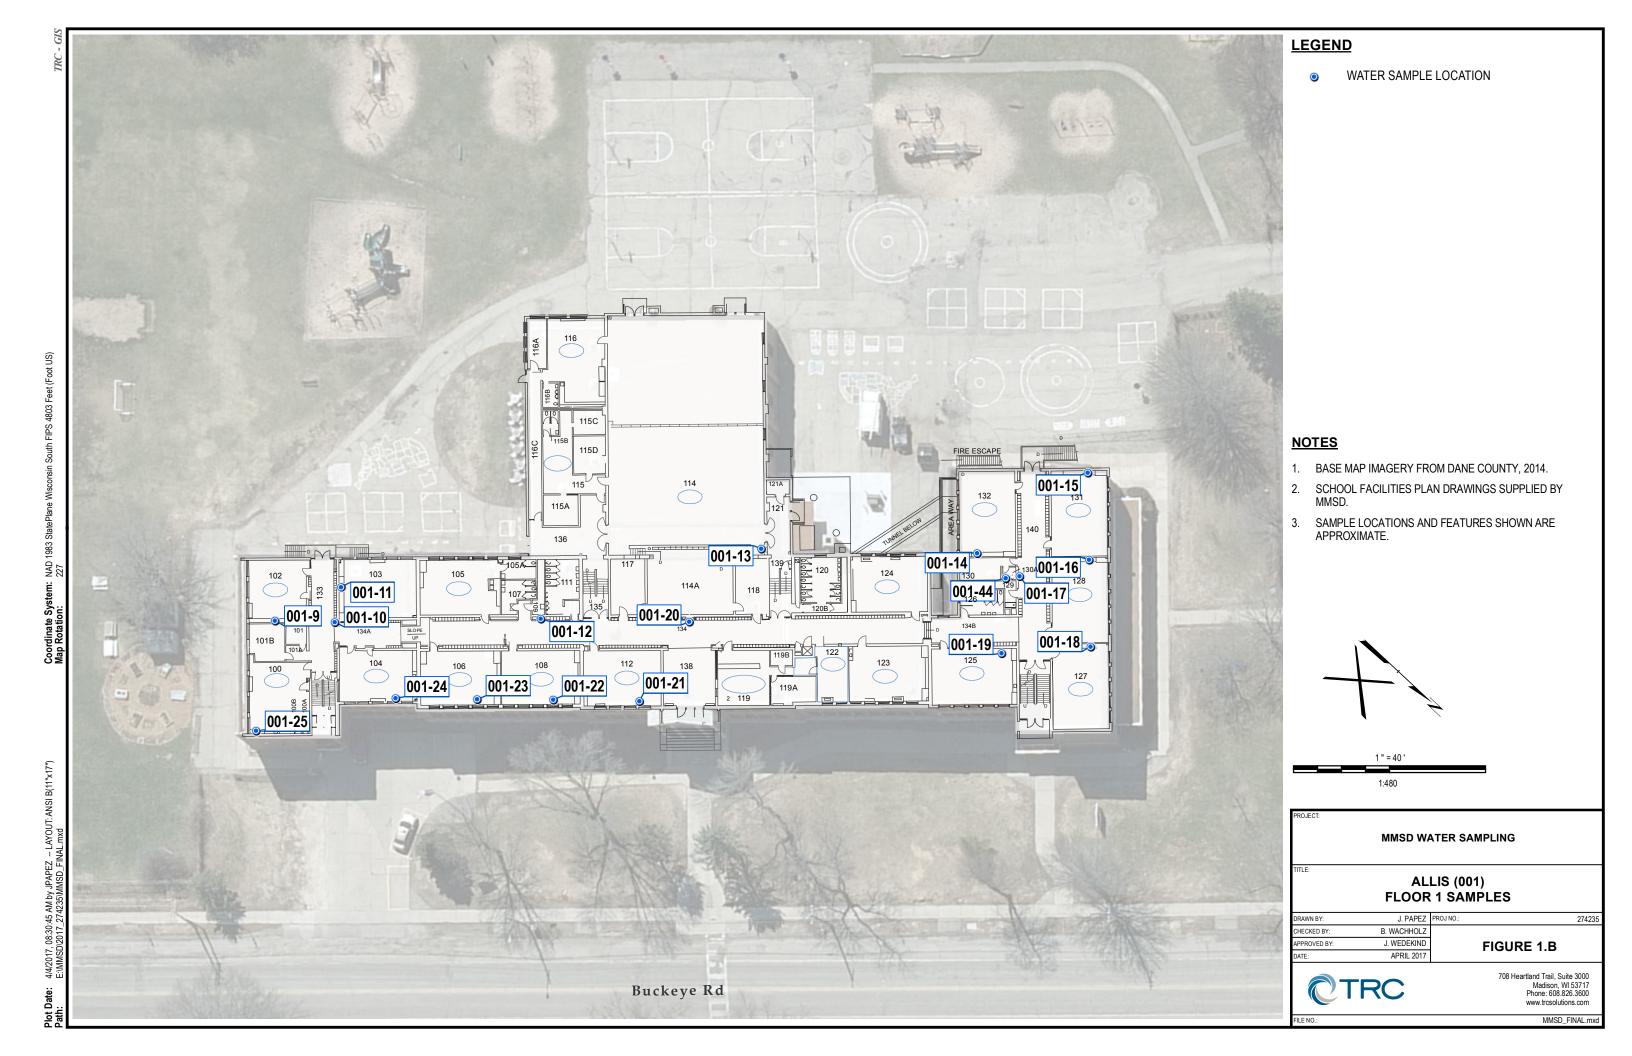
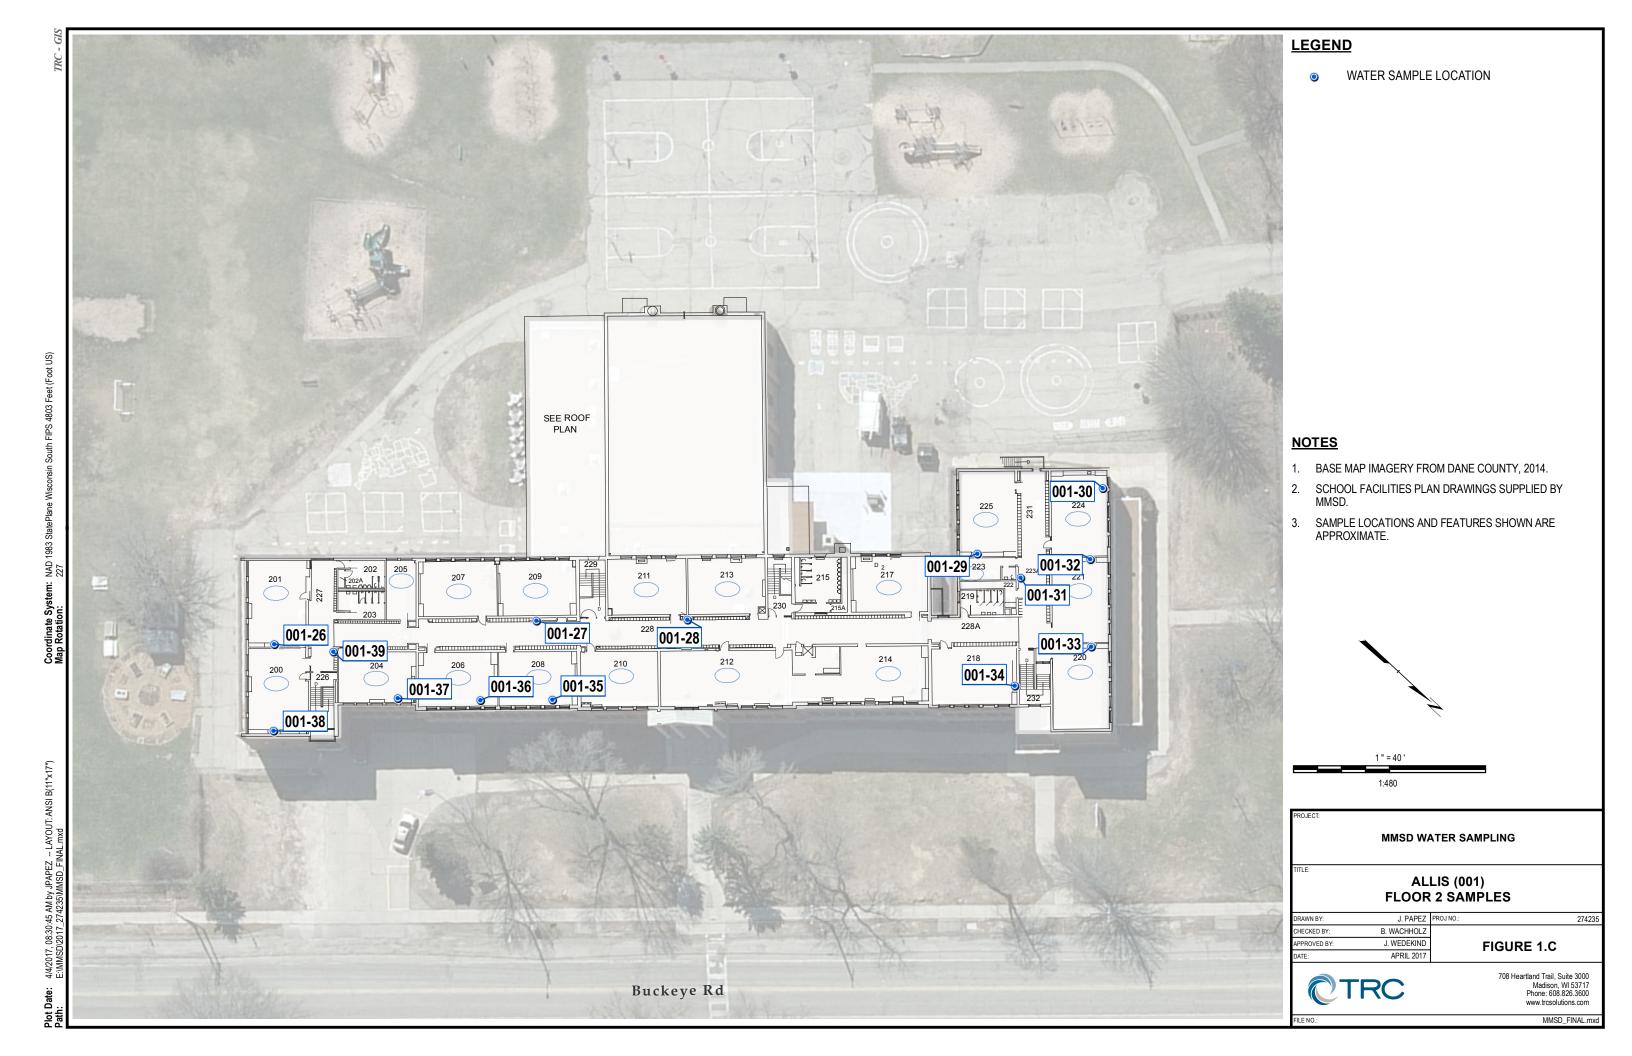
Location Map

Preliminary sample locations were identified by maps provided by MMSD. Following completion of sampling, TRC prepared a map of each school annotated with the final sample locations and identification numbers for each outlet. See Appendix A: Location Map.
