Subject: Water Testing for Lead  
Crestwood Elementary School  
5930 Old Sauk Rd.

As requested by the Madison Metropolitan School District (MMSD), TRC Environmental Corporation (TRC) performed testing for lead in water at Crestwood Elementary School.

PROJECT:		MMSD WATER SAMPLING	
TITLE:		CRESTWOOD (004) FLOOR 1 SAMPLES	
DRAWN BY:	J. PAPEZ	PROJ NO.:	274235
CHECKED BY:	B. WACHHOLZ	FIGURE 1.A	
APPROVED BY:	J. WEDEKIND		
DATE:	APRIL 2017		
FILE NO.:		MMSD_FINAL.mxd

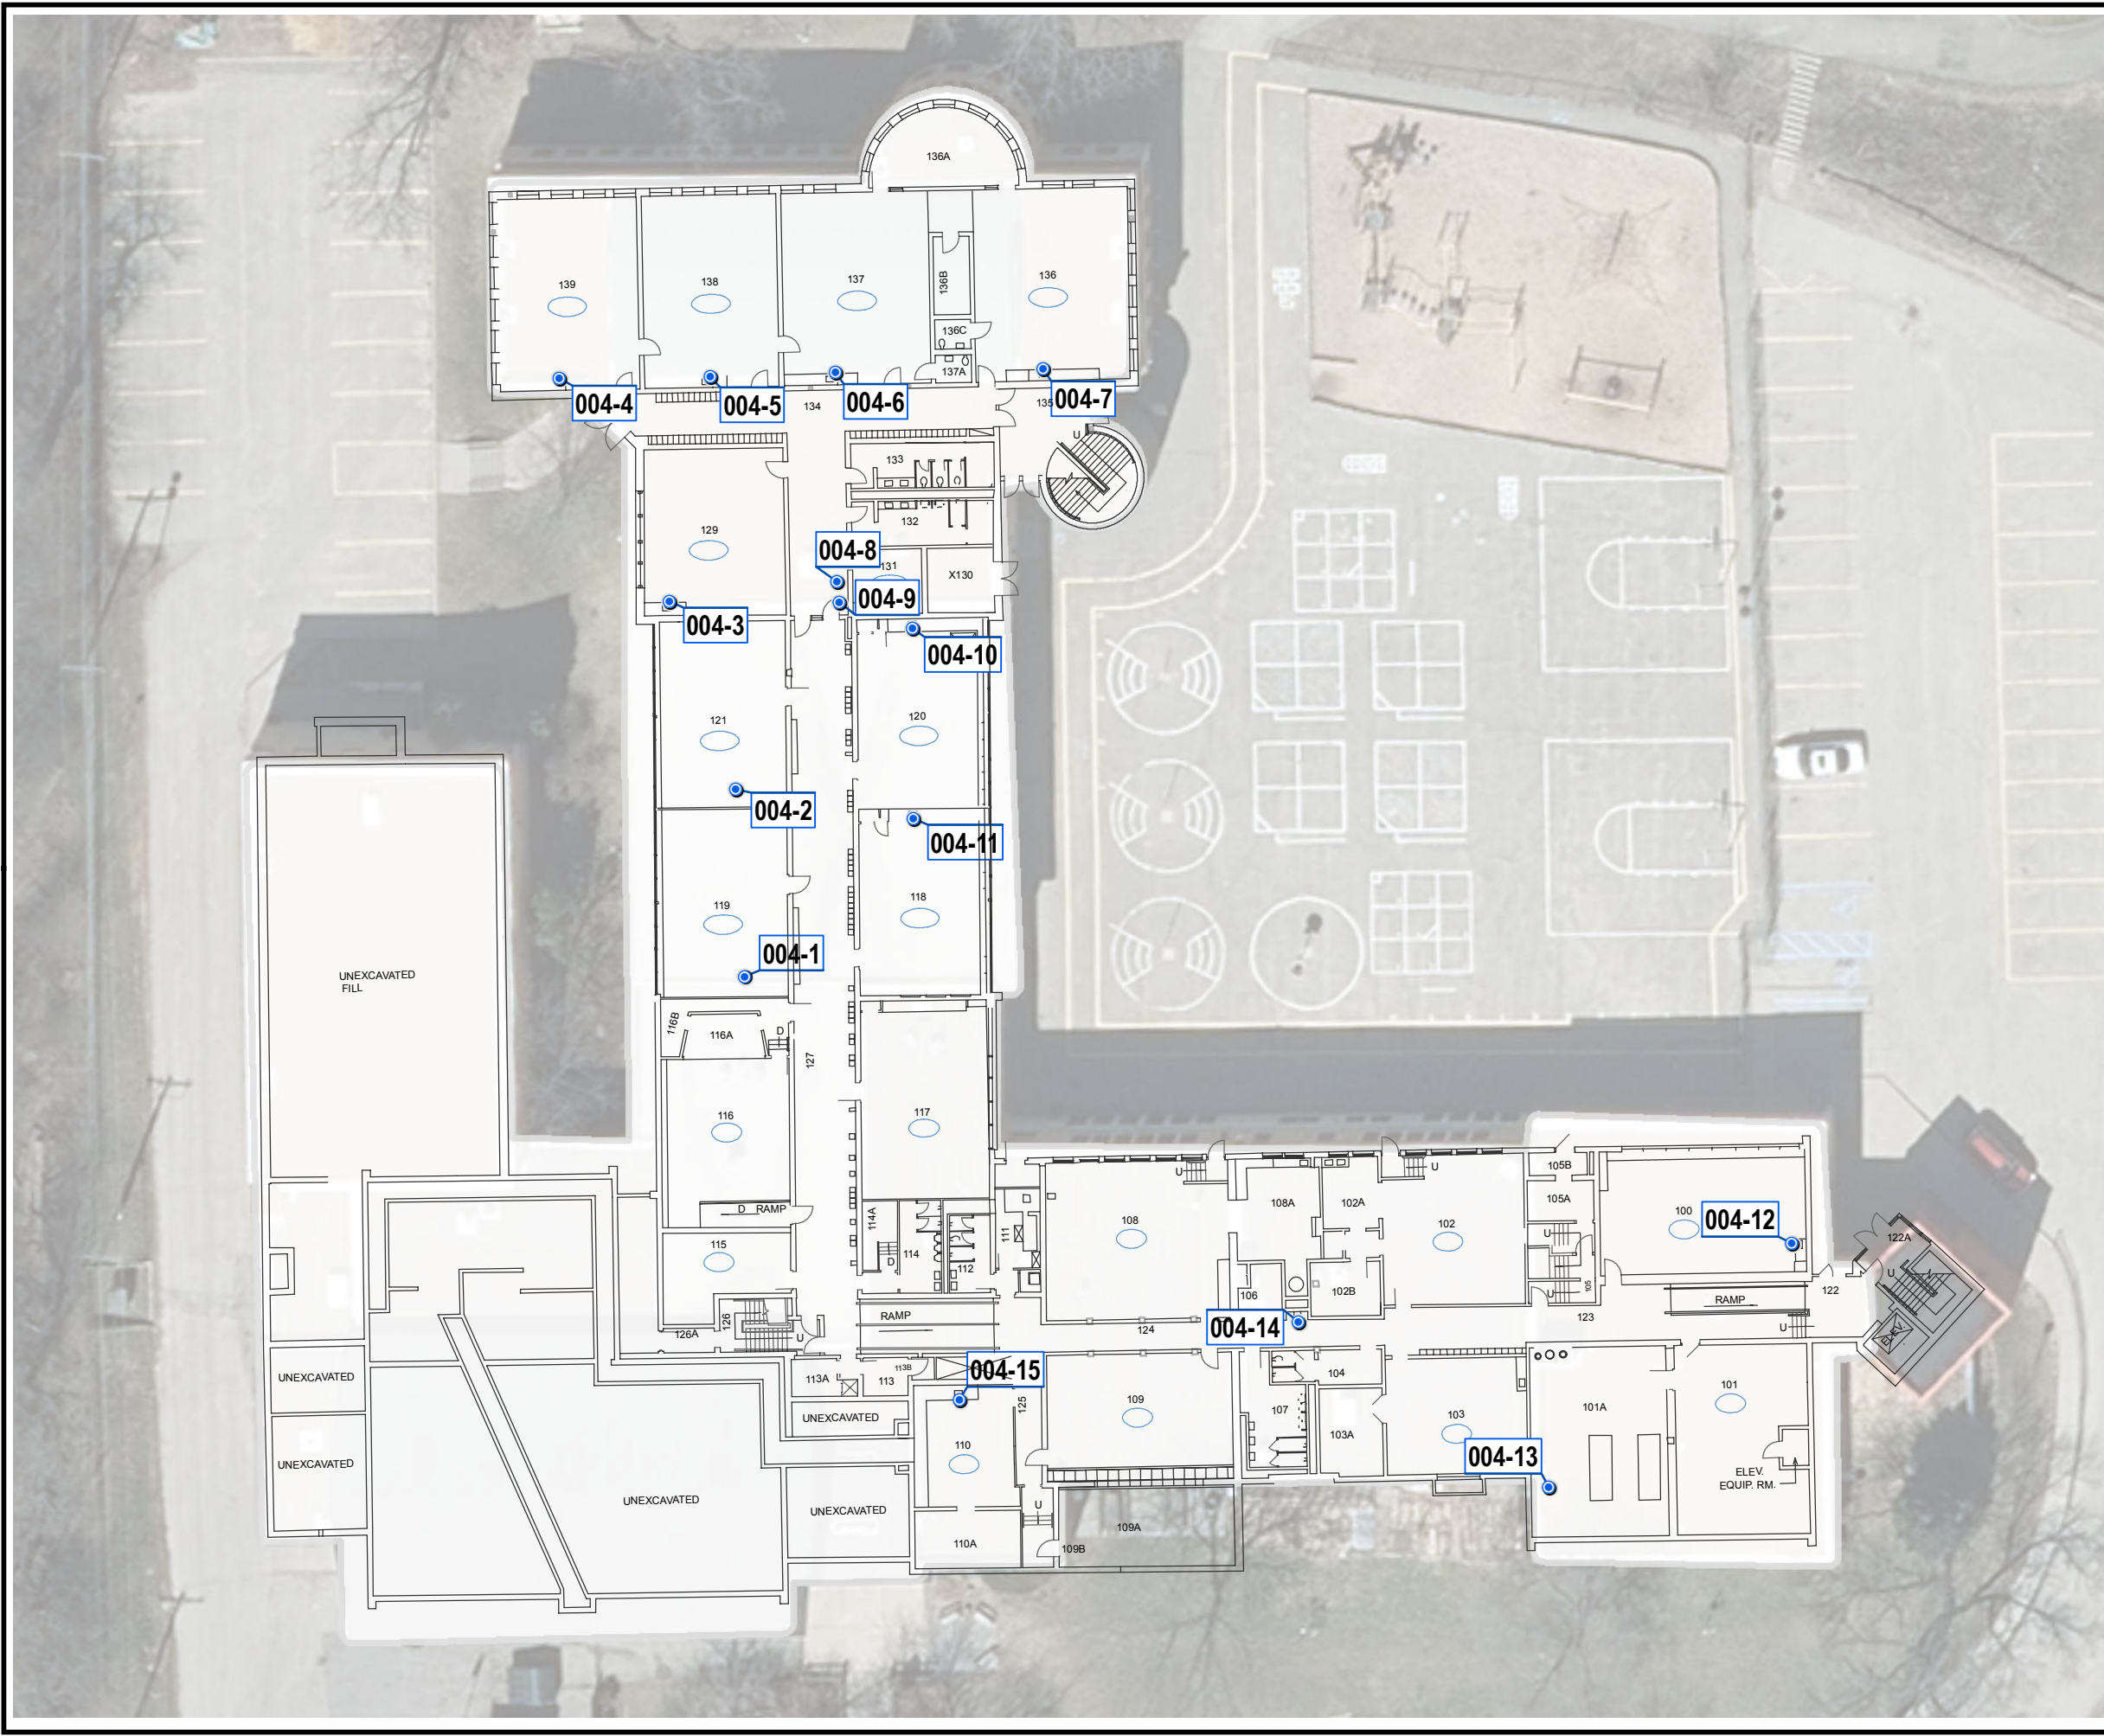
Preliminary sample locations were identified by maps provided by MMSD. Following completion of sampling, TRC prepared a map of each school annotated with the final sample locations and identification numbers for each outlet. See Appendix A: Location Map.
