Subject: Water Testing for Lead
Cherokee Middle School
4301 Cherokee Dr.

As requested by the Madison Metropolitan School District (MMSD), TRC Environmental Corporation (TRC) performed testing for lead in water at Cherokee Middle School.

Location Map

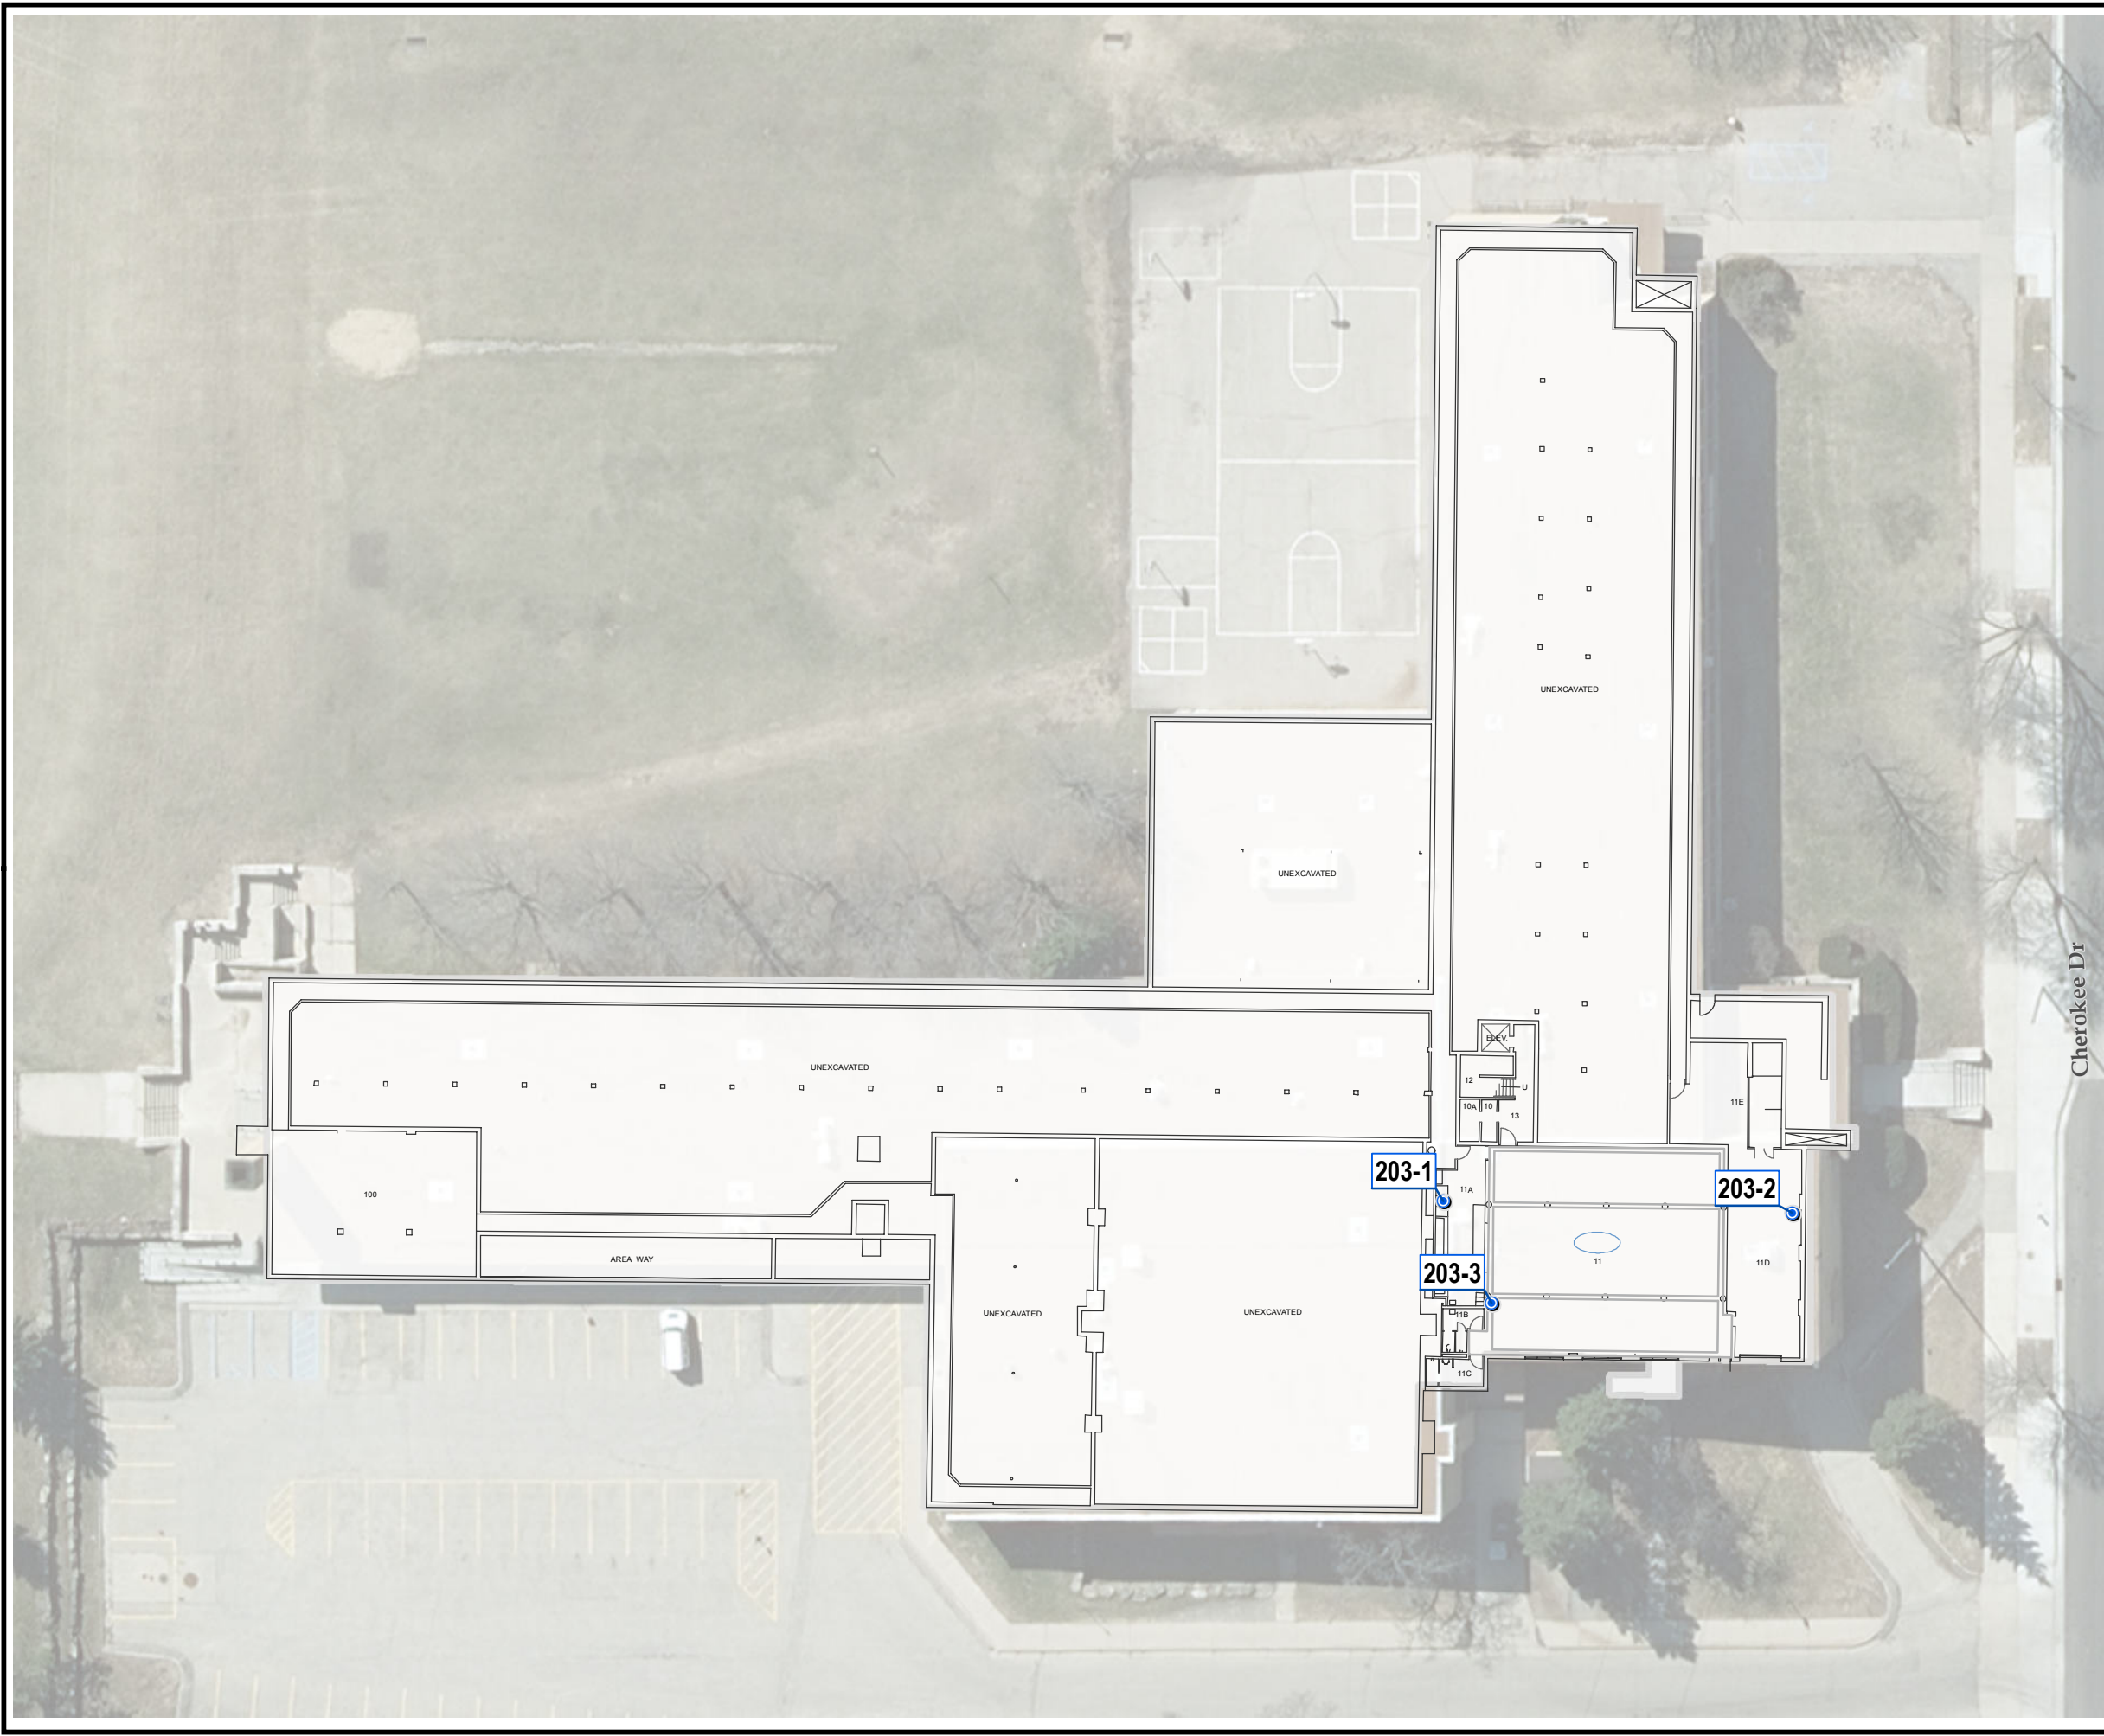
Preliminary sample locations were identified by maps provided by MMSD. Following completion of sampling, TRC prepared a map of each school annotated with the final sample locations and identification numbers for each outlet. See Appendix A: Location Map.
