Subject: Water Testing for Lead
Hawthorne Elementary School
3344 Concord Ave.

As requested by the Madison Metropolitan School District (MMSD), TRC Environmental Corporation (TRC) performed testing for lead in water at Hawthorne Elementary School.

Appendix A
Location Map

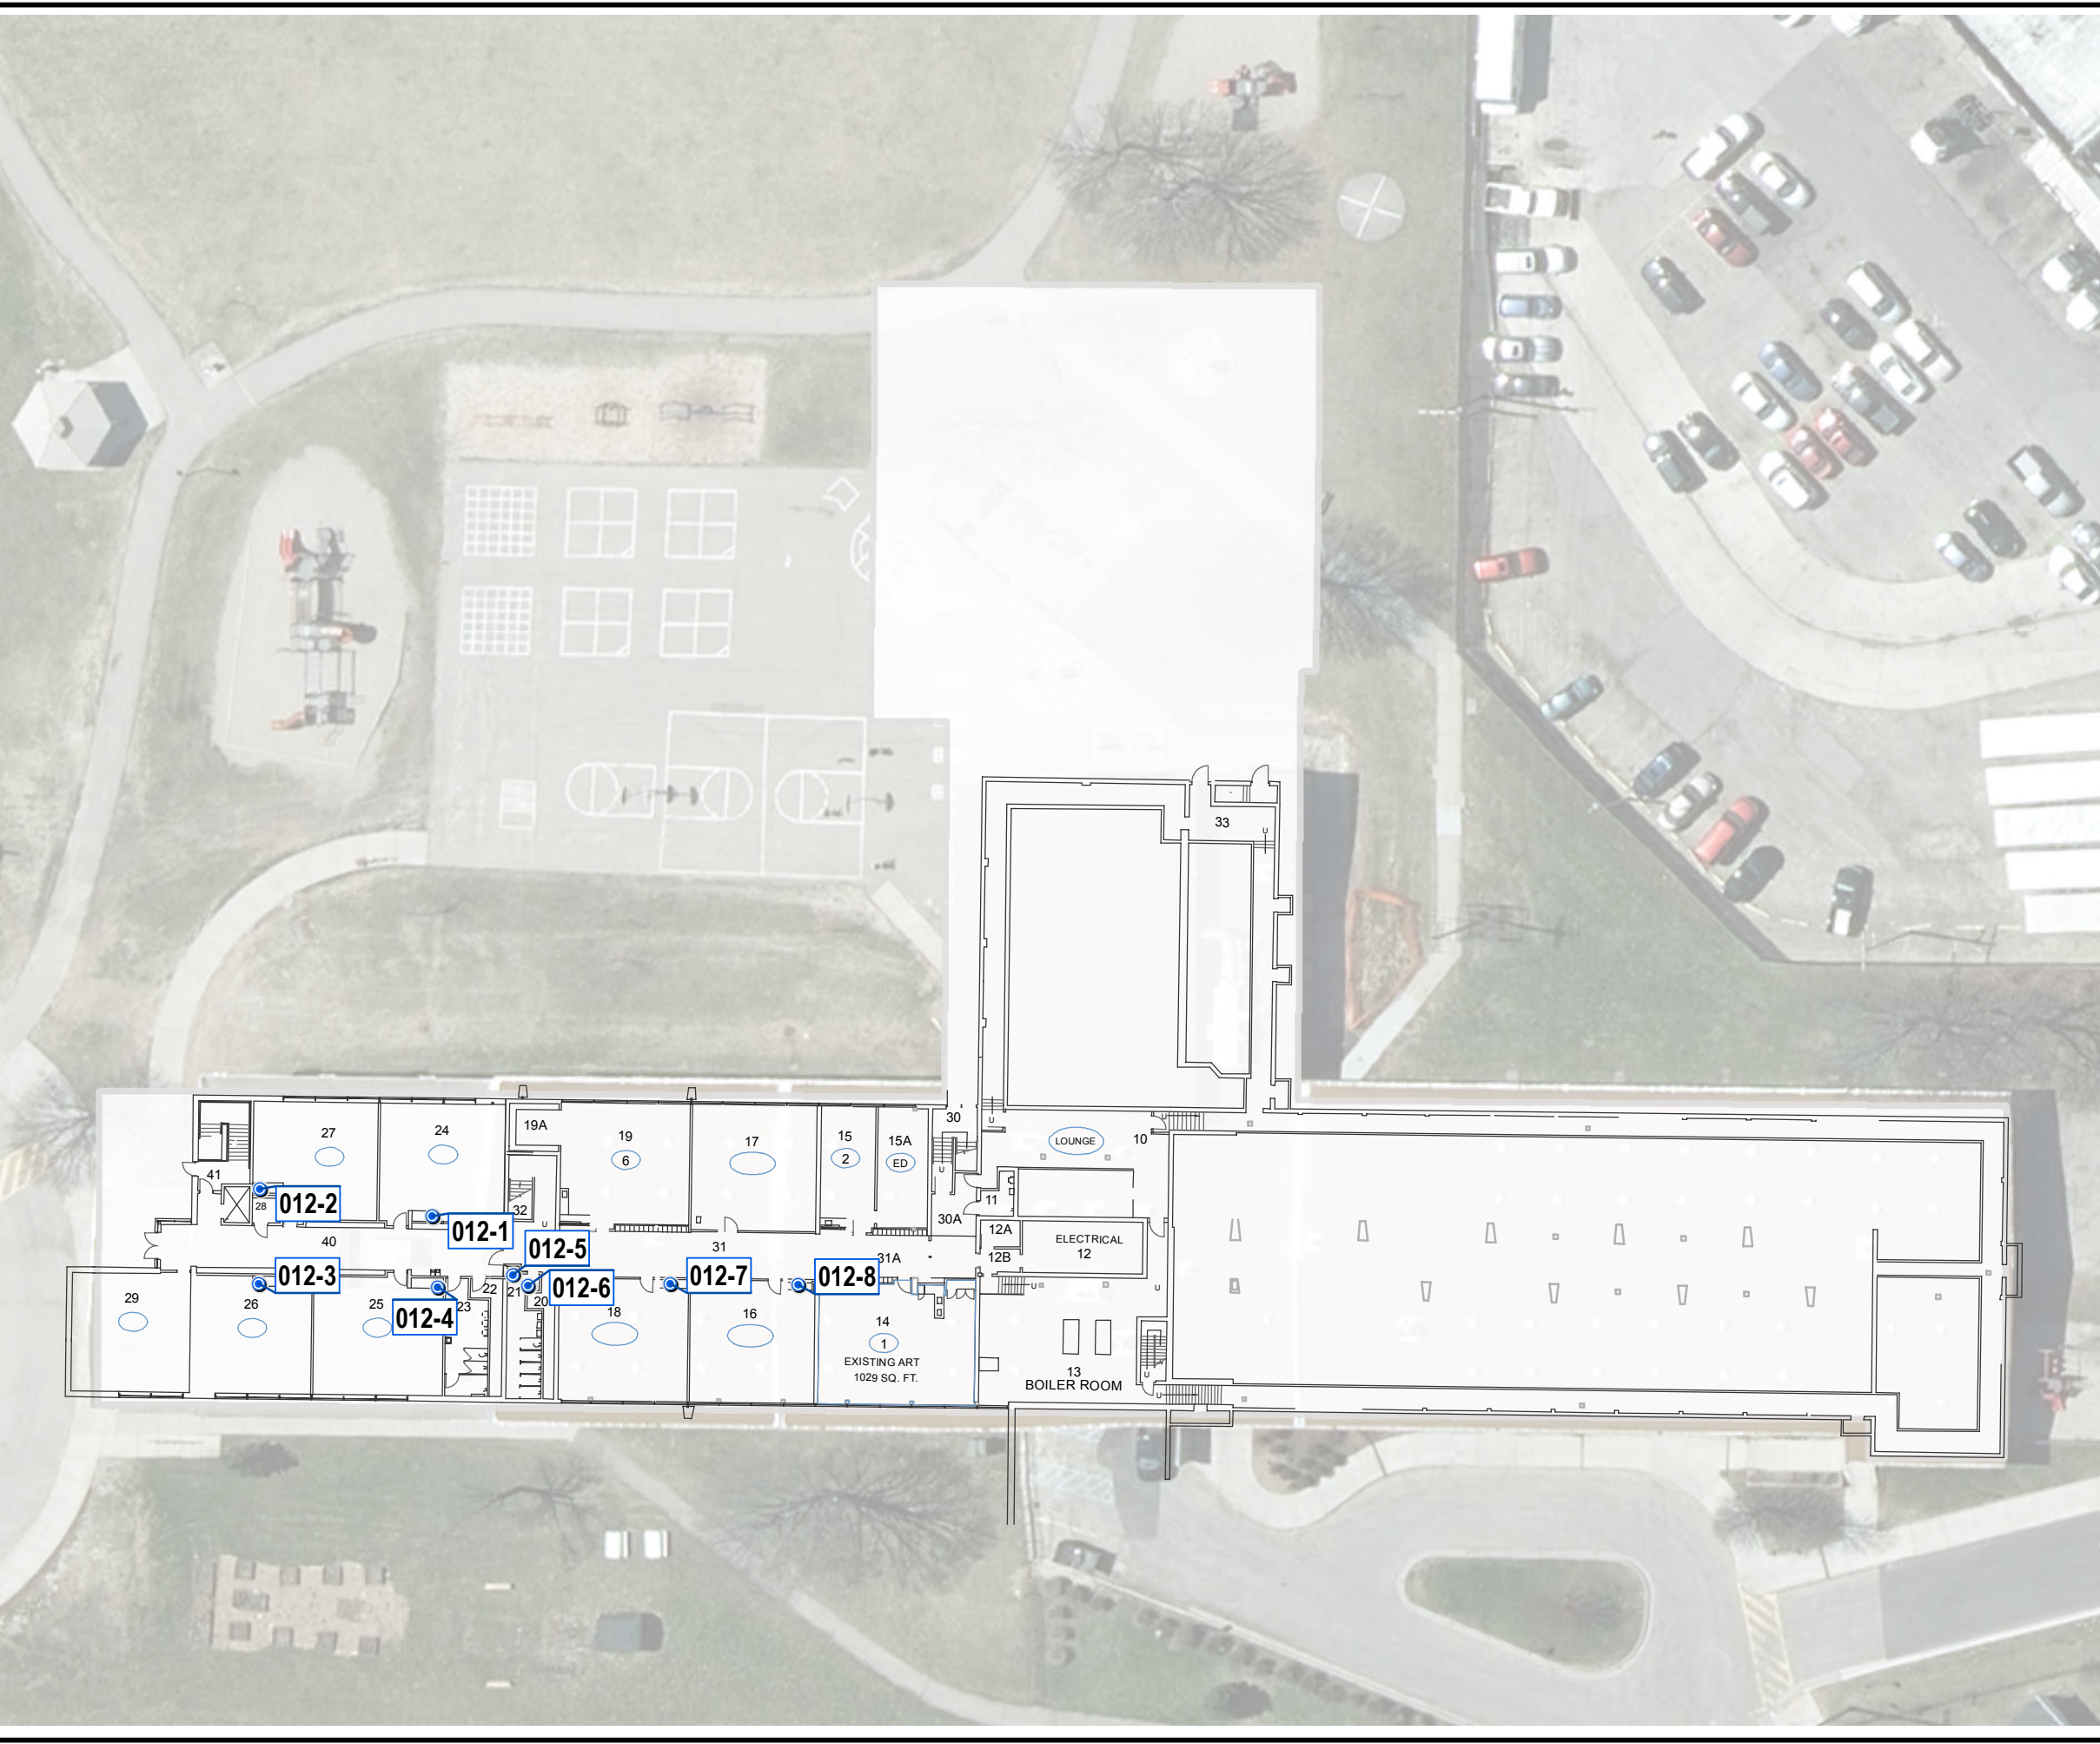
Preliminary sample locations were identified by maps provided by MMSD. Following completion of sampling, TRC prepared a map of each school annotated with the final sample locations and identification numbers for each outlet. See Appendix A: Location Map.
