Subject: Water Testing for Lead
Jefferson Middle School
101 S. Gammon Rd.

As requested by the Madison Metropolitan School District (MMSD), TRC Environmental Corporation (TRC) performed testing for lead in water at Jefferson Middle School.

Location Map

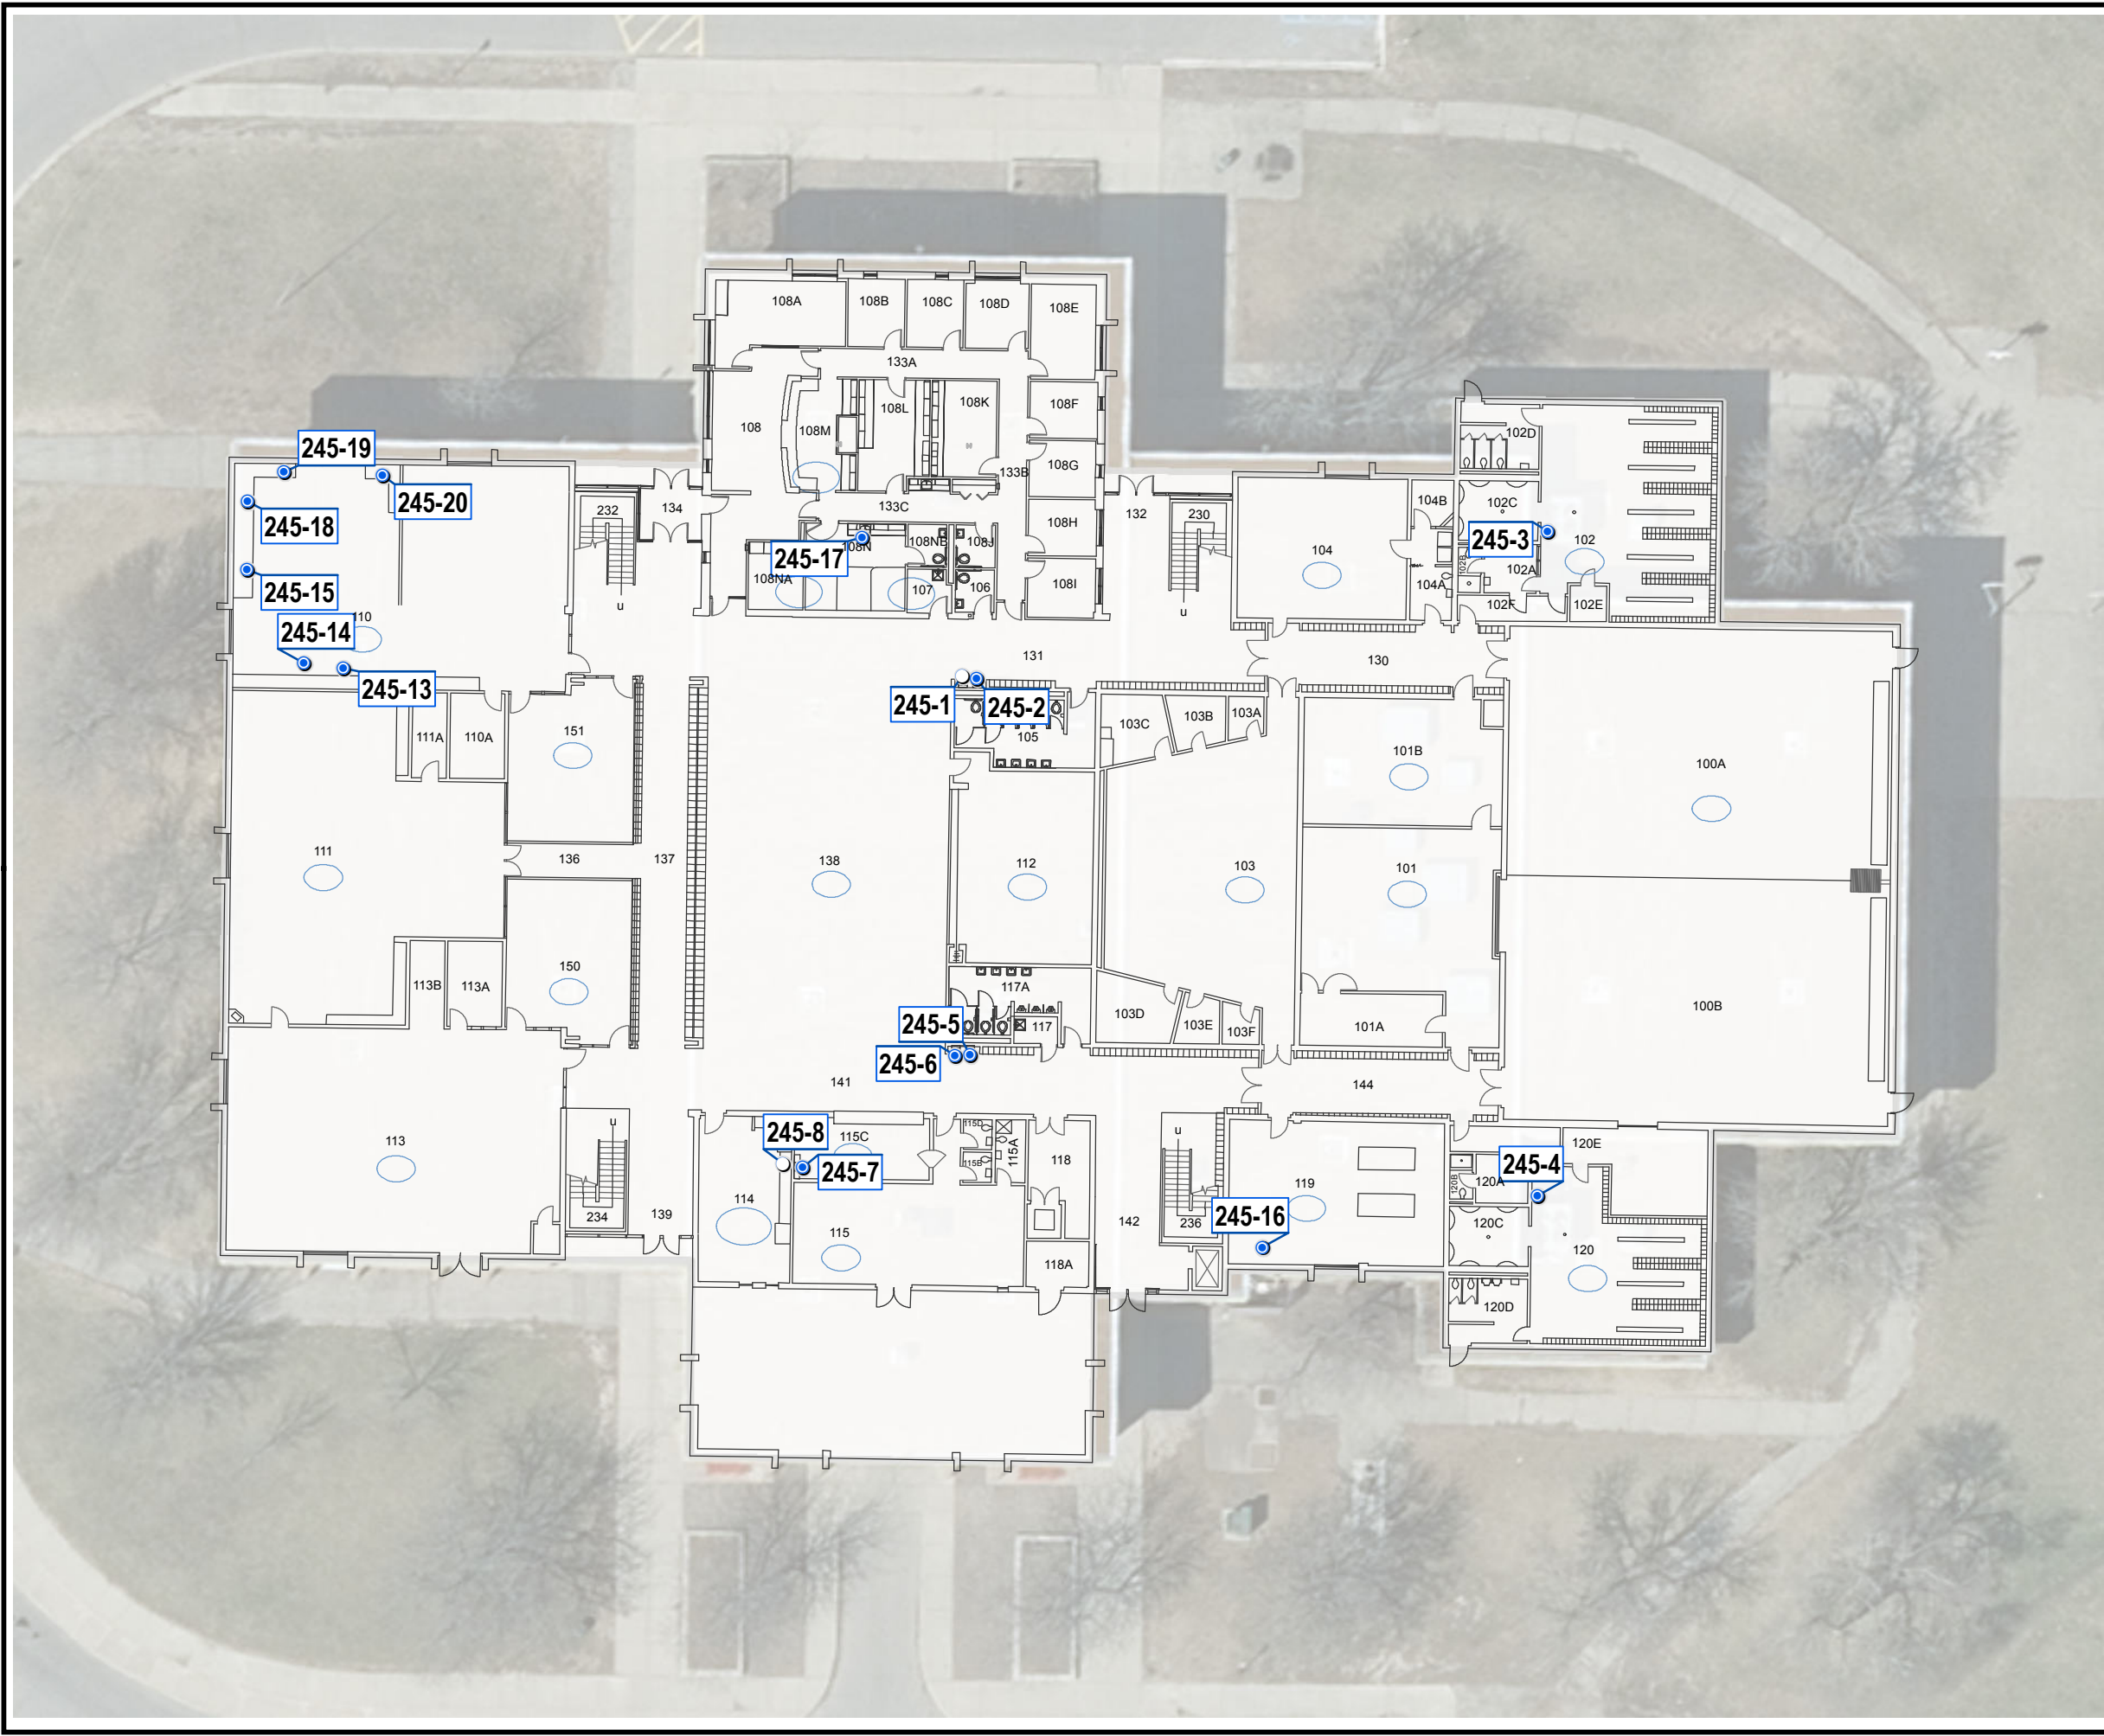
Preliminary sample locations were identified by maps provided by MMSD. Following completion of sampling, TRC prepared a map of each school annotated with the final sample locations and identification numbers for each outlet. See Appendix A: Location Map.

- WATER SAMPLE LOCATION

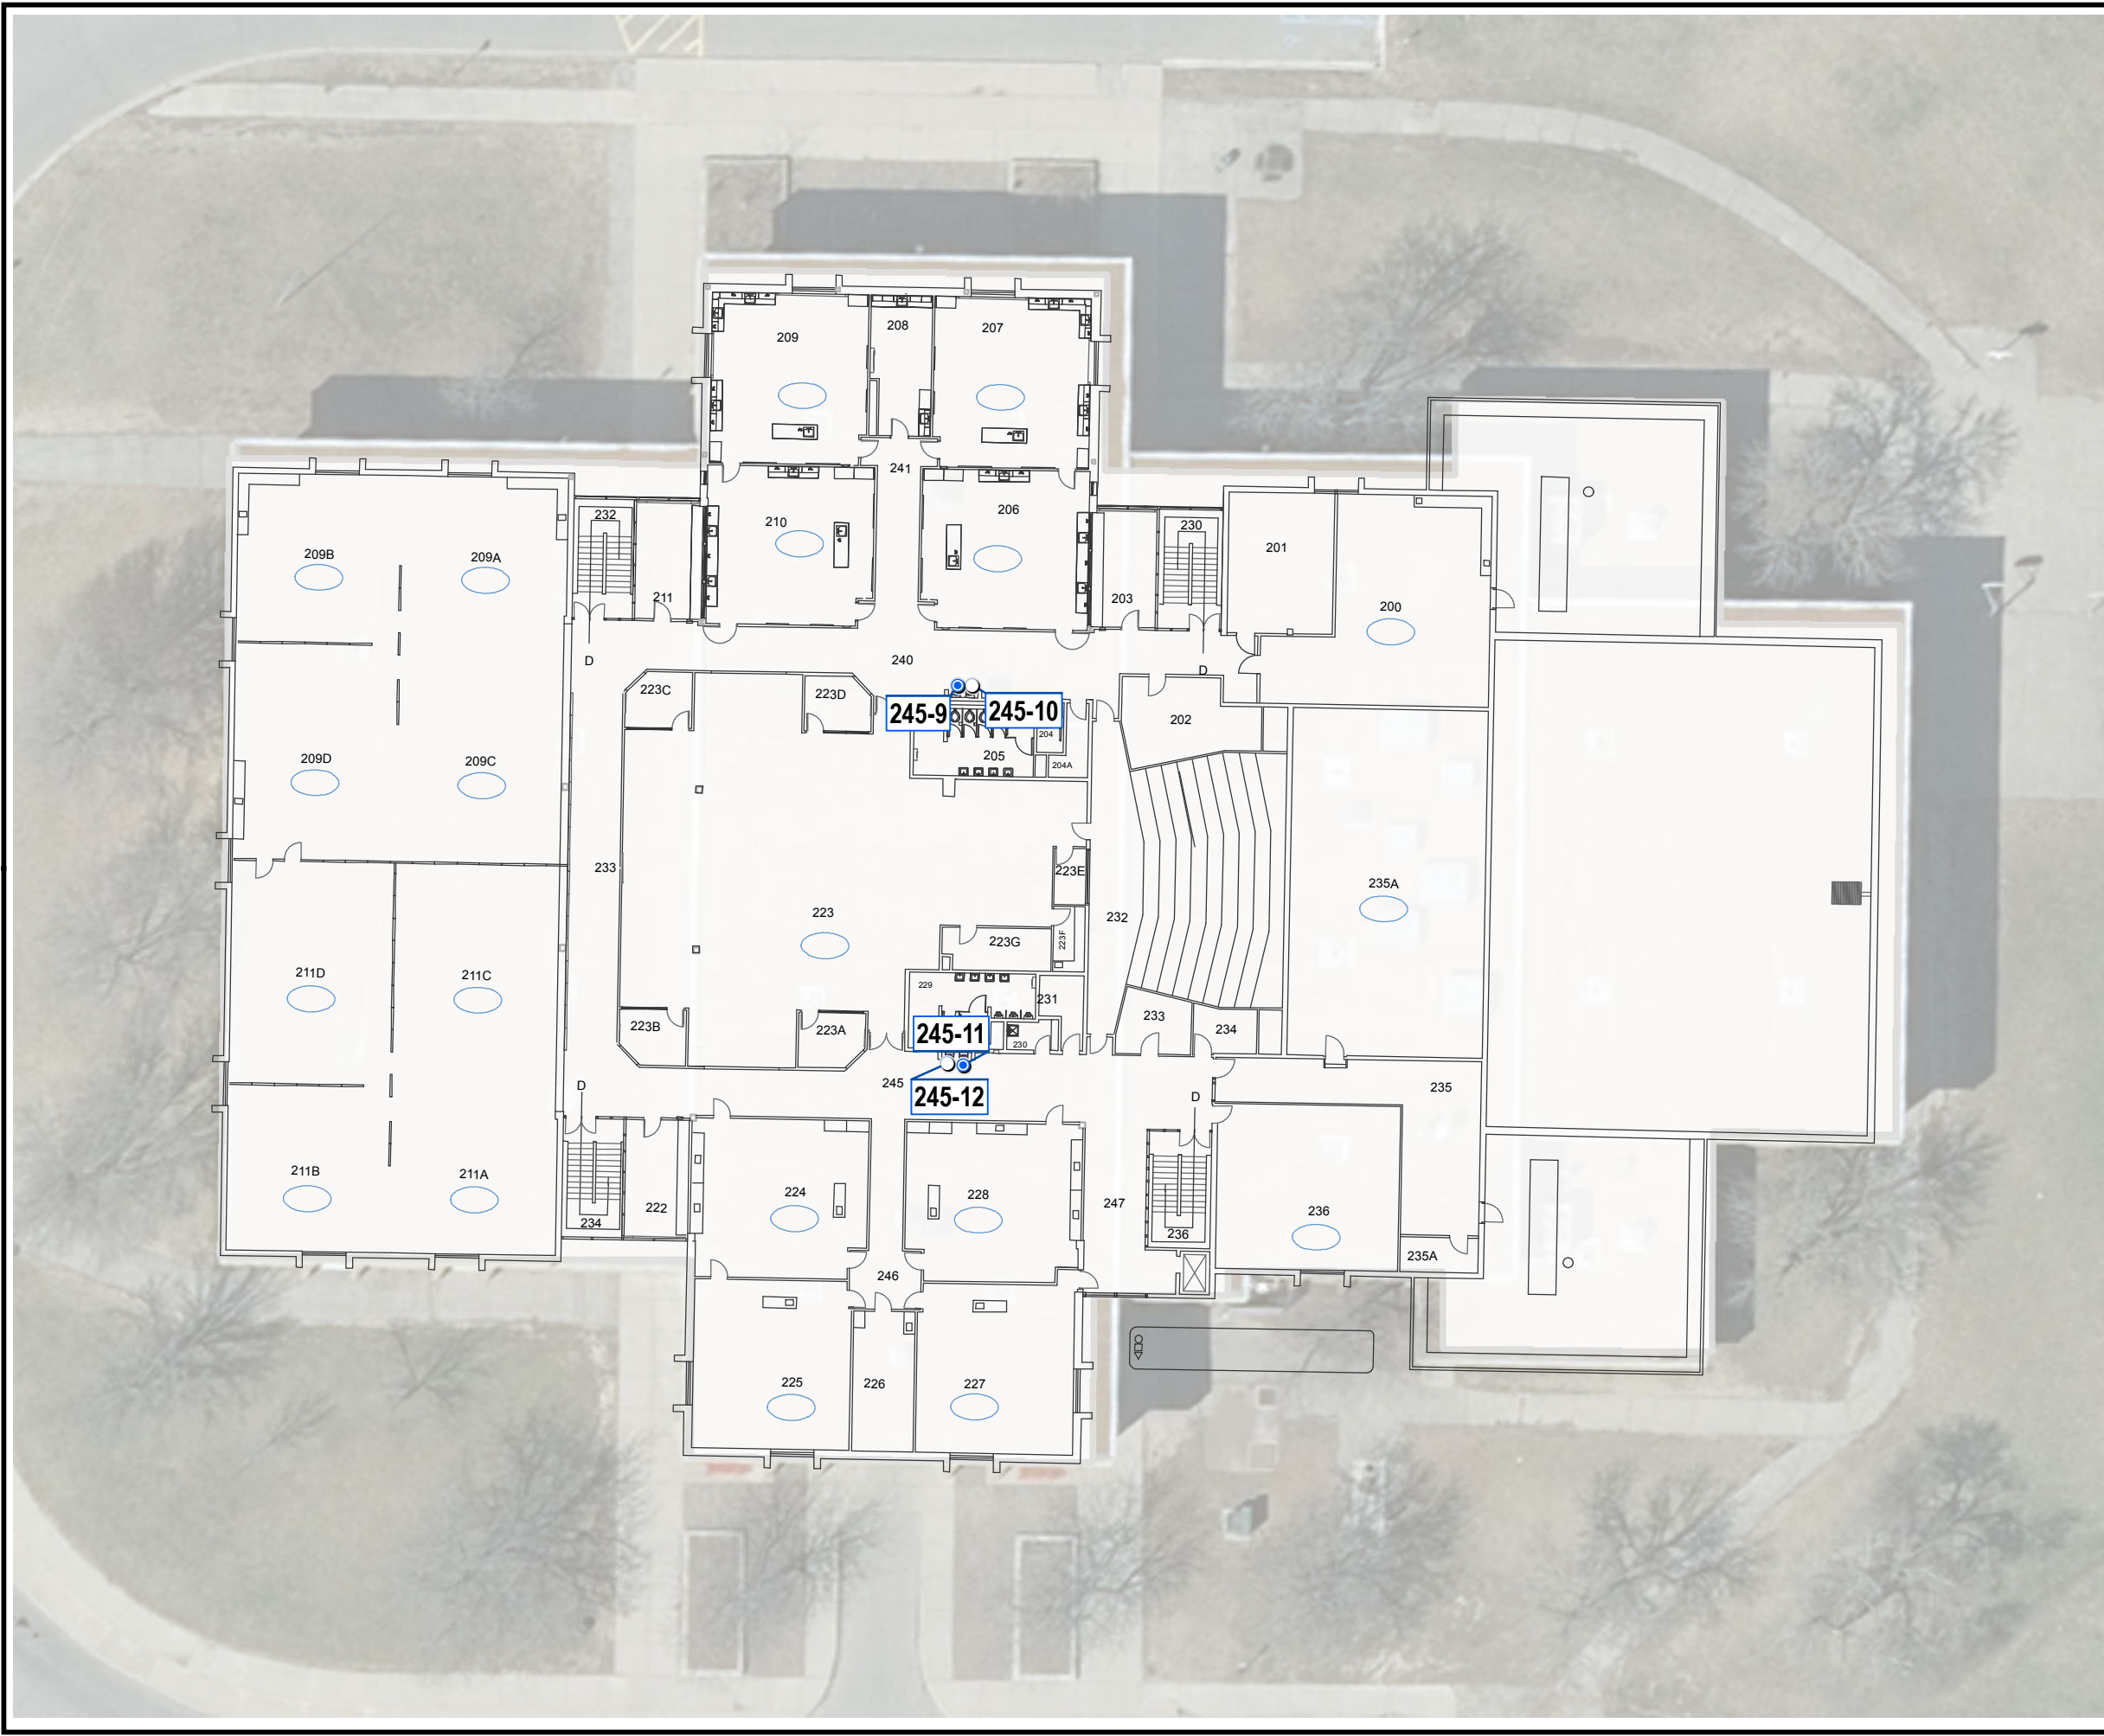
PROJECT:	
MMSD WATER SAMPLING	
TITLE:	
JEFFERSON (245) FLOOR 2 SAMPLES	
DRAWN BY:	J. PAPEZ
CHECKED BY:	A. SCHROEDER
APPROVED BY:	J. WEDEKIND
DATE:	APRIL 2017
FIGURE 1.B

- WATER SAMPLE LOCATION
