Subject: Water Testing for Lead
Shorewood Hills Elementary School
1105 Shorewood Blvd.

As requested by the Madison Metropolitan School District (MMSD), TRC Environmental Corporation (TRC) performed testing for lead in water at Shorewood Hills Elementary School.

Appendix A
Location Map

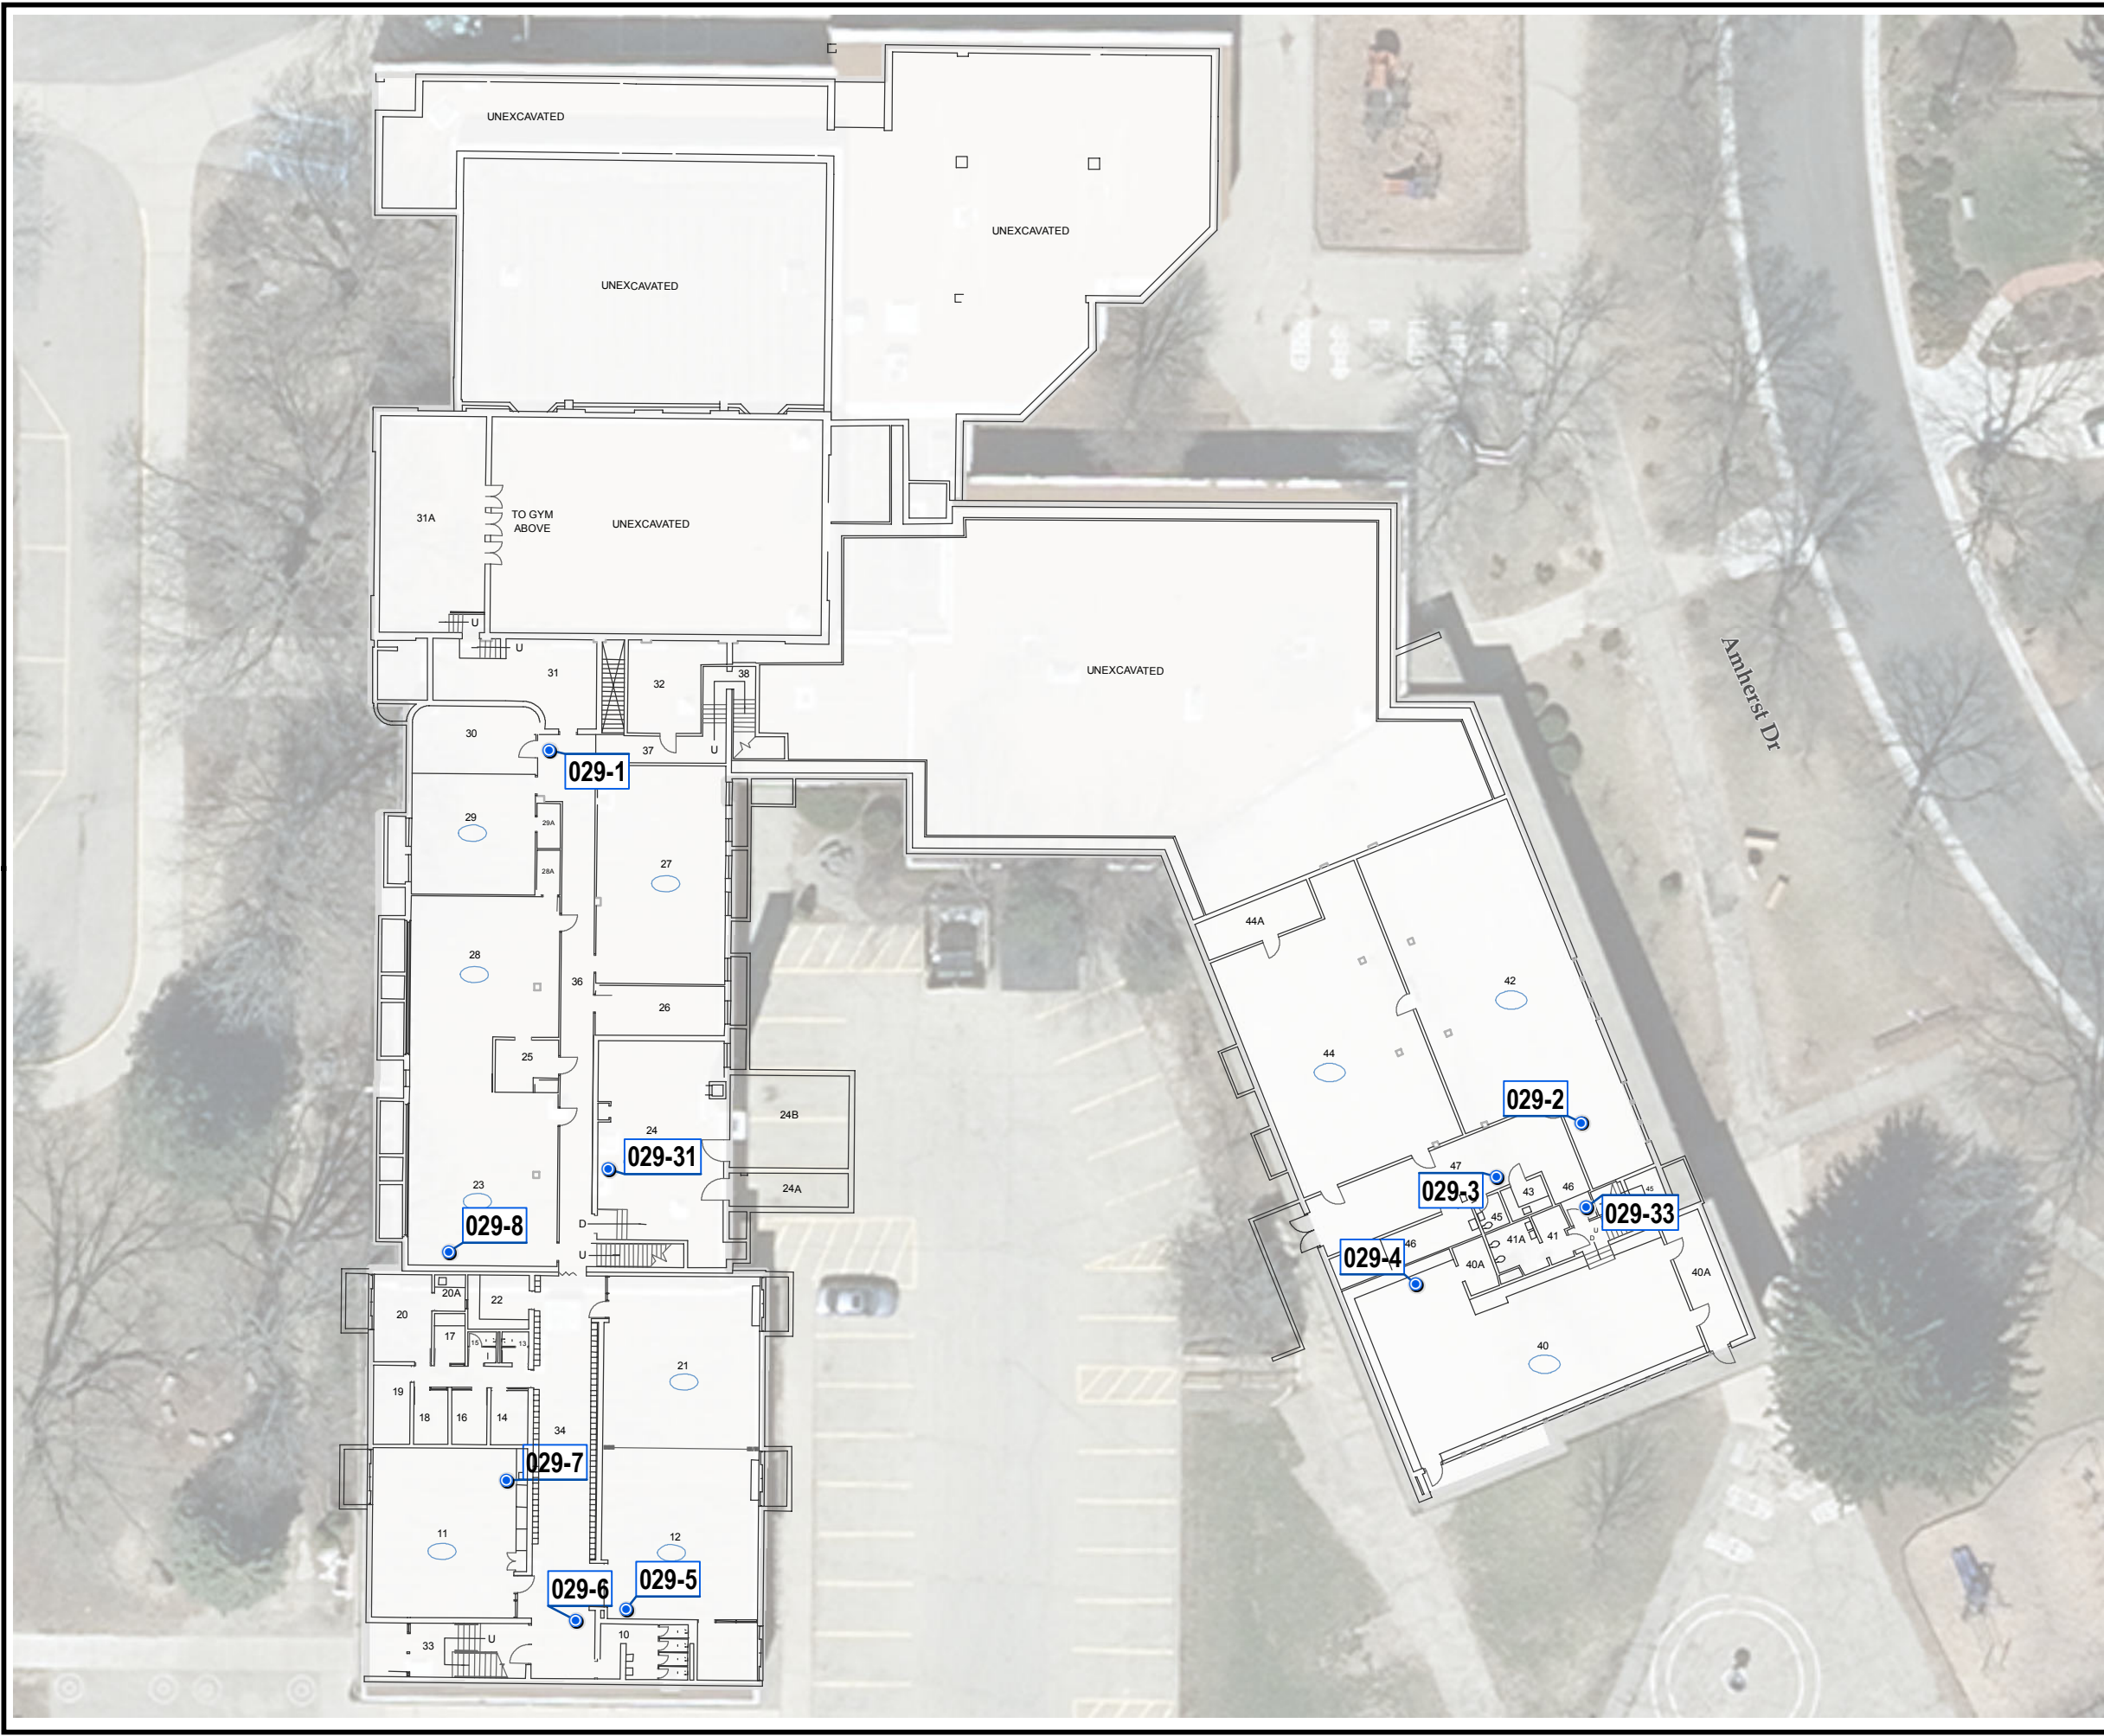
Preliminary sample locations were identified by maps provided by MMSD. Following completion of sampling, TRC prepared a map of each school annotated with the final sample locations and identification numbers for each outlet. See Appendix A: Location Map.
