# EXISTING SITE CONDITIONS LA VETA TK-6 ELEMENTARY

## Orange Unified School District Facilities Master Plan

2800 E. La Veta Ave., Orange CA 92869

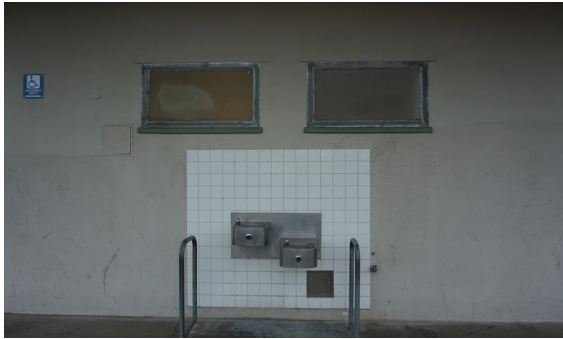
Typical water fountains in need of an update.

- The drinking fountains are original and need to be replaced.

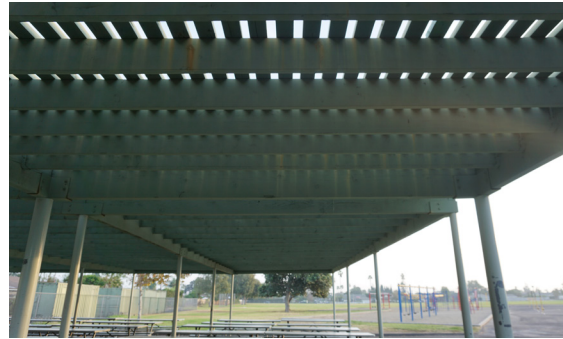
Wood-slat lunch shelter in need of an update.

- days and create root issues.
- Lunch Shelter - Existing lunch shelter is in poor condition due to termite damage. Requires ongoing repairs.

- The wood shelter needs to be replaced.

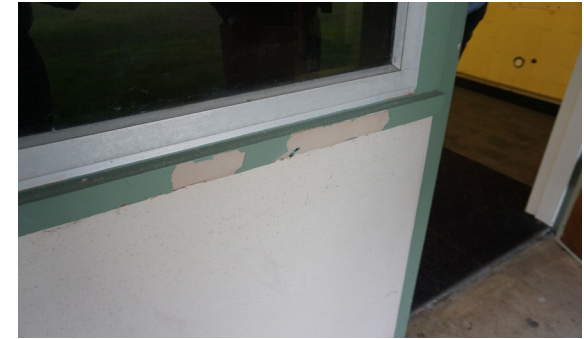
Window trim in need of replacing.

- Plexiglas Windows : Fogged, scratched, hazy and caulking damage
- The window systems are original and need to be replaced.

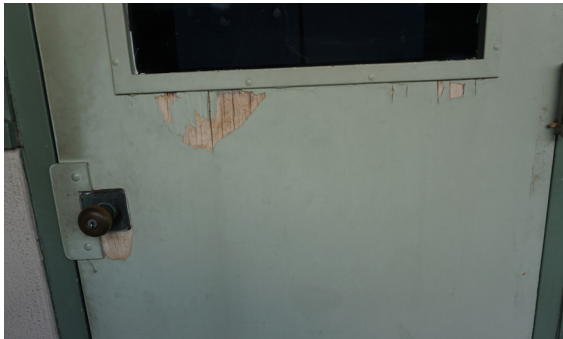
Doors and door hardware in need of replacing.

- Doors and Door Jambs: Scuffed, chipped, and peeling paint throughout
- The doors and frames are original and need to be replaced.

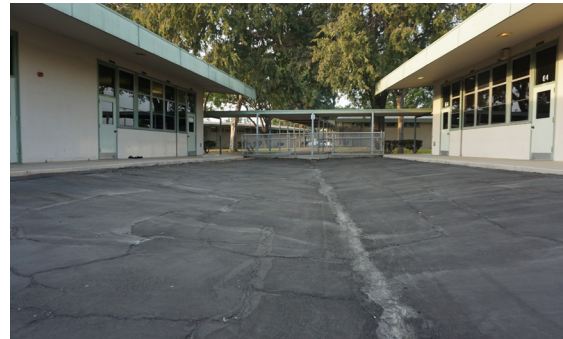
Flooding issues between buildings.

- The storm drain system needs to be repaired to address the flooding on site between buildings.

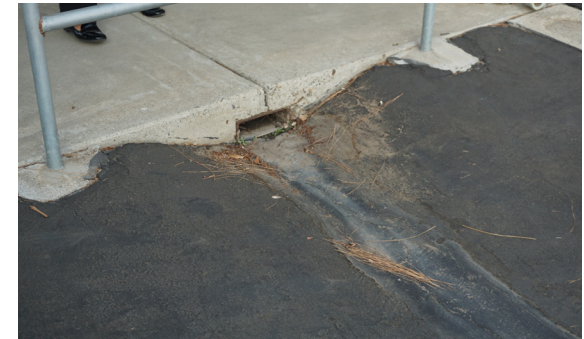
Drainage issues around campus.

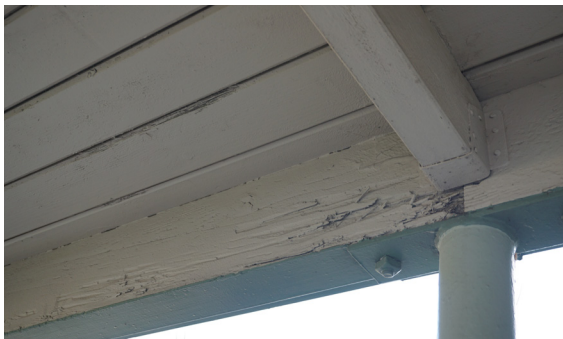
Building fascia boards need attention.

- Exterior painting is needed on many buildings.
- The fascia boards on most buildings need to be replaced.

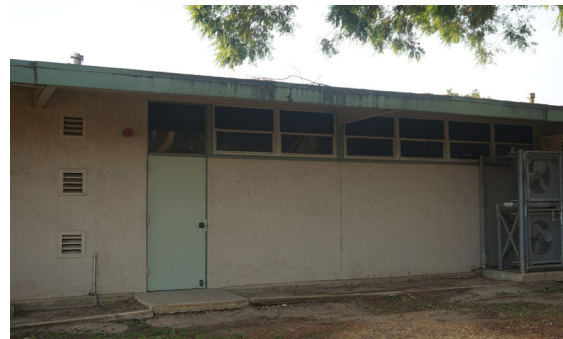
Building exteriors need attention.

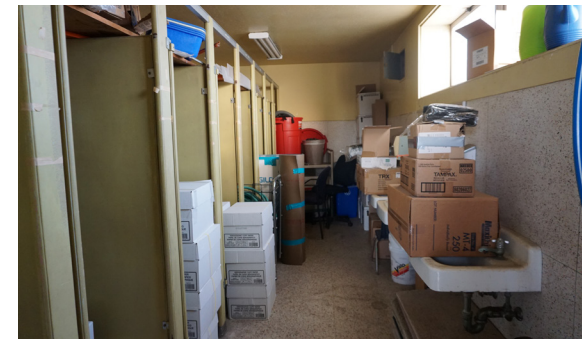
In need of proper storage - bathroom converted to storage.
