<b>Project Name:</b>	Fairfield Ward High School				
<b>Client Info:</b>	Fairfield Public Schools	<b>Site Info:</b>	Football Field		
<b>Report Date:</b>	5/10/23	<b>Test Date:</b>	5/9/23		
<b>Report Status:</b>	Complete	<b>Job #:</b>	23504449		
<b>Prepared by:</b>	Roger Clough				
<b>Checked by:</b>	James Leszuk

New England Turf Management was commissioned to perform on-site Gmax impact testing per ASTM F1936. A complete test was performed in accordance with the ASTM F1936 Standard. The results have been summarized in the quick reference table below. Complete results and background can be found in the subsequent sections of this report.

# On-Site Testing GMAX Impact Evaluation

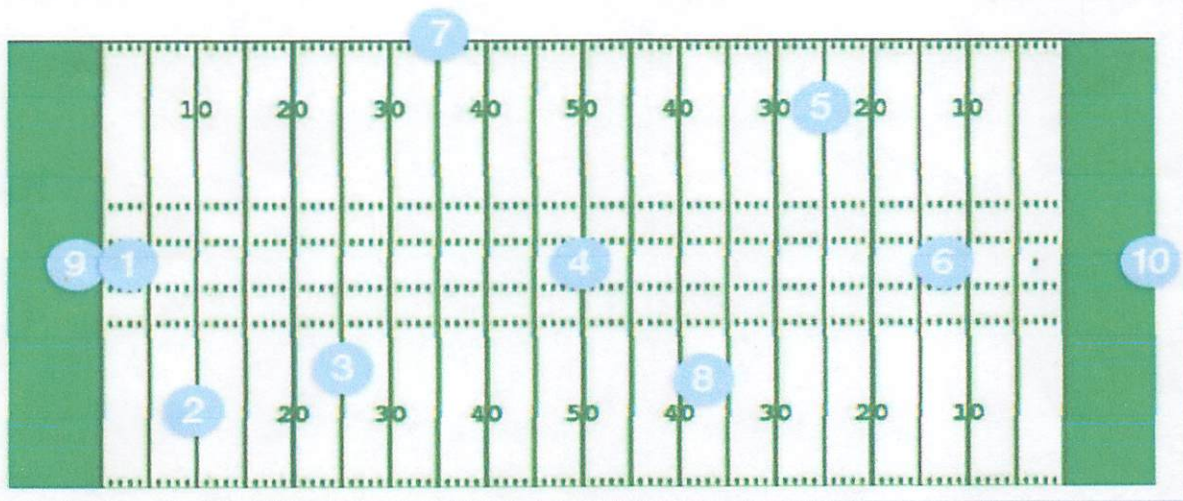
## Location Map

The above table outlines your Gmax score for the second and third drop at each location on the field and an average Gmax score for both drops. The location numbers correspond to the above field map. It also includes an infill depth reading. Per ASTM standards your Gmax score should be under 200.
