**Project Information**

<b>Project Name:</b>	Fairfield Ludlowe High School		
<b>Client Info:</b>	Fairfield Public Schools	<b>Site Info:</b>	Football Field
<b>Report Date:</b>	5/10/2023	<b>Test Date:</b>	5/9/2023
<b>Report Status:</b>	Complete	<b>Job #:</b>	23504449
<b>Prepared by:</b>	Roger Clough		
<b>Checked by:</b>	James Leszuk

# On-Site Testing GMAX Impact Evaluation

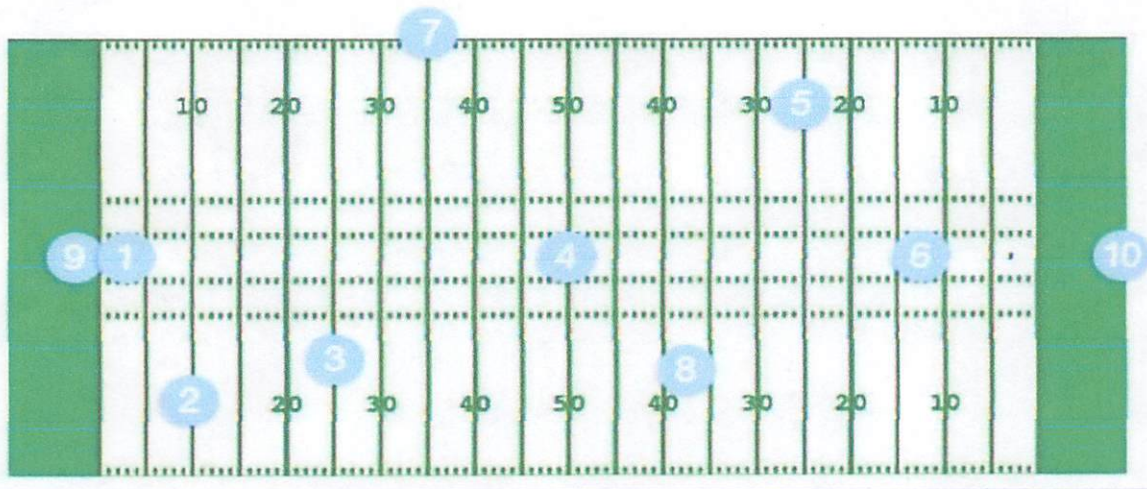
## Location Map

The above table outlines your Gmax score for the second and third drop at each location on the field and an average Gmax score for both drops. The location numbers correspond to the above field map. It also includes an infill depth reading. Per ASTM standards your Gmax score should be under 200.

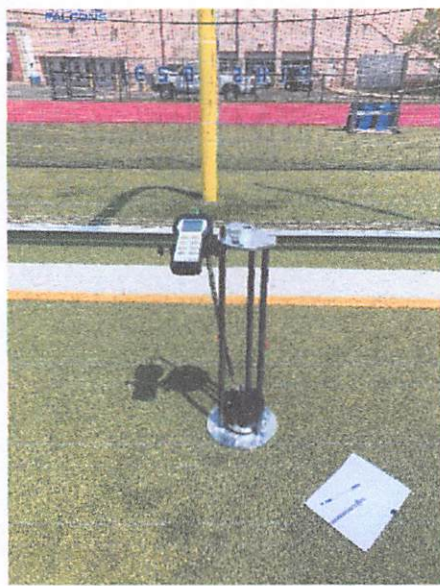
**Drop #9**

Loc#	Drop #	Gmax (g's)	Location Description	Gmax Avg (g's)	Infill Depth (mm)	Surface Temp (°F)
7	3	158		157	30	60
8	2	152			29	60
8	3	156		154	29	60
9	2	160			31	60
9	3	163		162	31	60
10	2	156			30	60
10	3	159		157	30	60

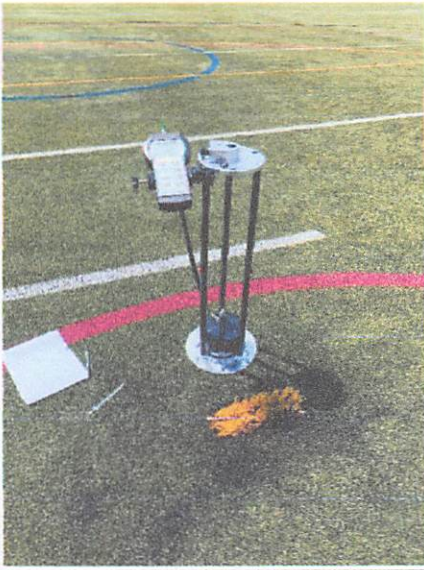
Location #1

Loc#	Drop #	Gmax (g's)	Location Description	Gmax Avg (g's)	Infill Depth (mm)	Surface Temp (°F)
1	2	185			25	60
1	3	187		186	25	60
2	2	145			29	60
2	3	149		147	29	60
3	2	163			25	60
3	3	162		162	25	60
4	2	166			29	60
4	3	168		167	29	60
5	2	161			30	60
5	3	166		164	30	60
6	2	200			18	60
6	3	214		207	18	60
7	2	155			30	60
