Field and Building Access Photo Locations

Woodland Field and Building Access Picture Index

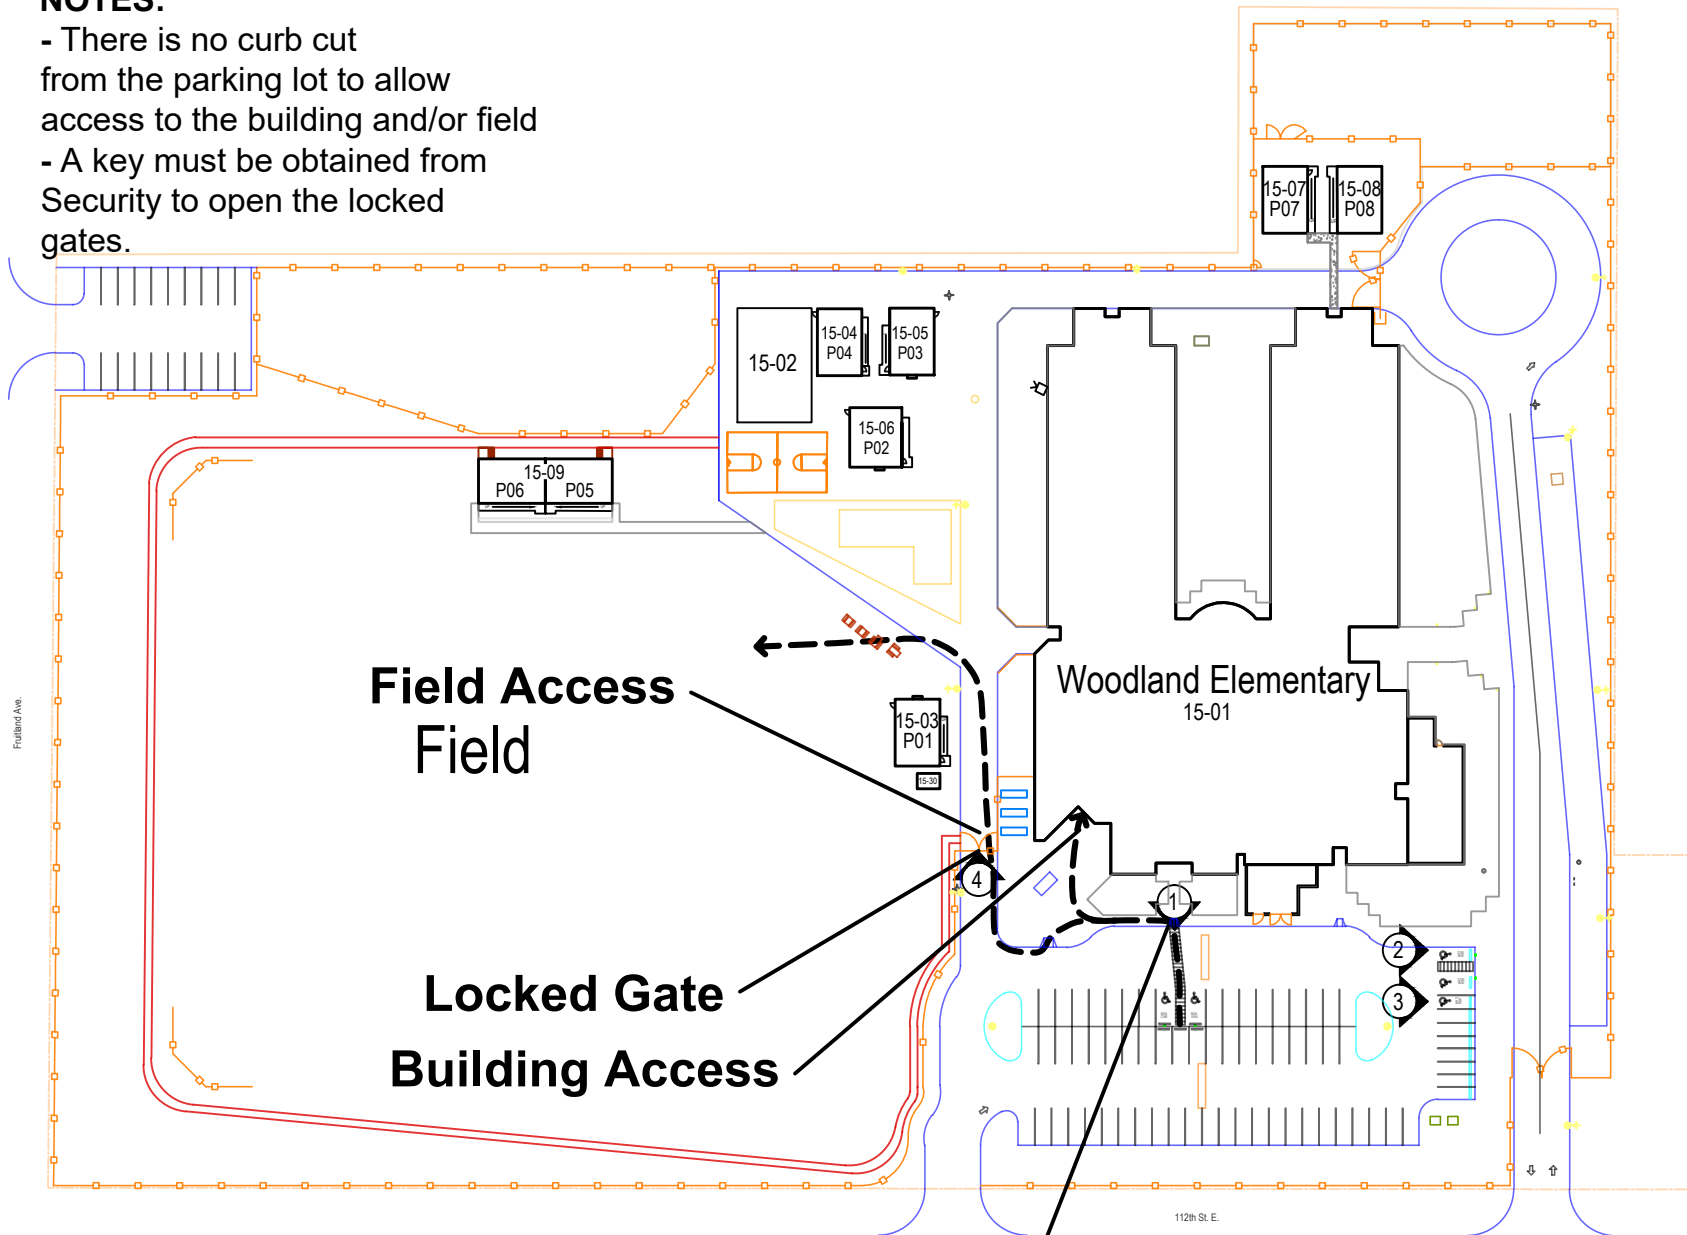
- There is no curb cut from the parking lot to allow access to the building and/or field
- A key must be obtained from Security to open the locked gates.

Curb cuts do not meet ADA standards

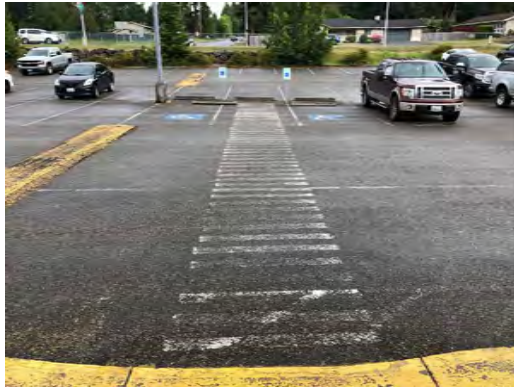
1

From main ADA stalls in parking lot, use the crosswalk and curb cut to gain access to the sidewalk. Note that the curb cut does not meet all ADA standards. For building access, use the nearest door, at the southwest corner of the school.

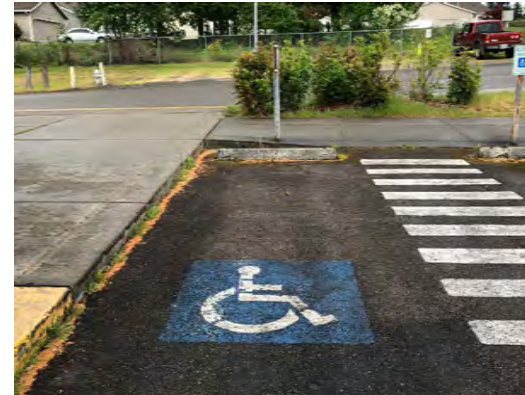
2

The other ADA stalls, at the east end of the parking lot, are both car stalls. The curb cut does not meet all ADA standards.

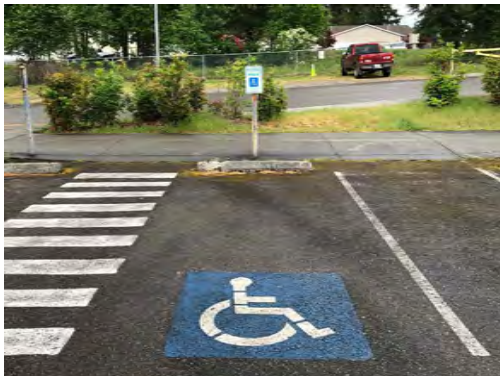
3

Note that the right ADA stall at the east end of the parking lot looks very wide due to there being excess room.

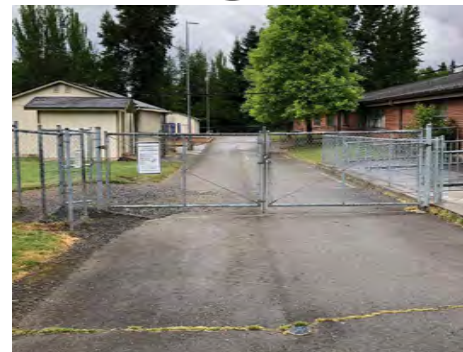
4

For field access, continue to the north western part of the parking lot. Continue straight through the vehicle gate, and follow the pathway, on your left, out to the fields. Note that this gate is locked at most times. A key may be obtained from Security.
