School Name: Lake Elmo Elementary (LE)

Date: 5/4/2023

Lake Elmo Elementary  
Lead in Drinking Water  
First Floor  
Project #23072

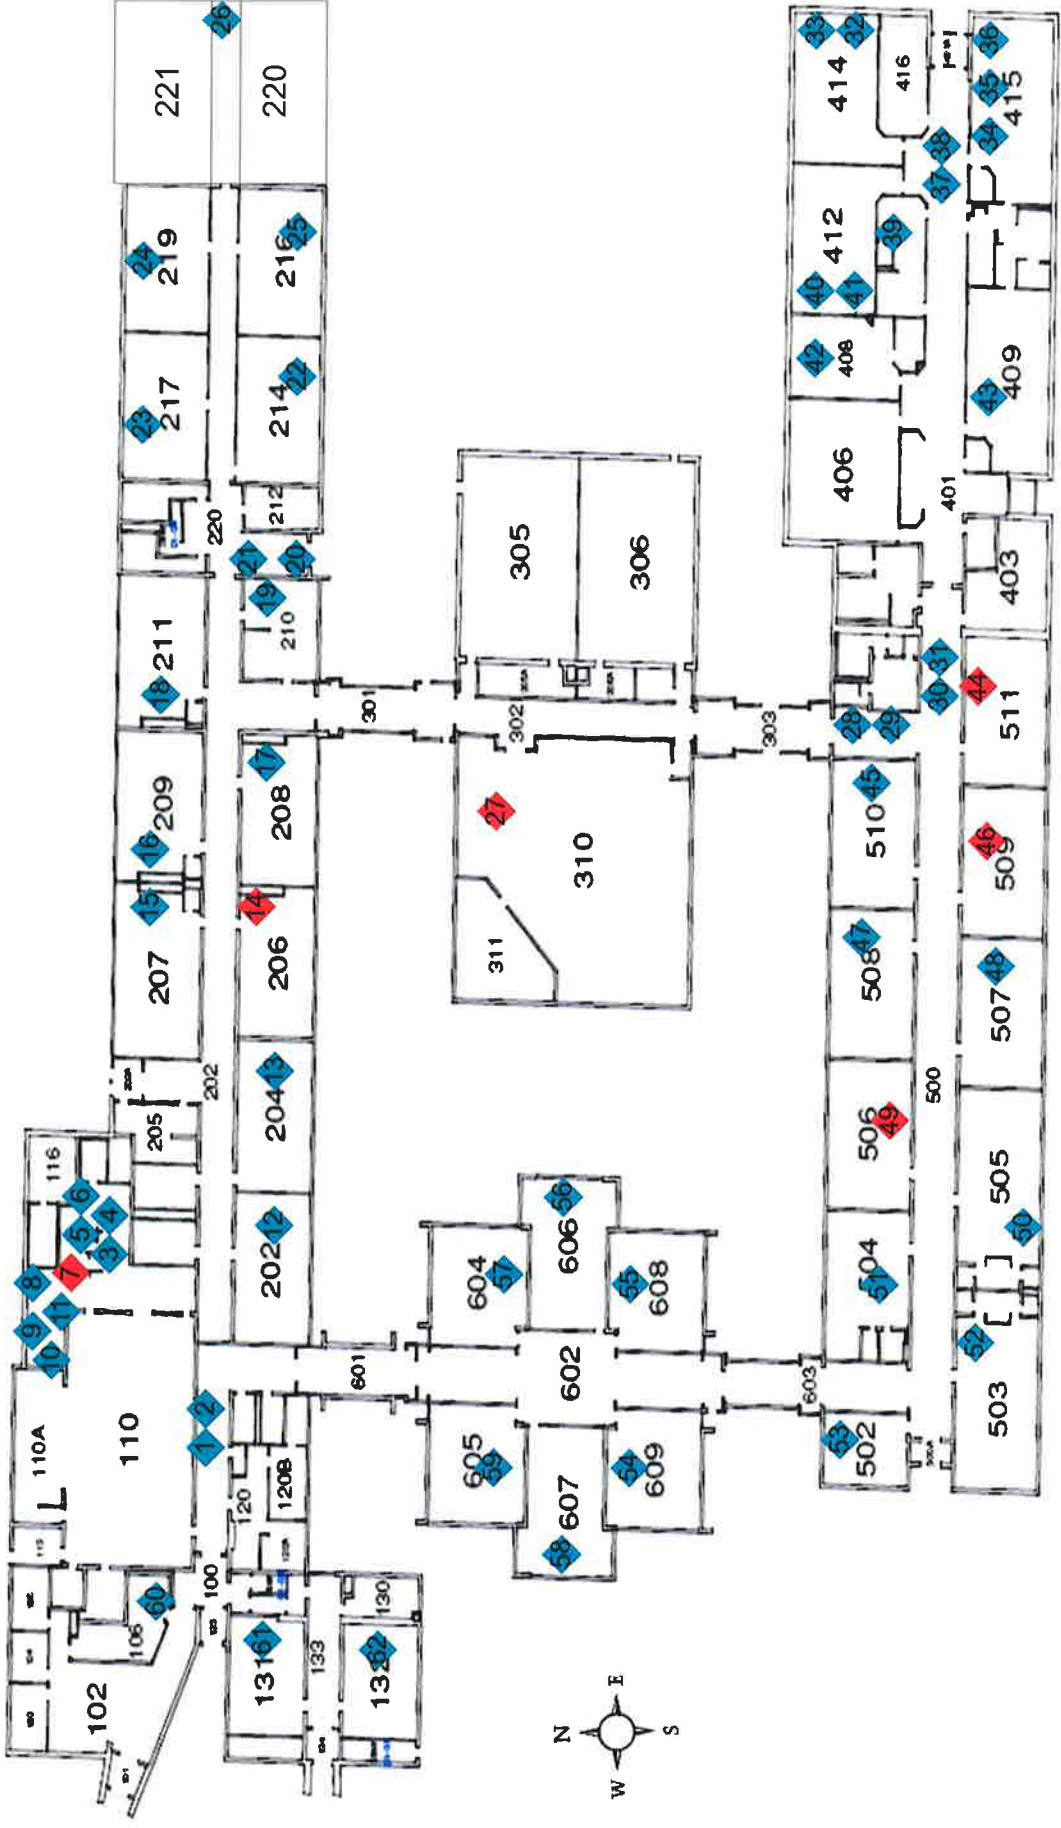
First Draw Sampling (2023)

- Blue Diamond: Lead <= 20 ppb
- Red Diamond: Lead > 20 ppb

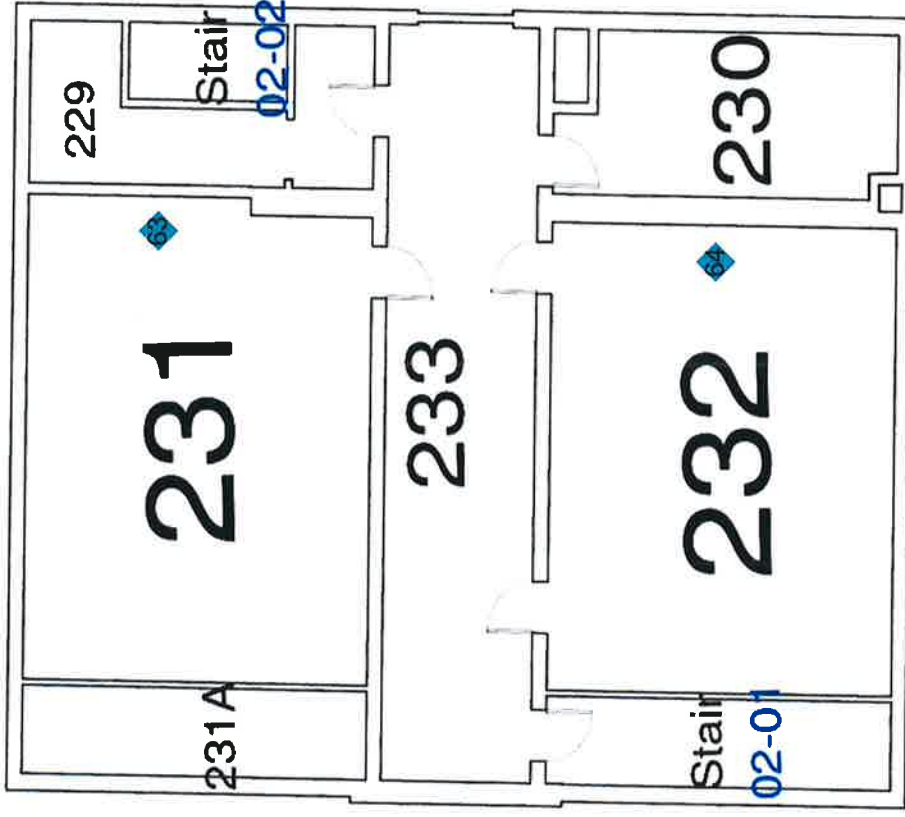
Lake Elmo Elementary  
Lead in Drinking Water  
Second Floor  
Project #23072

First Draw Sampling (2023)

- ◆ Lead  $\leq$  20 ppb
- ◆ Lead  $>$  20 ppb

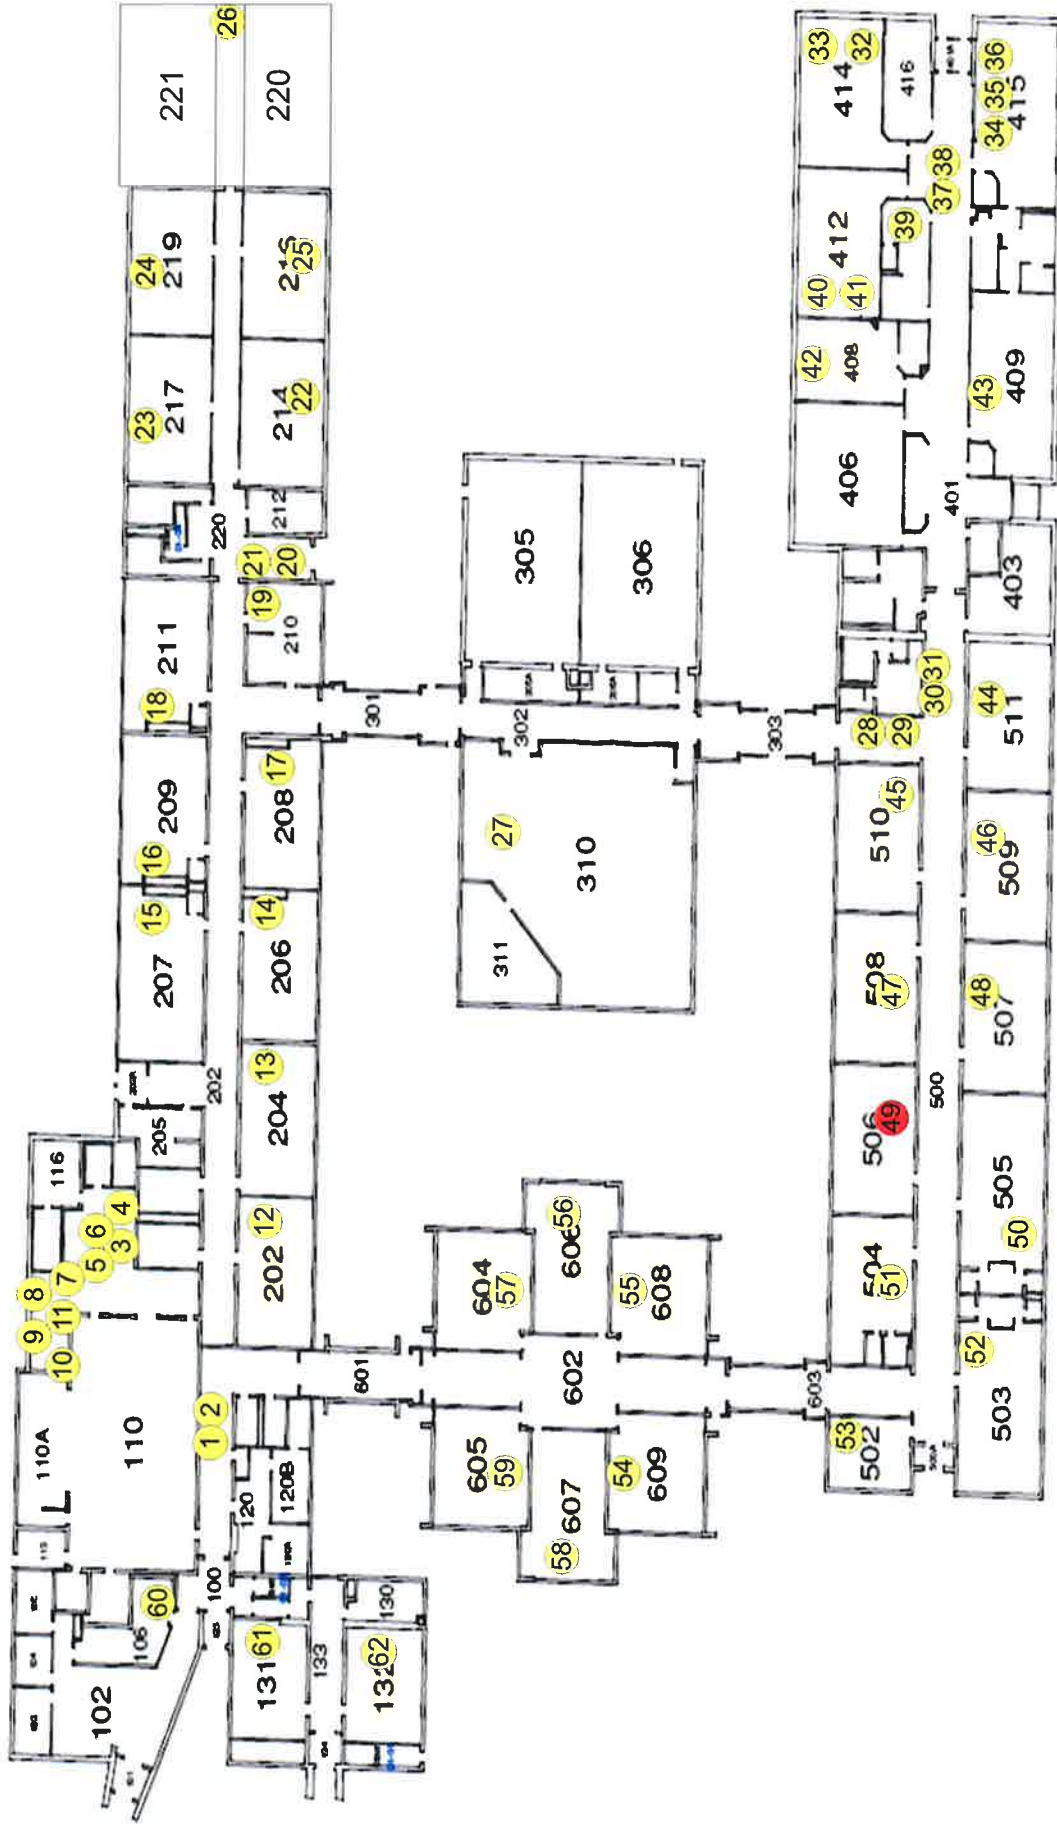
Lake Elmo Elementary  
Copper in Drinking Water  
First Floor  
Project #23072

First Draw Sampling (2023)

- Copper ≤ 1300
- Copper > 1300

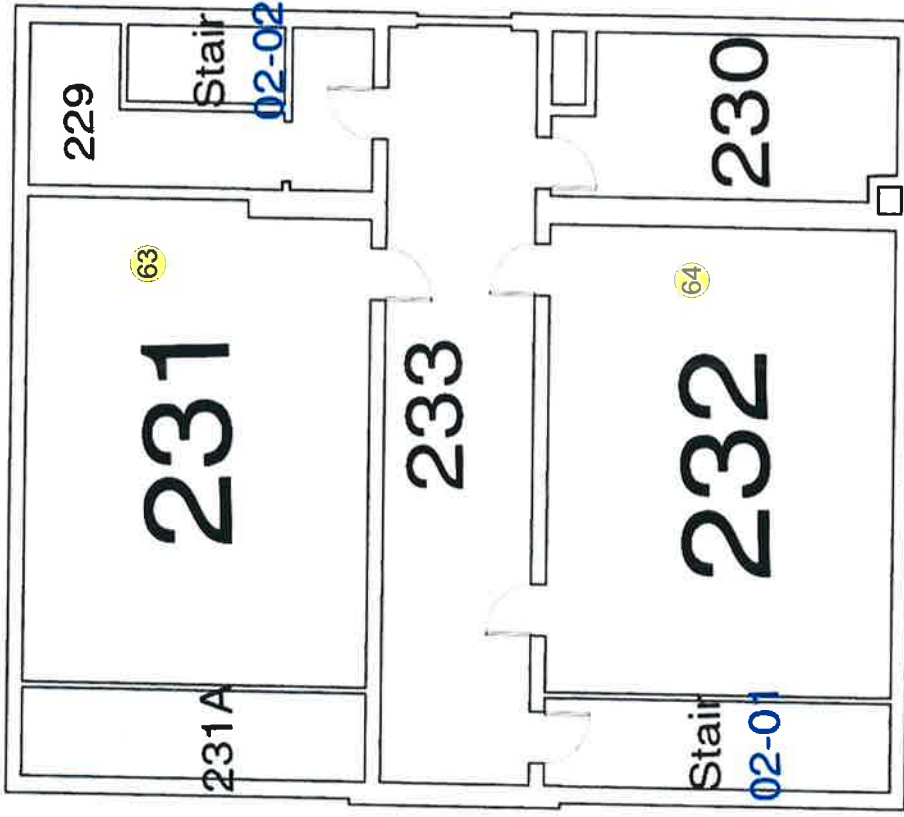
Lake Elmo Elementary  
Copper in Drinking Water  
Second Floor  
Project #23072

First Draw Sampling (2023)

● Copper  $\leq$  1300

● Copper  $>$  1300
