School Name: **Oak Park Building (OP)**Date: **5/4/2023**

Oak Park Elementary
 First Floor
 Lead in Drinking Water
 Project #23072

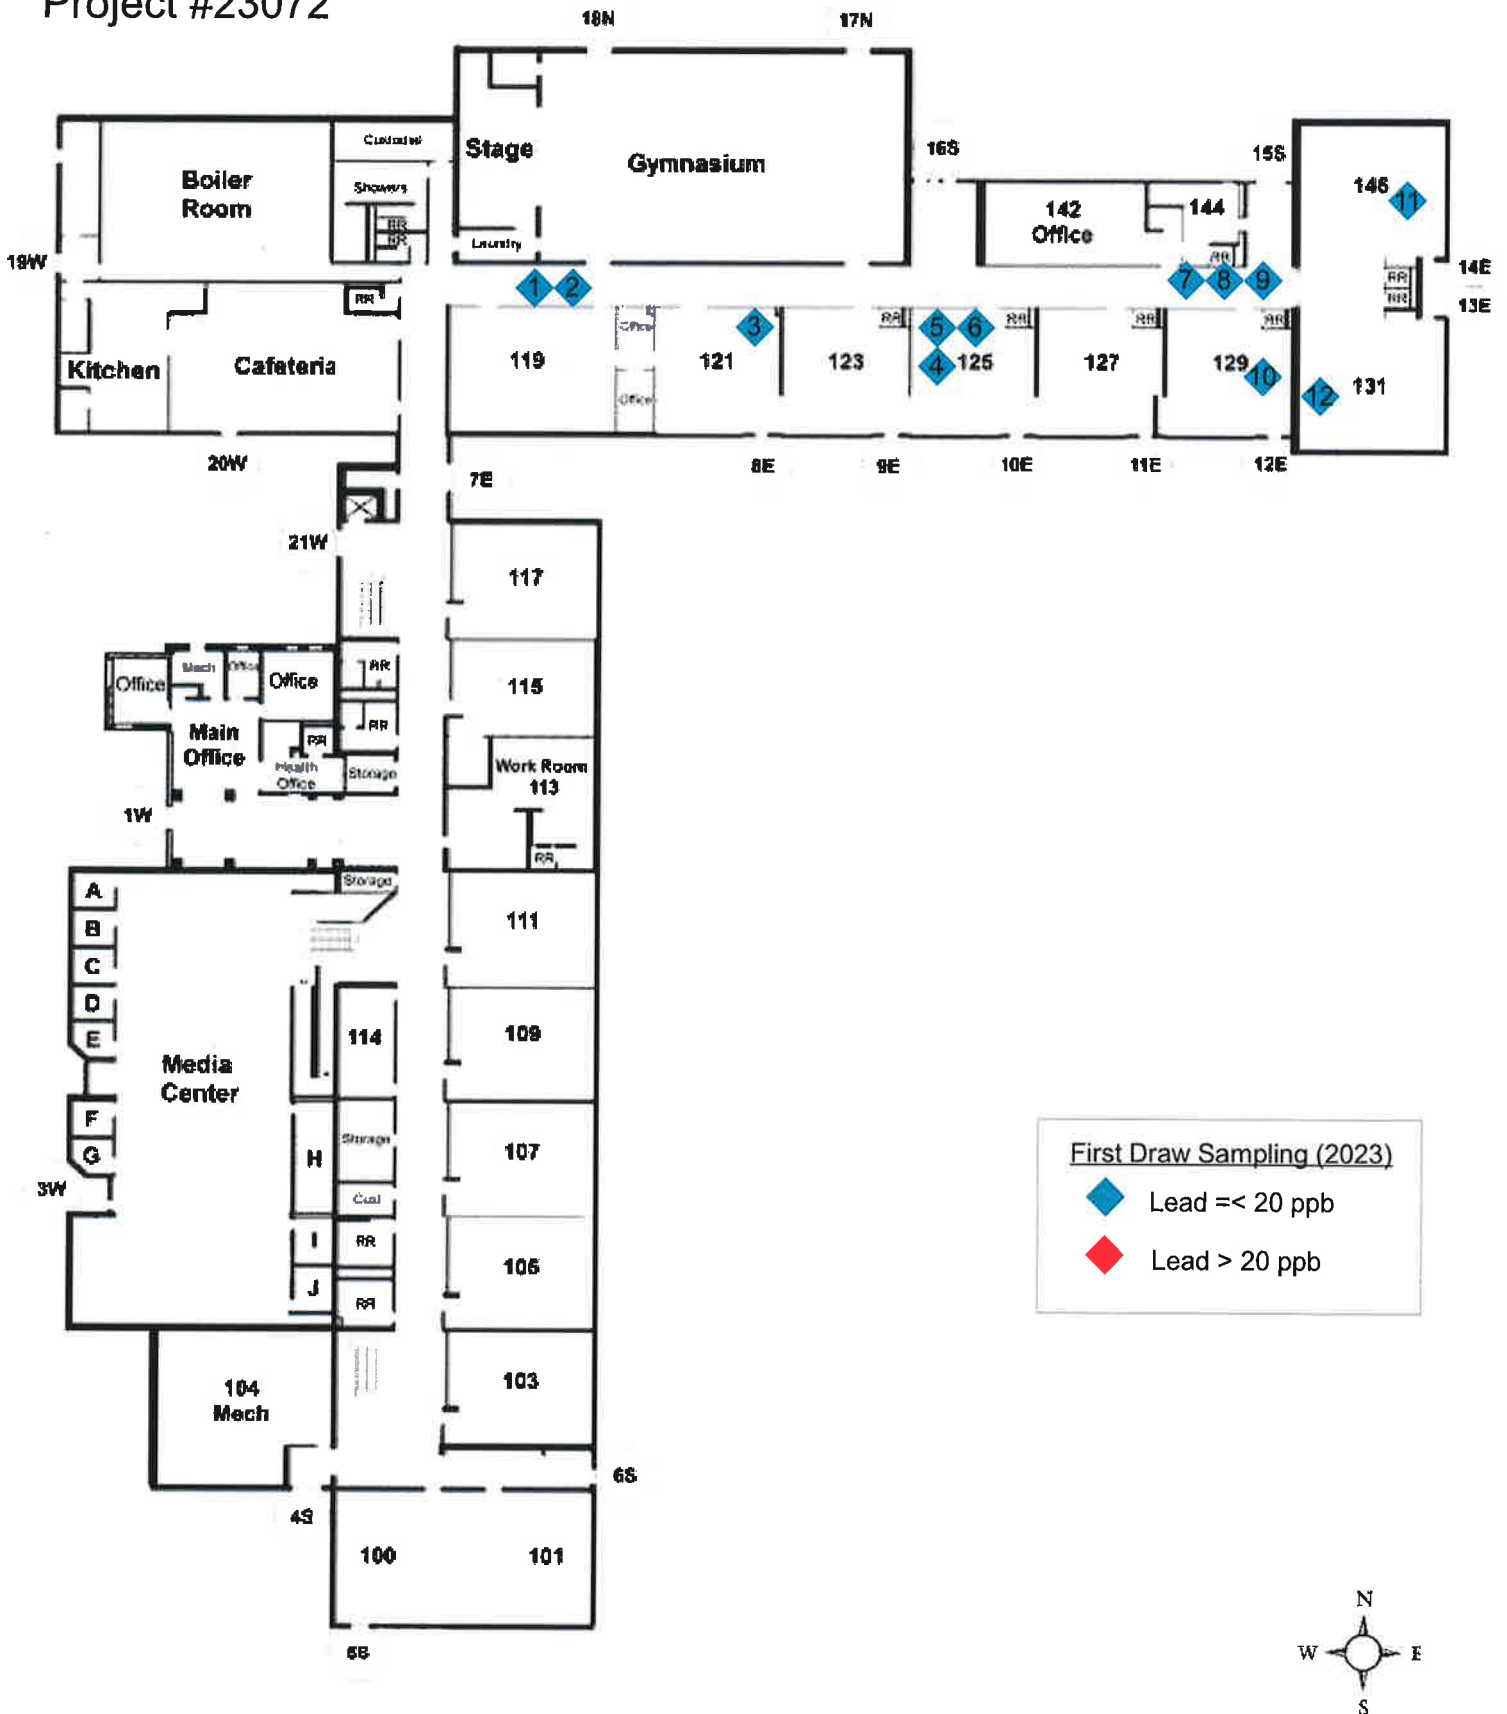
Only the newly renovated section of the building was tested.

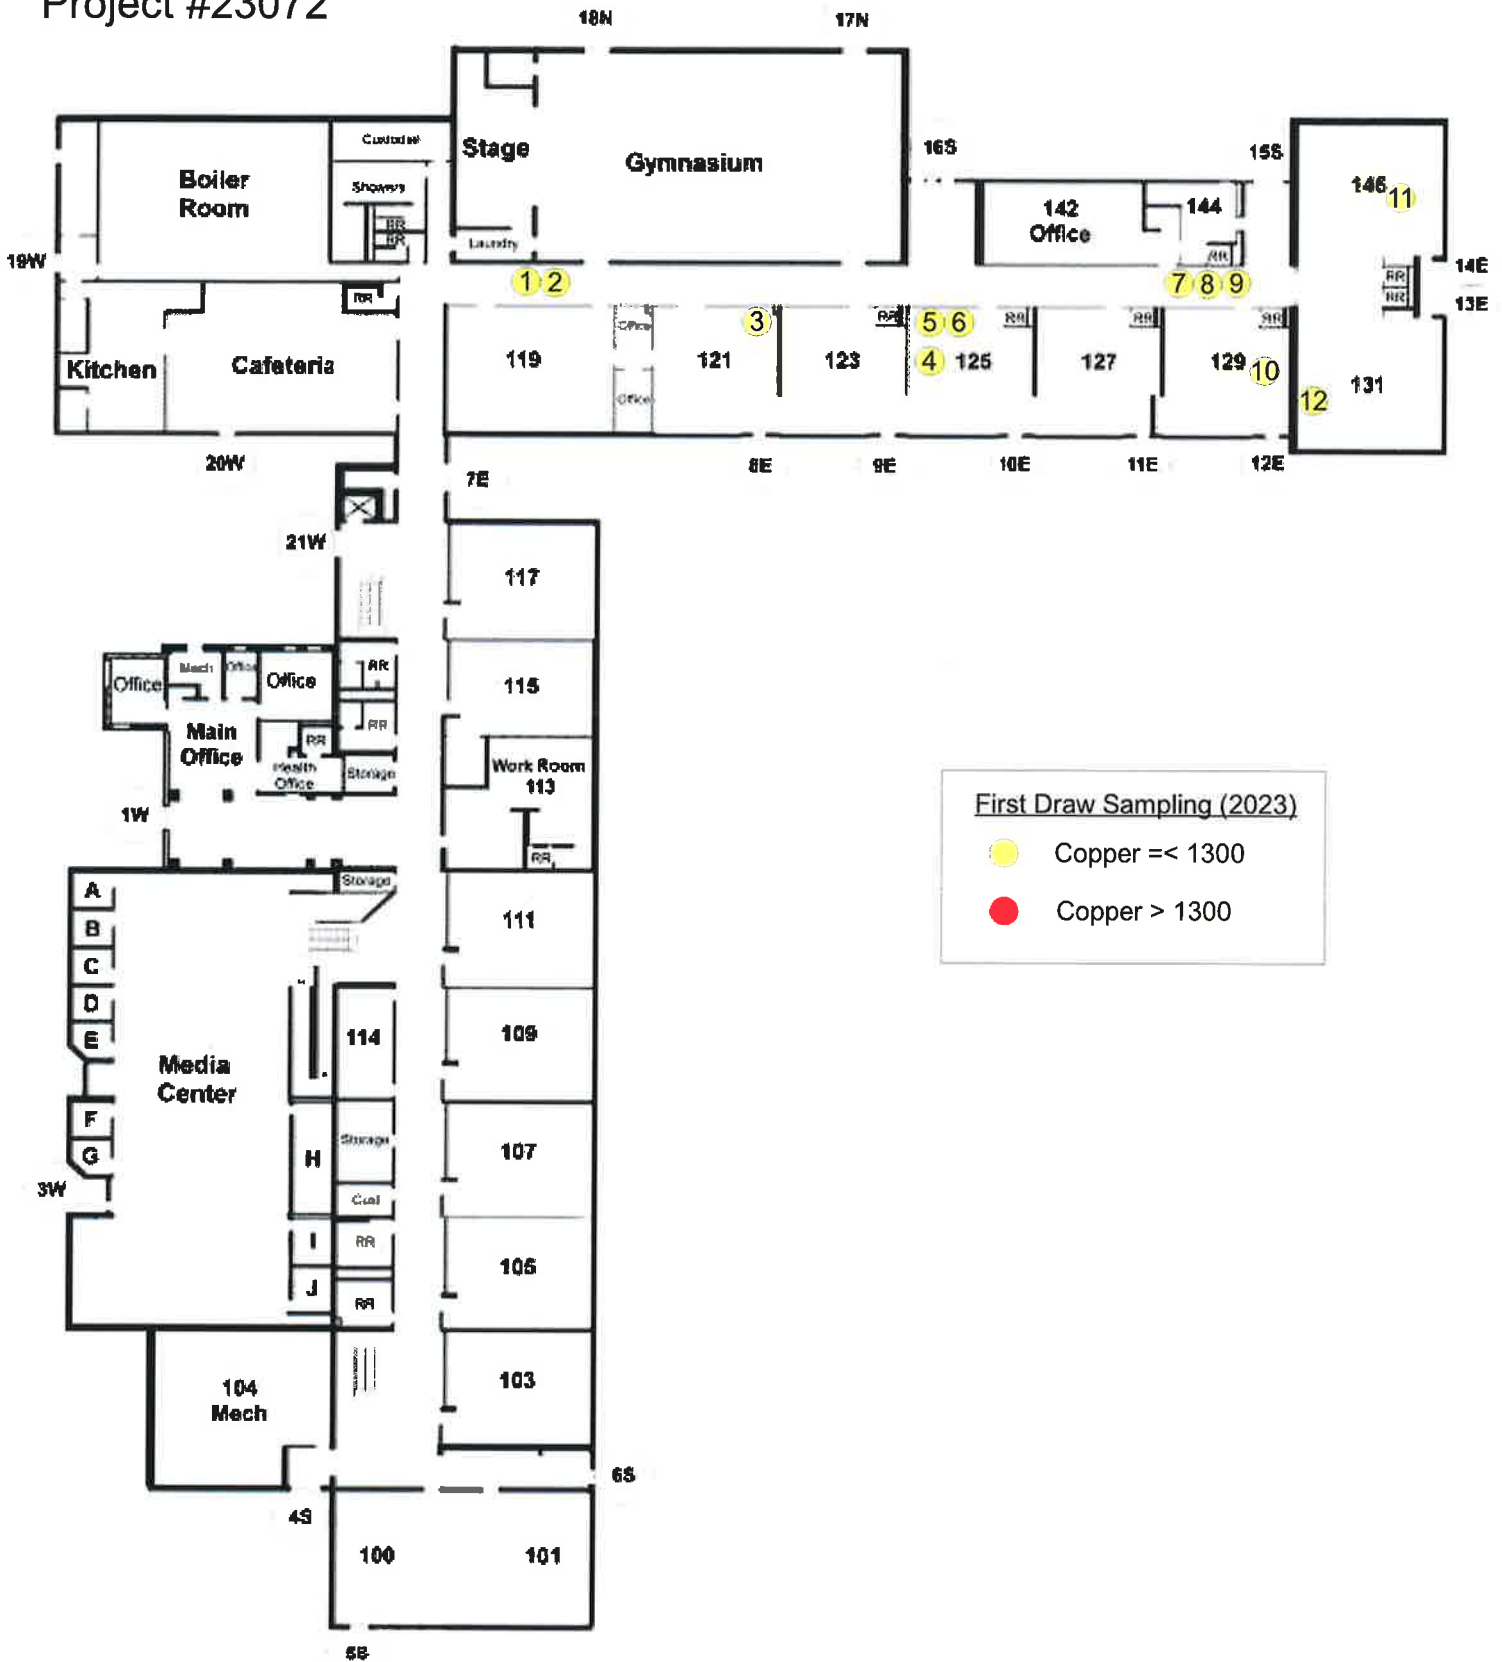
Oak Park Elementary
 First Floor
 Copper in Drinking Water
 Project #23072

Only the newly renovated section of the building was tested.
