# Center Grove High School Football Bleachers

# Summary: Home Side Bleachers

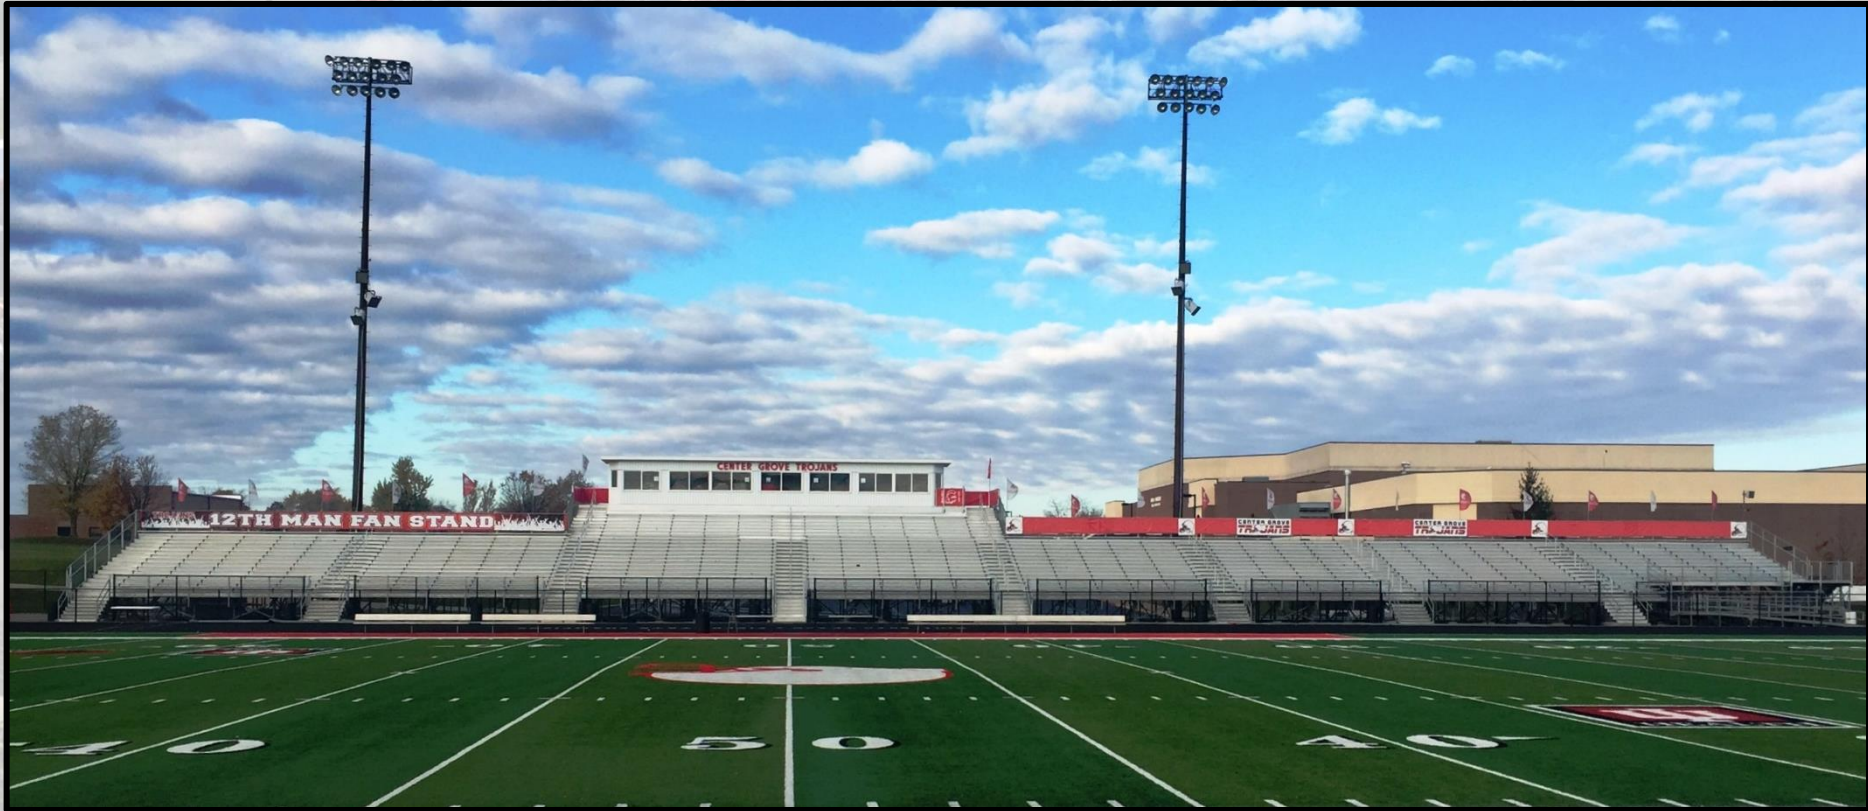
- Galvanization is thin and beginning to lose its ability to protect the steel.
- A large percentage of the nuts and bolts that hold the system together are rusted and will continue to deteriorate, more rapidly than in the past
- Misalignment or shifting of “stringers”, which don’t meet current load requirements
- The connections of the columns to the foundation only used two of the four available holes in the base plates

- Handicap seating is substantially under the required amount necessary, location does not meet the intent of the code

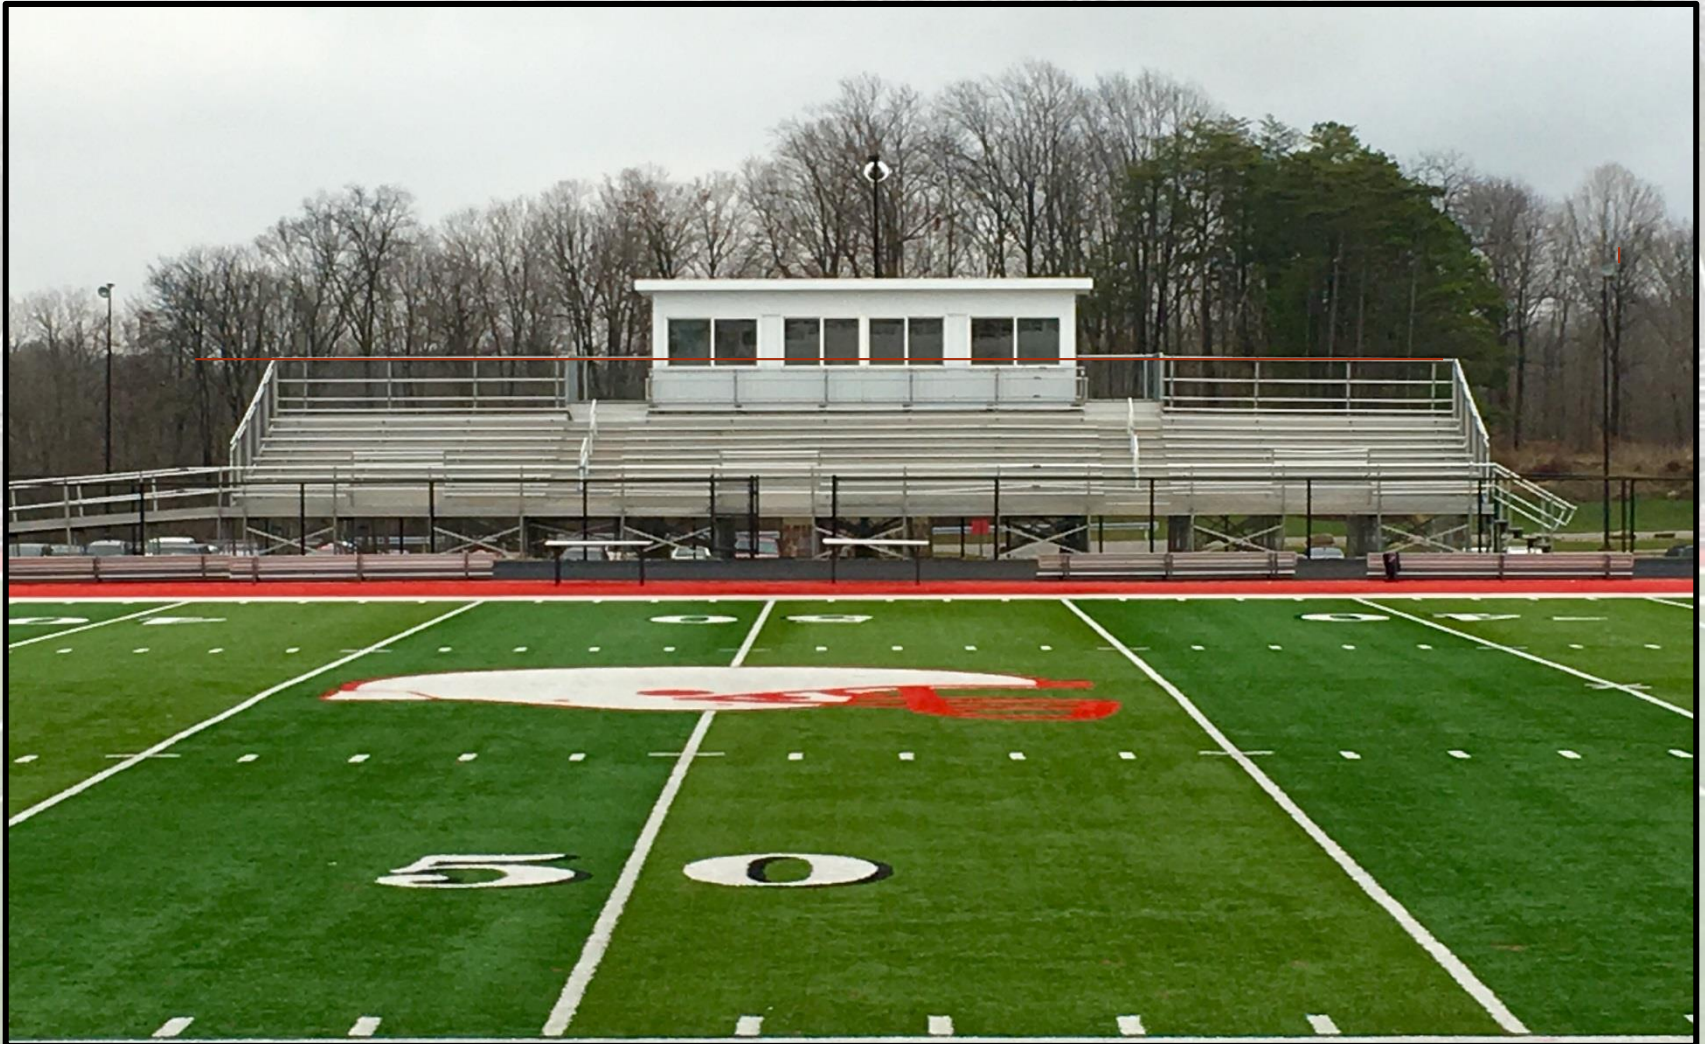
# Visitor Bleachers

# Summary: Visitor Side Bleachers

- No apparent foundation system
- No evidence of any anchorage system
- Footboards improperly installed
- No chain link fence along the front walkway

- No provisions for handicap accessible seating
