Board Update, April 2023

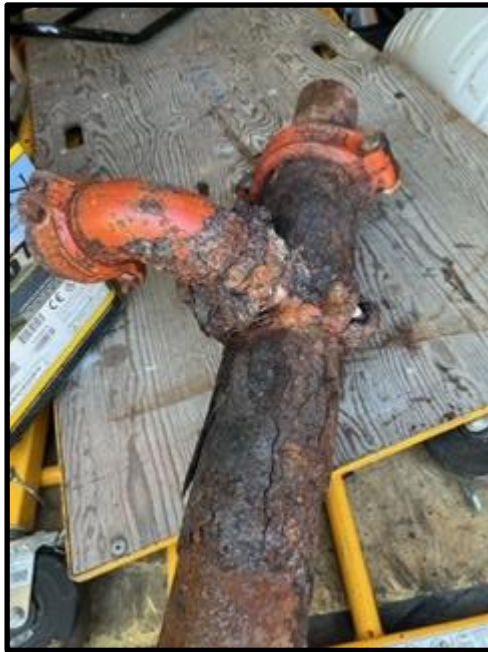
- Another holiday, another leak. The domestic hot water line ruptured in the Salisbury gym ceiling on Monday. 200-degree water was leaking into the gym. Thankfully, it was detected and repaired before much damage was done.

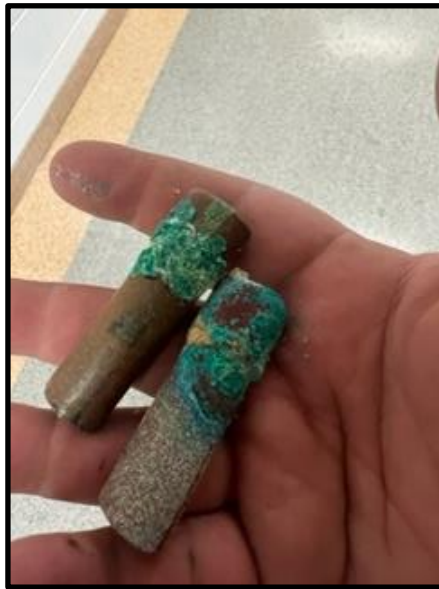
- Paradise also had a leak recently. In the original design copper pipe branched off of the main domestic water loop for possible future use/expansion. Those connections are starting to corrode due to water not flowing through them. We are replacing them with ball valves so that they can be periodically bled.

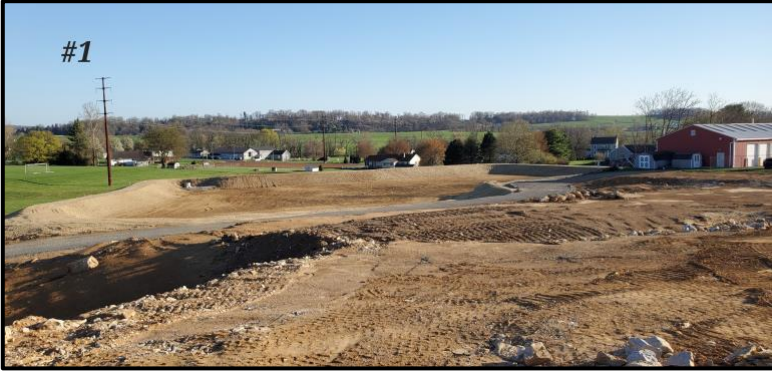
Water retention basin below storage shed

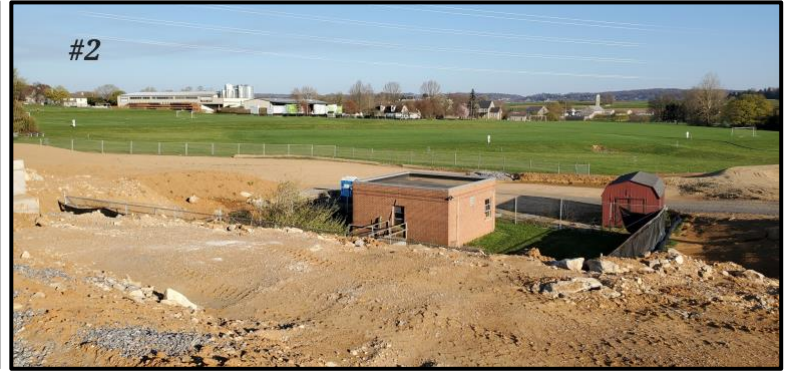
Fill around the existing sewer plant

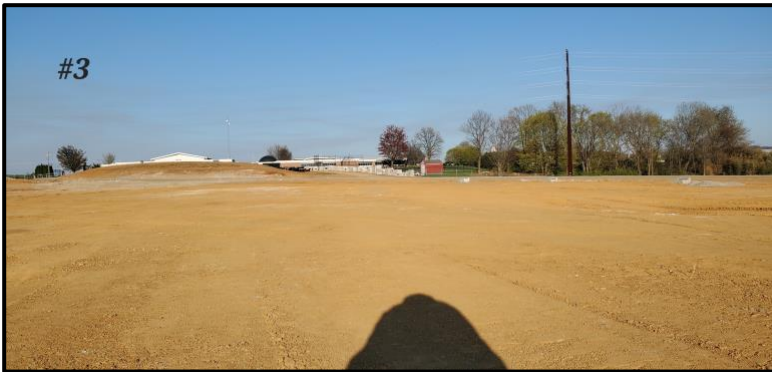
Grade level looking towards the middle school

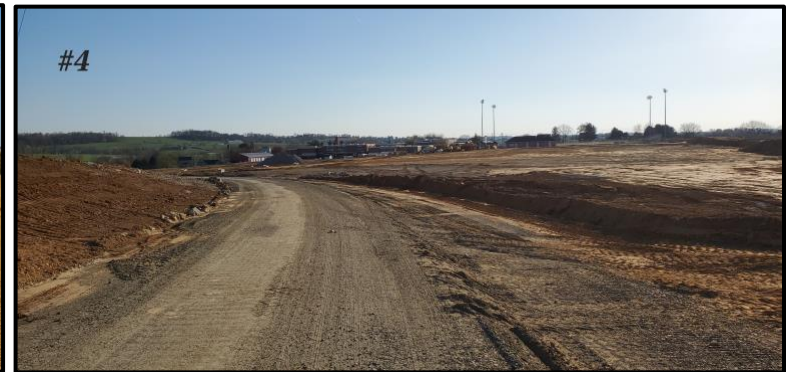
Access road between buildings

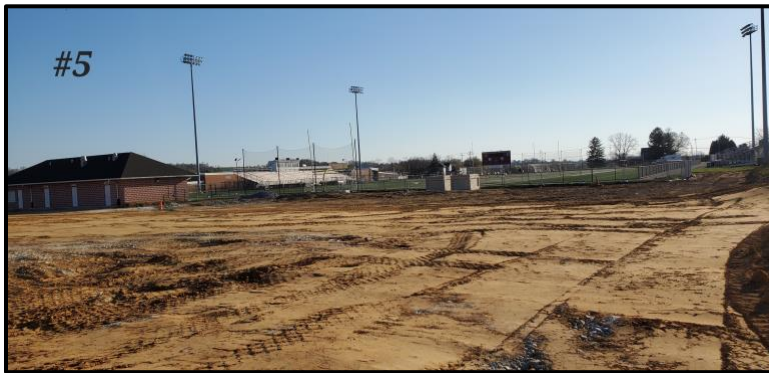
Grade level looking towards the stadium

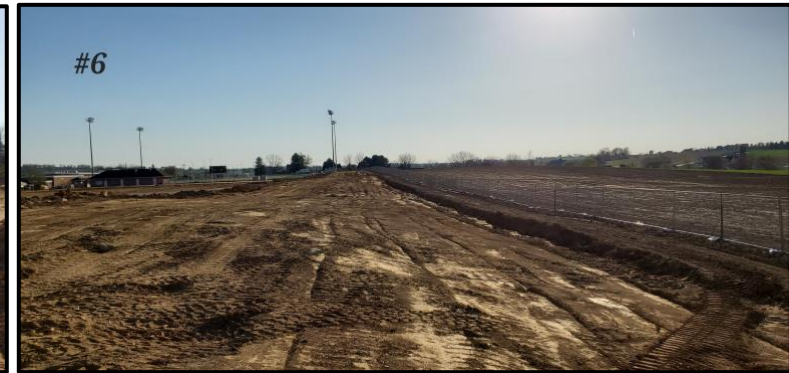
Grade along the west property line

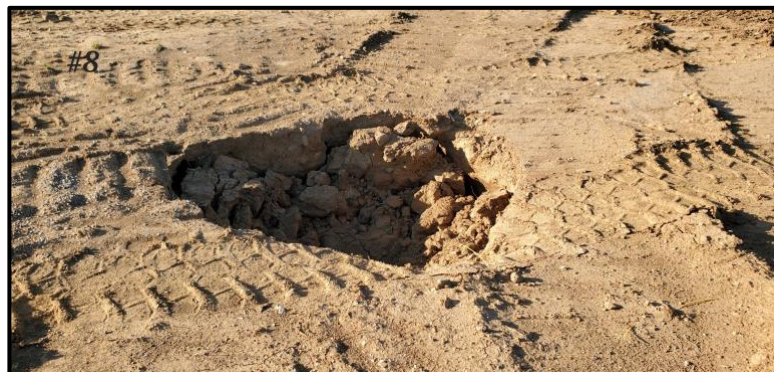
Possible sink hole
