Date: 1/29/20

Location: Bancroft School

RE: Radon Testing

DIAGRAM #1 - RADON SAMPLE LOCATIONS

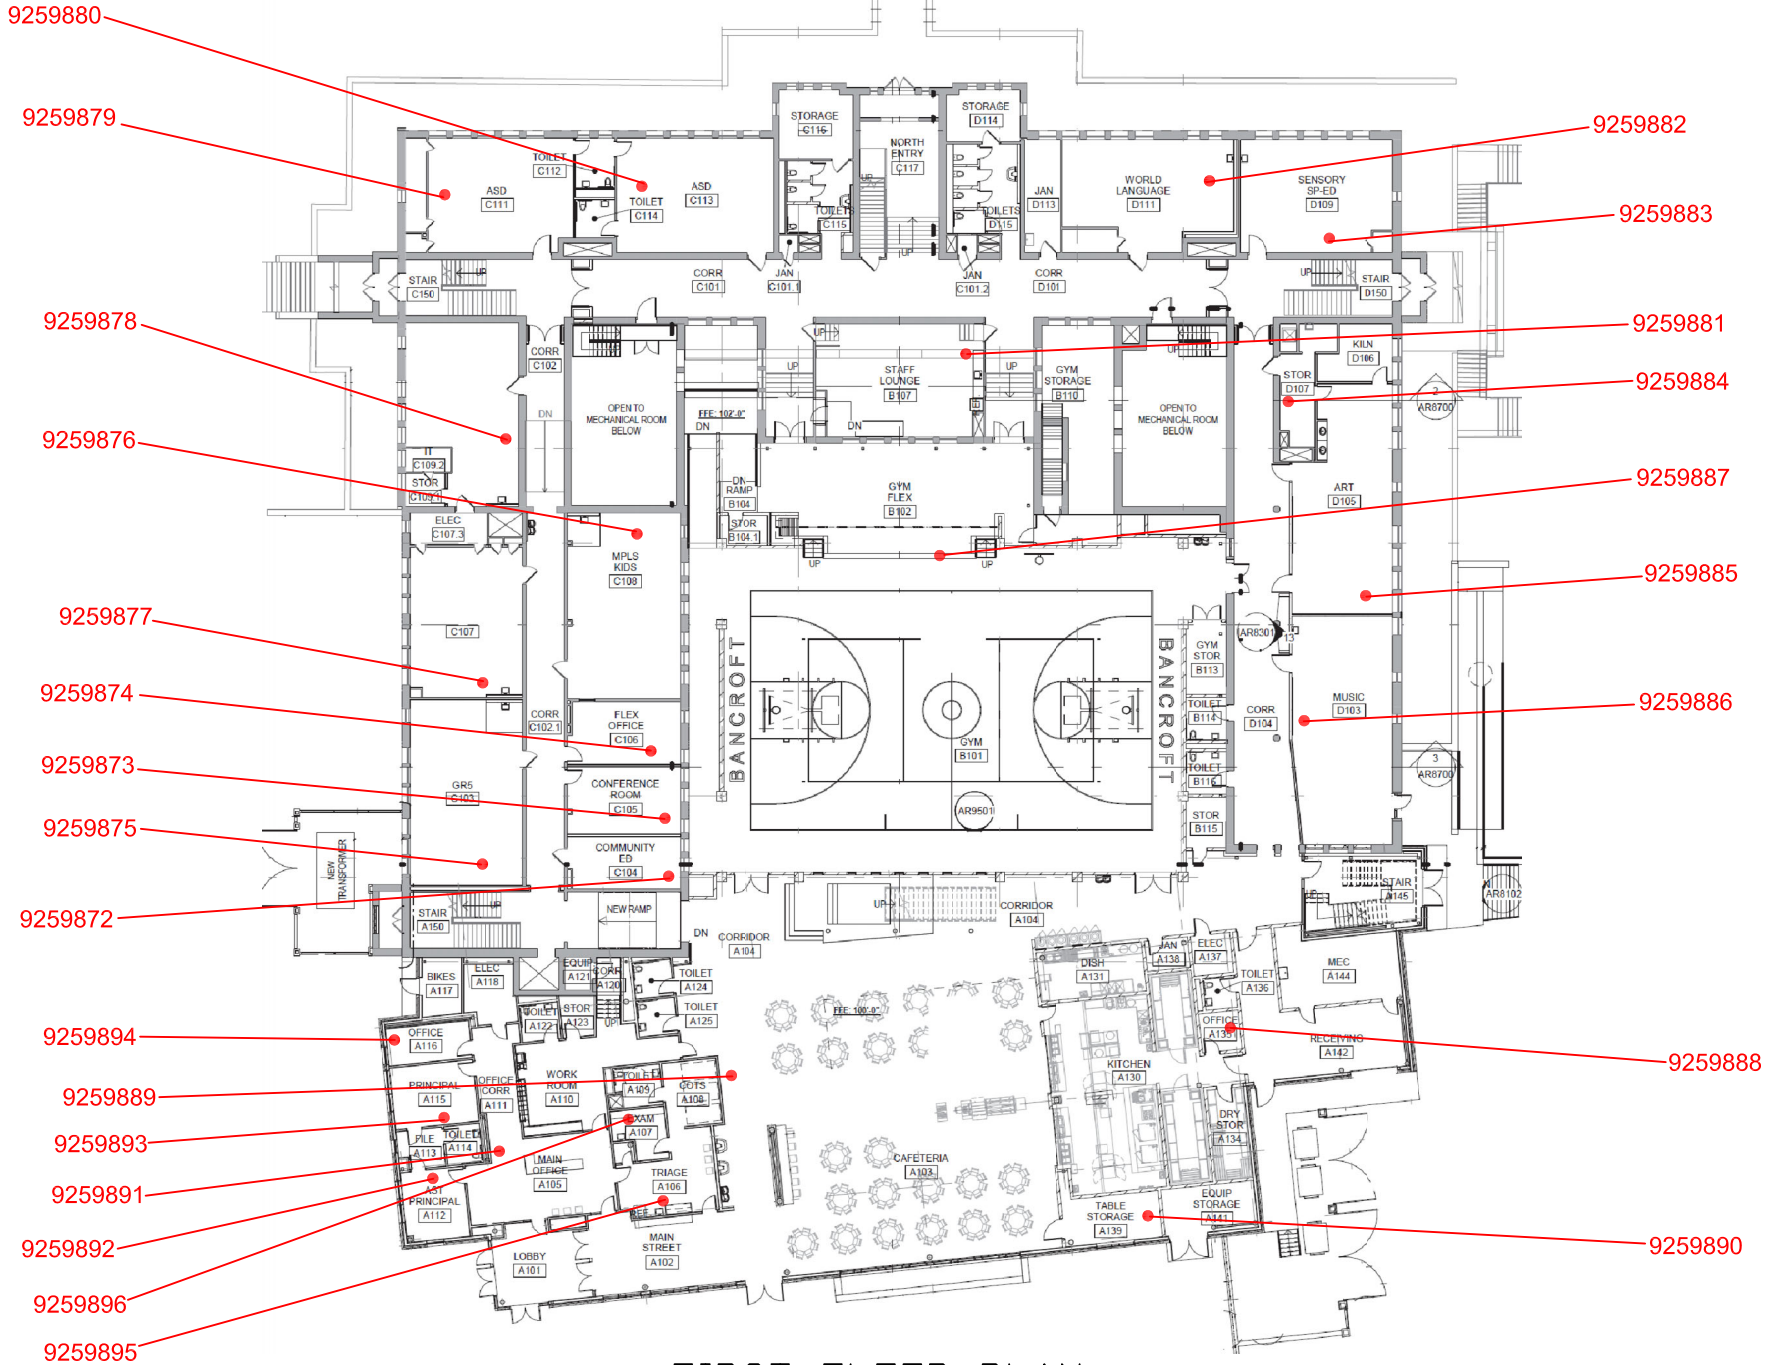
All of the areas that were tested were found to have radon gas levels below 4.0 picocuries per liter of air (pCi/L), which is the EPA and MDH action level. (Note: Rooms B & BB were the blank samples.)

FIRST FLOOR PLAN
