Hendrick Hudson Central School District

**Districtwide Lead in Drinking Water
Sampling and Remediation Plan**

2020-2021

Project #20662

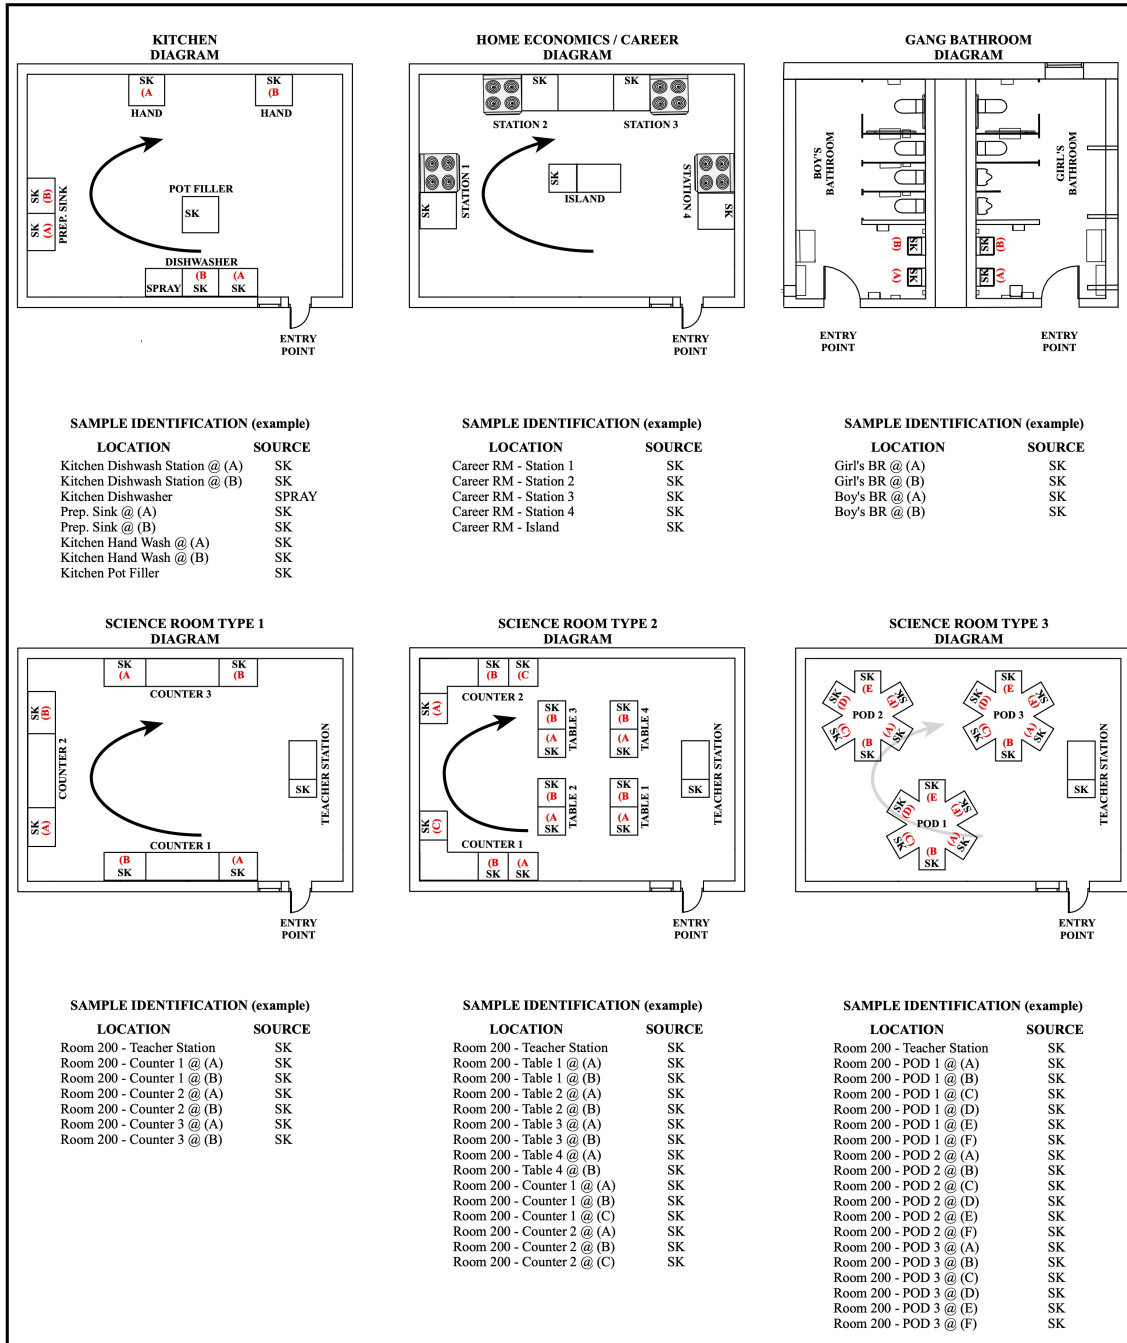
Sampling Location Schematics

In accordance with the regulation, Enviroscience Consultants, Inc. performed initial water sampling throughout the Hendrick Hudson Central School District from March 24-26, 2021. Samples were collected in wide-mouth 250 milliliter containers and were collected in the morning hours before the facilities opened. The water sources were not used for at least 8 hours and not more that 18 hours prior to sampling. Unique source numbers and designations were assigned to each source location. Unique sample identification numbers were assigned to each sample taken. The key to fixture type codes and the sampling location schematics are shown below.
