IAQ, and Mold Assessment

Hobomock Elementary School, Pembroke

Sample date: October 10, 2023

Report date: October 30, 2023

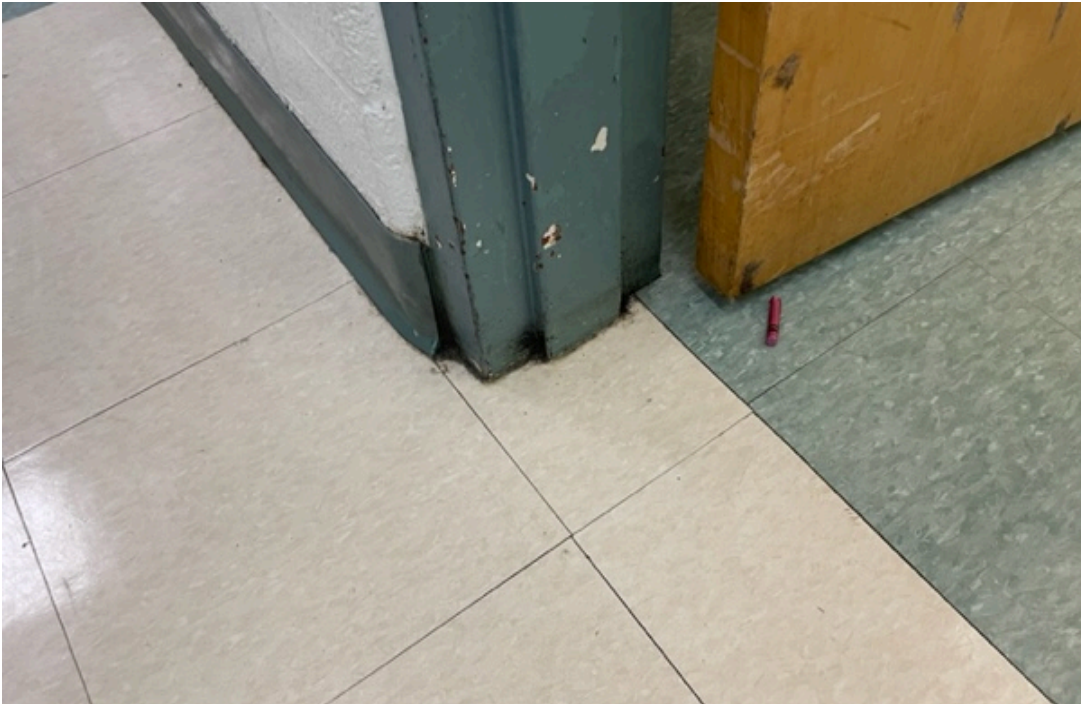
Room 263 base of door:

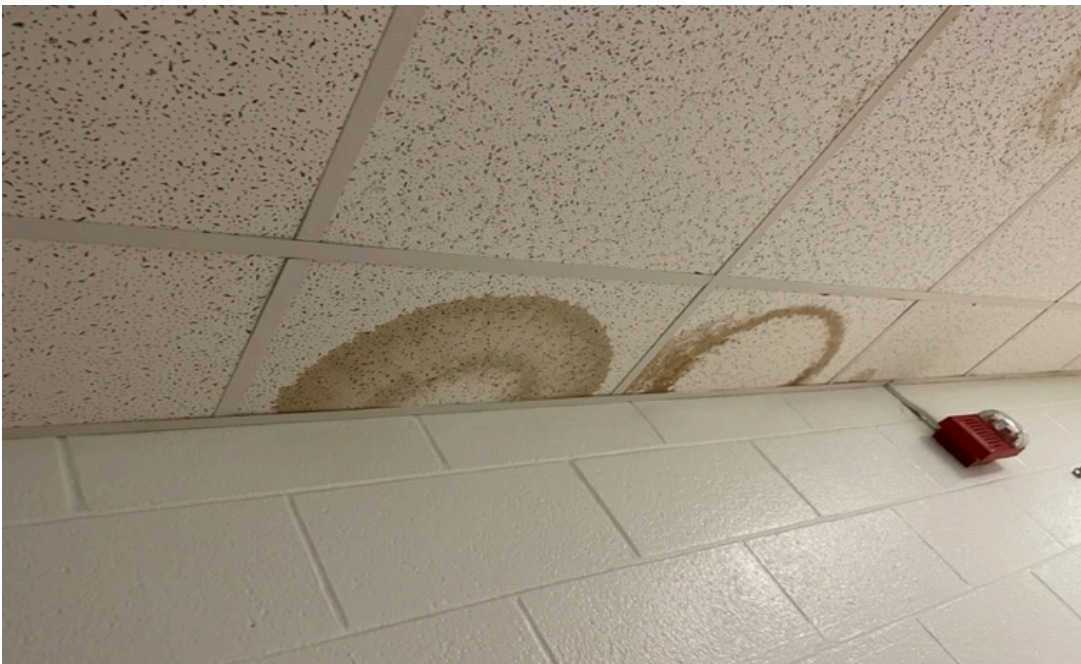
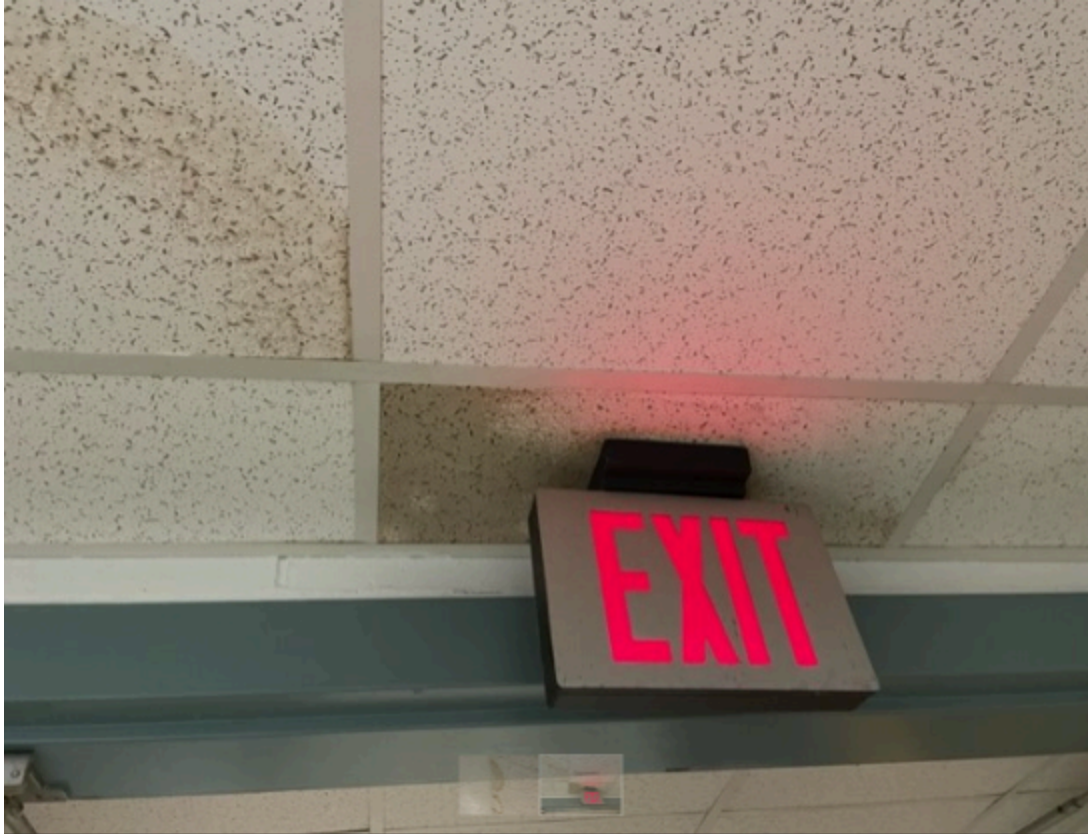
Ceiling: 1st and 2nd grade hallway

- d. Monitor, assess, and investigate all sources of moisture intrusion into the building, stained ceiling tiles and high levels of relative humidity. Map out signs of moisture and install methods, technologies, and equipment to reduce relative humidity in the building and potential sources of mold growth. If a ceiling tile is stained, not only replace it, but find and seal the source of moisture. Utilizing central HVAC dehumidification, air conditioning, portable de-humidifiers, and air cleaners if needed. Insulate copper tubing above the plenum. Run dehumidifiers and air purifiers at least an hour before the building is occupied and an hour after the space is not used. Run the system over vacation periods when the building isn't occupied. Check the building regularly especially during periods of high humidity. To avoid interior mold growth in the future, any moisture intrusion must be corrected by repairing immediately and drying out any resulting affected areas within 48 hours.

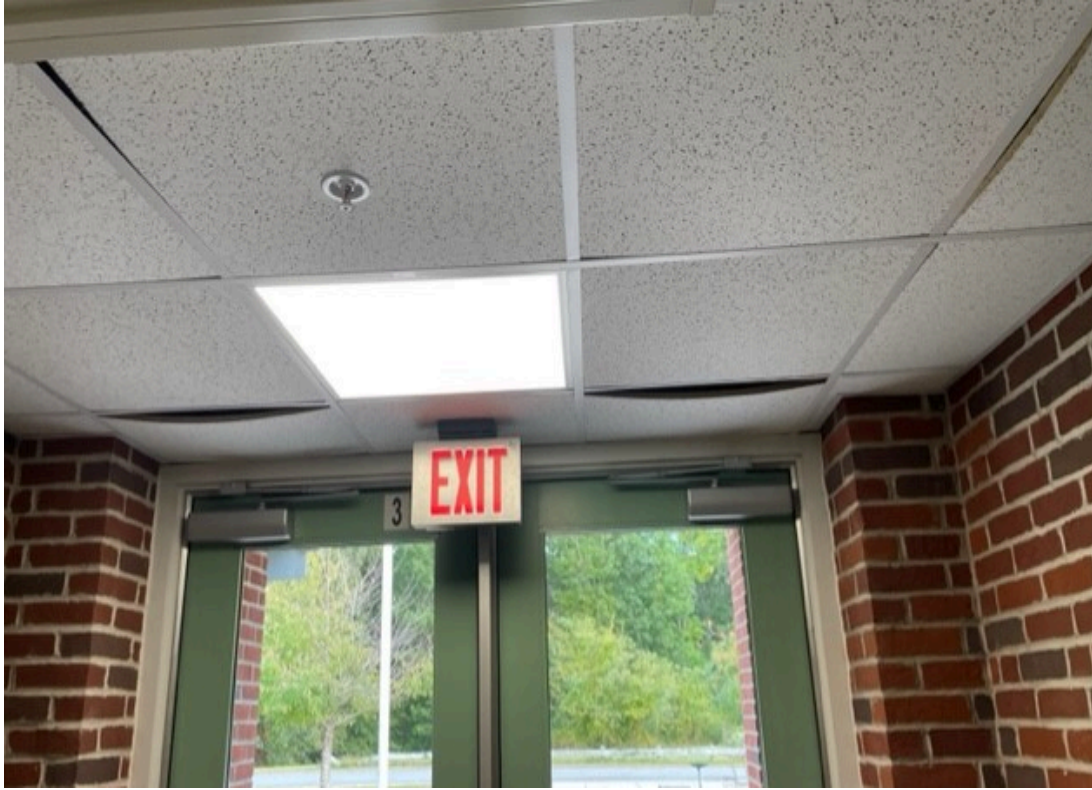
Bowed ceiling tile outside room 12:

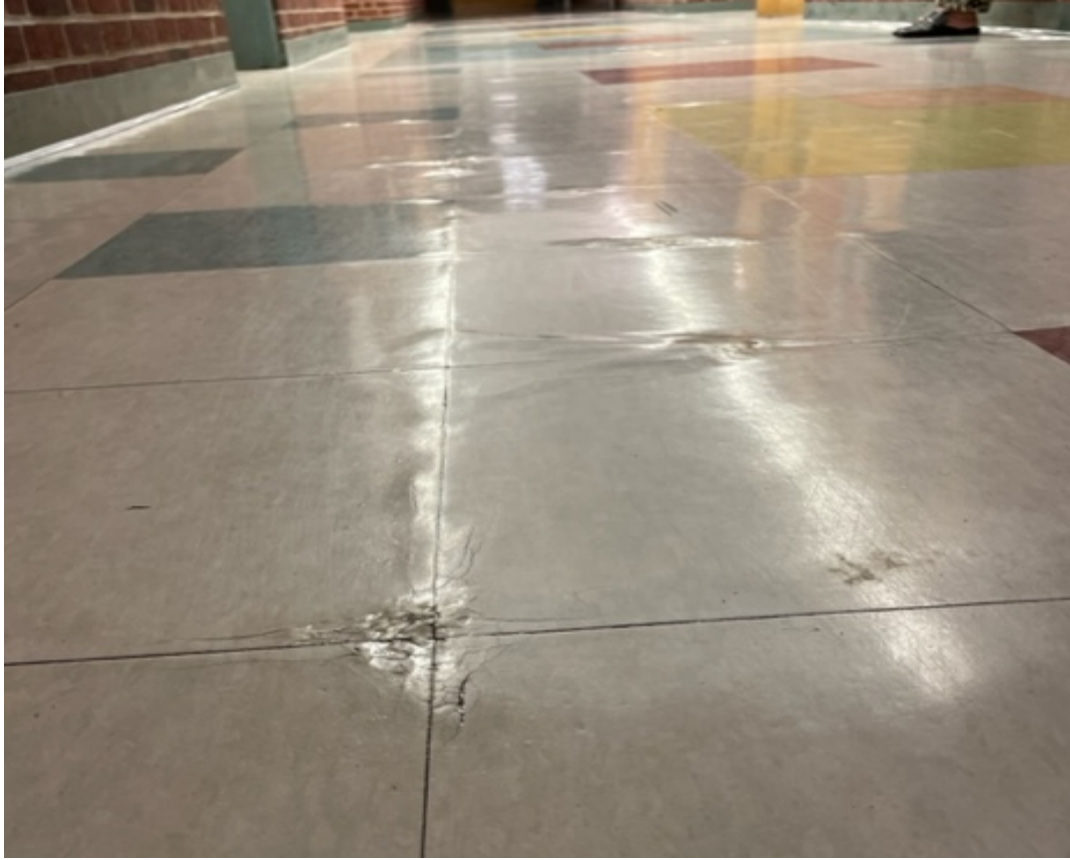
Foor hallway outside nurses office:

- g. During the rainy season, assess the concrete slab for elevated levels of humidity and moisture. See the Appendix 1 protocols and technologies in the Appendices of this report.
