Date: 11/22/22

Location: Hmong International Academy – 1501 30th Avenue North, Minneapolis, MN 55411

RE: Radon Testing

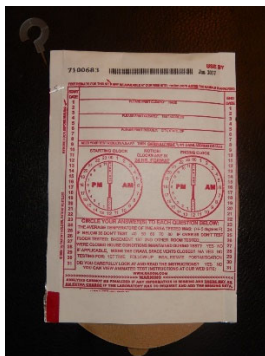
If your room is selected for testing, please do your part by ensuring that the devices are not removed or tampered with in any way. The devices are small, rectangular envelopes, approximately 4 by 6 inches and will typically be hung from the ceiling or an interior wall. The short-term radon detectors are planned to be placed and collected November 14 – 17, 2022. When available, sample results will be shared with your principal and placed on the EH&S webpage available through the main MPS website.

An example of the detector is pictured below:
