Radon Survey Analysis
Job# 19-C110R

Eagle Point School District
Eagle Point High School
c/o Angie Hamilton

23 N Platt Ave

November 26, 2019

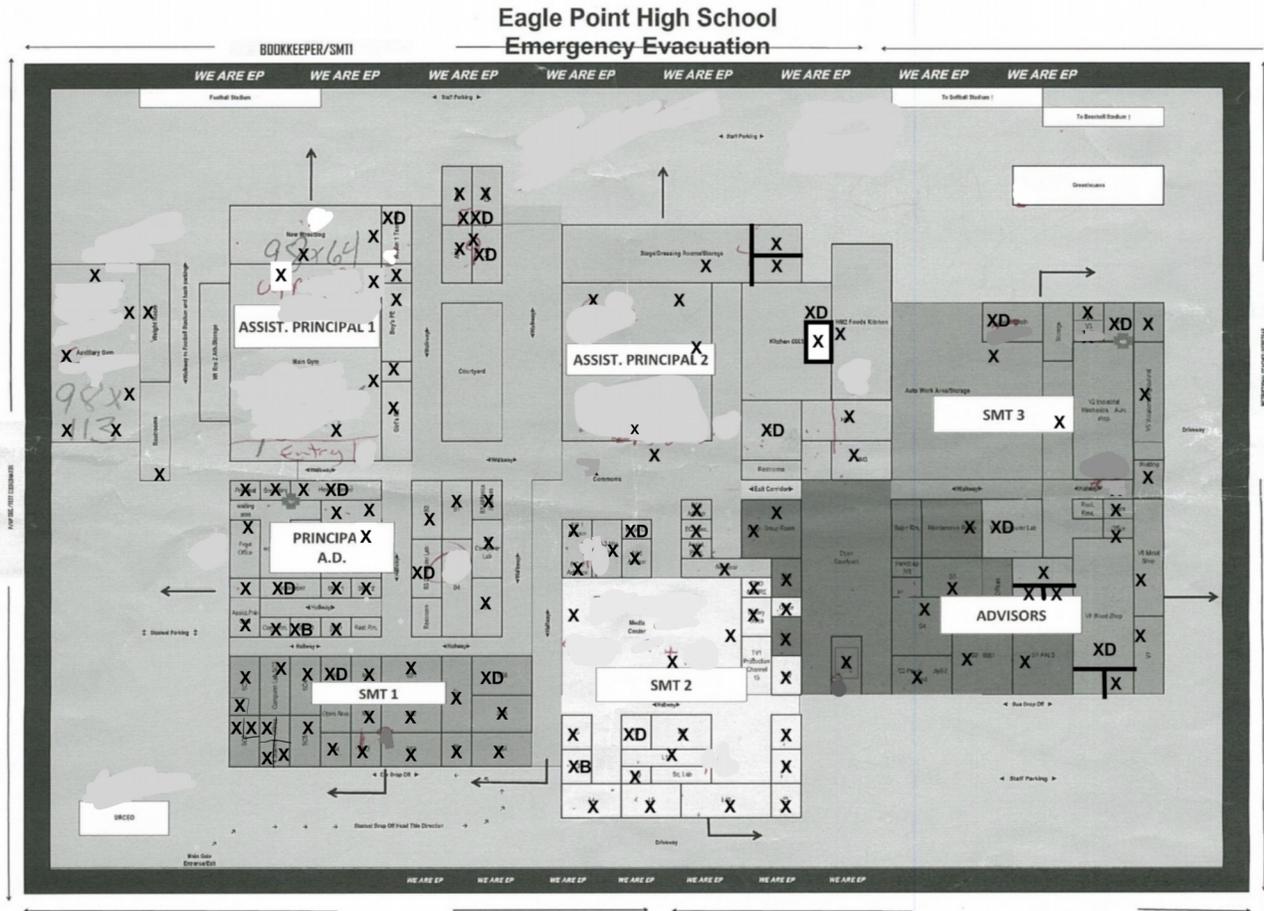
Appendix A: Test Placement Map

Test was a “Short-Term” test, with minimum duration of 72 hours. See the chart below of areas in buildings that were tested, and the corresponding levels found. All current test results are provided in Table 1. Maps of the test levels are provided in Appendix A. Note that one of one-hundred and fifty-five (155) locations tested had results above the USEPA Action Level of 4.0 pCi/L. There were three test locations that did not maintain closed building conditions and the results were void. Three were also two test locations that had missing test devices. Not maintaining closed building conditions may affect the accuracy of the tests in surrounding test locations.
