BID NO. 2024-25.10
WILSON HIGH SCHOOL: MEDIA CENTER UPGRADE
February 11, 2025
ADDENDUM NO.01

ADDENDUM 01 Details

**WILSON HIGH SCHOOL
MEDIA CENTER REMODEL
HACIENDA LA PUENTE UNIFIED SCHOOL DISTRICT**

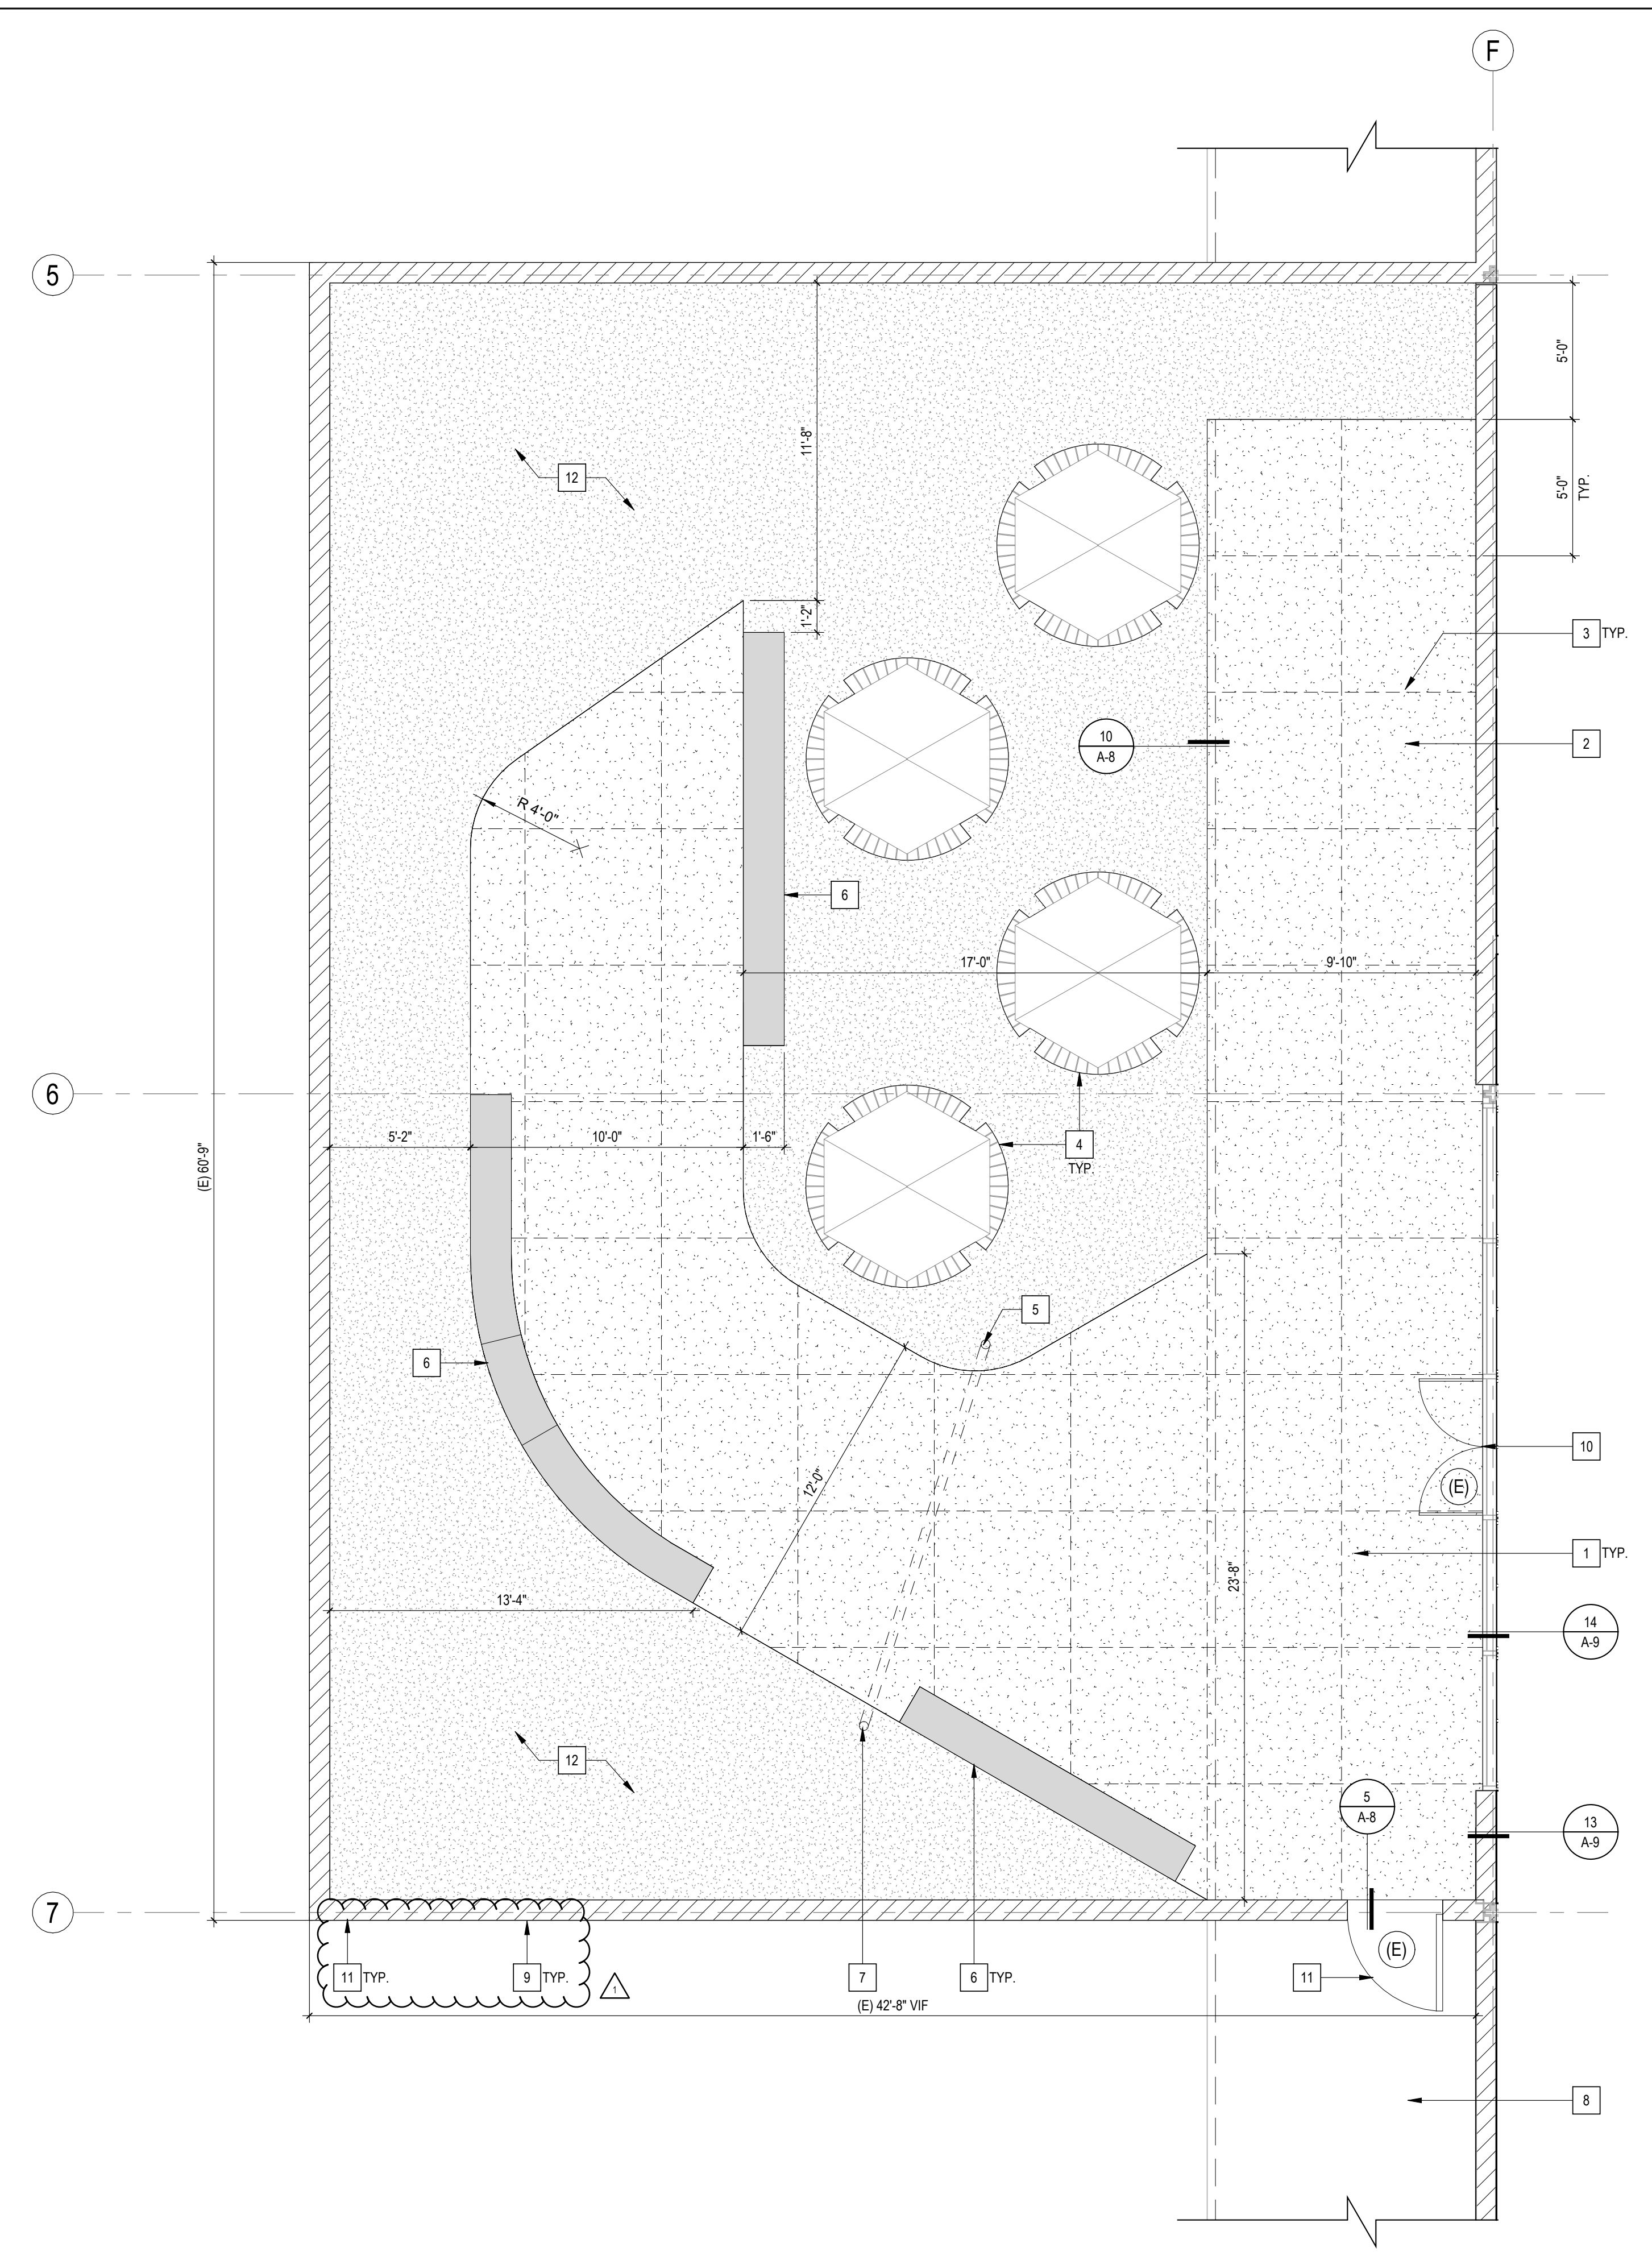
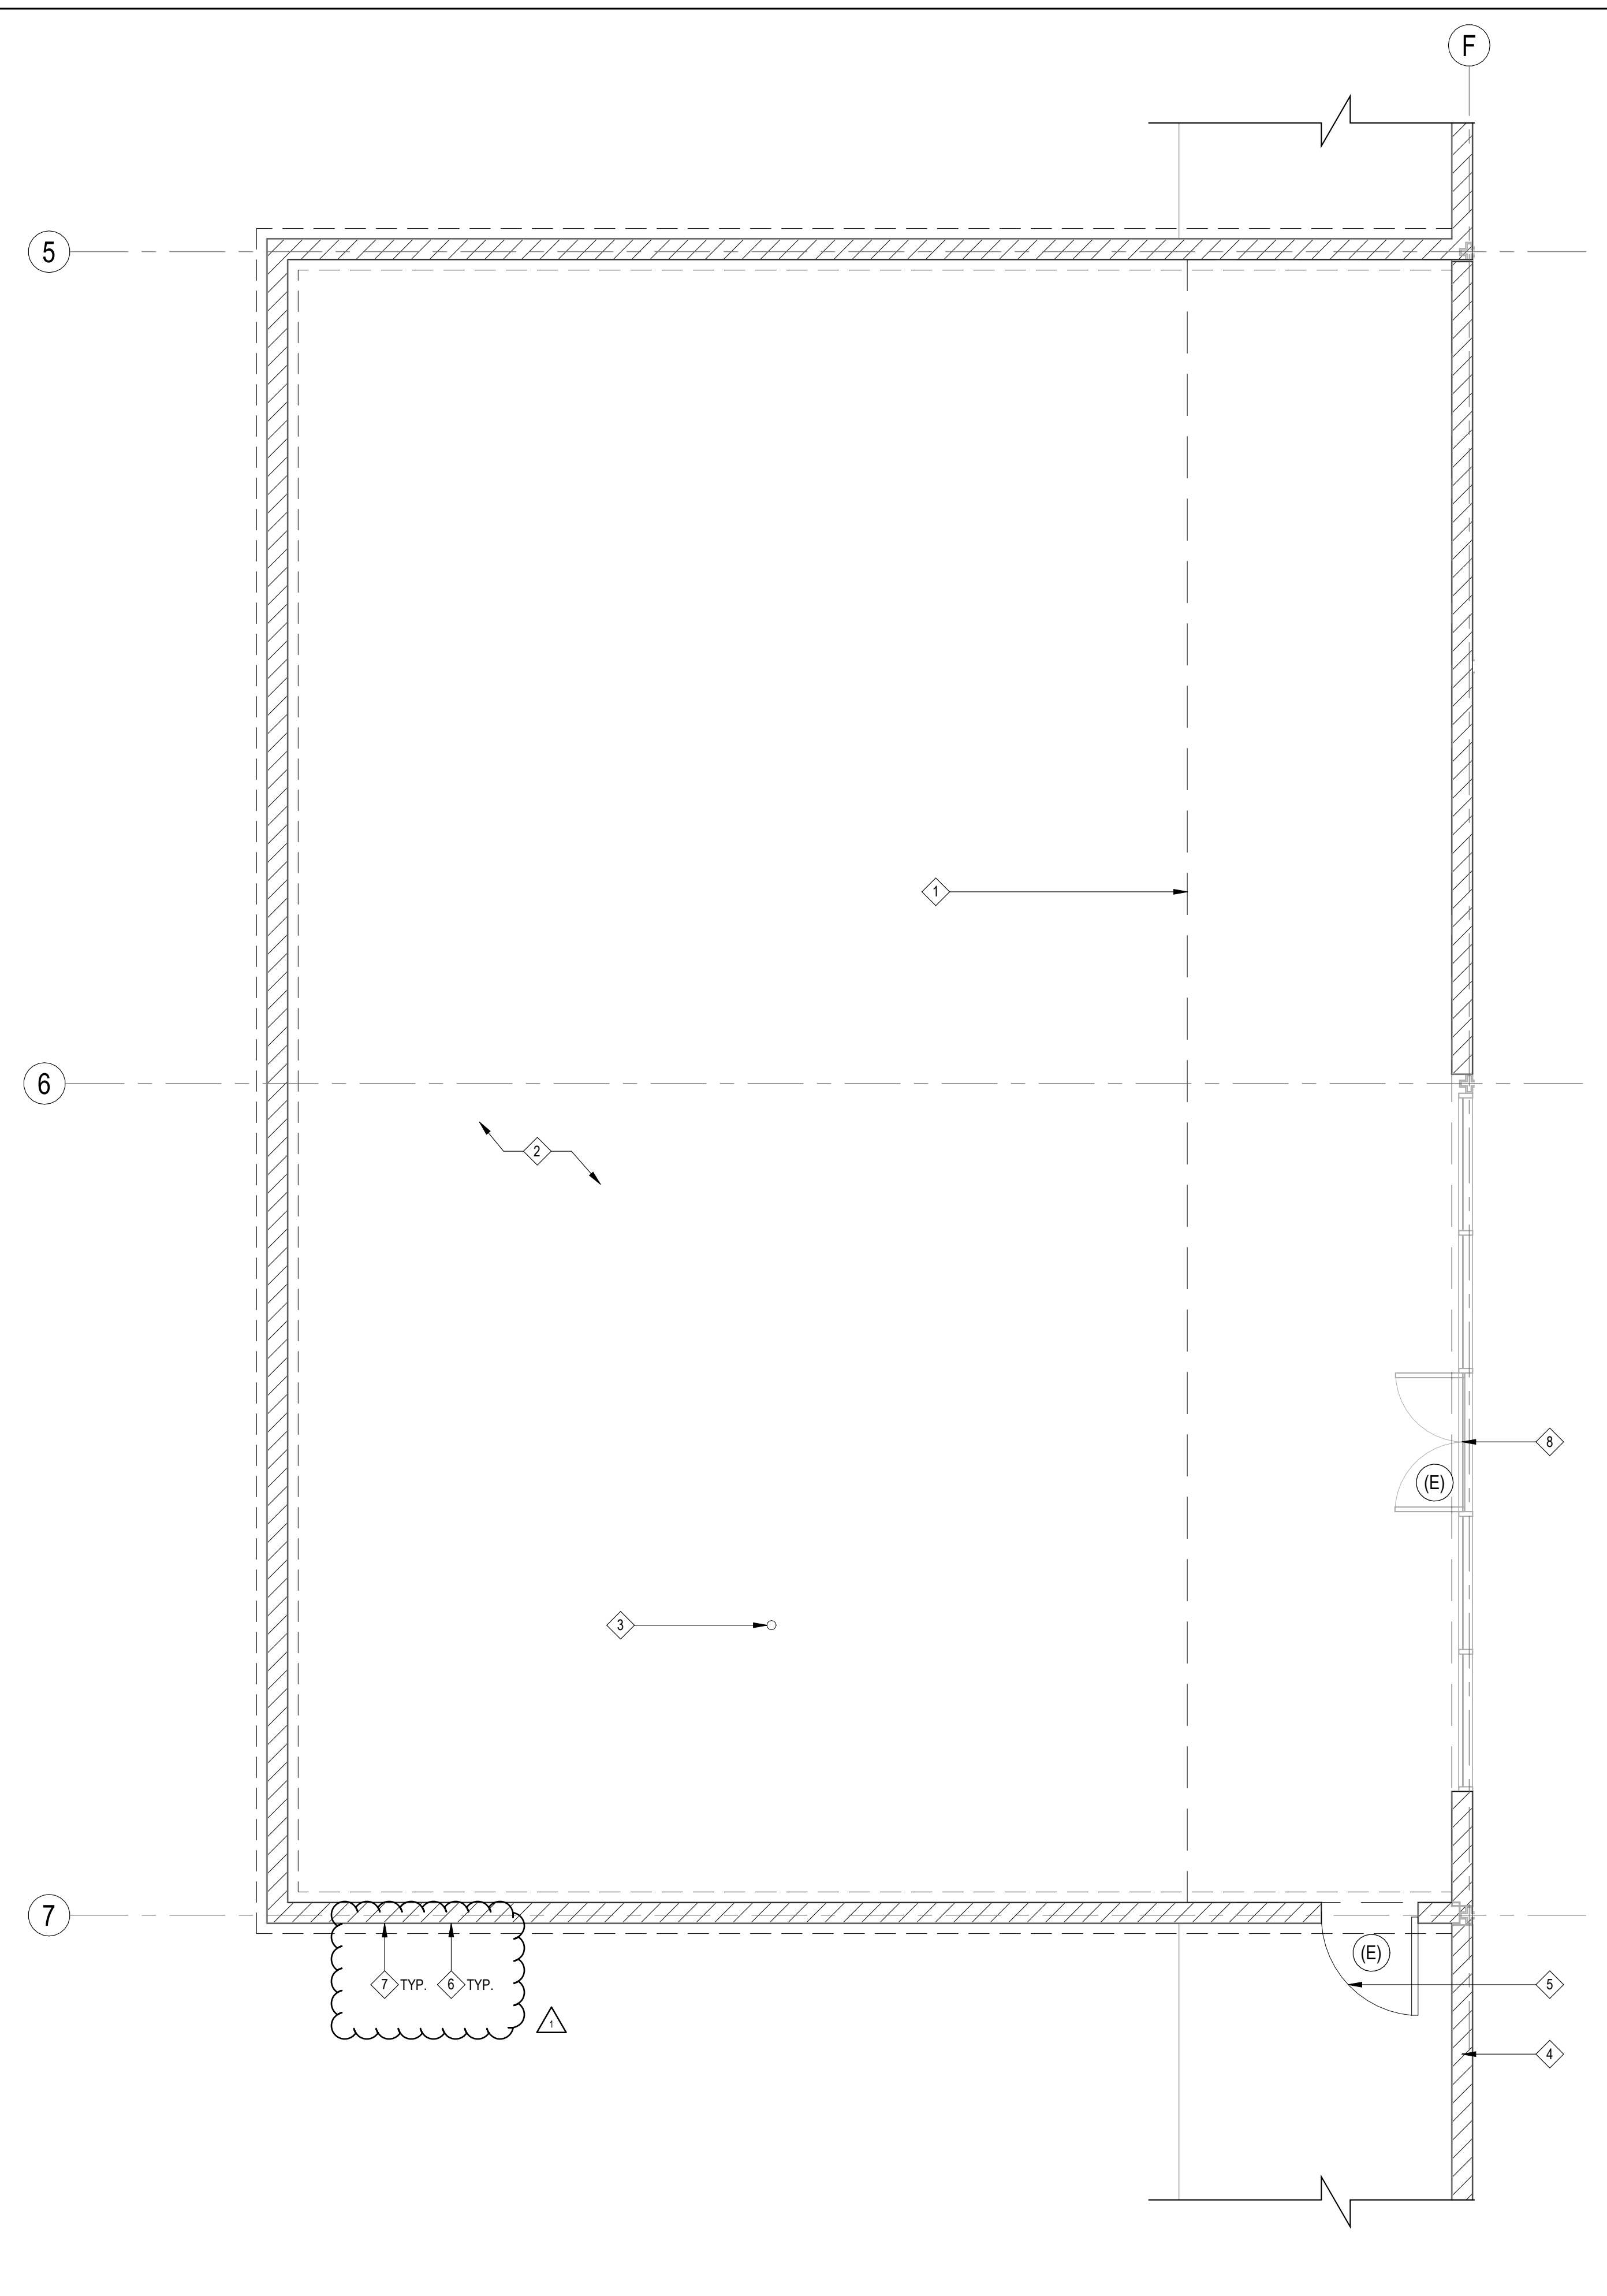
drawing no.:
A-0

SITE PLAN 1
SCALE: 1/4" = 1'-0"

SITE DEMO PLAN 2
SCALE: 1/4" = 1'-0"

1. SHEET A-0 SITE DEMO AND REMODEL PLAN
 - a. Site Demo Plan - Revised demolition Keynote #7 to add the height of the existing brick wall for Bid Alt # 1.
 - b. Site Demo Plan - Revised Keynotes #6 and #7 have been labeled as "Typical" on the Site Demo Plan.
 - c. Site Plan - Keynotes # 9 and #11 have been labeled as "Typical" on the Site Plan.
 - d. Replace Sheet A-0 Site Demo and Remodel plan in its entirety issued with this addendum.
2. SHEET A-7 INTERIOR ELEVATIONS
 - a. Remodel Keynote # 10 was modified to include a projection screen mounting detail 20/A-9 and revise mounting height to
 - b. Replace Sheet A-7 Interior Elevation sheet in its entirety issued with this addendum.
3. SHEET A-9 INTERIOR DETAILS
 - a. Added Detail 20 /A-9 for the mounting of the motorized projection screen.
 - b. Replace Sheet A-9 Interior Detail sheet in its entirety issued with this addendum.

Response – Bid Alternate No.1 indicates the removal the entire masonry wall and foundation and replace it with new foundation and fencing and shall be excluded from the base bid and listed separately. Demolition keynote #7 “Bid Alt No.1” has been modified to indicate the wall height and is noted as typical for all sides of the masonry wall, and keynote #6 is noted as typical for all sides of the masonry wall. Site Plan keynote #11 “Bid Alt No. 1” and keynote #9 is typical for all sides of the masonry wall. Plan A-0 is attached to this addendum.

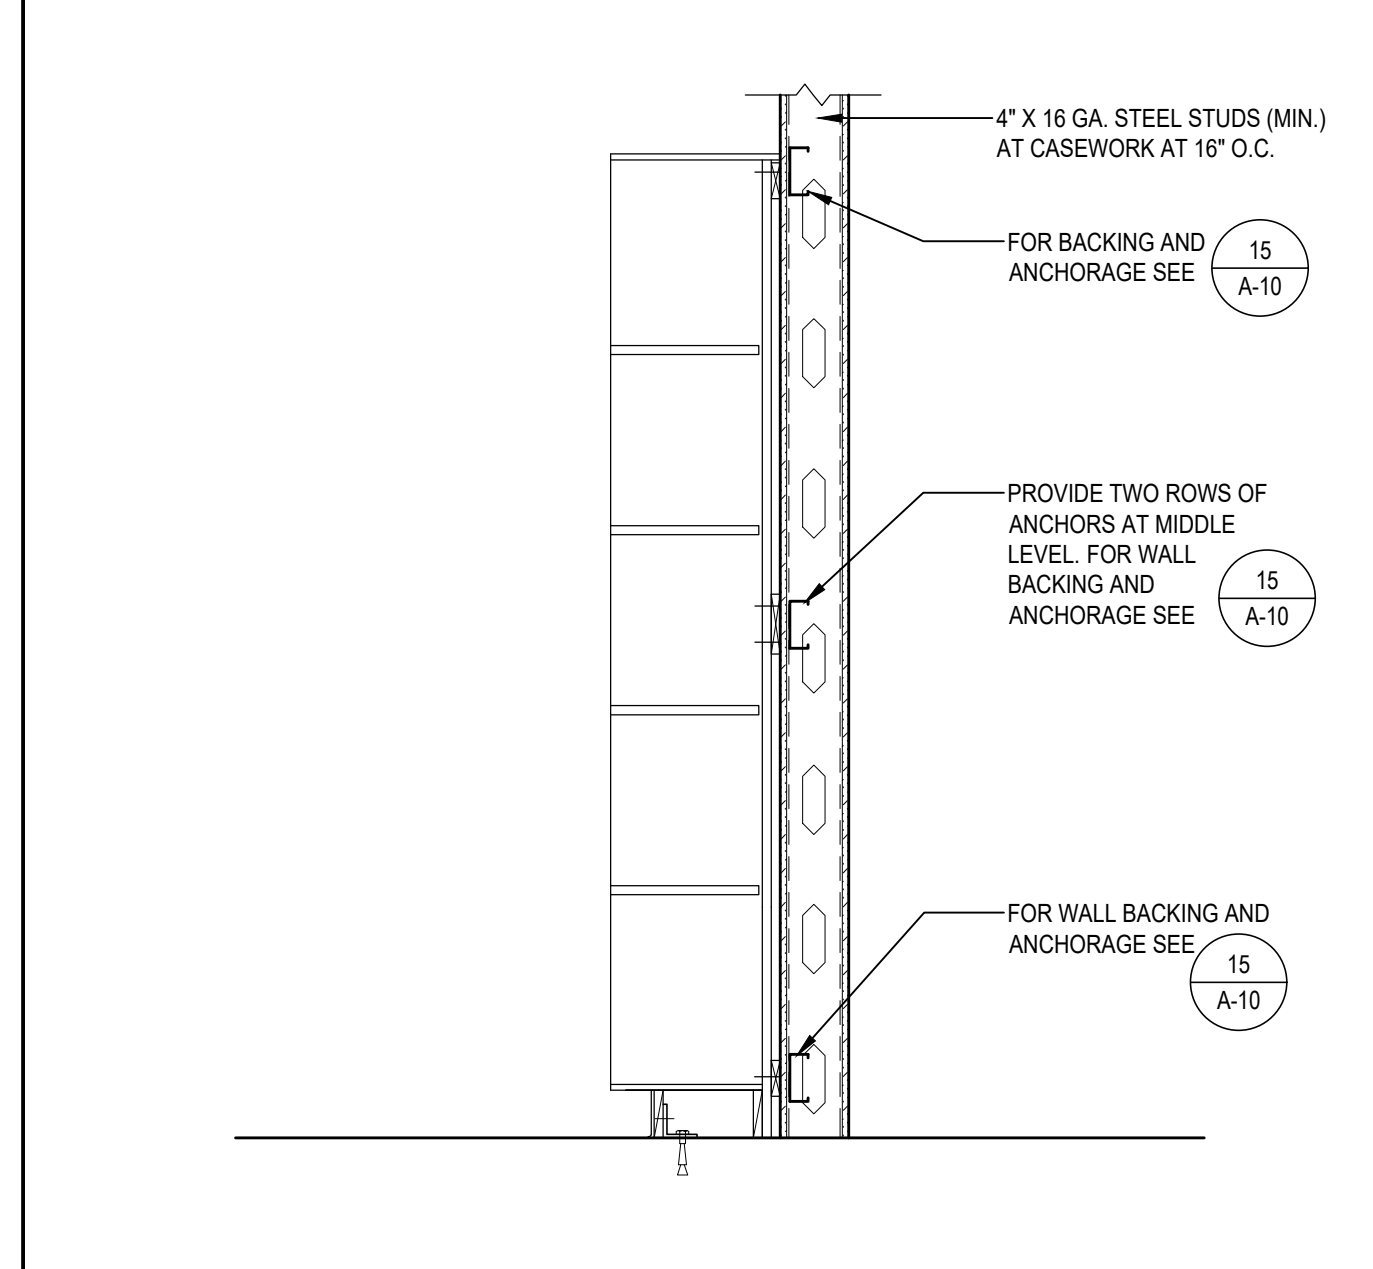
18

BOOKSHELF ANCHORAGE

- SEE 18/A-9 AND 19/A-9 FOR CASEWORK ANCHORAGE.

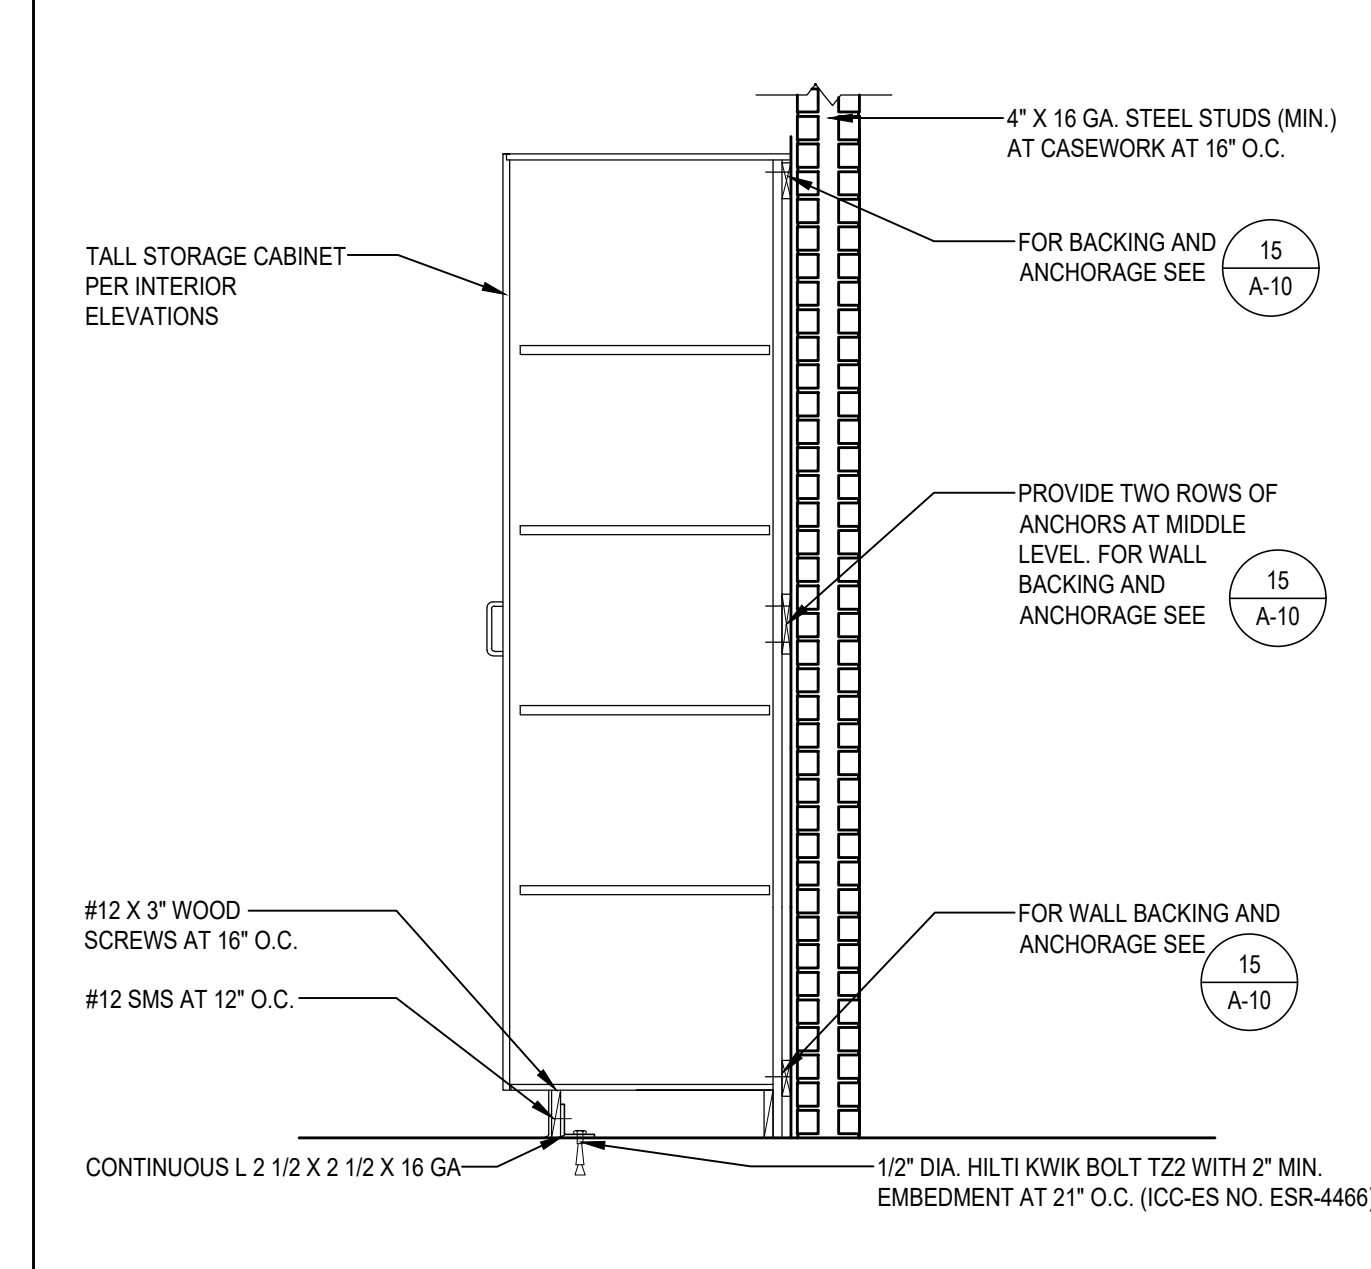
19

TALL STORAGE CABINET ANCHORAGE

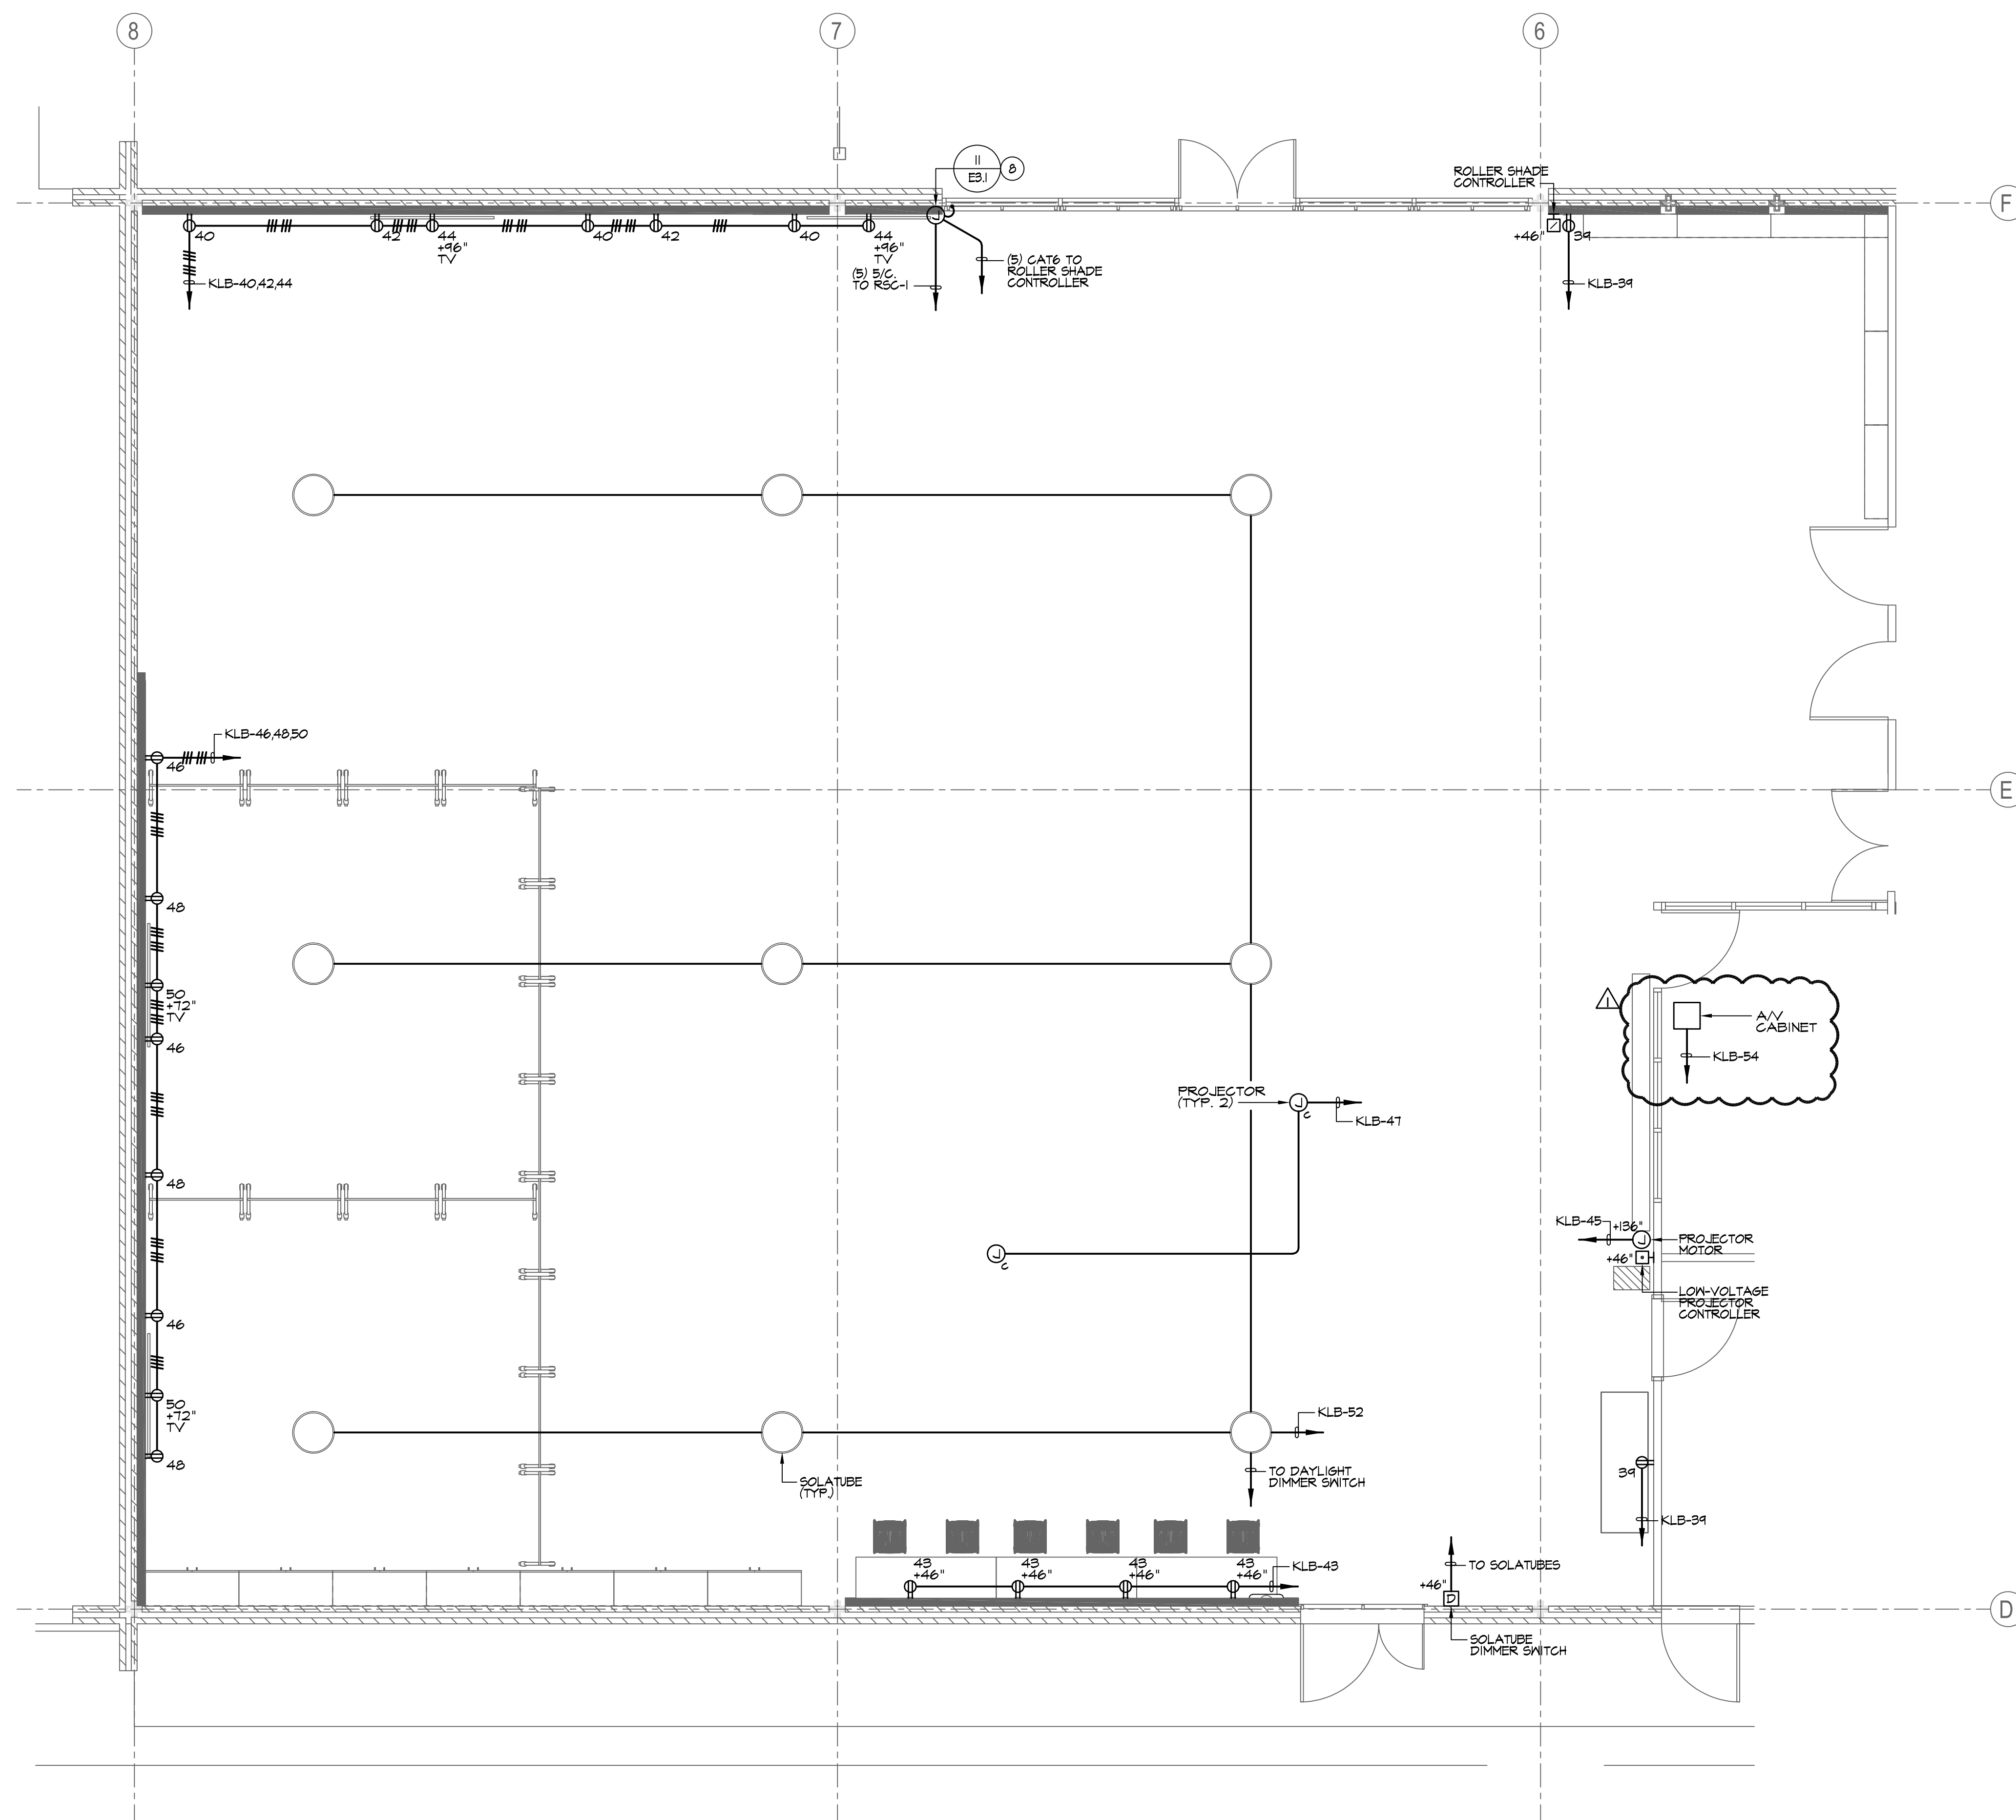
drawing title:
REMODEL POWER PLAN
drawing no.:
E-2.0
drawing of

6. SHEET E2.0 REMODEL POWER PLAN
 - a. Added location of new AV Cabinet and power to Panel KLB.
 - b. Replace Sheet E-2.0 Remodel Power Plan in its entirety issued with this addendum.

REMODEL POWER PLAN

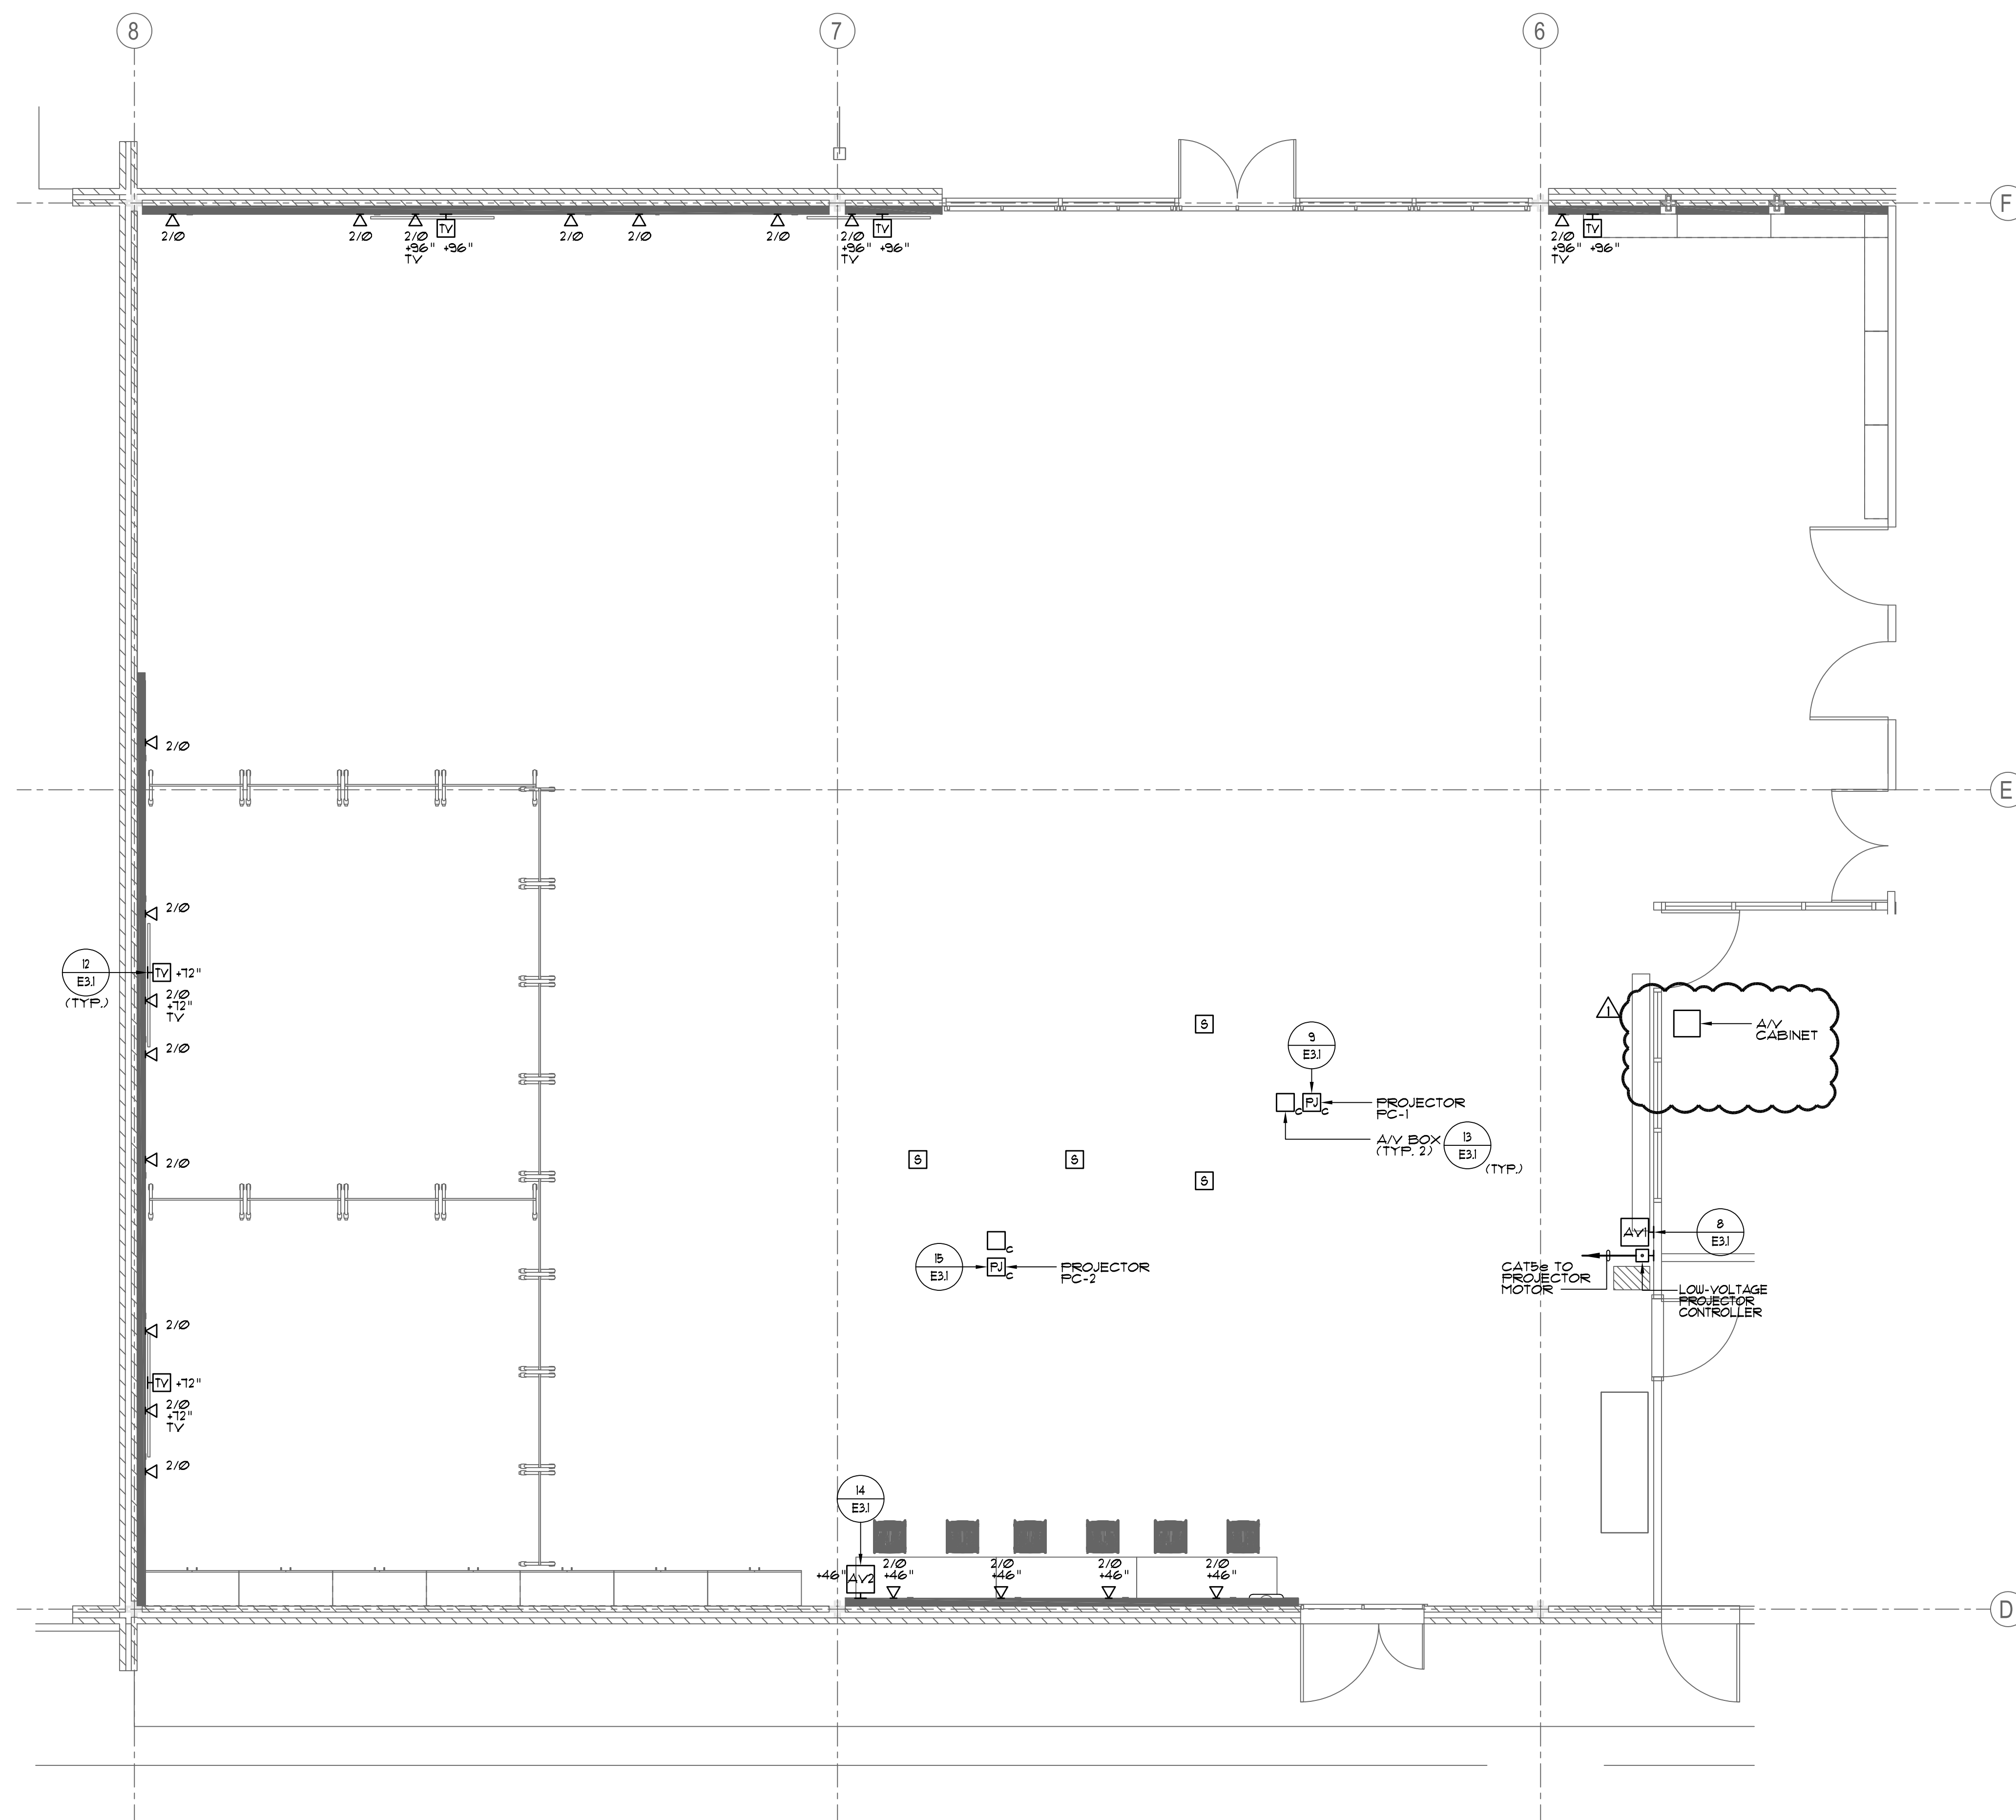
drawing title:
REMODEL SIGNAL PLAN
drawing no.:
E-2.1
drawing of

7. SHEET E-2.1 REMODEL SIGNAL PLAN
 - a. Added location of new AV cabinet.
 - b. Replace Sheet E-2.1 Remodel Signal Plan in its entirety issued with this addendum.

REMODEL SIGNAL PLAN 1
SCALE: 1/4" = 1'-0"

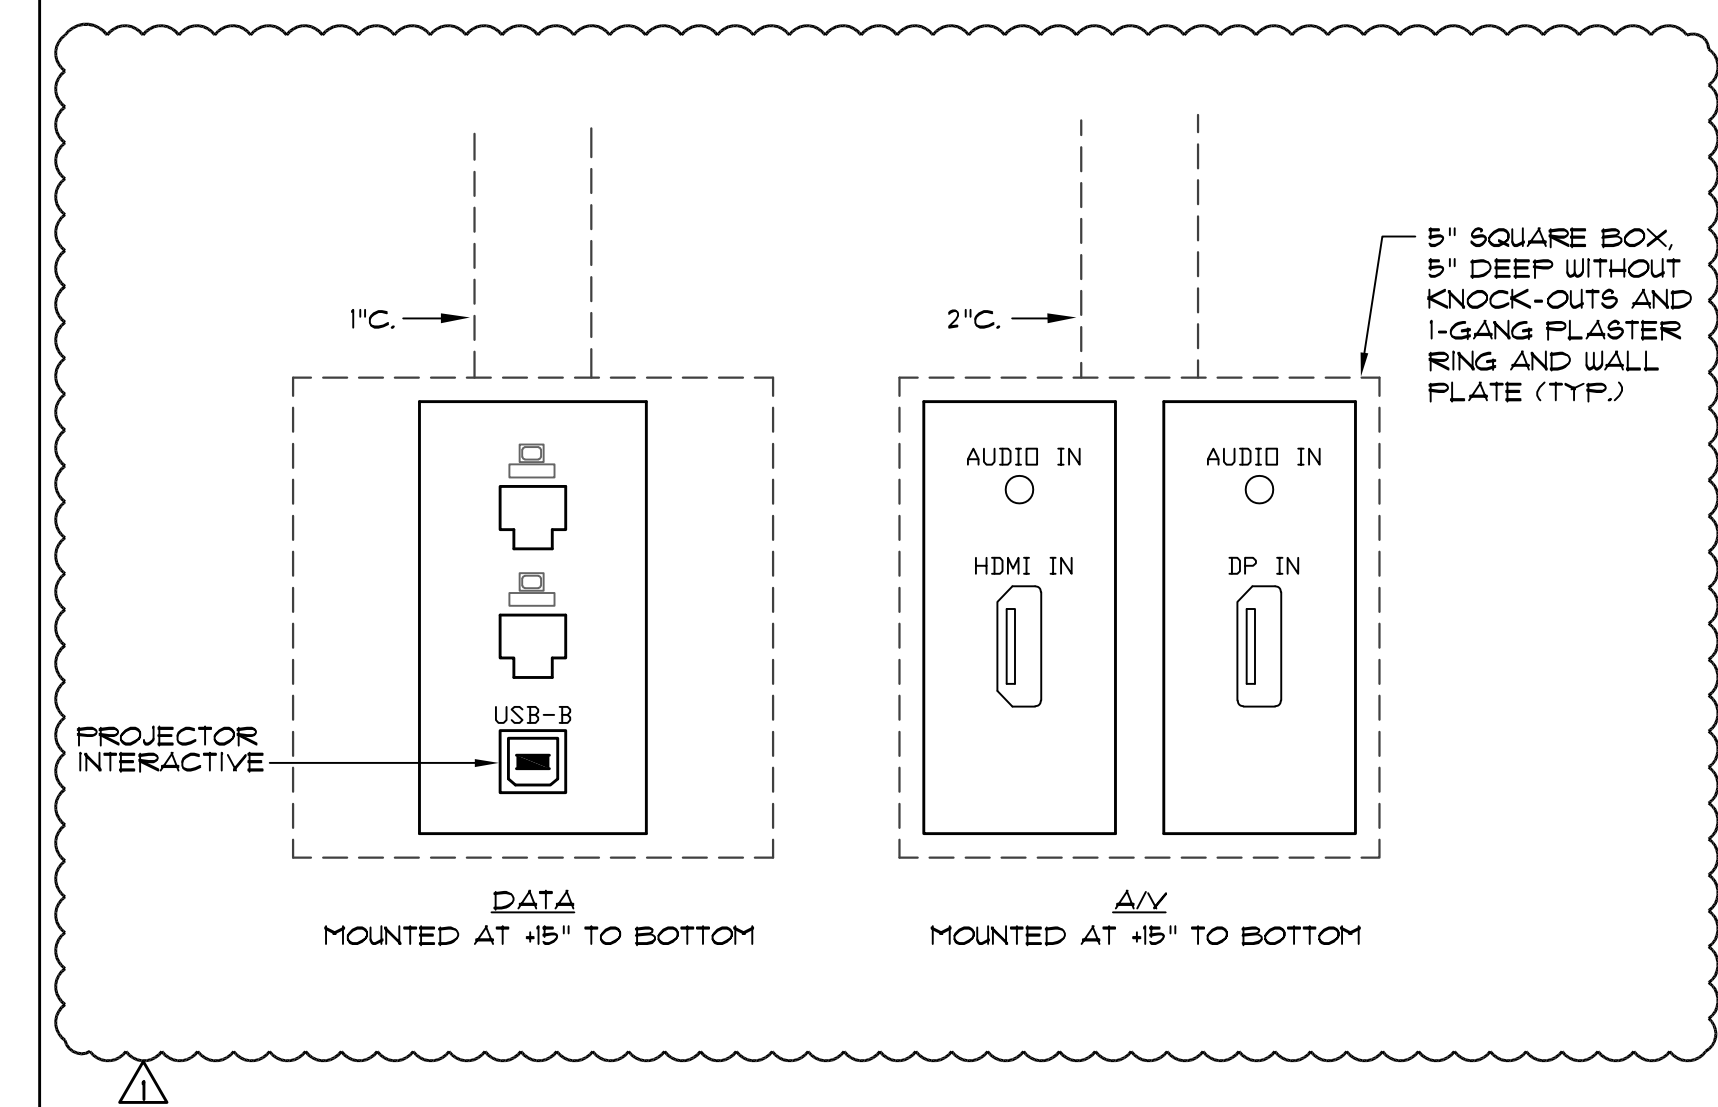
SCALE: NONE 8

A/V 1 OUTLET - FLUSH WALL MOUNTED

8. SHEET E3.1 ELECTRICAL DETAILS
 - a. Revise Details 8, 9, 13, 14, & 15.
 - b. Replace Sheet E-3.1 Electrical Details in its entirety issued with this addendum.

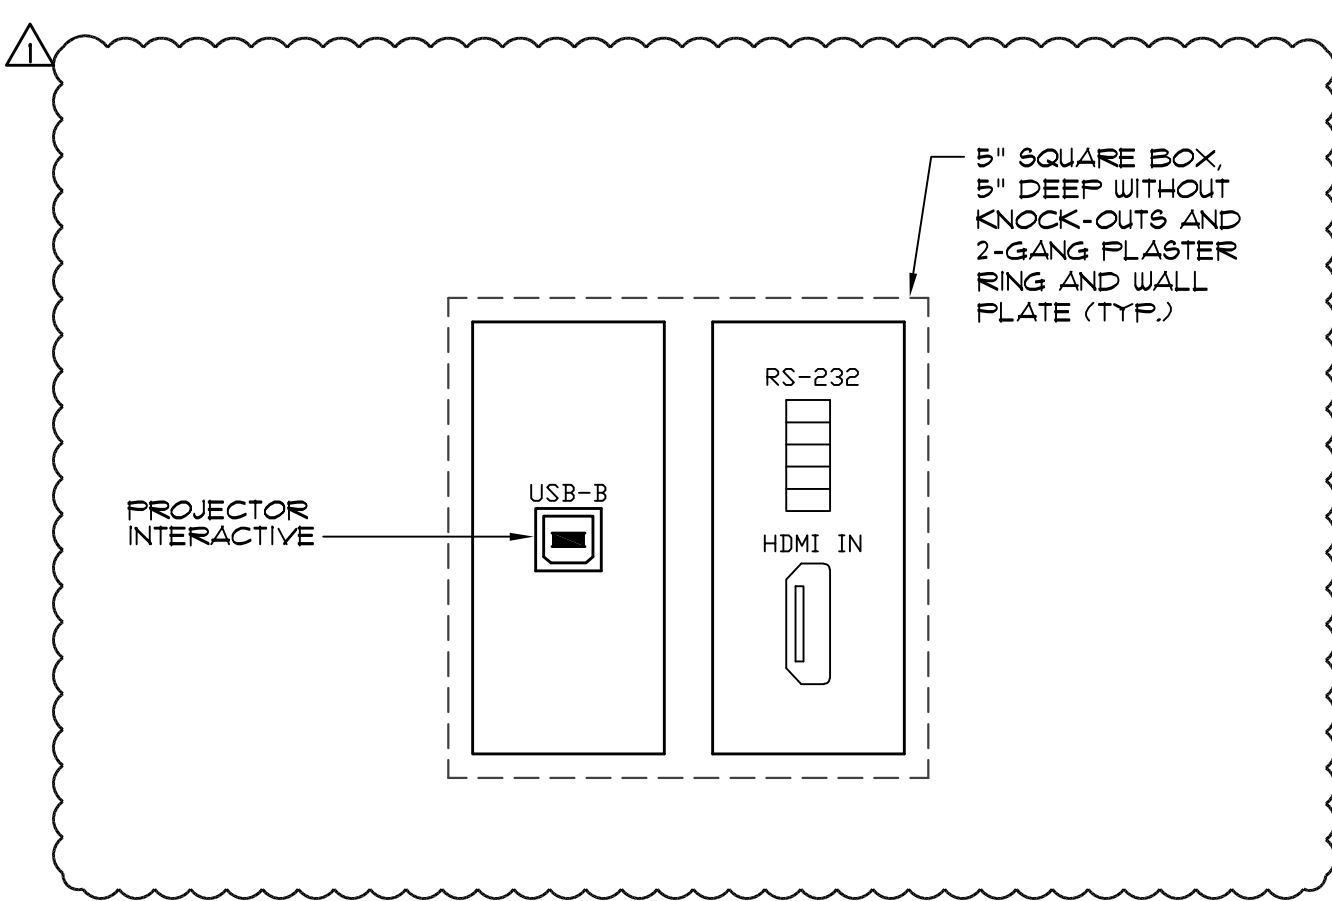
SCALE: NONE 9

PROJECTOR OUTLET PC-1 (CEILING)
