BID NO. 2024-25.10
WILSON HIGH SCHOOL: MEDIA CENTER UPGRADE
February 11, 2025
ADDENDUM NO.01

ADDENDUM 01 Details

**WILSON HIGH SCHOOL
MEDIA CENTER REMODEL
HACIENDA LA PUENTE UNIFIED SCHOOL DISTRICT**

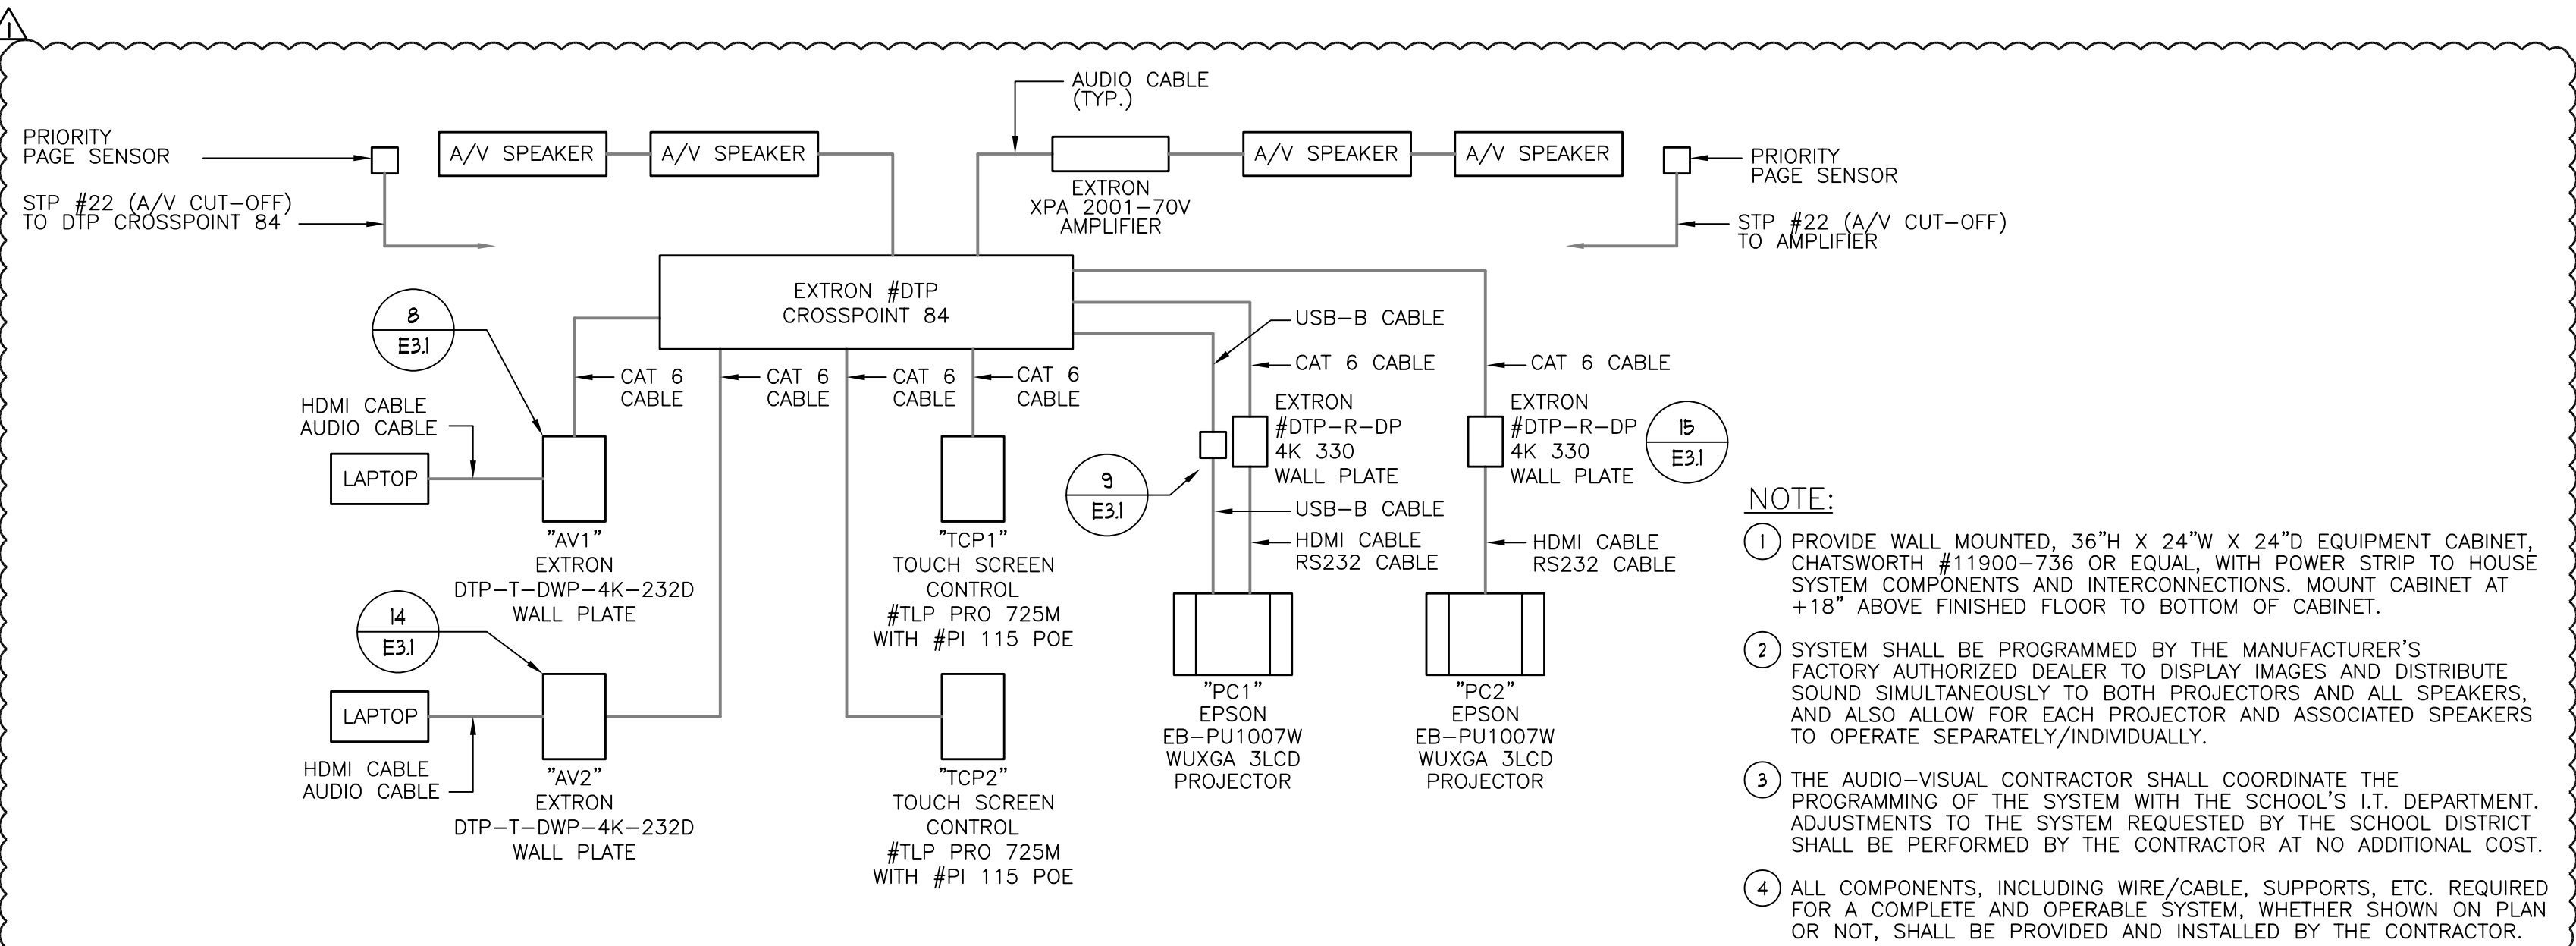
SCALE: NONE 13

A/V PROJECTOR LAYOUT DIAGRAM

8. SHEET E3.1 ELECTRICAL DETAILS
 - a. Revise Details 8, 9, 13, 14, & 15.
 - b. Replace Sheet E-3.1 Electrical Details in its entirety issued with this addendum.

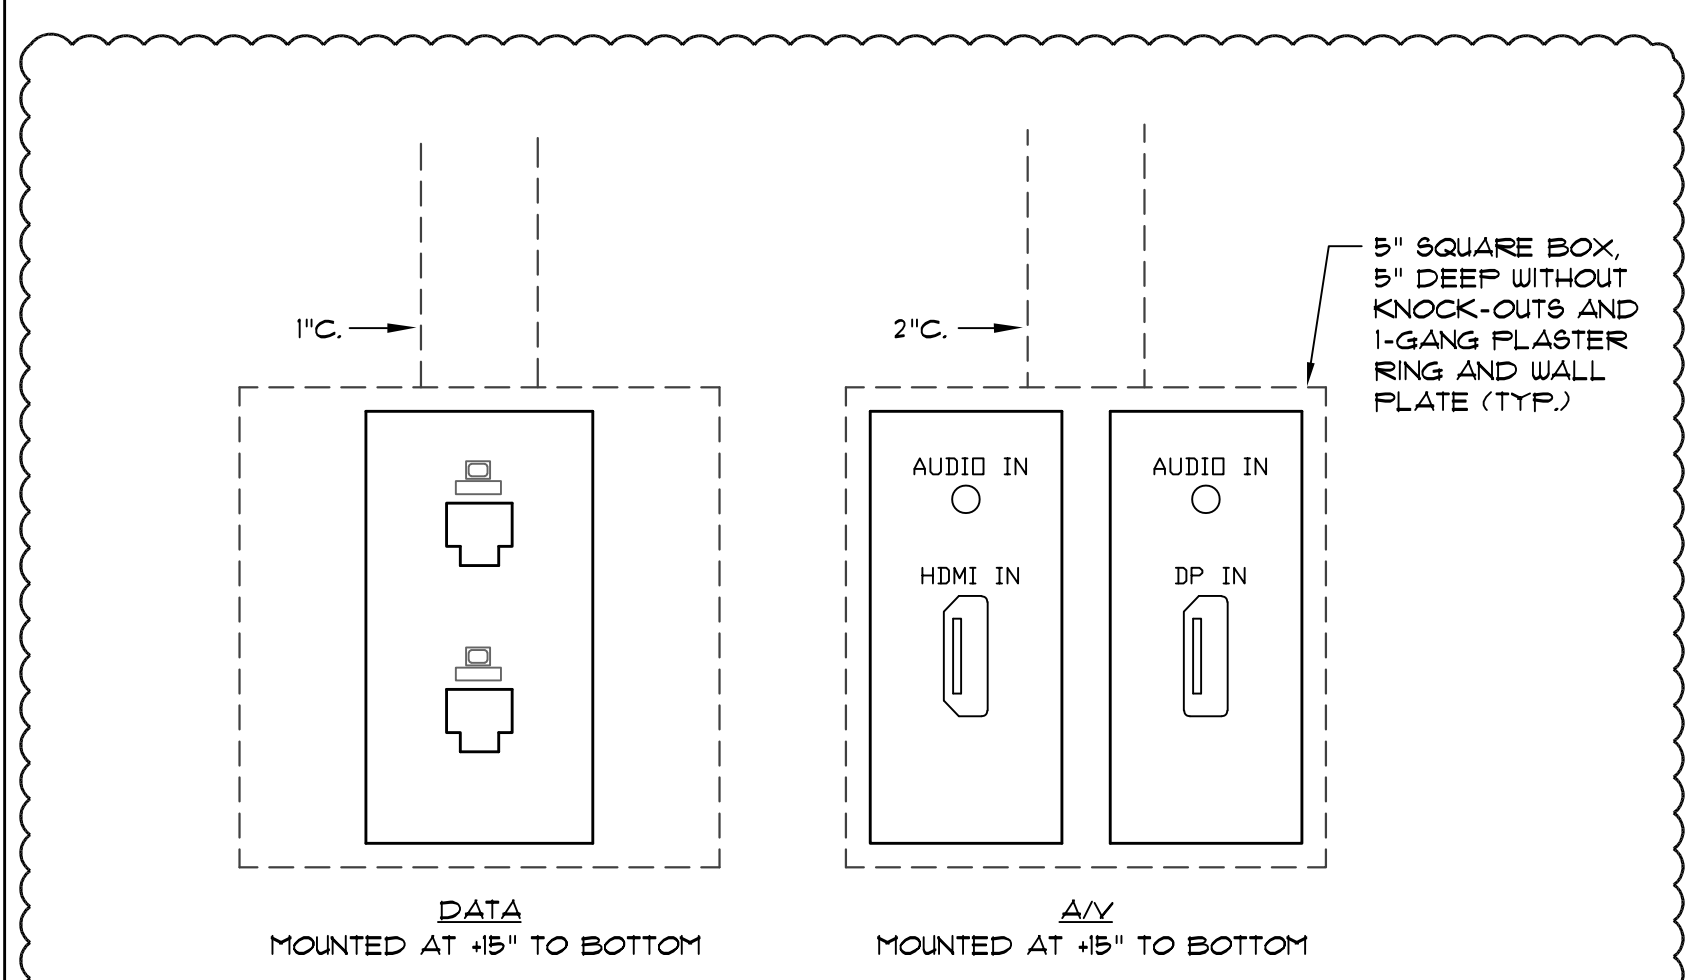
SCALE: NONE 14

A/V 2 OUTLET - FLUSH WALL MOUNTED

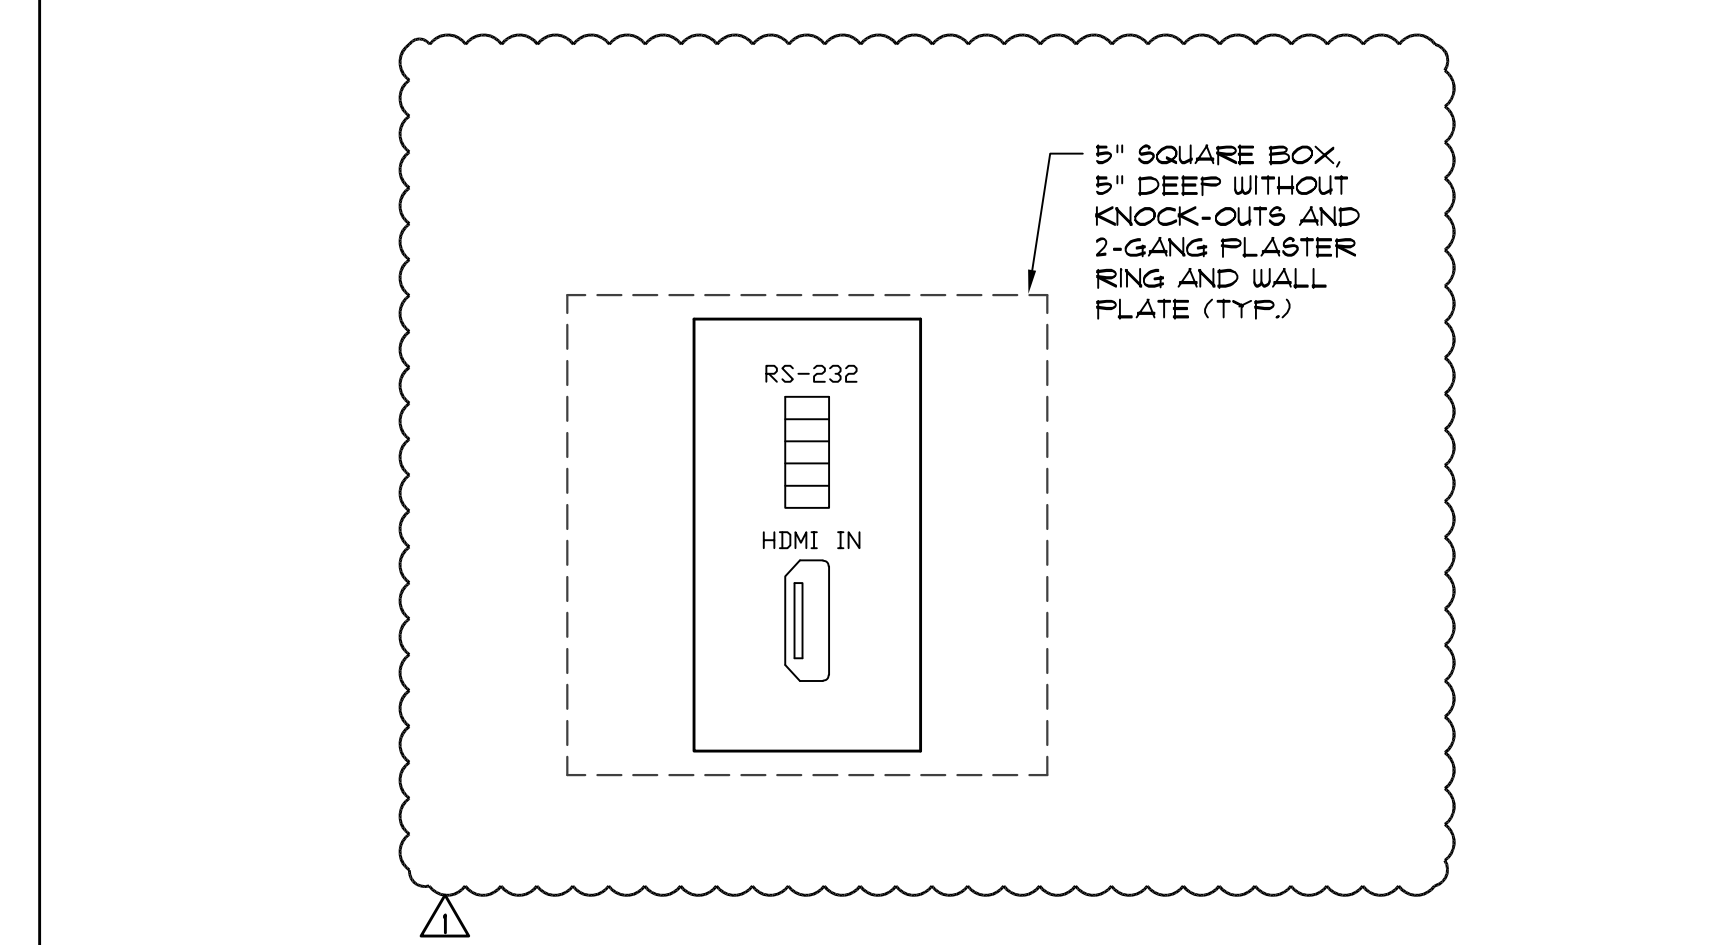
SCALE: NONE 15

PROJECTOR OUTLET PC-2 (CEILING)
