**Town of New Hartford, Connecticut**  
**Air Quality & HVAC**  
**Review for New Hartford**  
**Schools**  
**Bakerville Consolidated**  
**Elementary School**

**TOWN OF NEW HARTFORD REPORT**

Prepared for:  
New Hartford, CT  
51 Cedar Lane, New Hartford, CT 06057  
Bakerville Consolidated School, New Hartford, CT 06057

Silver Petrucelli + Associates  
3190 Whitney Avenue | Hamden CT 06518  
311 State Street | New London CT 06320  
203 230 9007 [silverpetrucelli.com](http://silverpetrucelli.com)

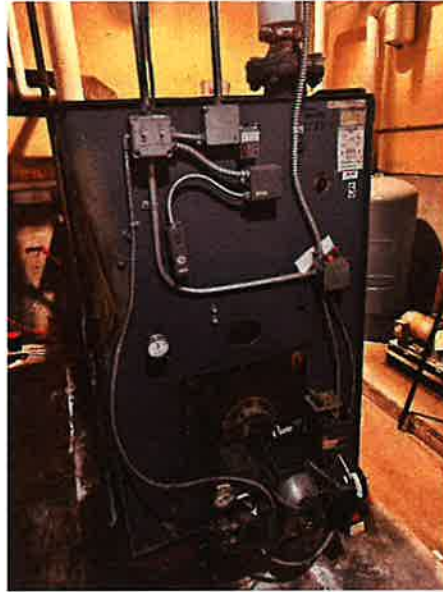
Photo 1: Hot Water Boiler

There is one gas fired hot water boiler that serves the building (see Photo 1: Hot Water Boiler).

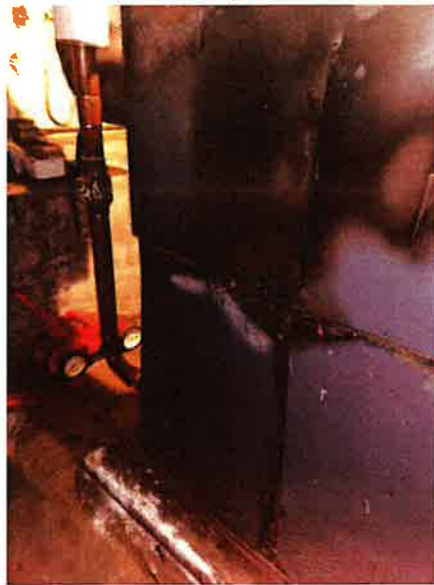
Photo 2: Boiler Damage

The boiler serves the perimeter radiators and the unit heaters throughout the school. It is in poor condition and has visible damage on its exterior (see Photo 2: Boiler Damage).

SP+A recommends replacing the boiler with two (2) hot water condensing boilers. Condensing boilers are typically more efficient than traditional cast iron boilers because they recover a portion of the heat that would usually be lost in the flue exhaust. More efficient heating equipment can result in energy savings for the school. SP+A also recommends installing a second boiler for redundancy in the event that one of the boilers was to be offline. The perimeter radiation should be replaced once it approaches the end of its useful lifespan of about 25 years.

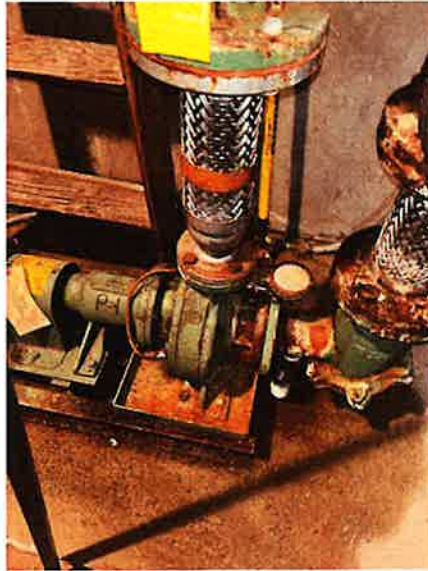
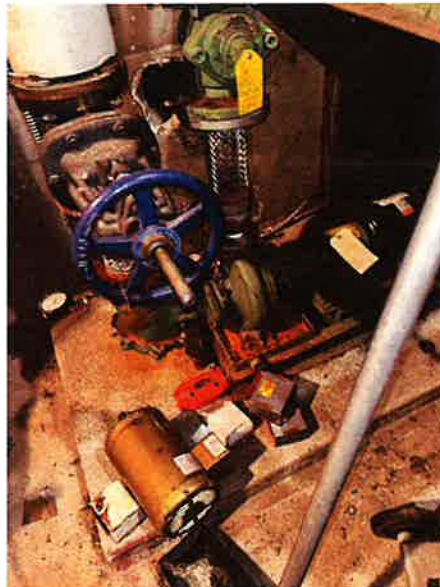
Photo 3: Hot Water Pump Condition

There are two (2) hot water pumps that pressurize the hot water system. The pumps are in poor condition (see Photos 3 and 4: Hot Water Pump Condition).

There is insulation missing from the hot water system and a lot of rust. SP+A recommends replacing the hot water pumps and insulating the entire hot water system in accordance with energy code.

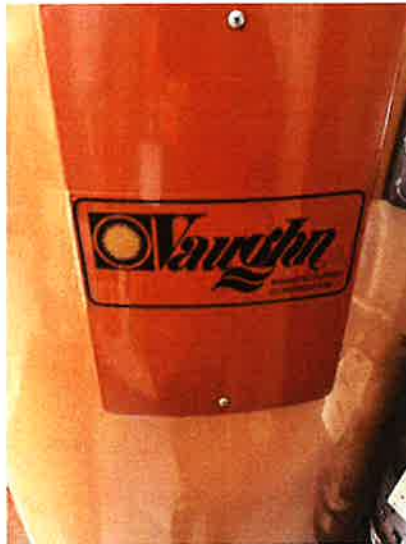
Photo 5: Domestic Hot Water Heater Condition

There is one (1) propane fired Vaughn domestic hot water heater that serves the Kitchen (see Photo 5: Domestic Hot Water Heater Condition).

The heater is in fair condition and was manufactured in 2006. The typical lifespan of a propane fired domestic hot water heater is about 10 years. There is also a domestic water heater in the Boiler Room (see Photo 6: Domestic Hot Water Heater – Boiler Room).

SP+A recommends replacing the hot water heater with a new propane hot water heater. SP+A also recommends installing hot water recirculation pumps with electrically commutated motors (ECM) which are a very efficient option for pump motors.

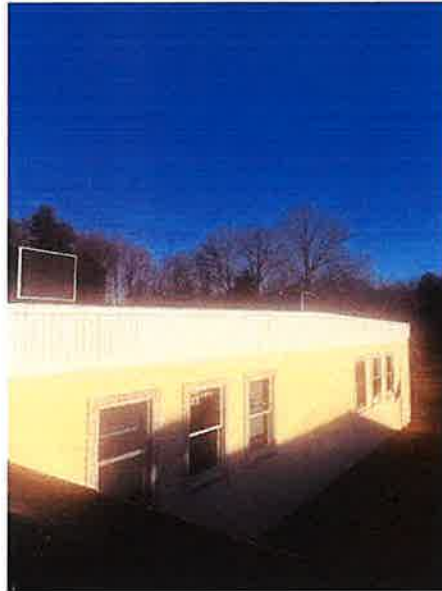
Photo 7: Rooftop Units

There are four (4) rooftop units that serve the addition part of the school (see Photo 7: Rooftop Units).

SP+A was informed that the units are beyond their useful lifespans and in poor condition. See Table 1 for the rooftop units' performance.

The rooftop units were considered deficient if their outdoor air flows were +/- 10 percent of the ASHRAE 62.1 recommended air flows. AHU-3 and AHU-4 are deficient because they are supplying ventilation air that is outside of the ten percent threshold of the code required ventilation rates. There are also several rooms that require ventilation but do not have any mechanical systems providing the ventilation. See Table 2 for non mechanically ventilated rooms.

The various deficient rooms require attention to increase their air quality. SP+A recommends removing the rooftop units and installing dedicated outdoor air systems (DOAS). DOAS will serve only the code required ventilation to the classrooms and corridors. The DOAS is an energy efficient system that will help the air quality of the building by ensuring the rooms will always be mechanically ventilated. The exact location of the DOAS will require architectural and structural investigation. To be paired with the DOAS, SP+A recommends installing variable refrigerant flow (VRF) equipment throughout the building. Heat pumps provide heating or cooling by removing or adding heat to the space depending on the system. VRF changes the flow of the refrigerant to modulate the heat transfer capability of the system depending on the heating and cooling load. Overall, VRF is an energy efficient system that will provide supplemental heating to the fin tube radiation as well as introduce cooling to the building. Provisions will have to be made for the heat pump outdoor units and their locations.

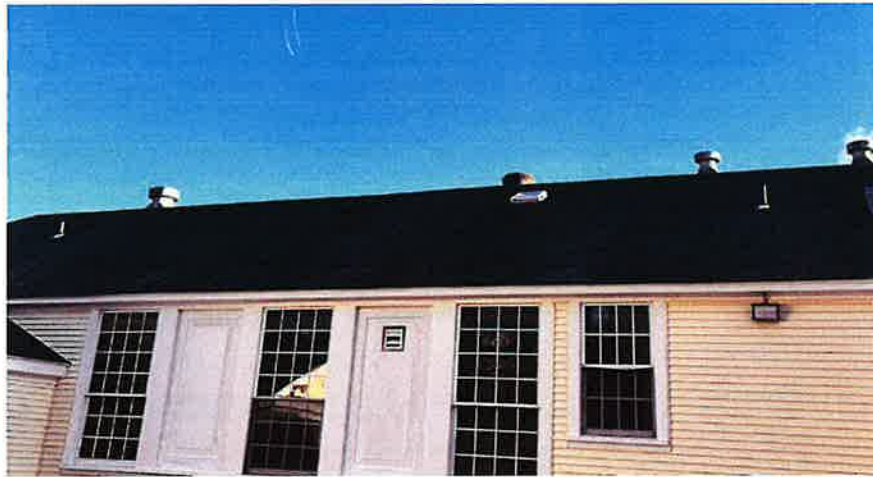
Photo 8: Exhaust Fans

There are also various exhaust fans that serve the classrooms (see Photo 8: Exhaust Fans).

SP+A does not recommend using the exhaust fans as ventilation for any of the rooms as the air that enters the rooms will be unconditioned and allow moisture into the building as well. The exhaust fans are in poor condition and beyond their useful lifespans of 20 years.

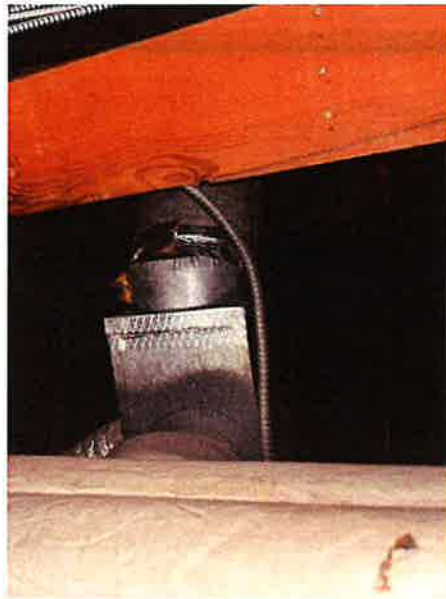
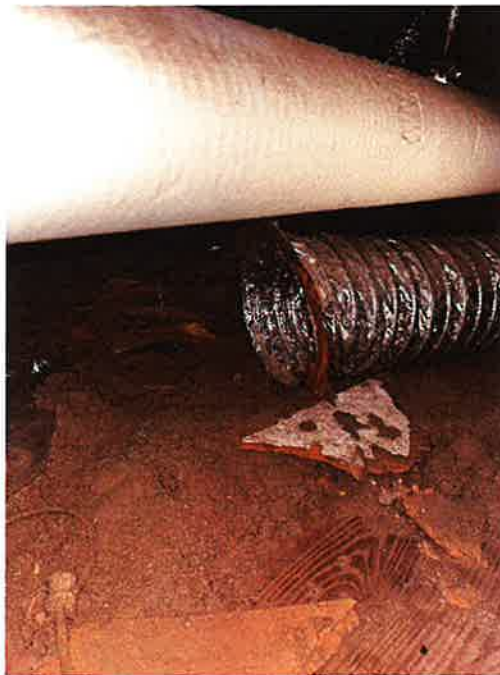
Photo 9: Attic Exhaust Fan

There is also an exhaust fan located in the crawl space attic (see Photos 9 and 10: Attic Exhaust Fan).

The exhaust fan is disconnected from the flexible duct in and does not appear to be operating. SP+A recommends removing the exhaust fan and tying the served rooms with the proposed DOAS. For the toilet exhaust performances see Table 3: Toilet Exhausts.

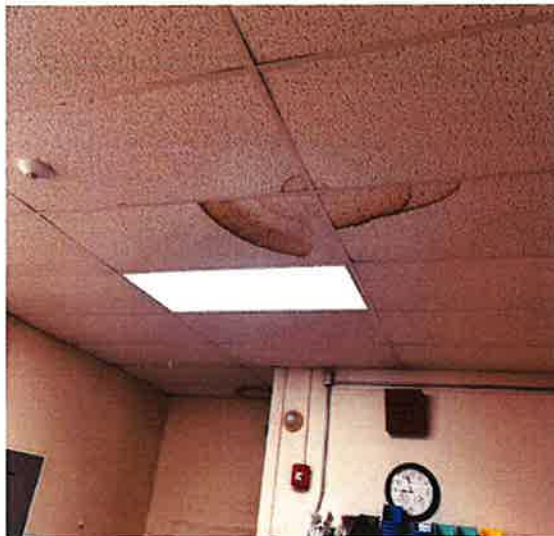
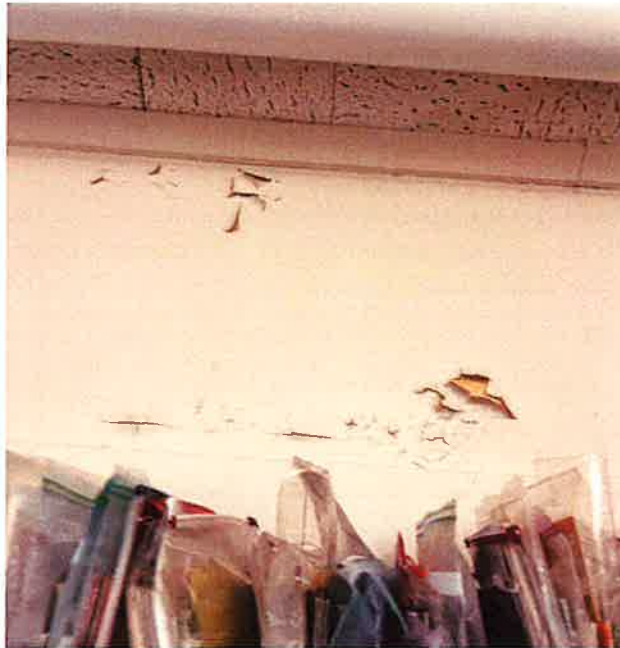
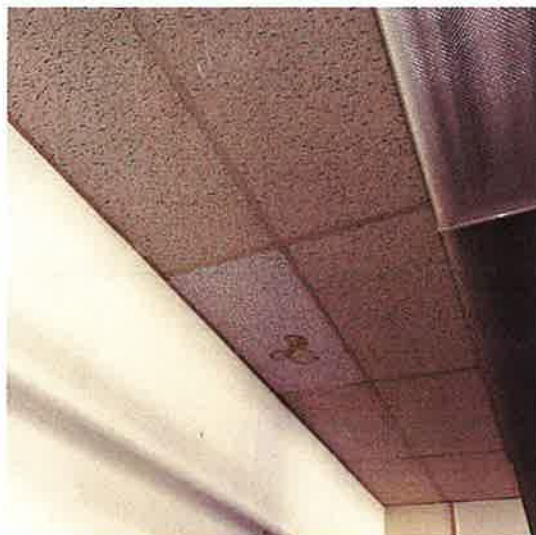
**Photo 11: Ceiling Discoloration**

- There was some ceiling discoloration and wall peeling which could be a sign of a humidity issue or a leak (see Photos and: Ceiling Discoloration and Wall Peeling).

SP+A recommends investigating all ceiling and wall discoloration as well as the wall peeling to determine what the source of the moisture is. Any form of moisture or humidity build up can promote the growth of microorganisms and decrease the overall quality of the air.

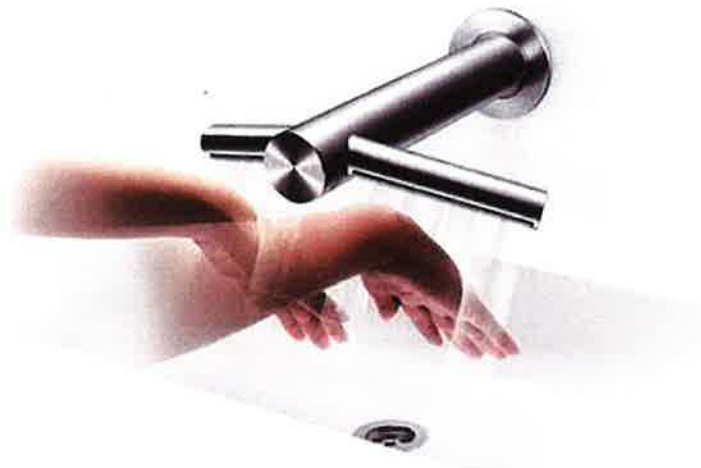
Photo 13: High Efficiency Sink and Hand Dryer

- SP+A recommends installing hand sanitation stations throughout the school to promote a healthy environment
- SP+A recommends investigating high efficiency sinks and hand dryers (see Photo 13: High Efficiency Sink and Hand Dryer).

High efficiency hand dryers (and others like it) can aid in promoting healthy indoor air quality because they filter the air for the dryer as opposed to traditional hand dryers which recirculate dirty bathroom air. They save energy because they are water efficient and dry hands faster.

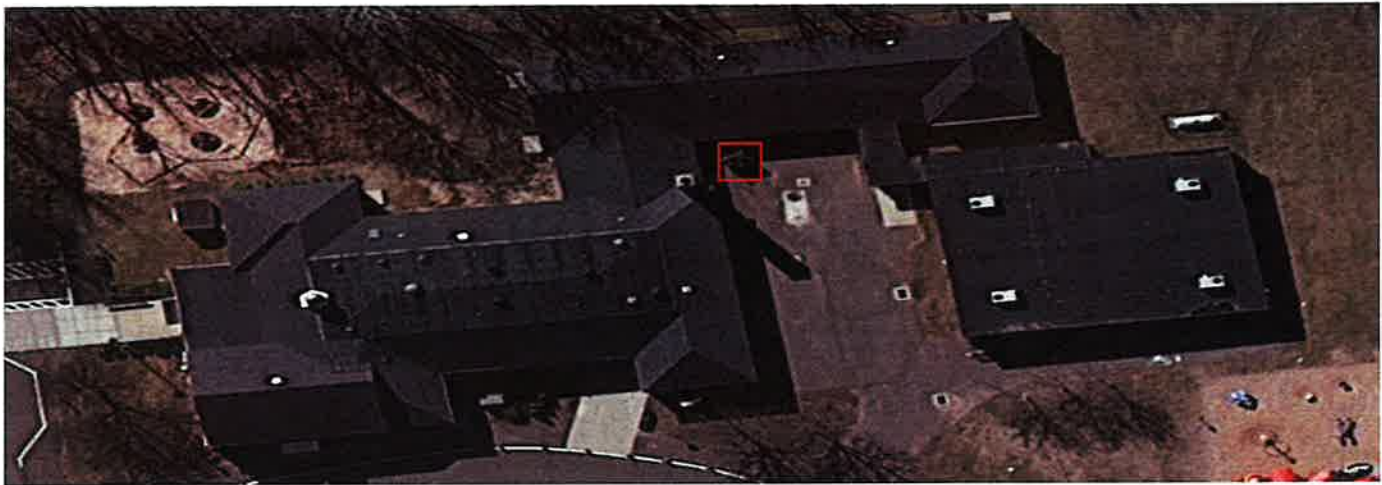
Photo 14: Arial View

- SP+A recommends the abatement of any asbestos in the school in accordance with CT standards.
- Provisions for radon were not witnessed. Per the CT Dept of Public Health, buildings should be tested for radon, and retested every 5 years if the initial measurements are less than 4.0 pCi/L. If the measurements are above the state's acceptable level then radon mitigation is required to reduce levels, and re-evaluation is performed every 2.5 years. Test for radon and take corrective action as needed.
- SP+A recommends investigating if there is adequate sealing for windows and door sweeps for exterior doors to help control the amount of moisture and bugs that get into the building.
- SP+A observed that the school's dumpsters are relatively close to the school (see Photo 14: Arial View)

The school's dumpsters (outlined in red above) are approximately within 5ft from the school's perimeter. SP+A recommends relocating the school's dumpsters to at least twenty five (25) ft from the school's perimeter. Increasing the distance of the school's garbage will decrease the likelihood of bugs and creatures coming into the building which will hurt the overall air quality.
