**Districtwide Lead in Drinking Water  
Sampling and Remediation Plan**

**South Country CSD**

**May 2024  
(updated October 2024)**

**Enviroscience Project #23553**

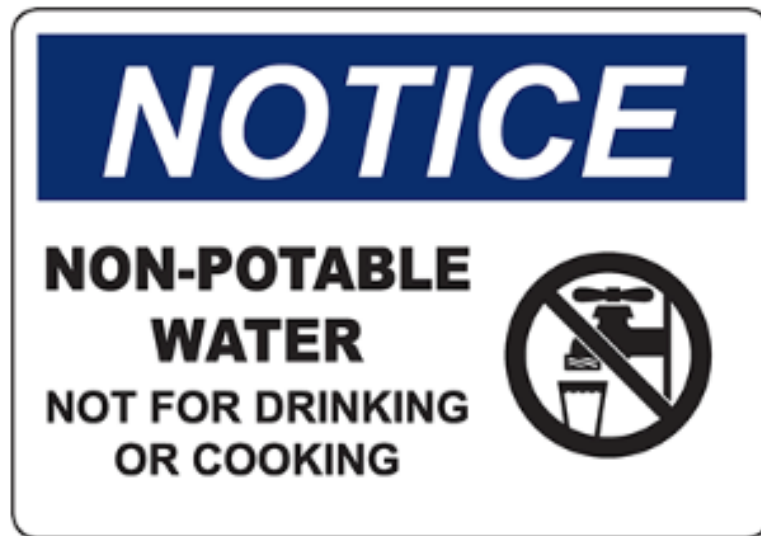
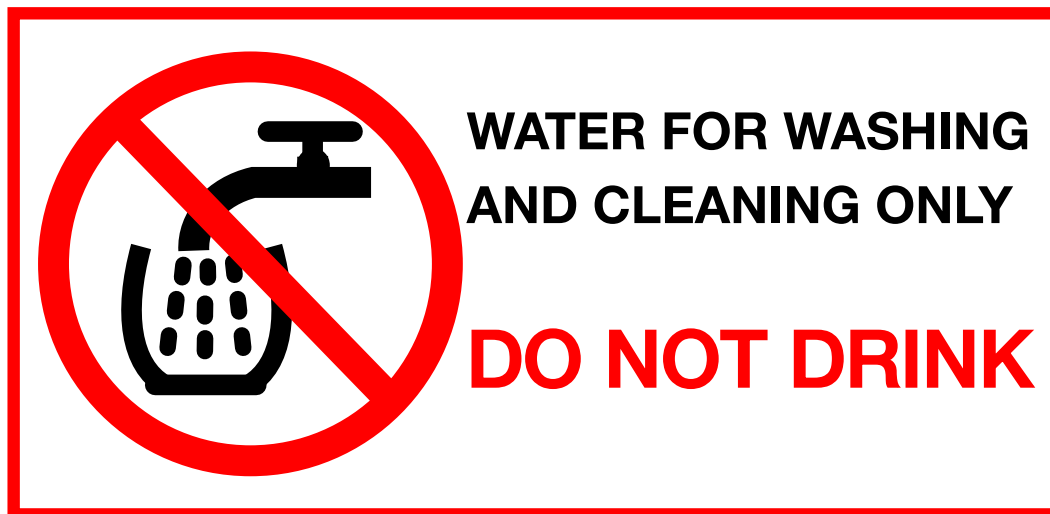
All locations deemed non-applicable, but do not have signs, should be taken offline until signs have been posted. Signs are suggested to have pictures that instruct for handwashing only, do not drink.
