Glen Cove City School District
Districtwide Lead in Drinking Water
Sampling and Remediation Plan

Districtwide Lead in Drinking Water
Sampling and Remediation Plan

Glen Cove City School District
150 Dosoris Lane
Glen Cove, NY 11542

June 2021

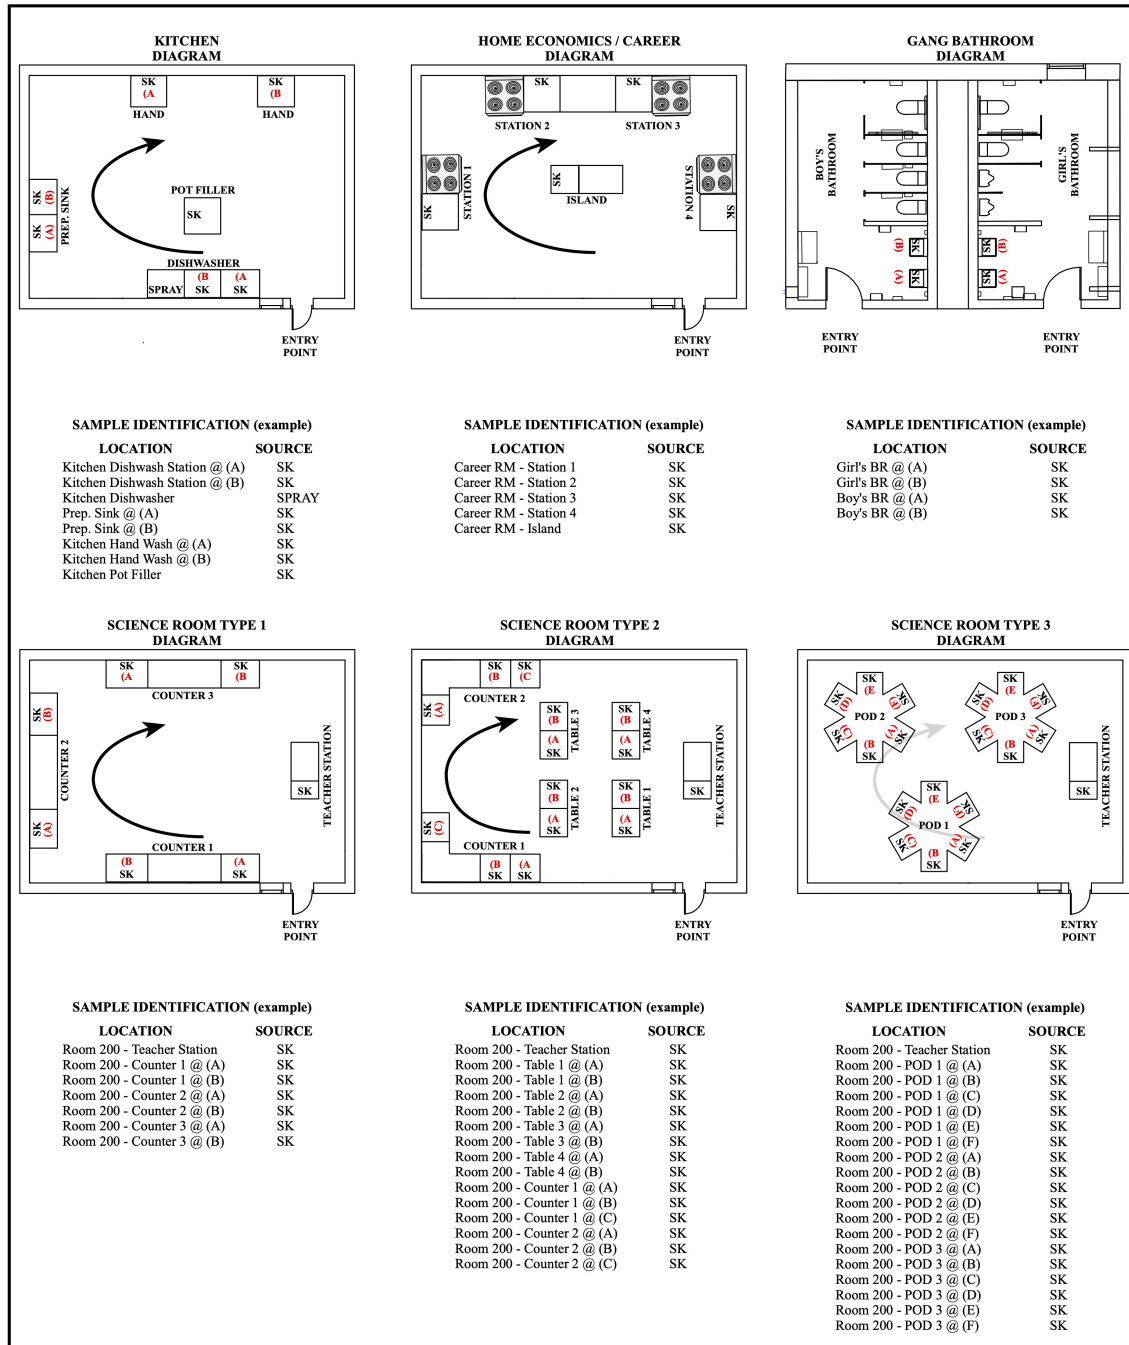
Sampling Location Schematics

In accordance with the regulation, Enviroscience Consultants, Inc. performed initial water sampling throughout the Glen Cove City School District on June 8, 9 and 22, 2021. Samples were collected in wide-mouth 250 milliliter containers and were collected in the morning hours before the facilities opened. The water sources were not used for at least 8 hours and not more that 18 hours prior to sampling. Unique source numbers and designations were assigned to each source location. Unique sample identification numbers were assigned to each sample taken. The key to fixture type codes and the sampling location schematics are shown below.
