1500 E Villa Street  
Pasadena, California 91106

**Soil Sample Analytical Results**

Pasadena Unified School District  
Environmental Soil Sampling  
and Analysis Post-Eaton Fire Recovery  
Jefferson Children's and Teen's Center

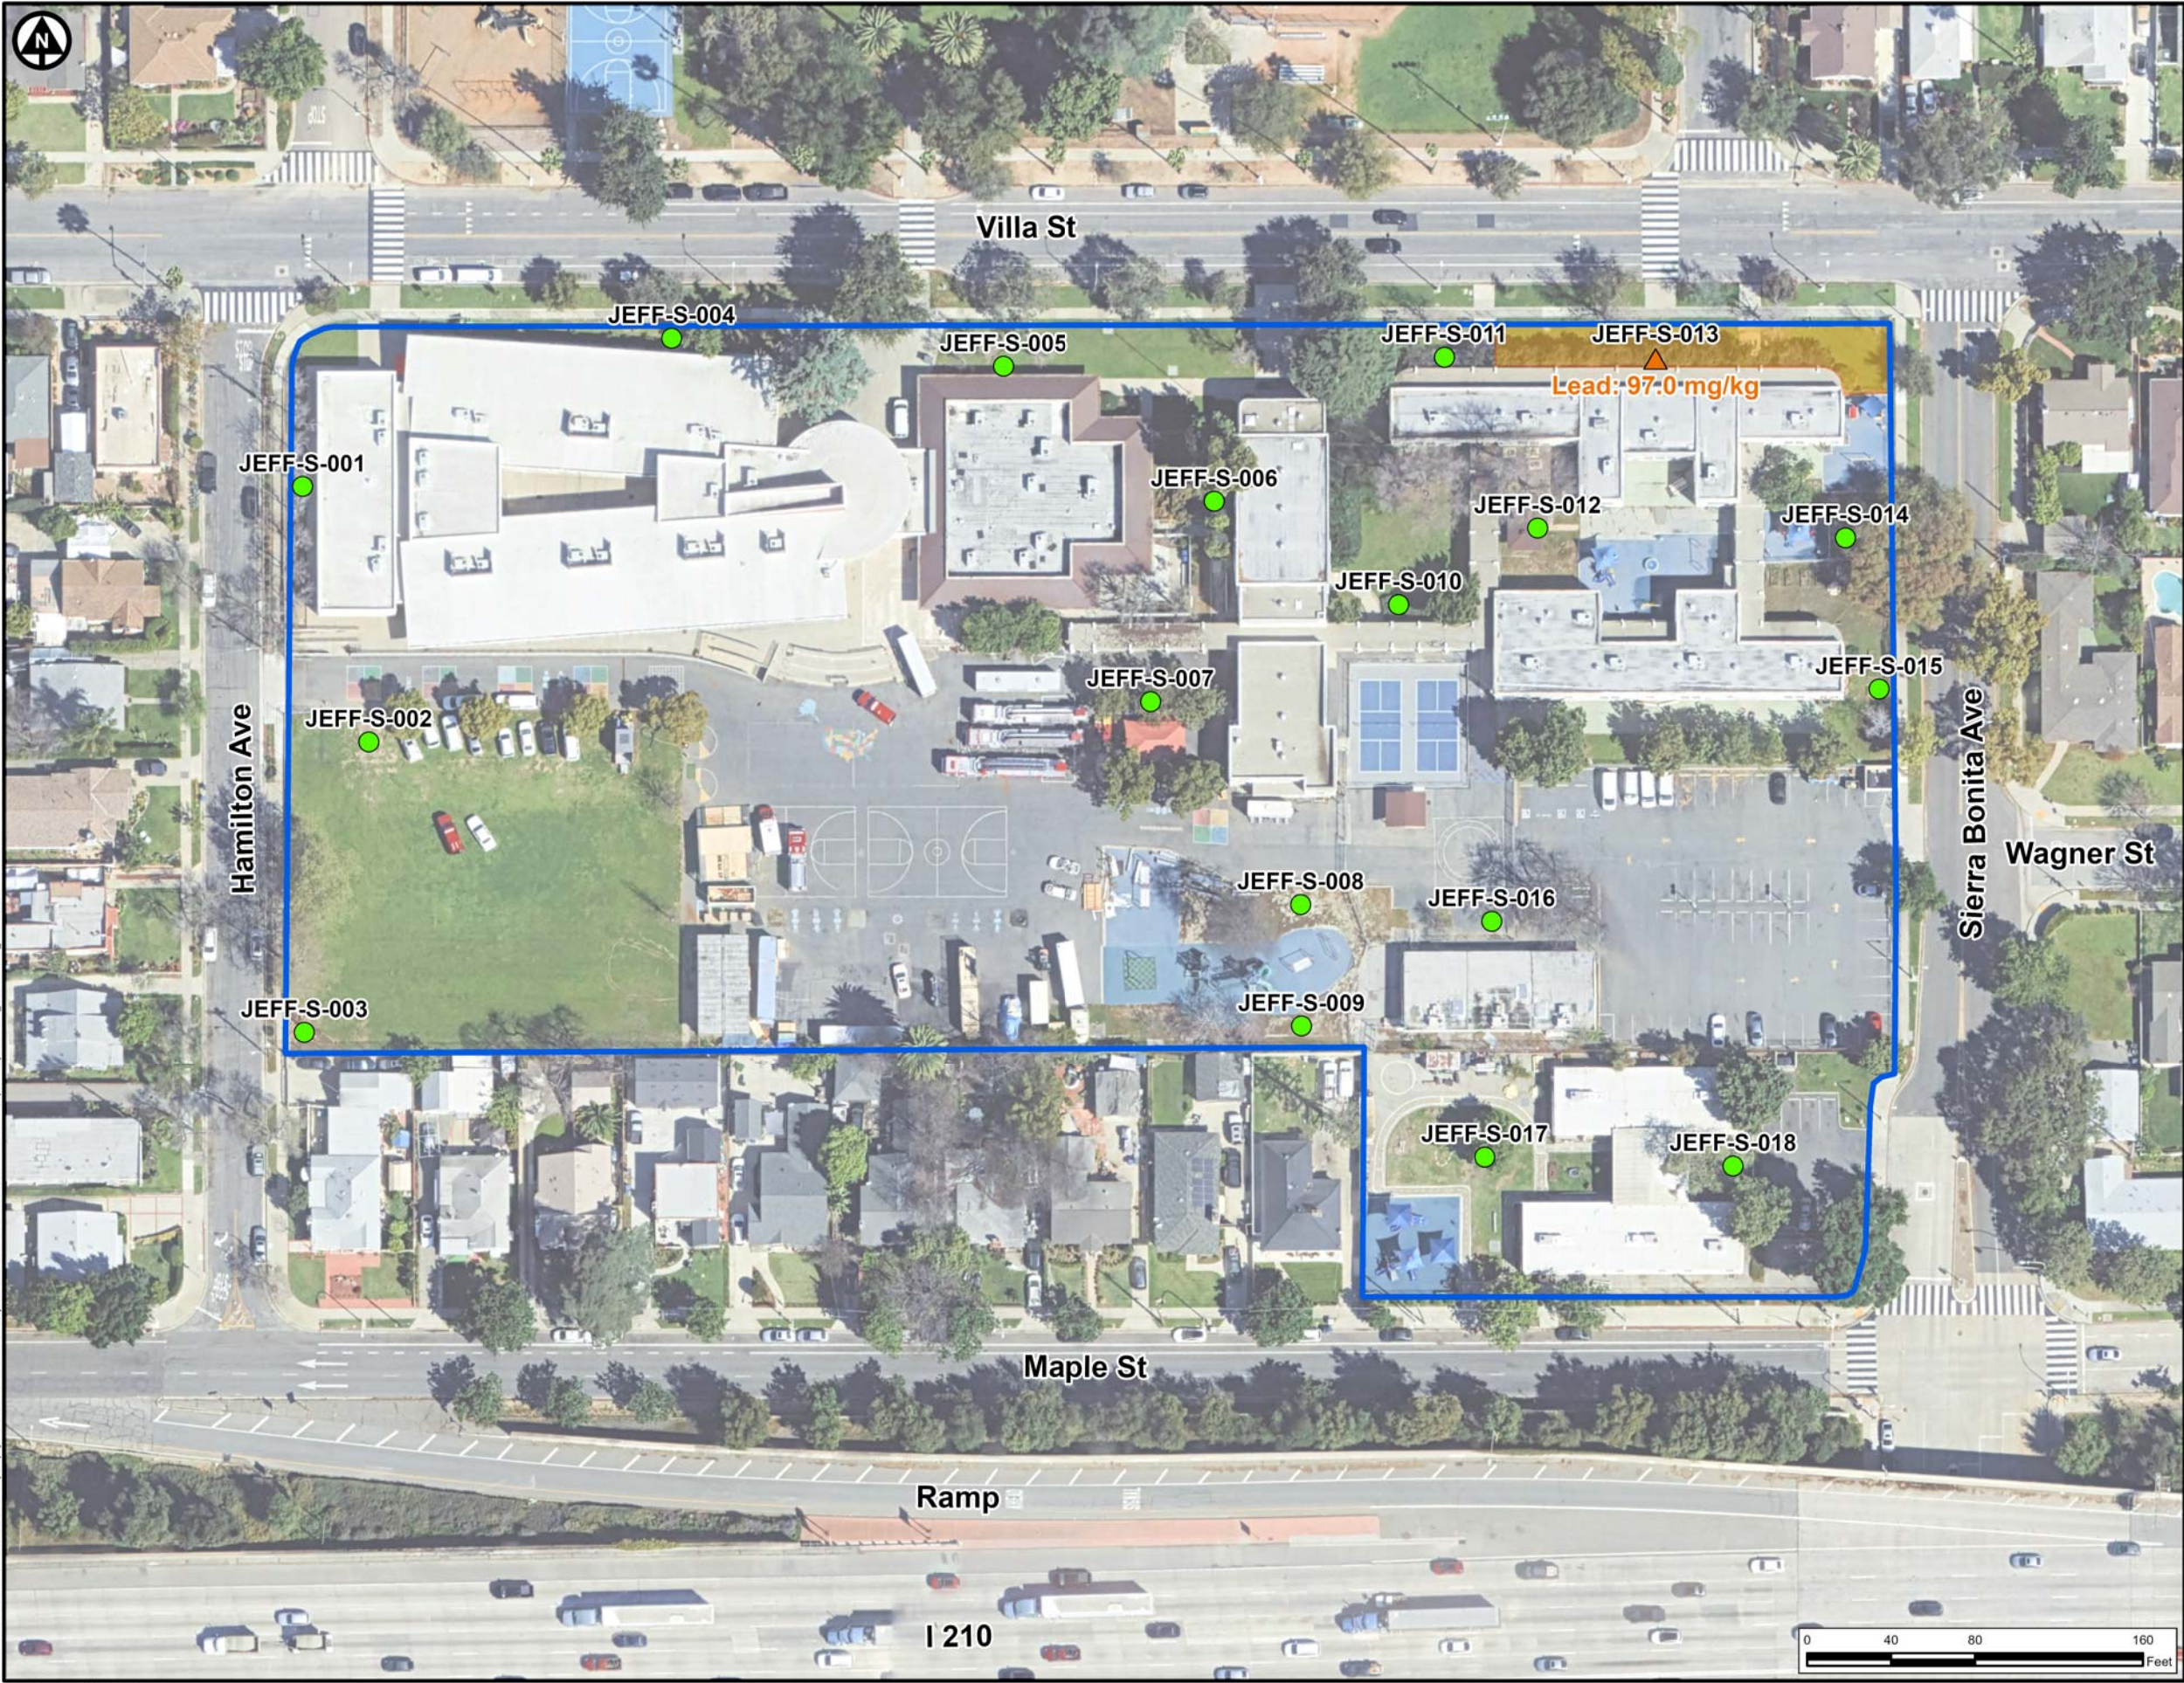
| Figure | 3 |

- ▲ Location of Surface Sample with Analytical Results Above Regulatory Screening Criteria
- Location of Surface Sample with Analytical Results at or below Regulatory Screening Criteria
- Approximate Site Boundary
- Areas to Remain Closed
- mg/kg Milligrams per kilogram
