DeKalb County School District/Elementary Schools

# Smoke Rise Elementary

## School Assessment Report

May 20, 2016

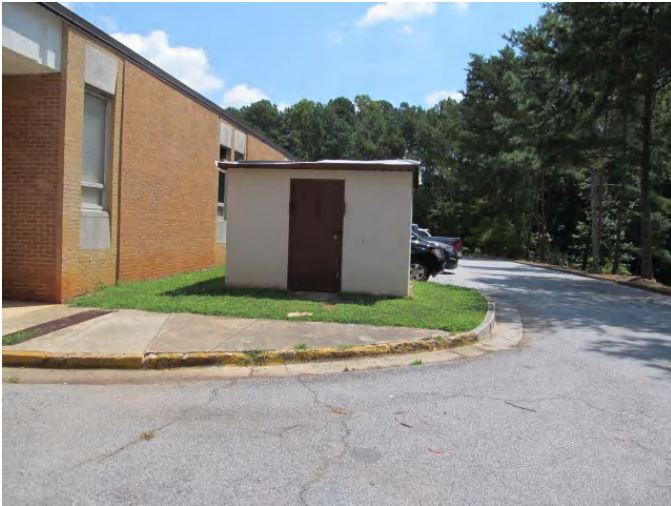
#### **System: G1020 - Site Demolitions and Relocations**

**Location:** Entire Building

**Distress:** Beyond Service Life

**Notes:** The building is scheduled for demolition. This deficiency is for demolition and removal of the building. SPLOST project 509-422 to replace school.

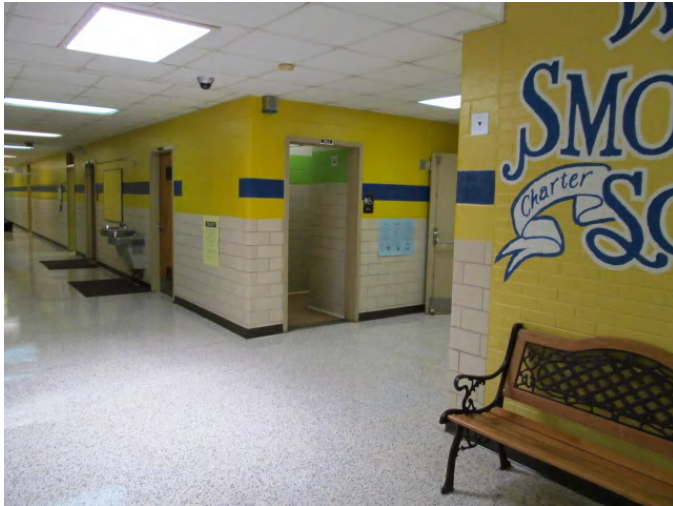
#### **System: G1020 - Site Demolitions and Relocations**

**Location:** Entire Building

**Distress:** Beyond Service Life

**Notes:** The building is scheduled for demolition. This deficiency is for demolition and removal of the building. SPLOST project 509-422 to replace school.

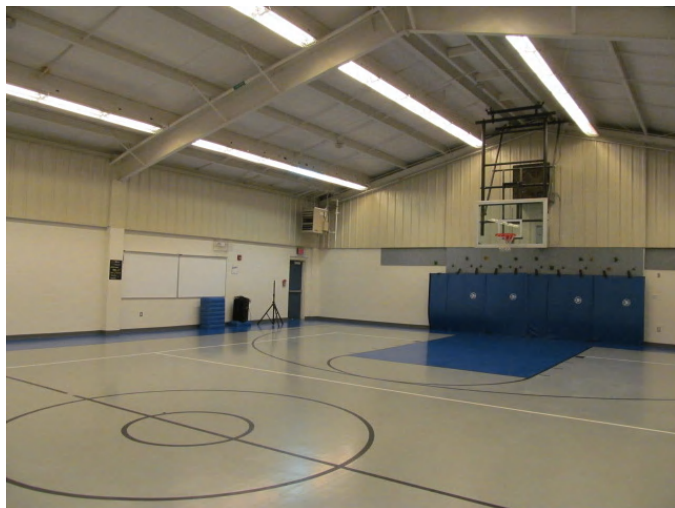
#### **System: G1020 - Site Demolitions and Relocations**

**Location:** Entire Building

**Distress:** Beyond Service Life

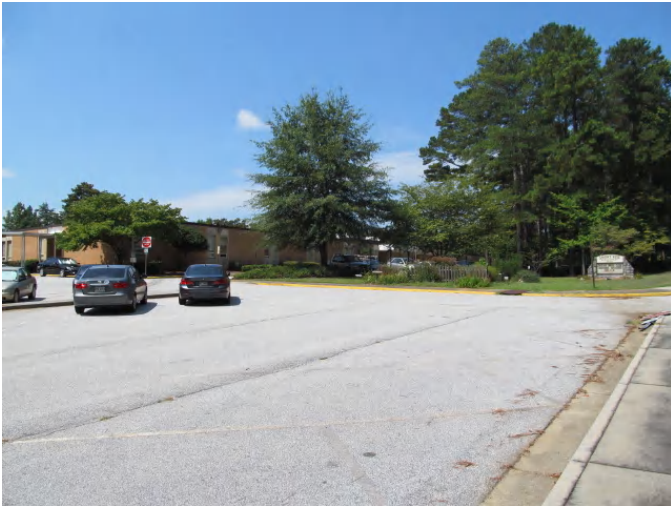
#### **System: G1020 - Site Demolitions and Relocations**

**Location:** Entire Site

**Distress:** Beyond Service Life
