Regarding: Short Term Radon Testing  
Rigler Elementary School  
5401 NE Prescott Street  
Portland, Oregon 97218  
PBS Project 25000.241 Phase 0017

## RADON MONITORING REPORT

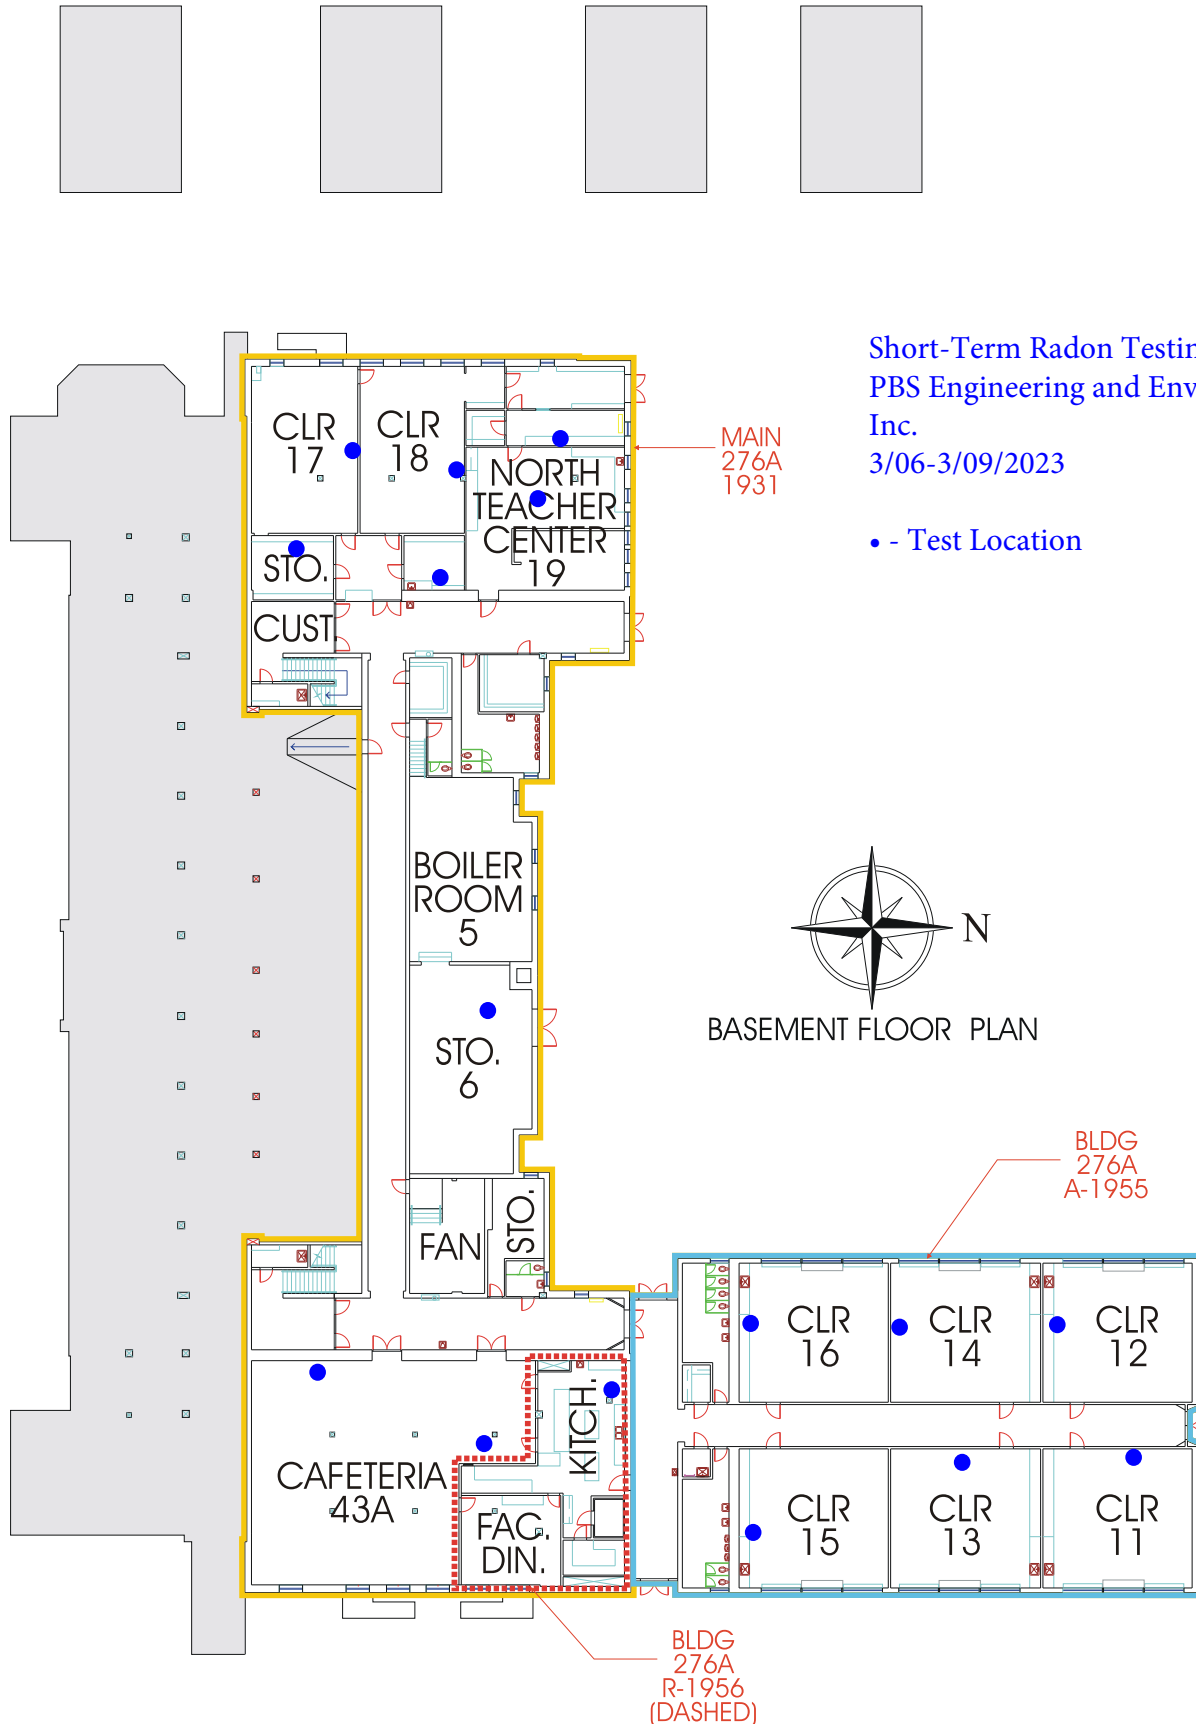
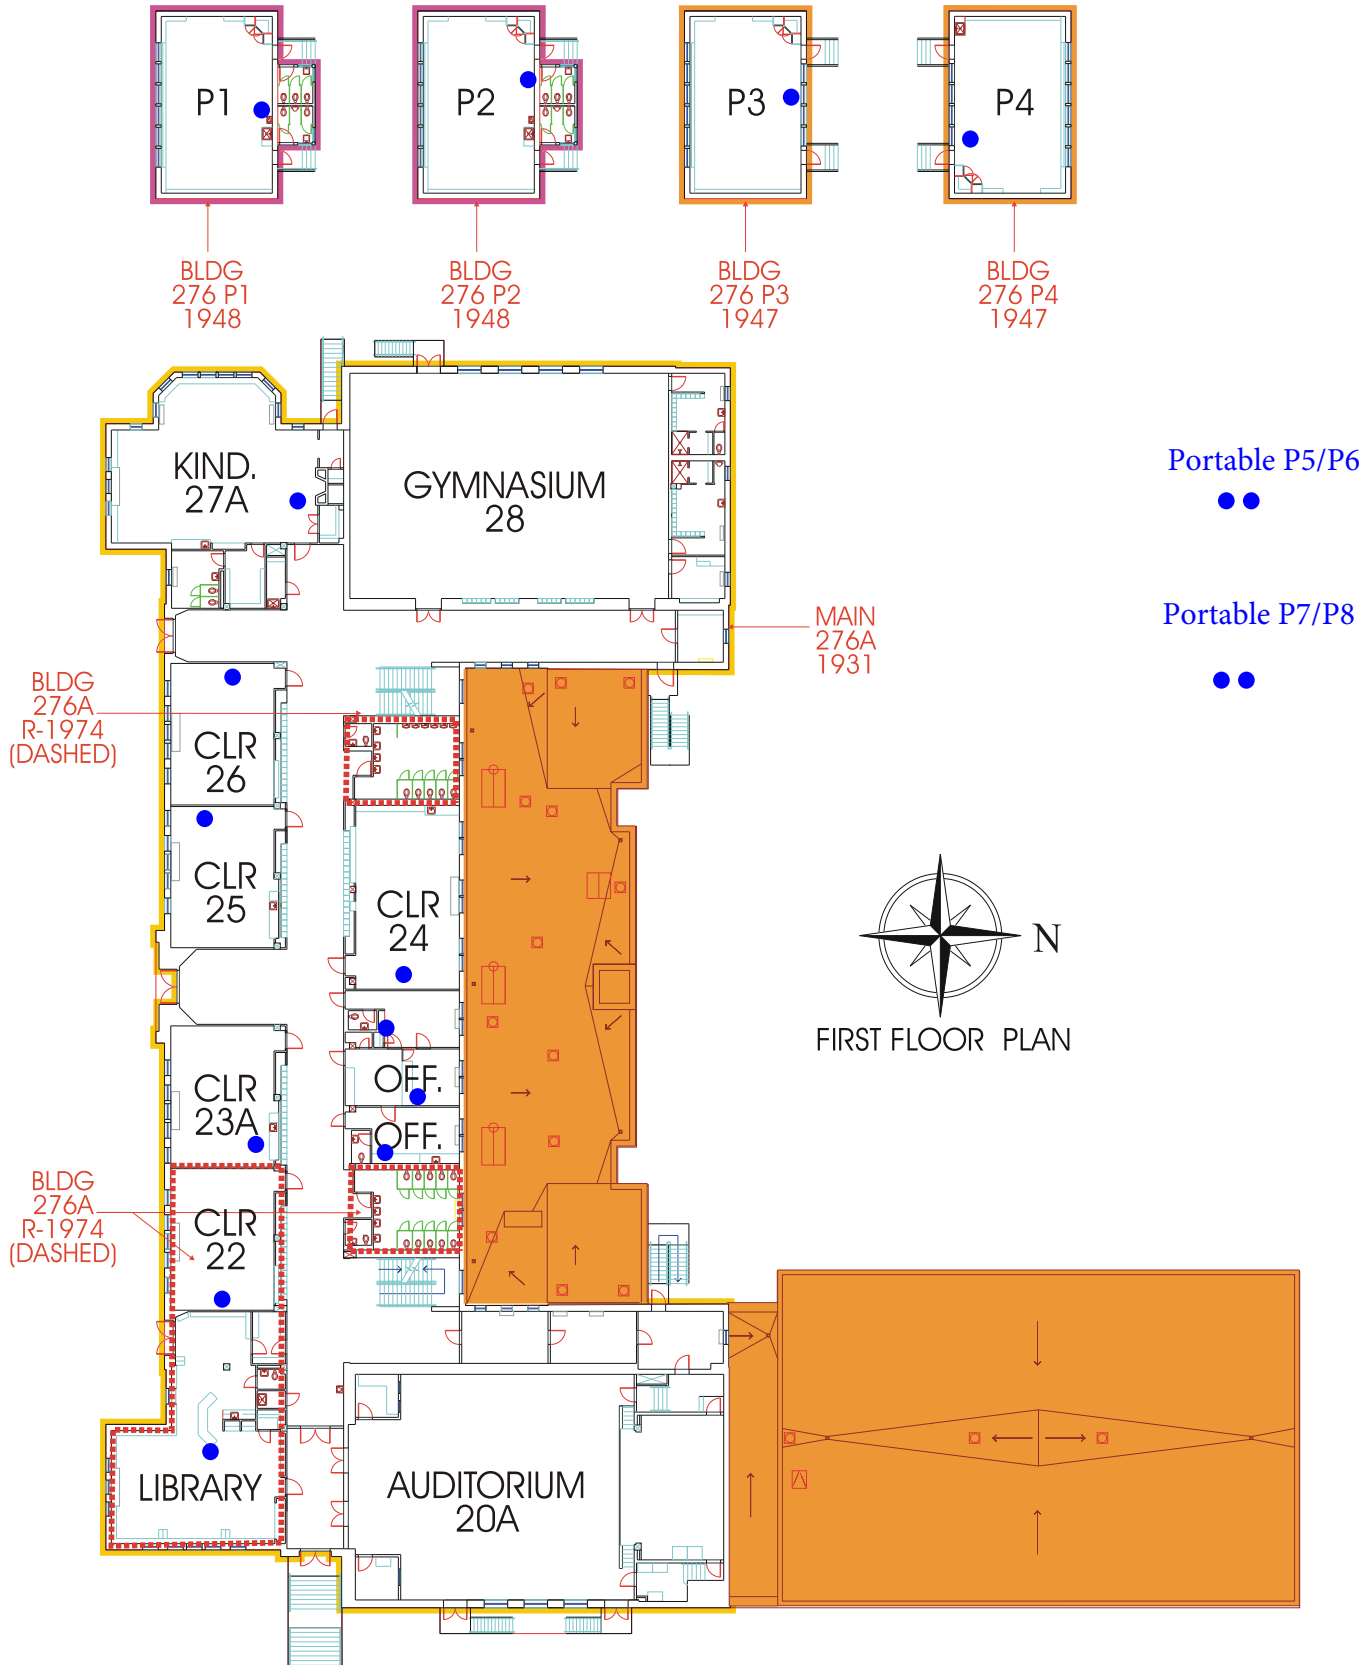
## *Rigler Elementary School* 5401 NE Prescott Street 97218 *Facility Plan*

Only the basement custodial office, identified as Storage 6 on the map, was found to have elevated concentrations of radon. This is likely due to the area's proximity to soil and bedrock in the crawlspace, and the lack of sufficient fresh-air ventilation.

See the attached laboratory analysis report for more details and the attached informal sample location map approximate locations of where samples were collected.

- **If the result is from 4.0 pCi/L to 8.0 pCi/L**, perform a follow-up measurement of that room using a long-term test. This test should be conducted over as much of a nine-month school year as possible, when the room is likely to be occupied. If that result is equal to or greater than 4.0 pCi/L, the radon in the room should be fixed (i.e., lowered).
