# School Safety Assessment Technical Memorandum

## Daniel Webster Elementary School

Jefferson Elementary School District

October 2019

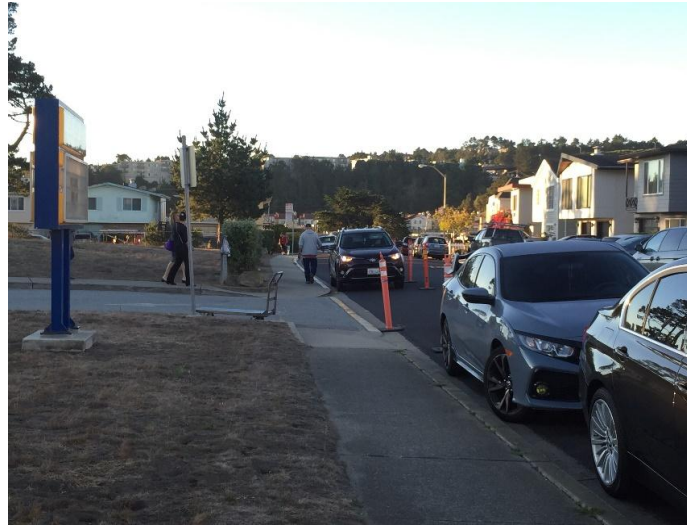
- ◆ Most students arrive at school using the eastern sidewalk along El Dorado Drive. While the sidewalk meets ADA requirements, audit participants noted that the sidewalk is too narrow for the pedestrian traffic volumes experienced during the morning arrival. Further, SSA participants recorded sidewalk obstructions caused by parked cars where passengers open their doors onto the sidewalk.

*Figure 1: Drop-off zone in front of school; there is limited sidewalk space for pedestrians during peak hours.*

- 1 El Dorado Drive at Staff Parking Lot**
  - Consider widening sidewalk near the school onto city right-of-way to east side of existing sidewalk.
- 2 El Dorado Drive at Cerro Street**

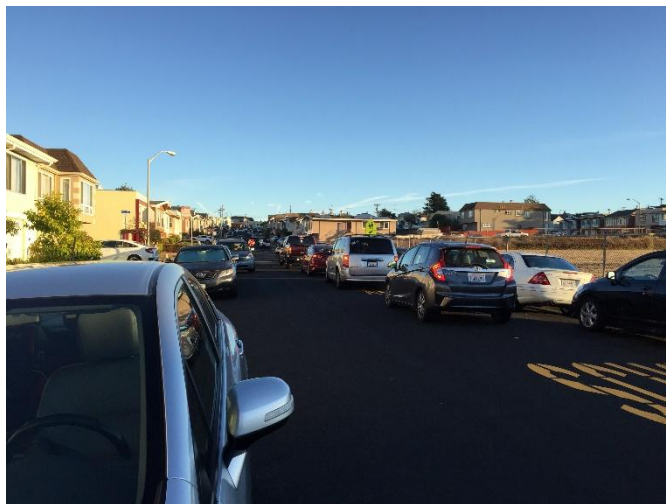
- Walk audit participants perceived the process as efficient. However, some congestion and automobile buildup at the intersection of El Dorado Drive and Cerro Drive was reported during peak arrival periods.

*Figure 2: Traffic backups along El Dorado Drive experienced during peak drop-off times.*

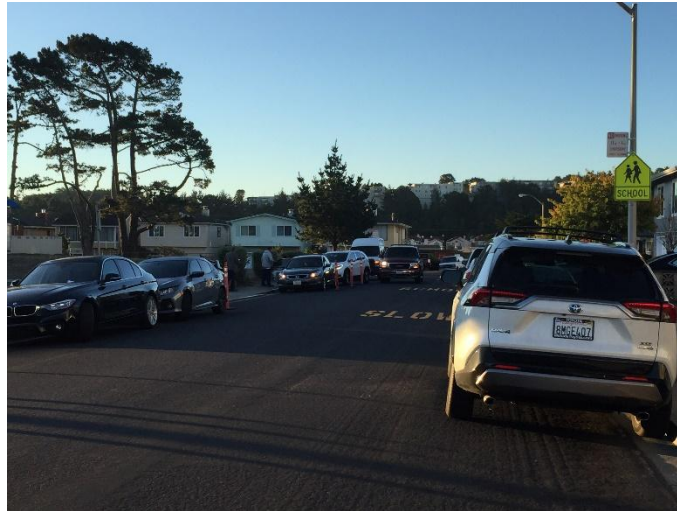
*Figure 3: Traffic backs up down El Dorado Drive as students are dropped-off.*

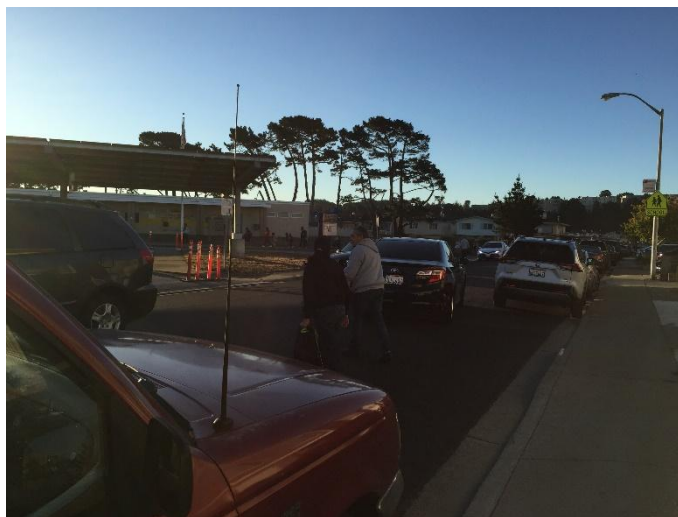
- ◆ Walk audit participants observed student drop-offs occurring along the western sidewalk of El Dorado Drive. Students crossed the street at unmarked locations, posing a safety risk. Occasional U-turns and cut-arounds were noted along El Dorado Drive.

*Figure 4: Pedestrians crossing at unmarked locations across El Dorado Drive.*

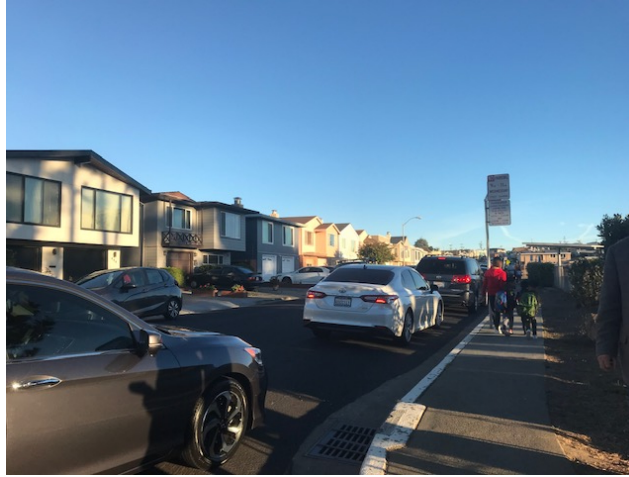
- ◆ While most motorists respect the pedestrian right-of-way on crosswalks, traffic builds up into and through the intersection during peak arrival times.

*Figure 5: Existing traffic backs into intersection of El Dorado Ave and Cerro Drive.*

- Short Term: Paint red curb around 15’ of the NE and SE corners of intersection to daylight intersection.
  - Short Term: Consider paint and post curb extensions. (Long Term: Install curb extensions on northeast and southeast corners of intersection. Consider incorporating green infrastructure.)

- Install a curb ramp on west side of the northern crosswalk.
- 3 El Dorado Drive at Southgate Avenue**
  - Study installing Pedestrian Hybrid Beacon or RRFB.

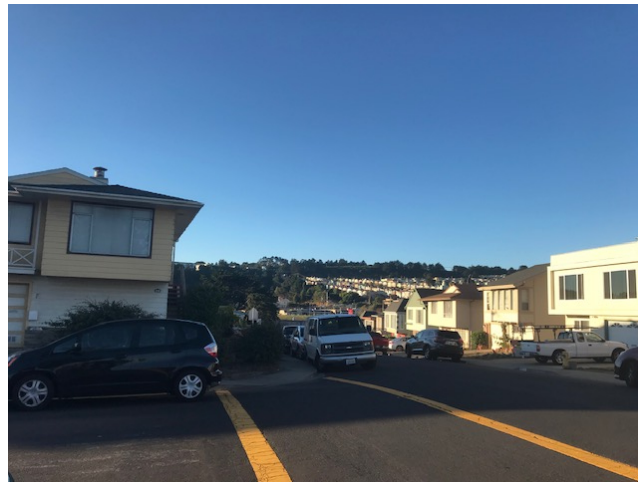
- ◆ Existing parking extending to the intersection limits sight lines for street and sidewalk users.
- ◆ Existing sidewalks were perceived to limit pedestrian access, especially when passengers open car doors onto the sidewalk.

*Figure 6: Cars parked along Cerro Drive create visibility issues.*
