School Safety Assessment Technical Memorandum

General Pershing Preschool

Jefferson Elementary School District

October 2019

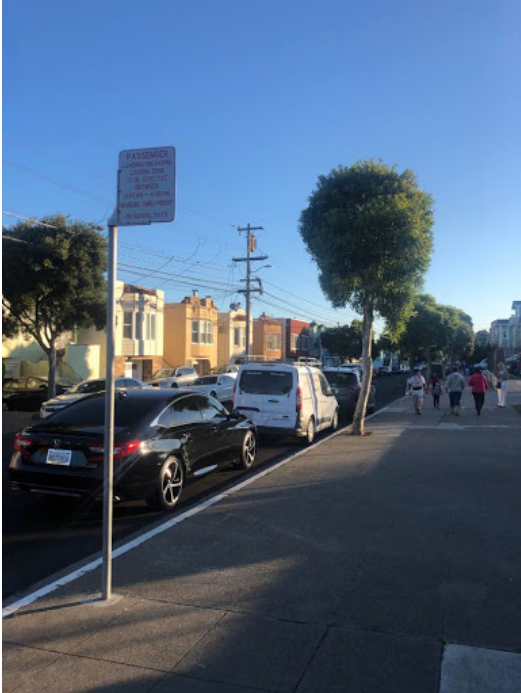
- ◆ SSA participants observed a high volume of pedestrian activity from both east and west along Hanover St.
- ◆ SSA participants noted that some families have children enrolled at both General Pershing Preschool and George Washington Elementary, an elementary school located two blocks east of the General Pershing Preschool. As a result, students and families walk along Hanover Street between both schools (see Figure 1).

Figure 1: A family walks toward General Pershing Preschool along Hanover Street. Cars are parked along portions of Hanover street denoted as passenger loading zones.

- 1 Hanover St**
 - Repaint existing white curb as green curb.
 - Enforce parking policies along the street.
 - At Hanover St and Acton St: Upgrade existing intersection crosswalks to high-visibility and daylight intersection with red curb.

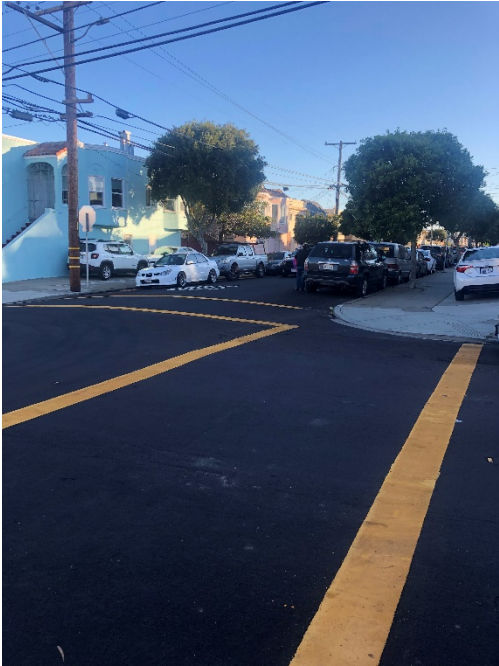
- ◆ SSA participants observed motorists making U-turns near the intersection of Hanover Street and Acton Street.
- ◆ SSA participants also observed unsafe driving maneuvers including incomplete stops along the middle of the street, parking on the existing sidewalk blocking pedestrian access, and double parking as students were dropped-off.

Figure 2: Drivers park close to crosswalk and intersection at the intersection of Hanover Street and Acton Street.

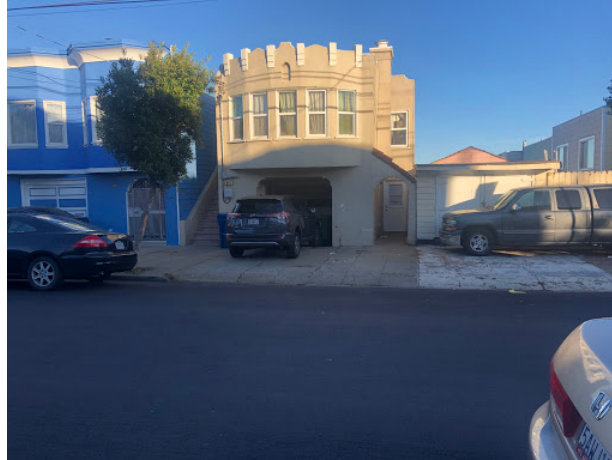
Figure 3: A parked car extending out of the garage blocks the pedestrian access routes along the sidewalk on Hanover Street.

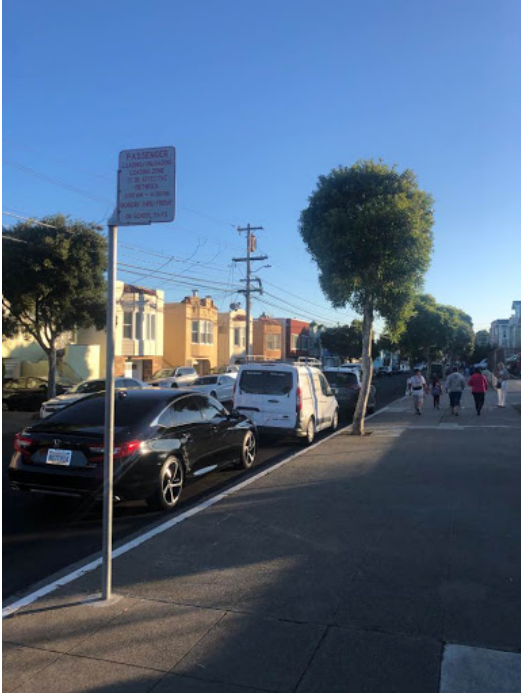
- ◆ SSA participants observed a high volume of pedestrian activity from both east and west along Hanover St.
- ◆ SSA participants noted that some families have children enrolled at both General Pershing Preschool and George Washington Elementary, an elementary school located two blocks east of the General Pershing Preschool. As a result, students and families walk along Hanover Street between both schools (see Figure 1).

Figure 1: A family walks toward General Pershing Preschool along Hanover Street. Cars are parked along portions of Hanover street denoted as passenger loading zones.

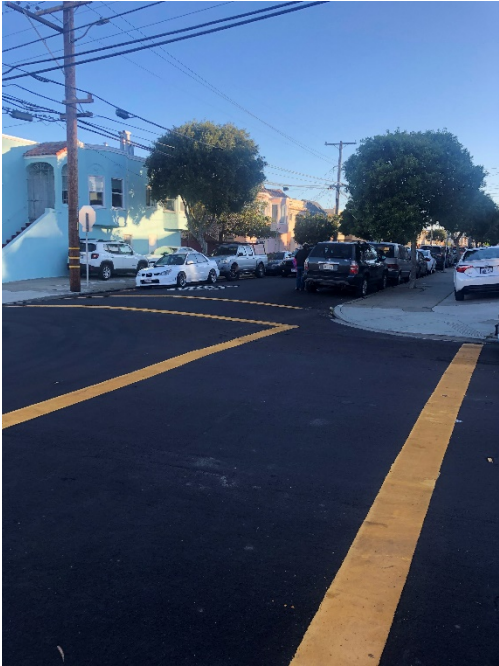
- ◆ SSA participants observed motorists making U-turns near the intersection of Hanover Street and Acton Street.
- ◆ SSA participants also observed unsafe driving maneuvers including incomplete stops along the middle of the street, parking on the existing sidewalk blocking pedestrian access, and double parking as students were dropped-off.

Figure 2: Drivers park close to crosswalk and intersection at the intersection of Hanover Street and Acton Street.

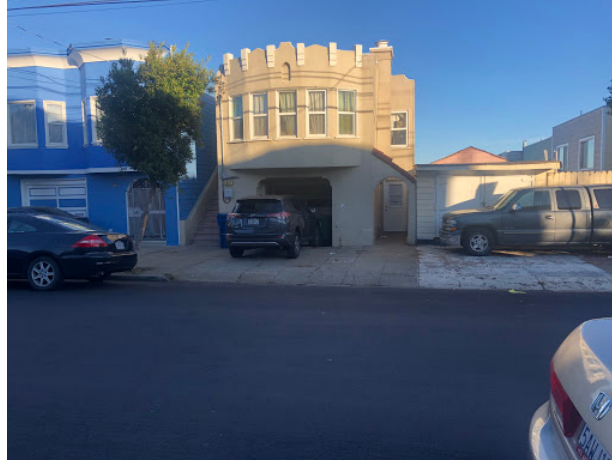
Figure 3: A parked car extending out of the garage blocks the pedestrian access routes along the sidewalk on Hanover Street.
