3600 Sierra Madre Boulevard  
Pasadena, California 91107

**Soil Sample Analytical Results**

Pasadena Unified School District  
Environmental Soil and Dust Sampling  
and Analysis Post-Eaton Fire Recovery  
Field Elementary School

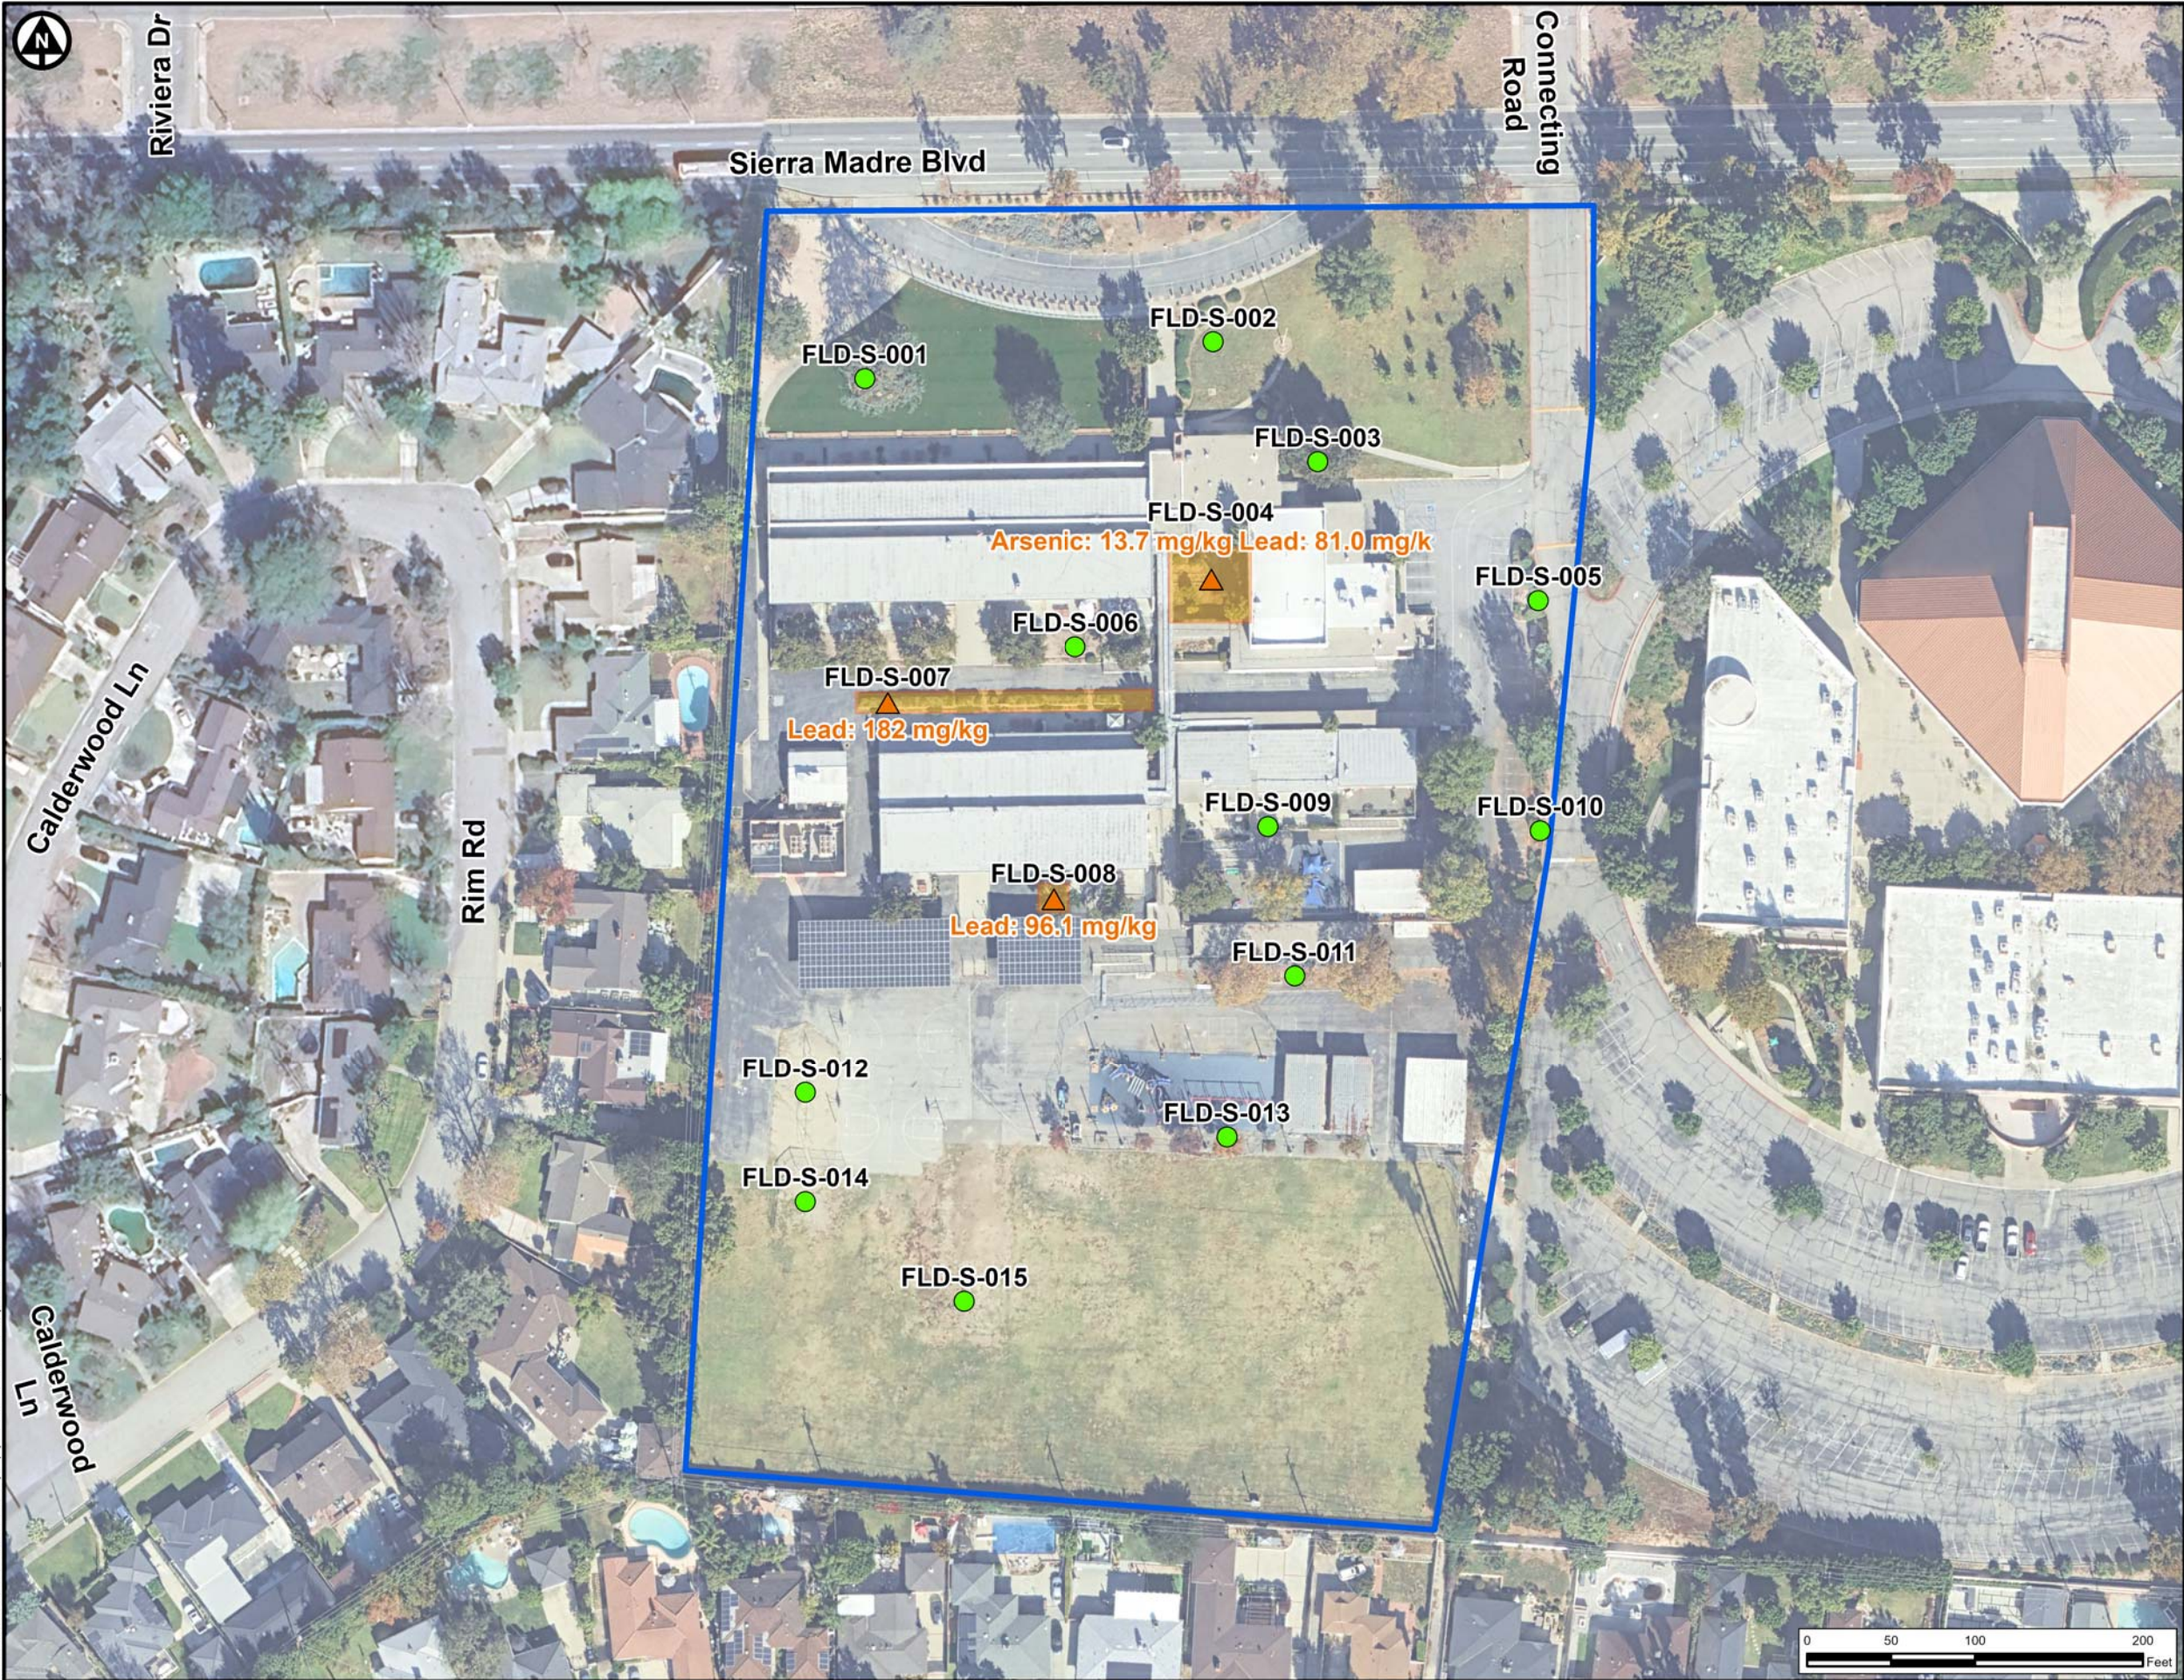
| Figure | 3 |

- ▲ Location of Surface Sample with Analytical Results Above Regulatory Screening Criteria
- Location of Surface Sample with Analytical Results at or below Regulatory Screening Criteria
- Approximate Site Boundary
- Areas to Remain Closed
- mg/kg milligrams per kilogram
