1090 Nithsdale Road  
Pasadena, California 91105

**Soil Sample Analytical Results**

Pasadena Unified School District  
Environmental Soil Sampling  
and Analysis Post-Eaton Fire Recovery  
San Rafael Elementary School

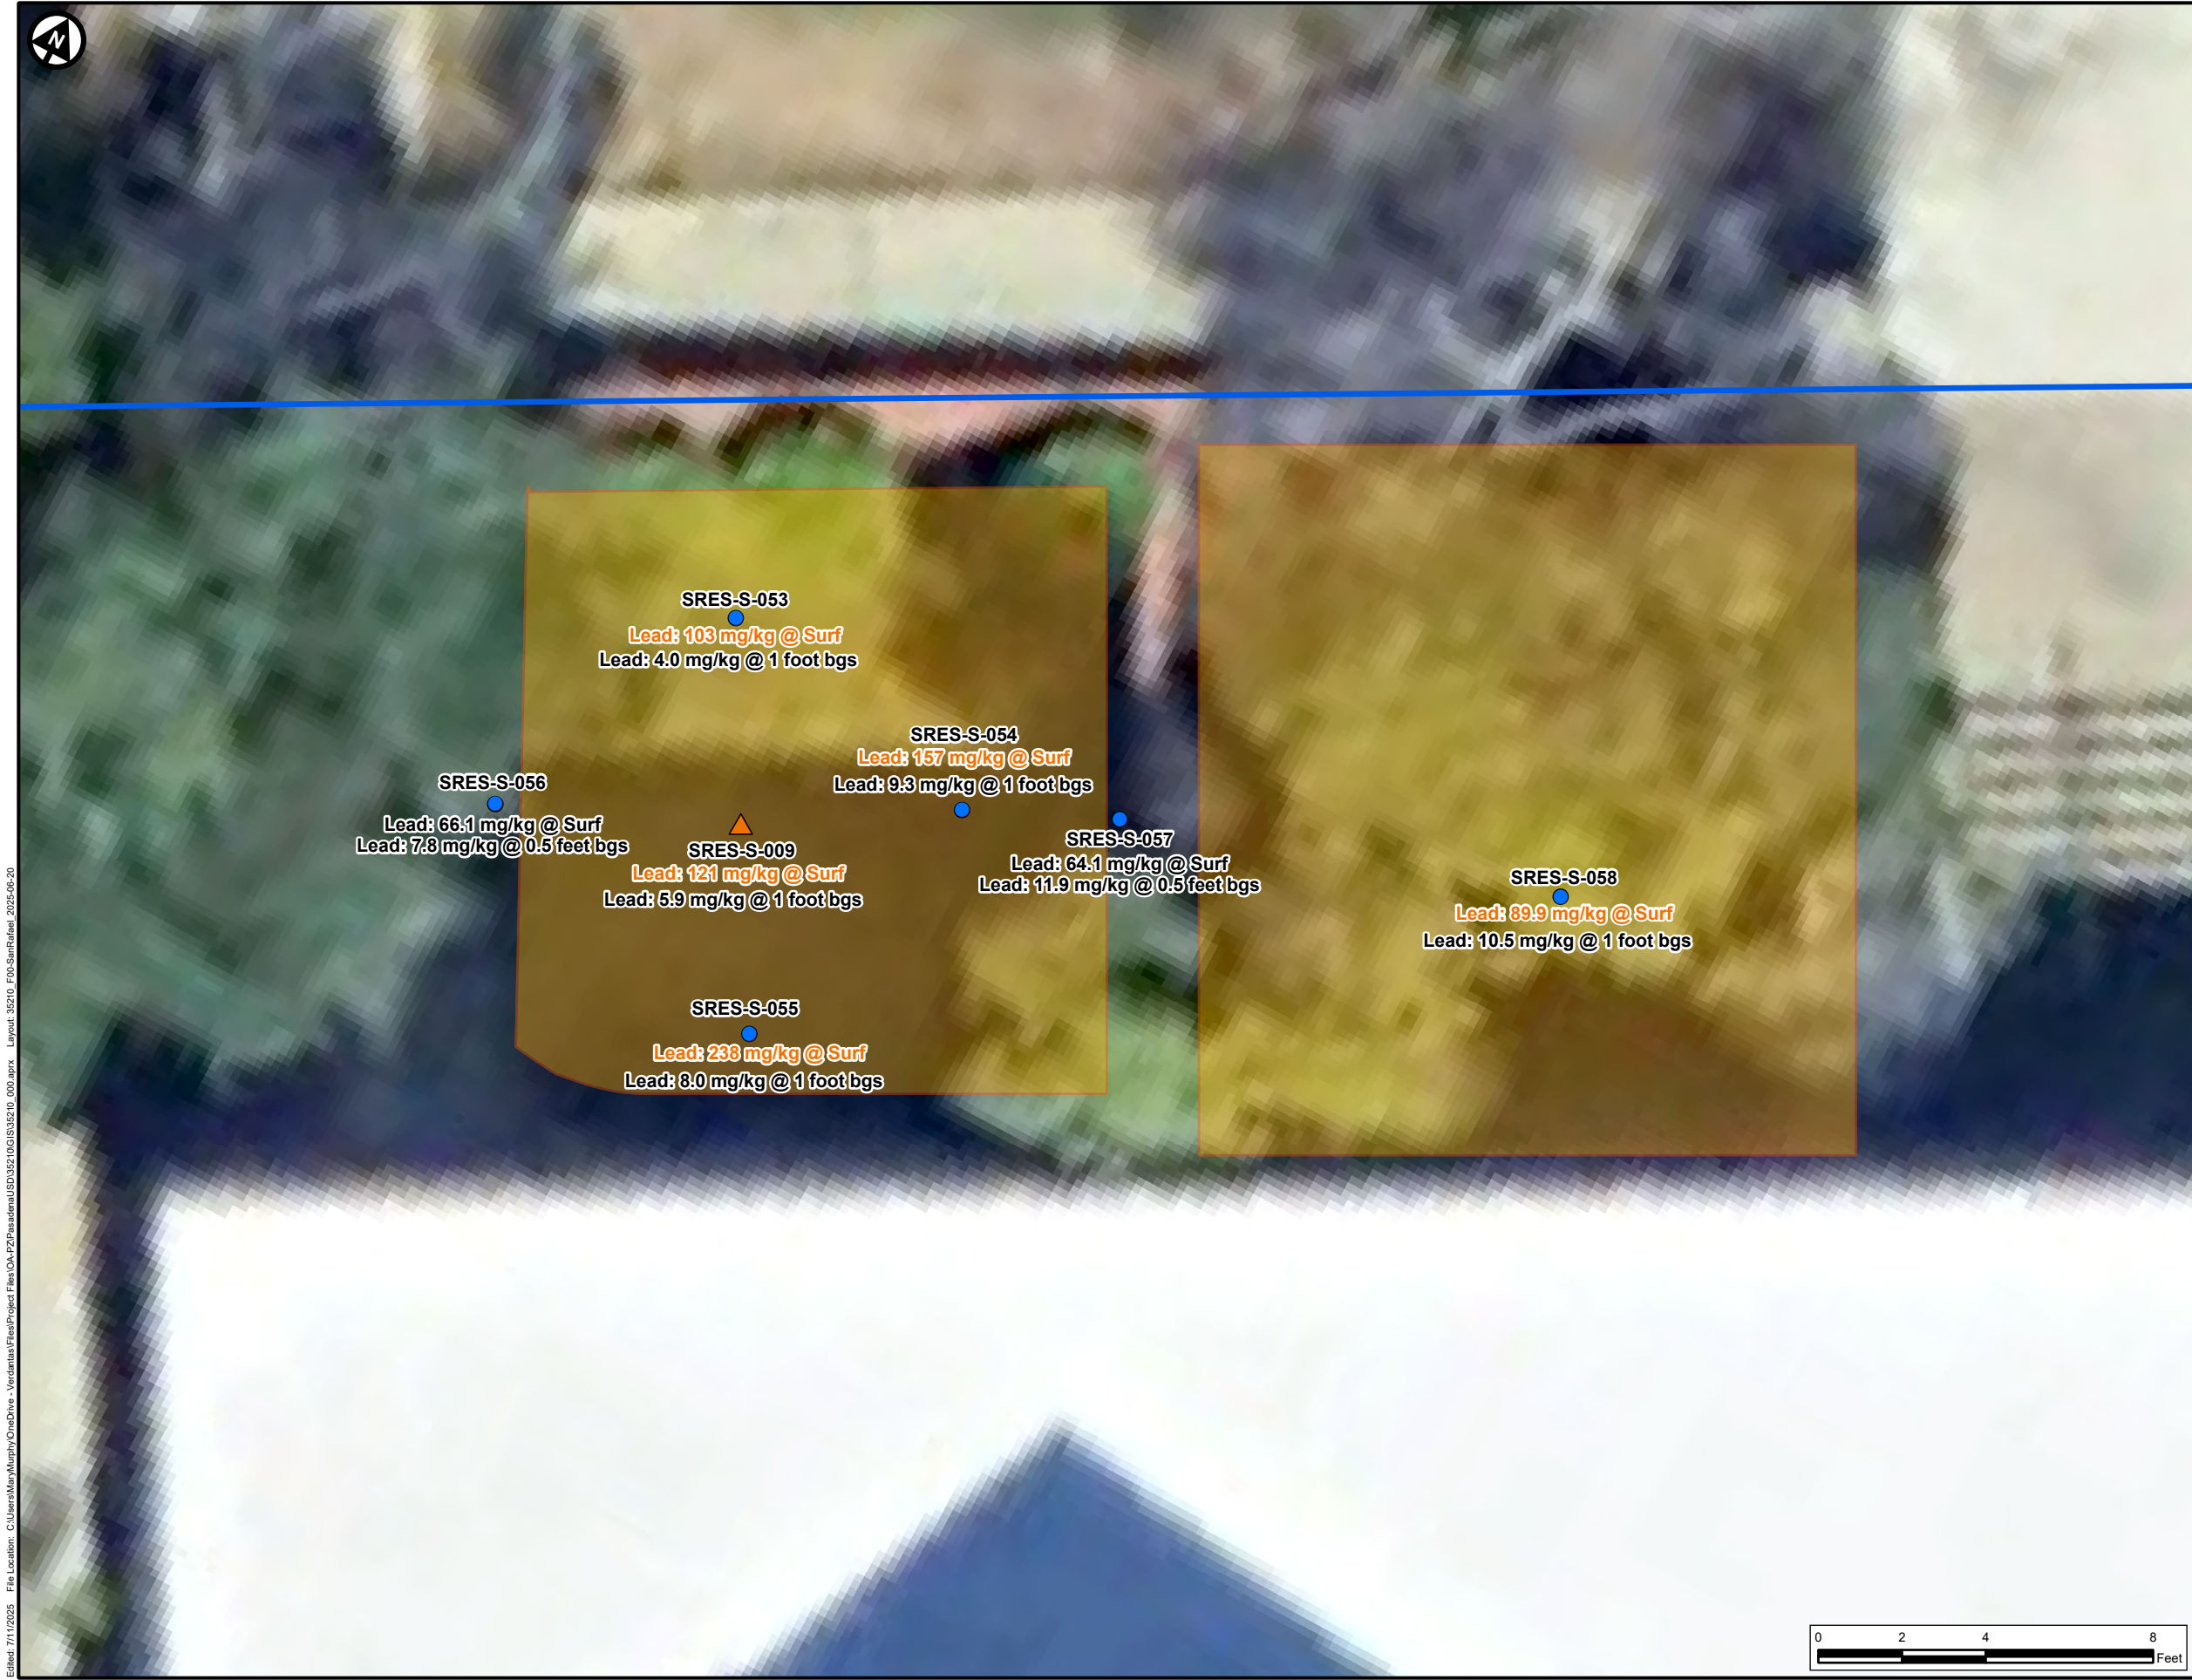
| Figure | <b>X</b> |

Location of Initial Surface Sample with Analytical Results Above Regulatory Screening Criteria

Location of Initial Surface Sample with Analytical Results at or below Regulatory Screening Criteria

Step-out Sample Location

Areas to Remain Closed

Orange values are above Regulatory Screening Criteria and black values are at or below Regulatory Screening Criteria

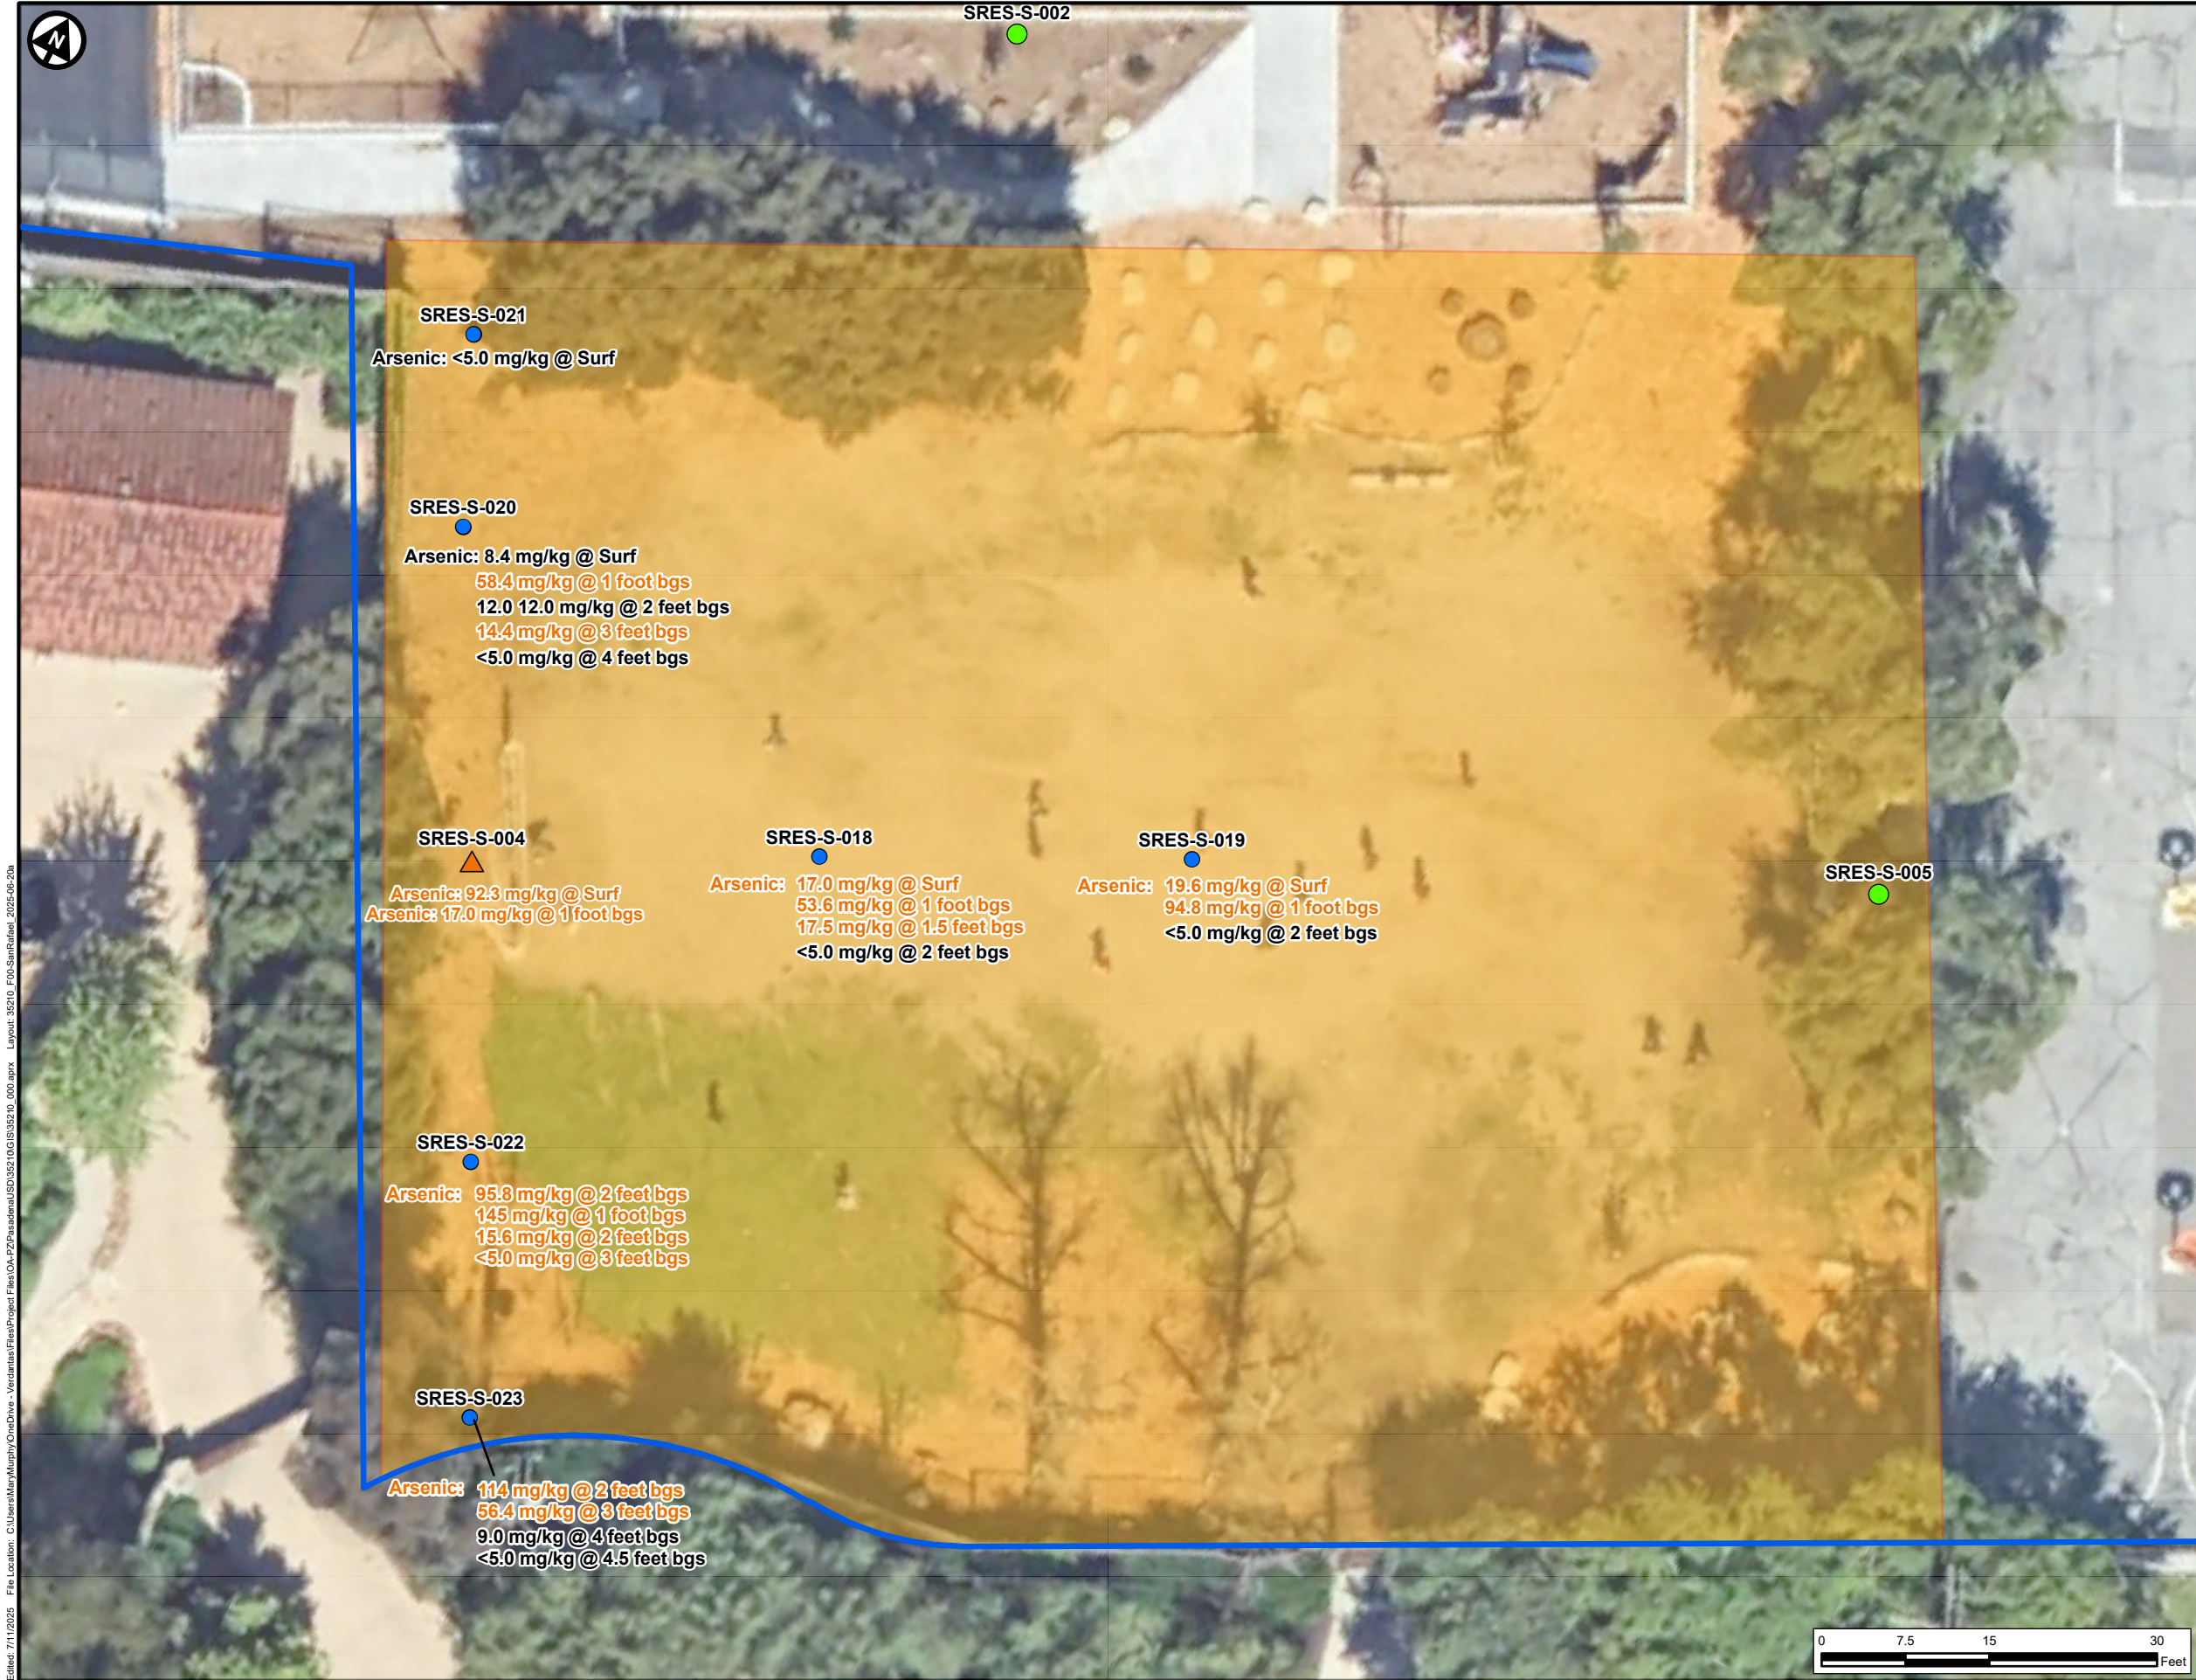
Figure  
**X**

Location of Initial Surface Sample with Analytical Results Above Regulatory Screening Criteria

Location of Initial Surface Sample with Analytical Results at or below Regulatory Screening Criteria

Step-out Sample Location

Areas to Remain Closed

Orange values are above Regulatory Screening Criteria and black values are at or below Regulatory Screening Criteria

**Soil Sample Analytical Results**
