## **LEAD CLEARANCE INSPECTION REPORT**

For Site Located at: Lincoln Avenue Elementary School 1817 W. Lincoln Avenue, WI., 53215

**Subject: Lead Clearance Inspection Report for Milwaukee Public Schools, Lincoln Avenue Elementary School, 1817 W. Lincoln Avenue, Milwaukee, WI. 53215**

LEAD CLEARANCE INSPECTION REPORT

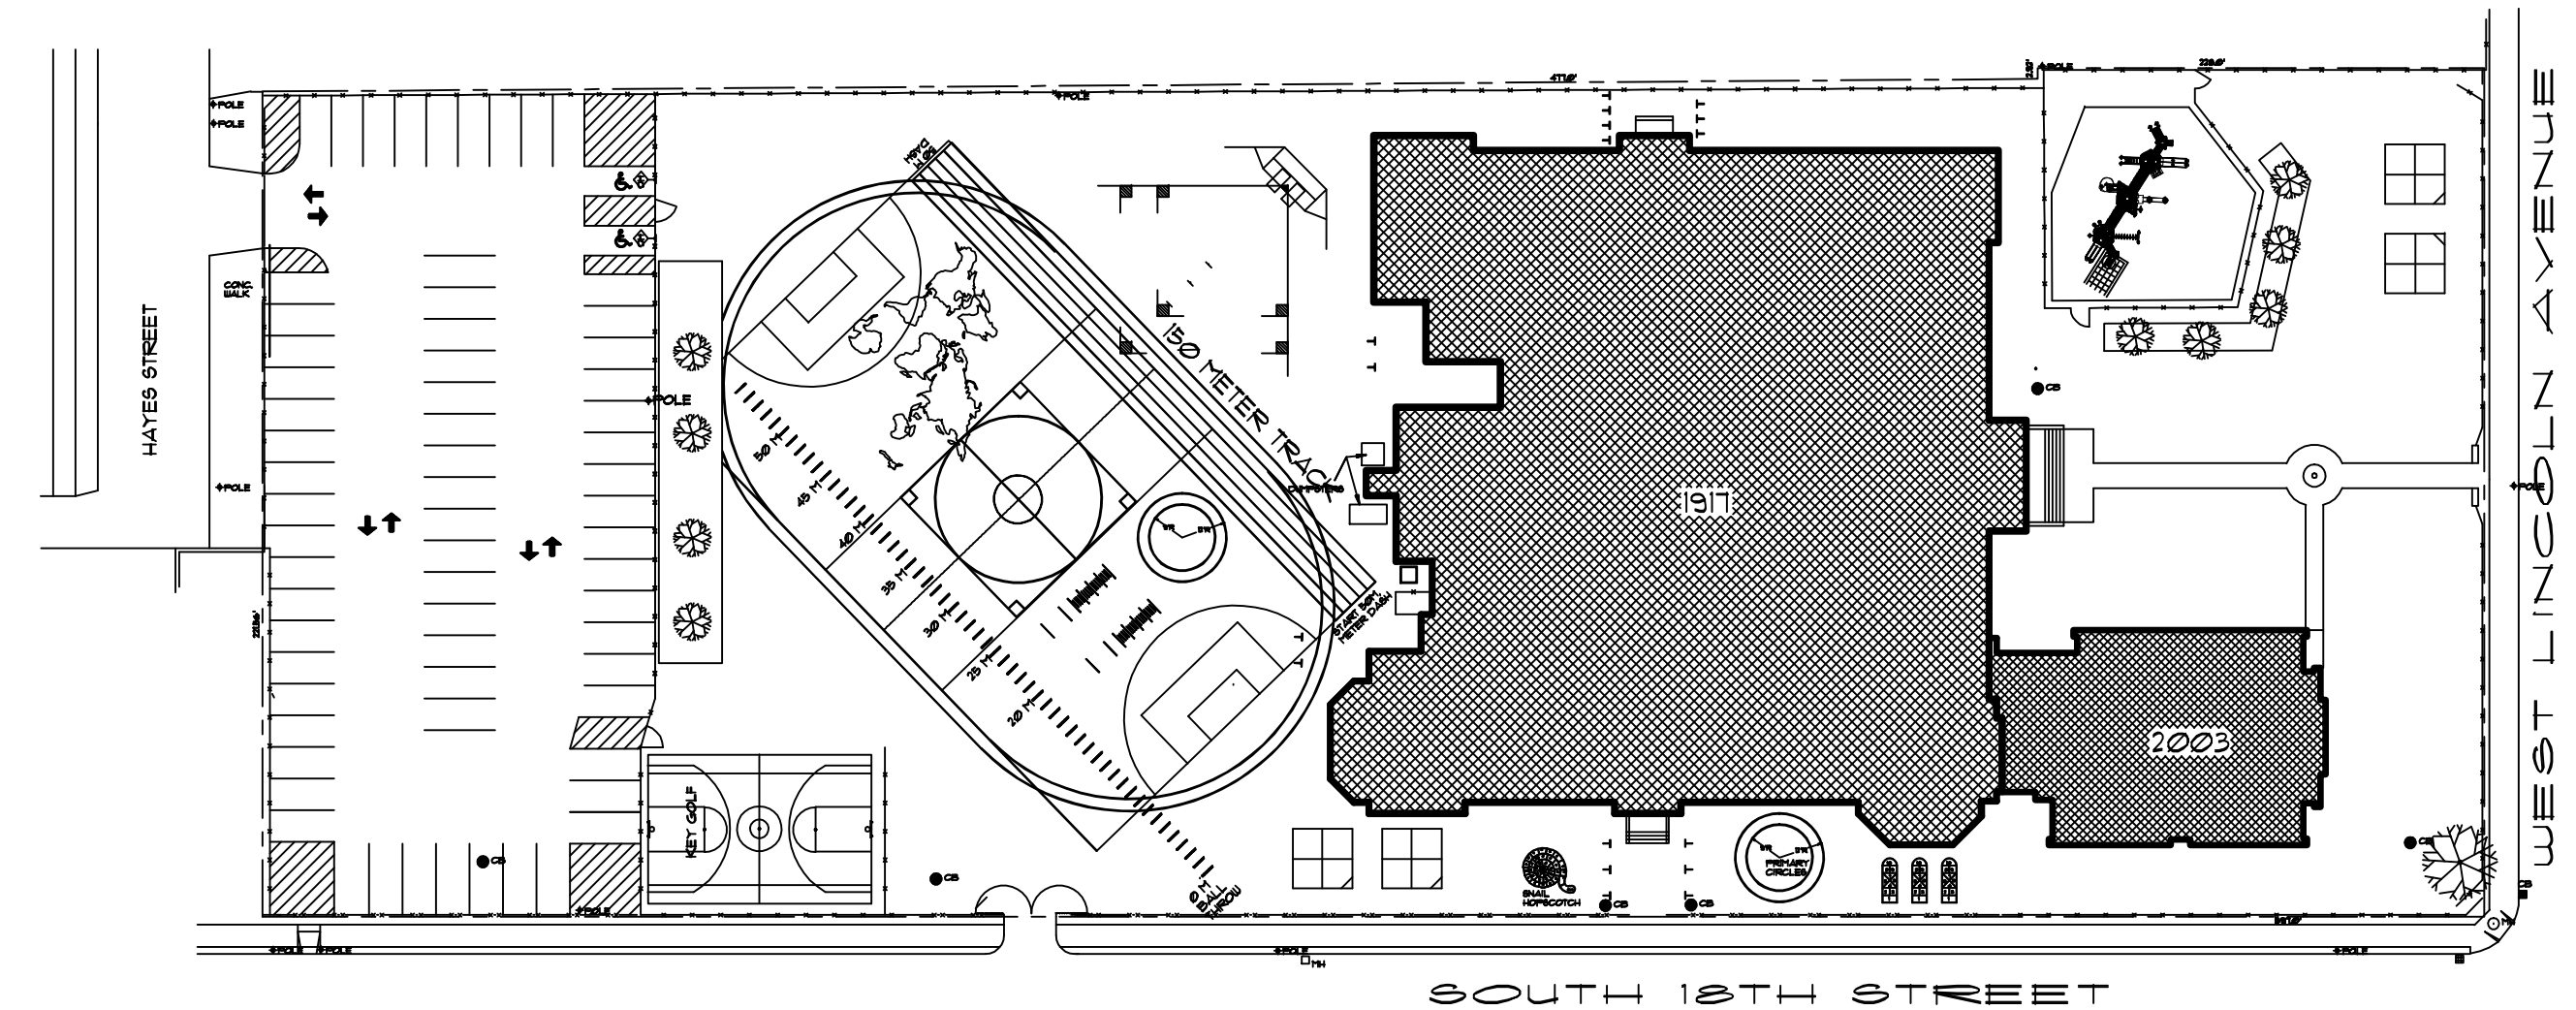
## SITE PLAN

A layout of the building can be found in Figure 1. On August 23, 2025, a visual inspection was conducted for the following rooms:

SITE NO. 250 - LINCOLN AVENUE ELEMENTARY SCHOOL  
 1817 W. LINCOLN AVE., MILW., WI., 53215  
 DATE: 12/14/07

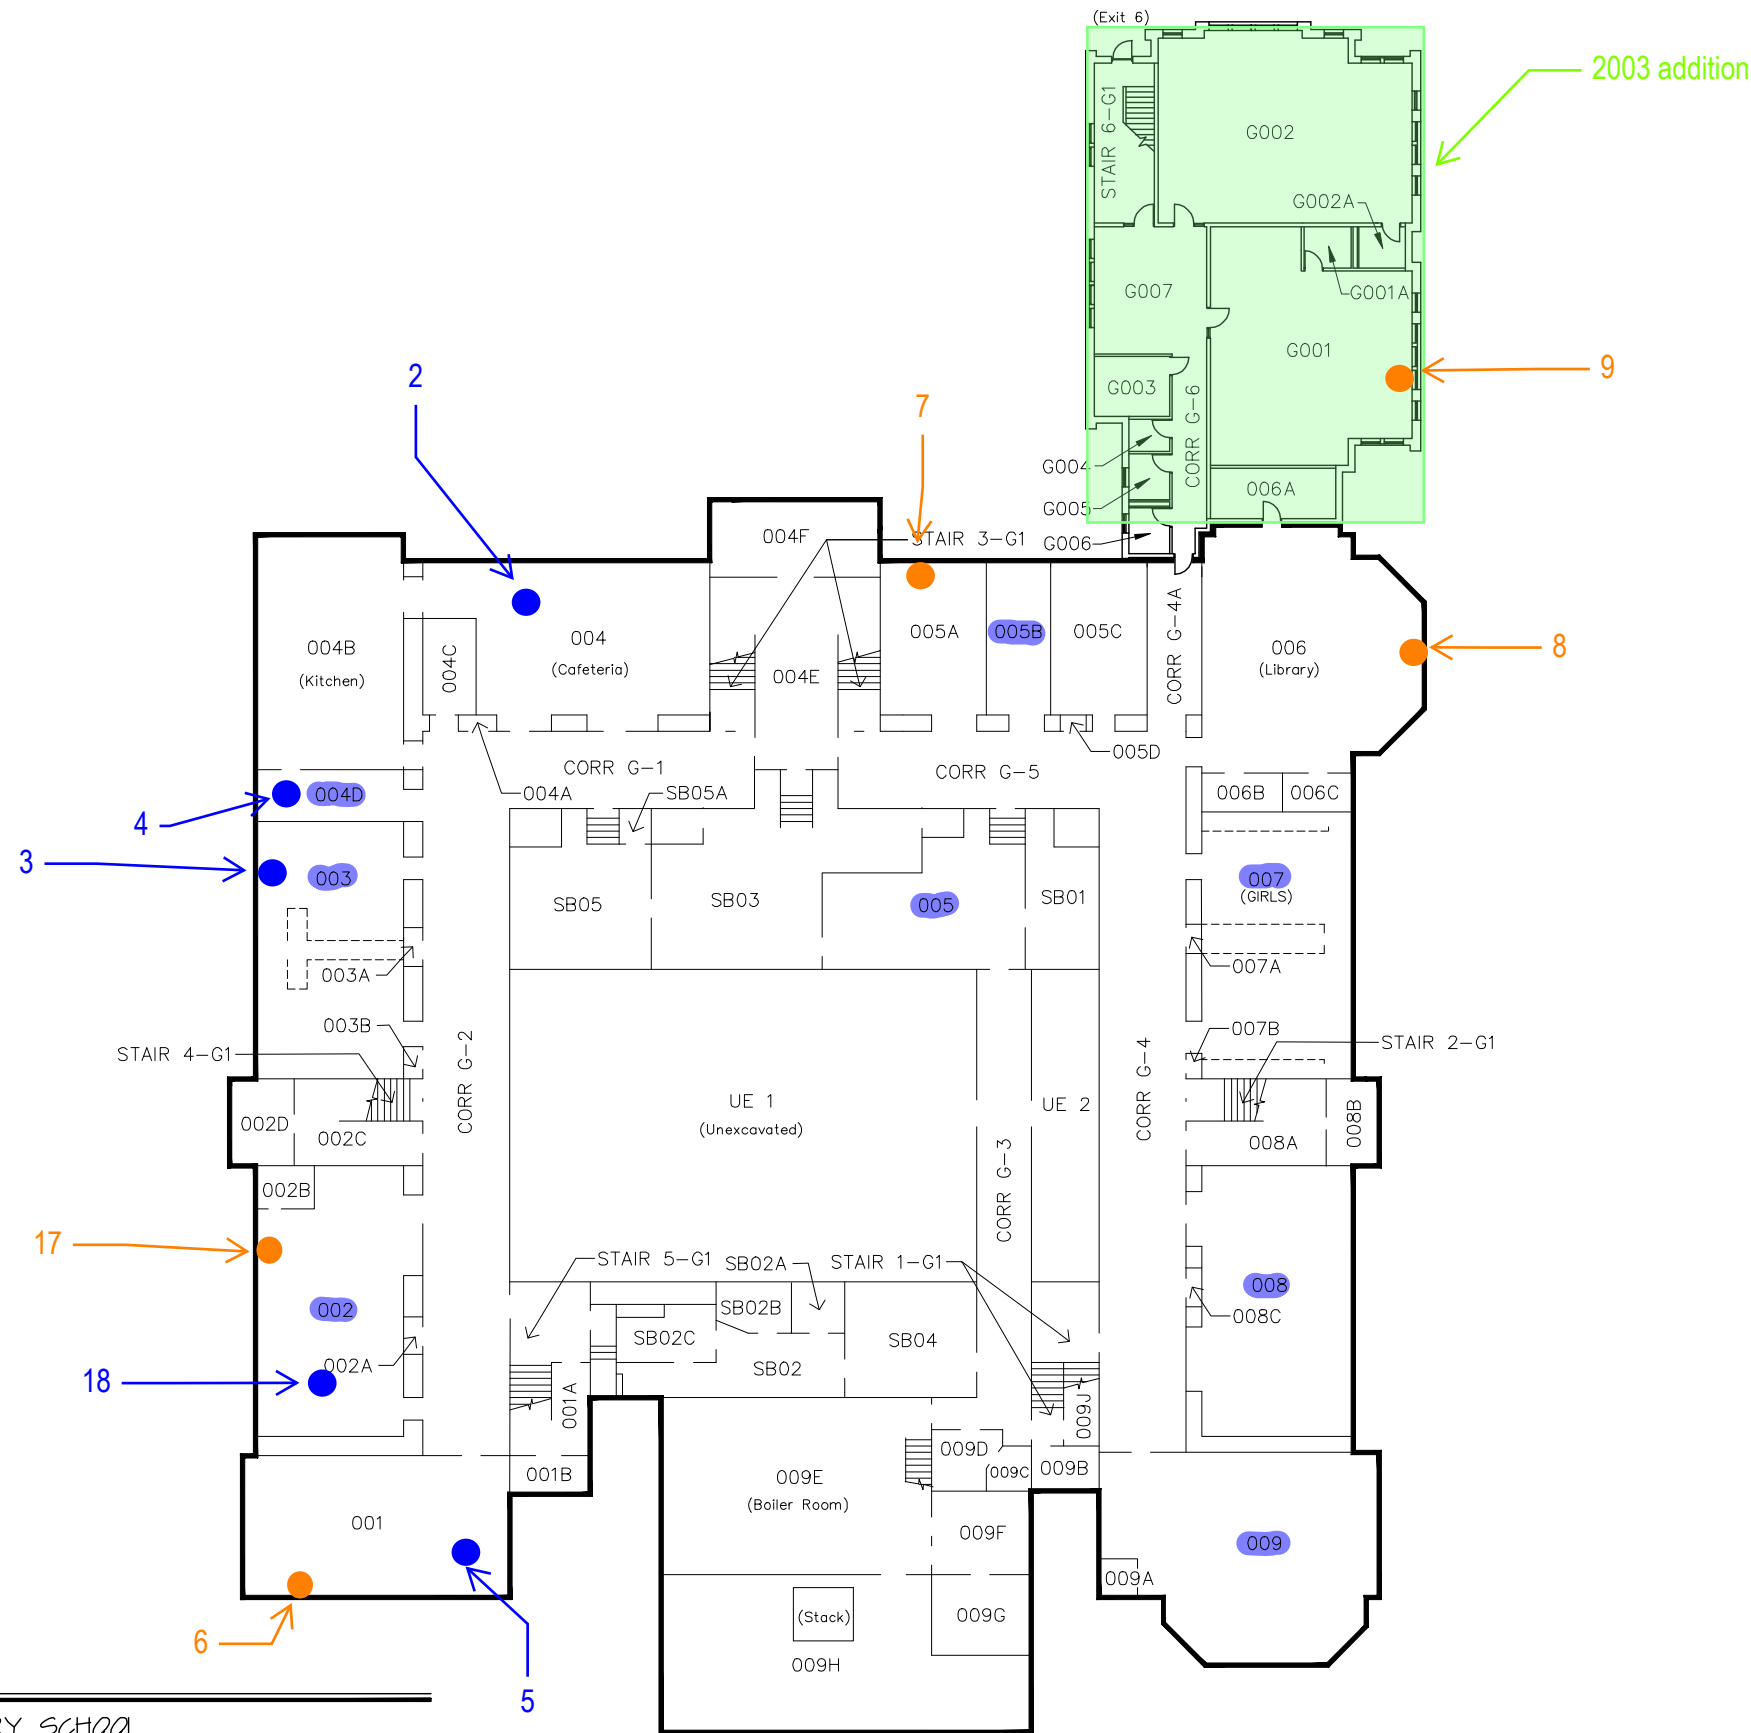
Figure 2: Ground Floor Sample Locations

- Orange dot: Location of windowsill sample
- Blue dot: Location of floor sample
- Yellow highlight: Exceeds standards
- Blue highlight: Rooms tested during previous clearance testing

## GROUND FLOOR PLAN

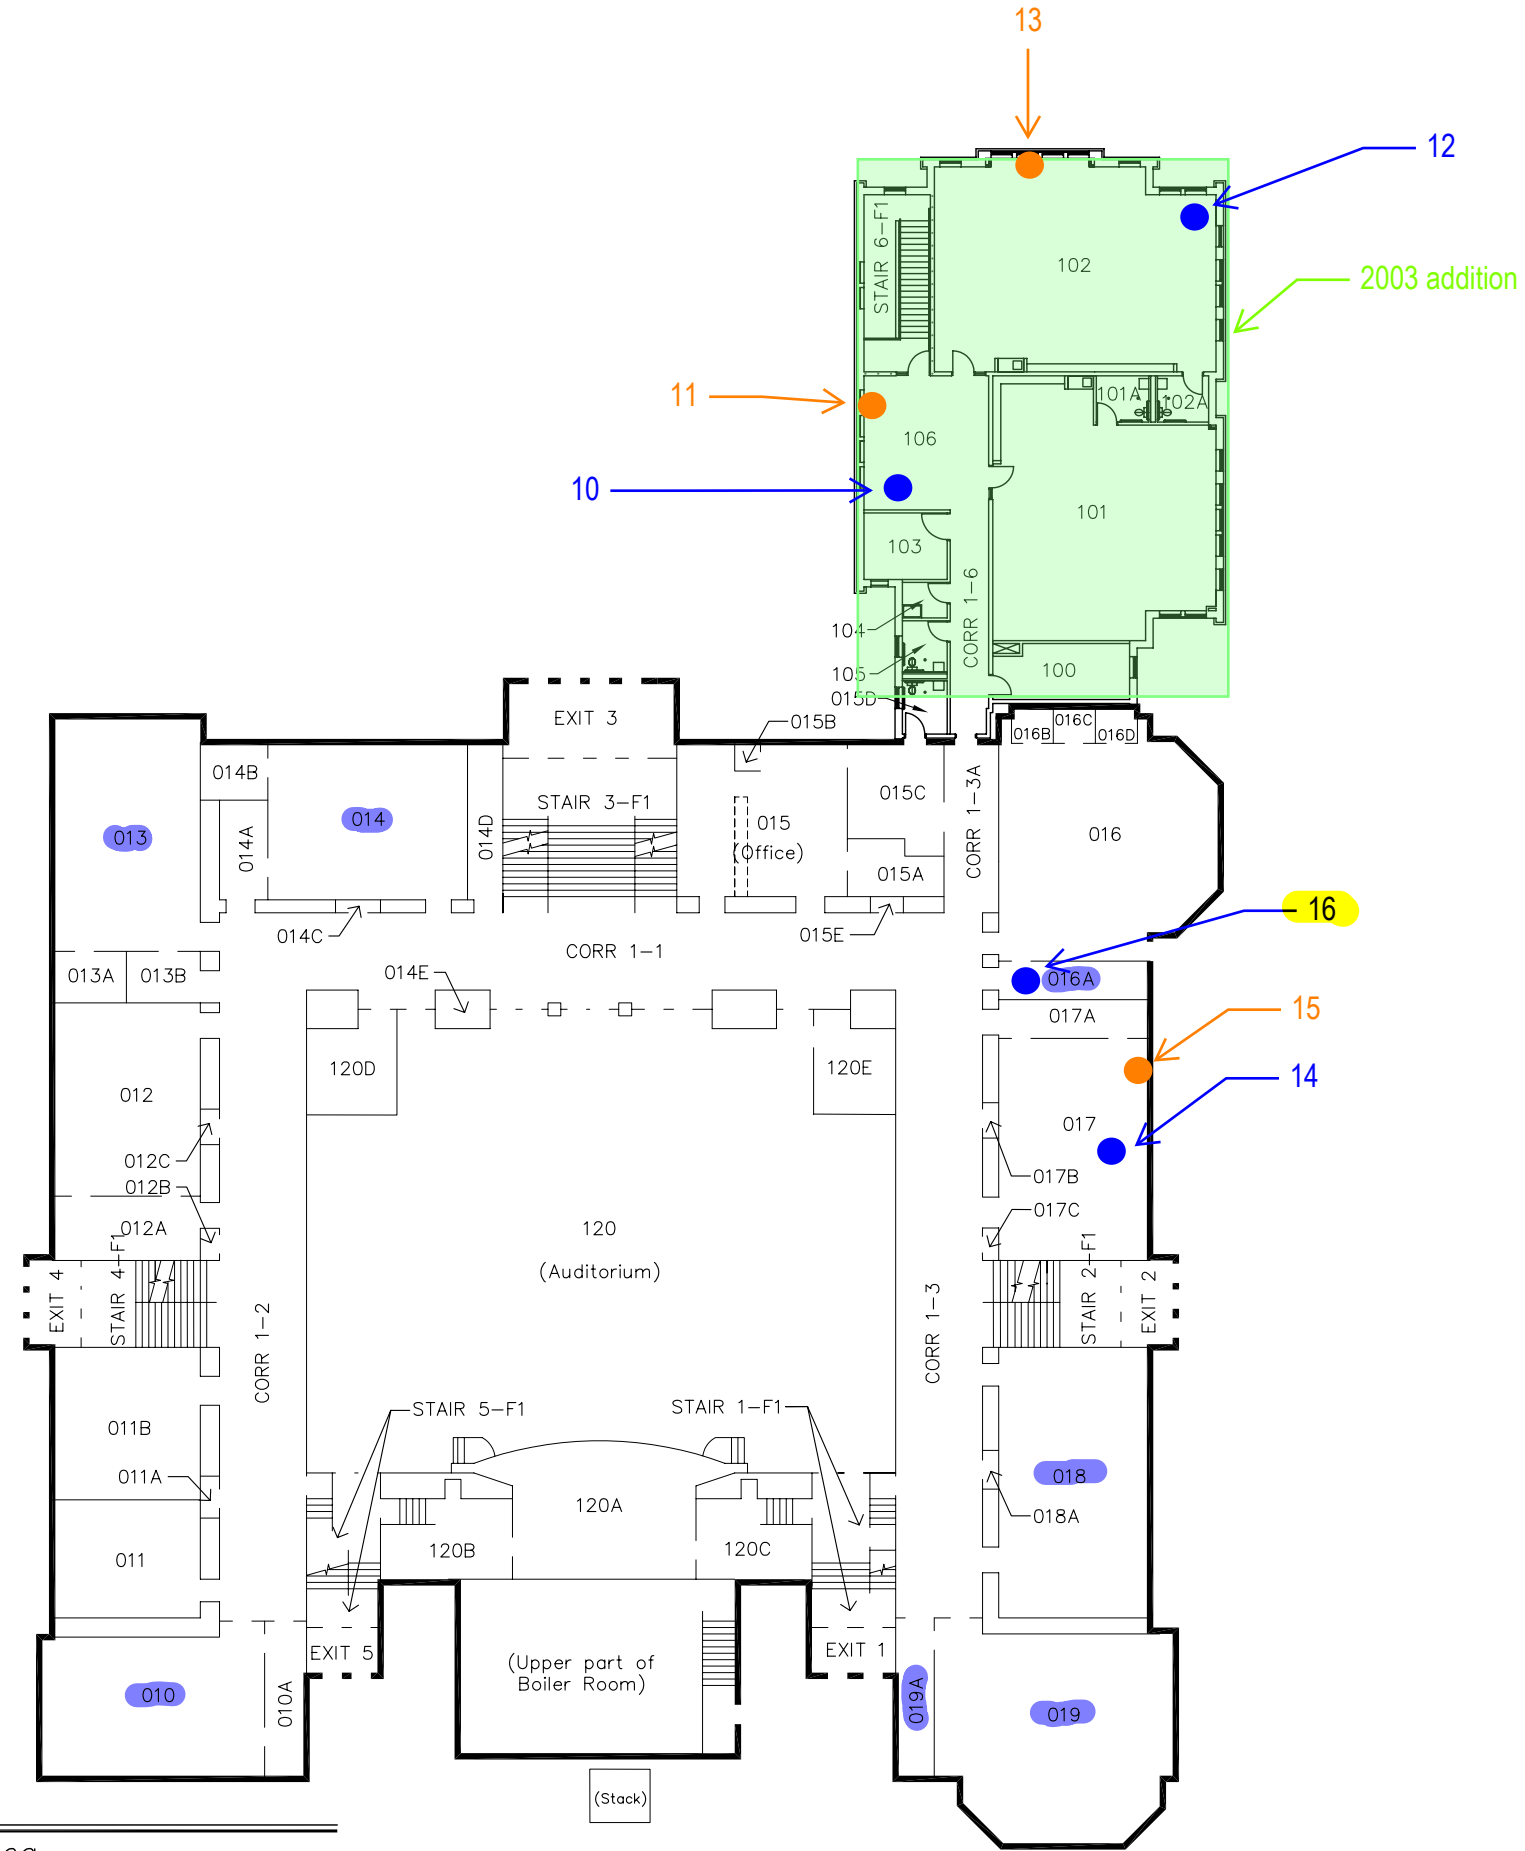
Figure 3: First Floor Sample Locations

Based on the results of laboratory analysis, one lead hazard was identified throughout the building, and the property has failed the clearance testing. The second clearance on August 23, 2025 identified floor sample in room 016A to exceed the standard of 10.0 µg/ft². The contractor was notified of their responsibility to re-clean all failed components and all like components in all unsampled rooms.

## FIRST FLOOR PLAN

Based on the results of laboratory analysis, one lead hazard was identified throughout the building, and the property has failed the clearance testing. The first failed clearance was on August 20, 2025 and identified to be in bathroom 016A, room 003, room 004D, and room 004. These samples were recorded as sample 16, 3, 4, and 2, respectively. The second clearance on August 23, 2025 identified floor samples in bathroom 016A to exceed the standard of 10  $\mu\text{g}/\text{ft}^2$ . The contractor was notified of their responsibility to re-clean all failed components and all like components in all unsampled rooms.

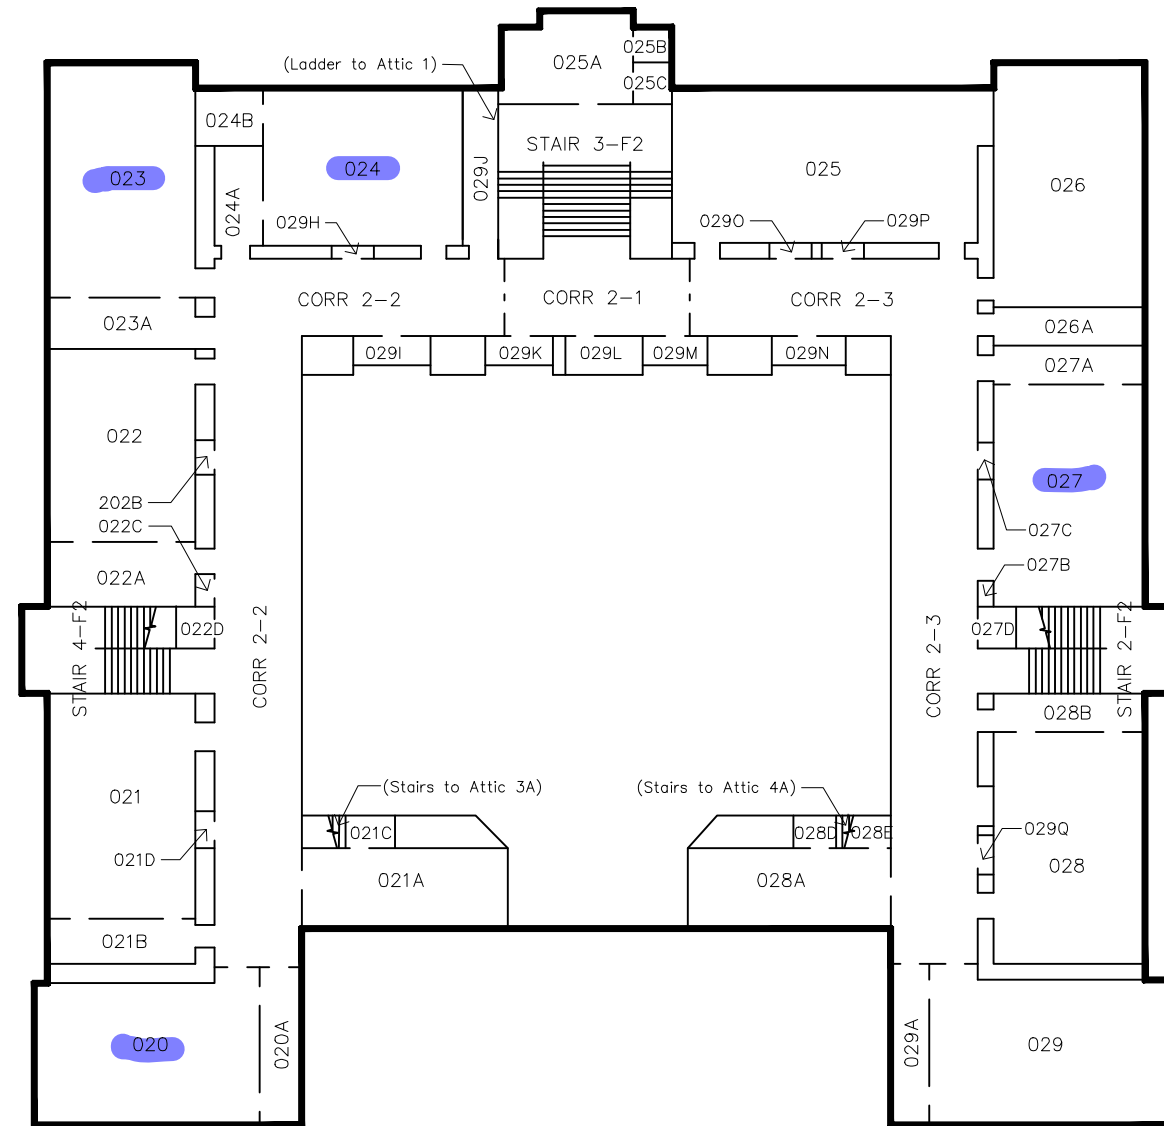
**Figure 4: Second Floor Plan**

When a sample from the first clearance failed, the entire story must be retested. A total of four floor samples and four windowsills must be reached on each story where an exceedance occurred. The second floor was not tested because all first-round clearance samples met the clearance standards.

**SECOND FLOOR PLAN**
