| | <b>Dorchester School District Two</b><br><br><b>Second Addendum</b> | Solicitation Number: | 2526-012 |

DESCRIPTION: Newington Elementary School Ceiling Grid & Abatement

Reference: **Limited Asbestos Assessment Report**  
**Newington Elementary School – Ceiling Replacement Project**  
10 King Charles Circle  
Summerville, South Carolina  
S&ME Project No. 25130131

Limited Asbestos Assessment Report  
Newington Elementary School – Ceiling Replacement Project  
10 King Charles Circle  
Summerville, South Carolina  
S&ME Project No. 25130131

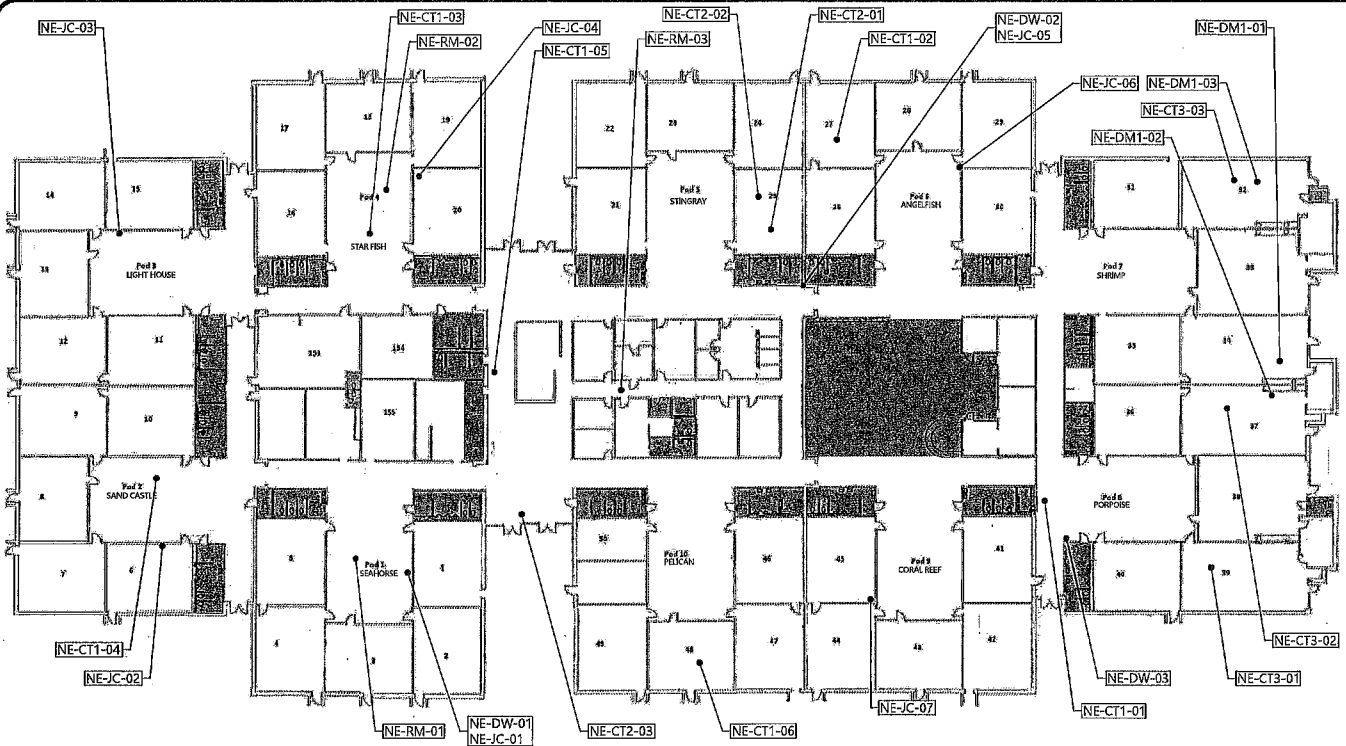
**Appendix II – Diagram of Bulk Sample Locations and  
Confirmed ACMs**

A summary of asbestos results is provided in Appendix I, and exhibits the sample number, location, type of material tested, approximate quantity of the material sampled, condition of the material, and corresponding result for each sample. A diagram of bulk sample locations and confirmed ACMs is provided in Appendix II, and a copy of the inspectors' SCDES licenses are provided in Appendix III. The laboratory analyses and chain-of-custody records are provided in Appendix IV.
