# ATHLETIC FACILITIES REPORT

| <b><u>Stadium Field</u></b> | | | |
| Schuylkill Valley SD<br>929 Lake Shore Drive<br>Leesport, PA 19533 | <b><u>In-Fill Make-Up:</u></b><br>Rubber / Sand | <b><u>Fiber:</u></b> Titan <b><u>Base:</u></b> Stone / 10mm Pad | <b><u>Turf Height (at install):</u></b><br>2.25" |

JOB:  
TURF CONDITIONING  
& FIELD ANALYSIS

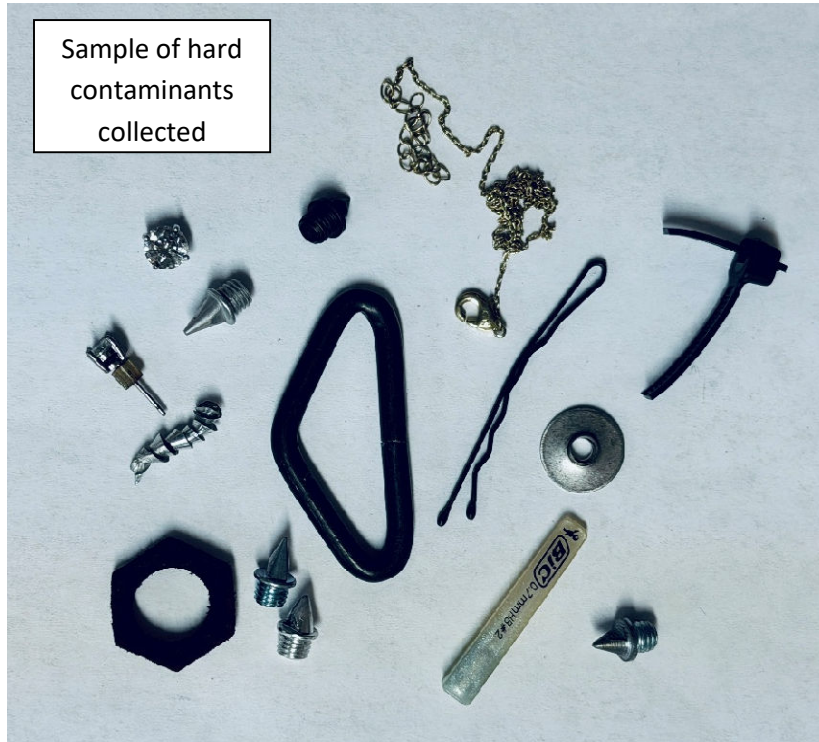
- 1.) Two passes made with Verti-Top, in opposite directions. Collected debris from field. See attached photo.
- 2.) 1 location of seam separation identified. See diagram attached for locations.
- 3.) 6 spots of sticky substance identified. See attached diagram for locations.
- 4.) Hot spots across field low in infill. See attached diagram for locations.
- 5.) Recorded depth measurements across field. See attached diagram for locations.
- 6.) Moss / weed growth around turf perimeter.
- 7.) 1/3 bag (42 gallon) of fiber and debris collected.

Sample of hard  
contaminants  
collected

- 6.) Maintain annual cleaning / conditioning for debris removal and field grooming.
- 7.) Apply a 4 – 6” spray of water base vegetation killer on all edges where turf abuts concrete. To prevent fungus, mold, and mildew buildup, use a solution with 1% hydrogen peroxide and 99% water. Allow time to soak in, flush thoroughly with water after application.

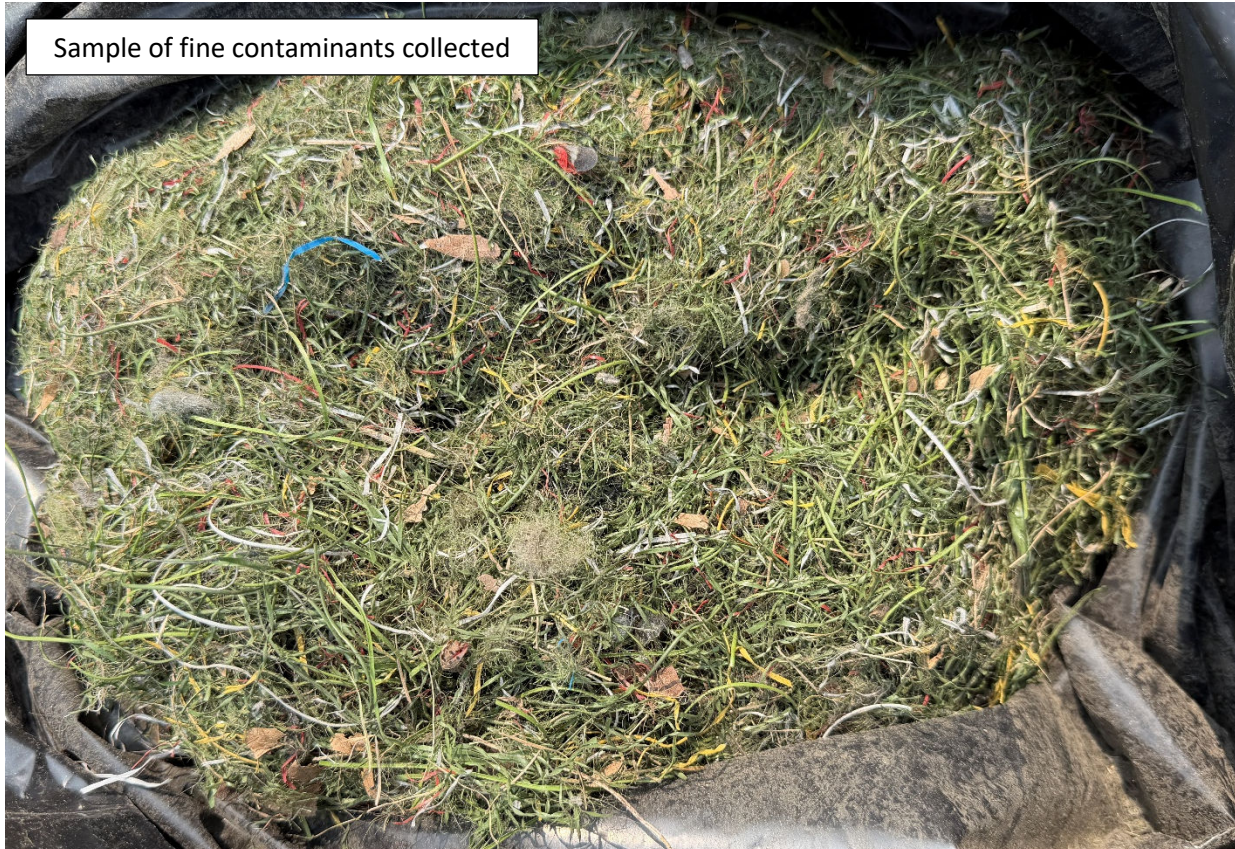
Sample of fine contaminants collected

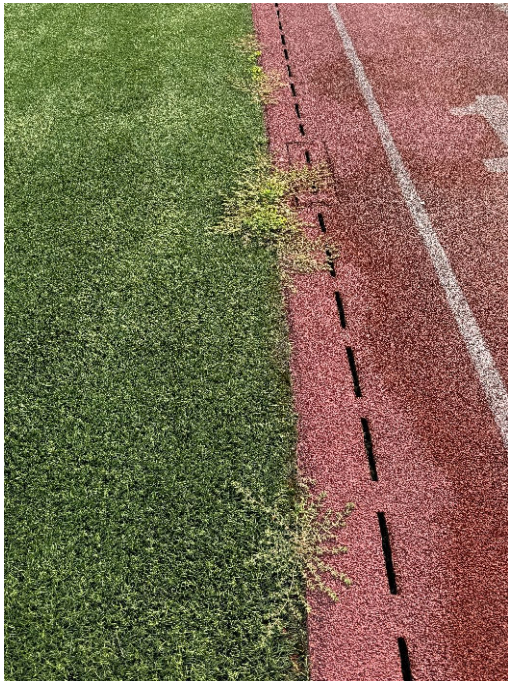
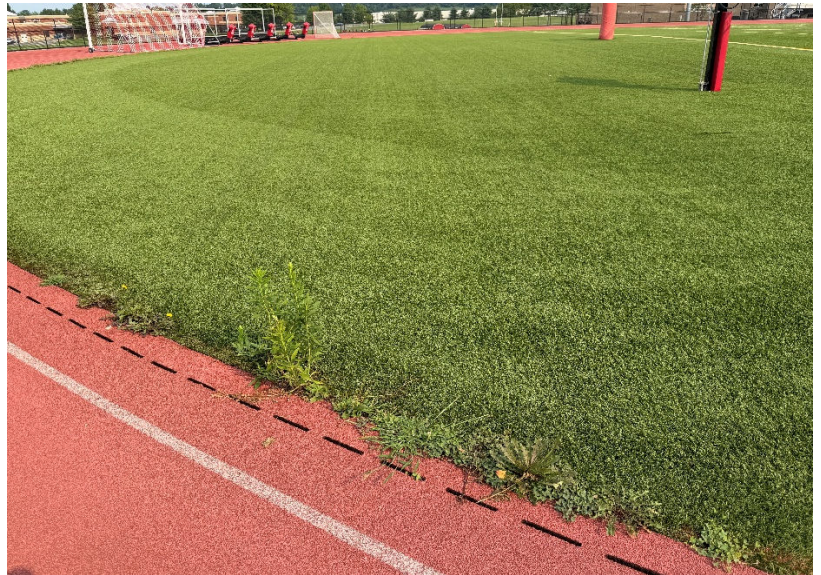
Example of Moss / weed growth  
around turf perimeter.

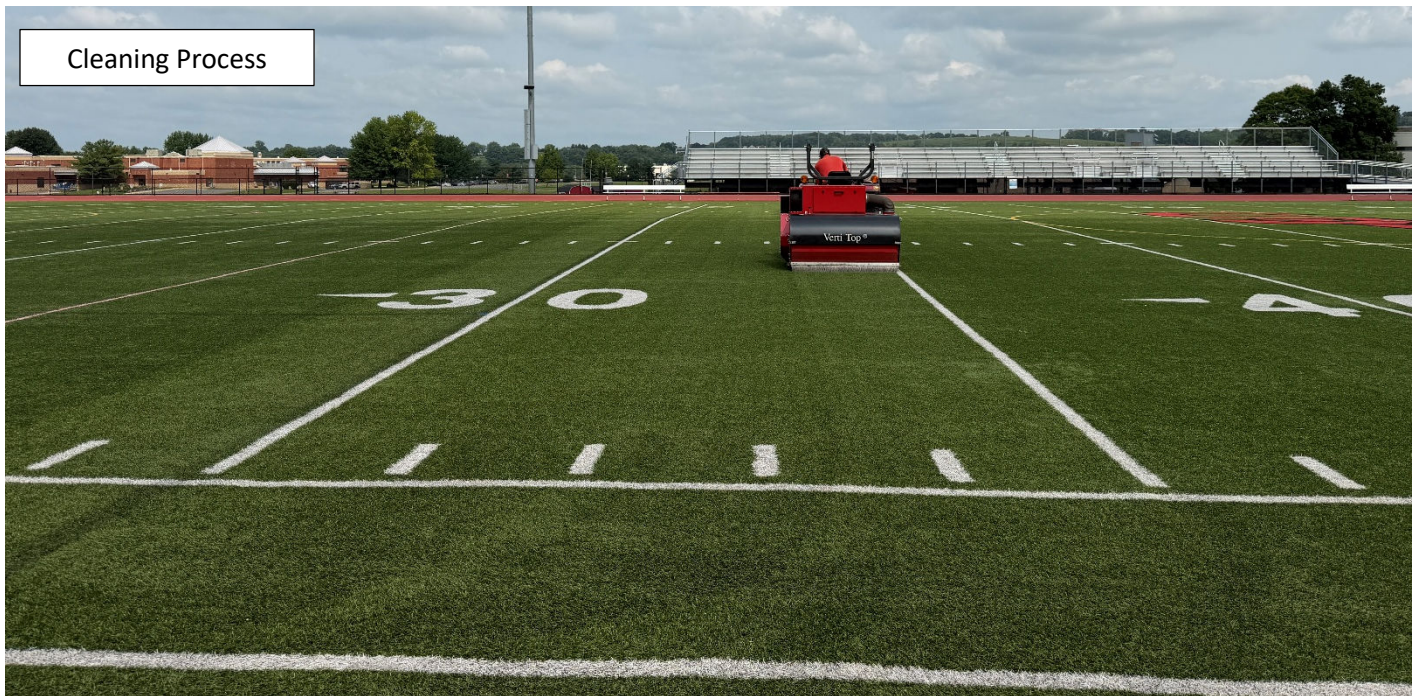
| <b><u>Service:</u></b> | <b><u>Date Completed</u></b> | <b><u>Tines</u></b> | <b><u>Roller</u></b> | <b><u>Angle</u></b> | <b><u>Unit</u></b> |
|---|---|---|---|---|---|
| 1.) Field Conditioning – Verti-Top | 08.13.2026 | 3 | 3 | 6 | # 2 |

Cleaning Process

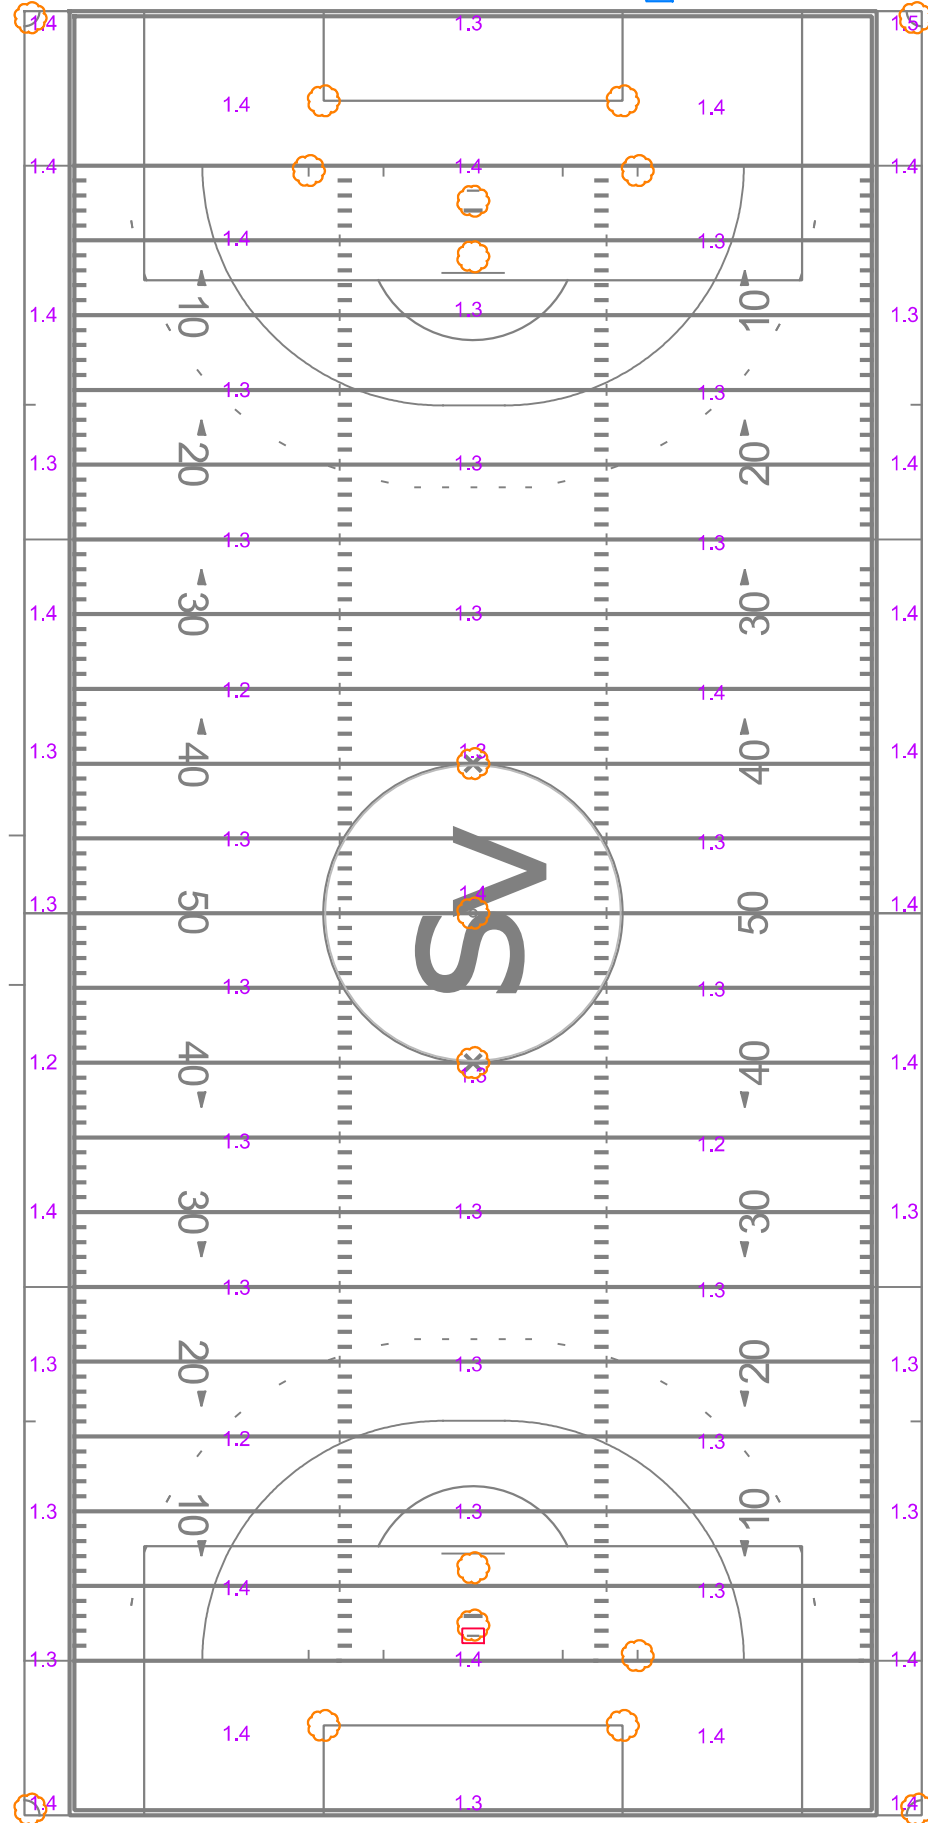
- AWAY
- HOME
- STICKY SUBSTANCE REMOVED
- LOOSE SEAM IDENTIFIED AND REPAIRED
- IN-FILL DEPTH MEASURED
- IN-FILL ADDED

- 3.) **Add rubber to locations noted on attached diagram. Regular inspection of “hot spot” areas. Add infill and / or redistribute infill regularly (monthly at minimum).**
