# PROPERTY CONDITION ASSESSMENT

MAINE SCHOOL OF SCIENCE & MATHEMATICS DORMITORY  
77 HIGH STREET  
LIMESTONE, MAINE

ECS PROJECT NO. 50:1008

JANUARY 20, 2019

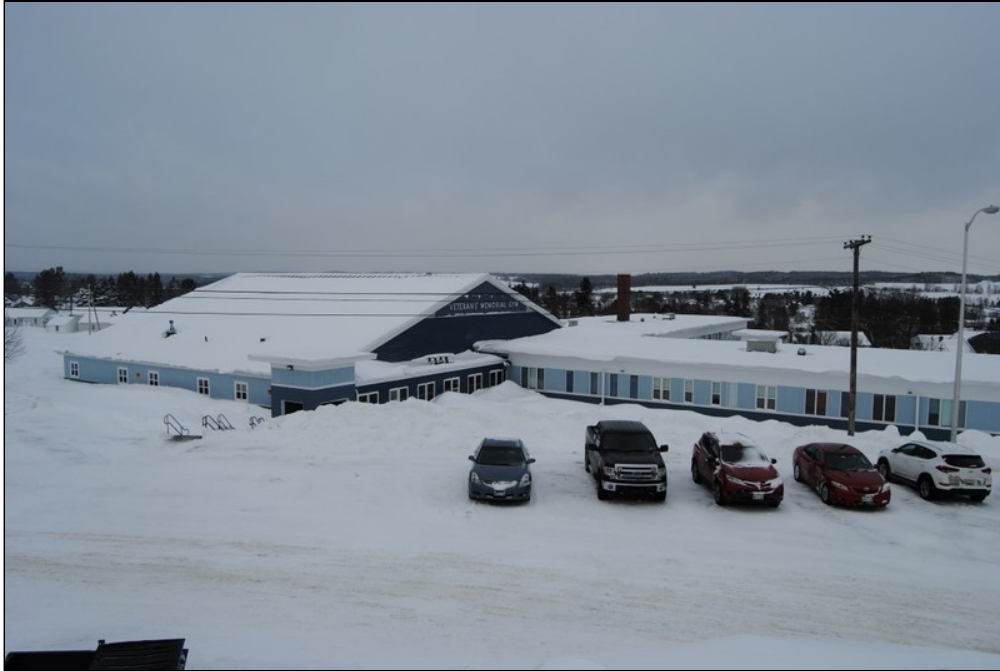
1 - overview

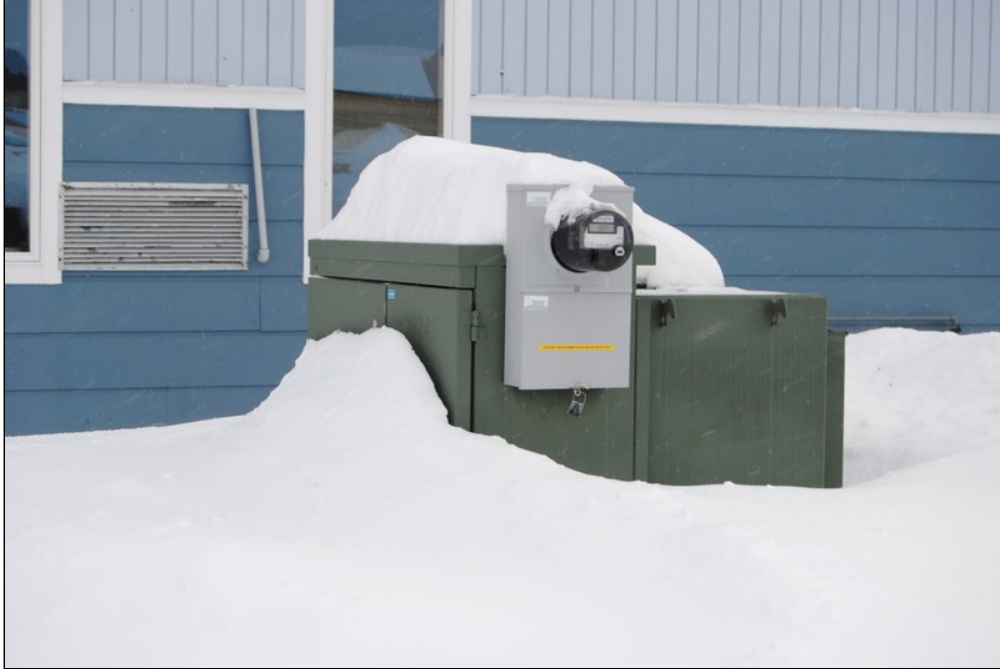
5 - transformer

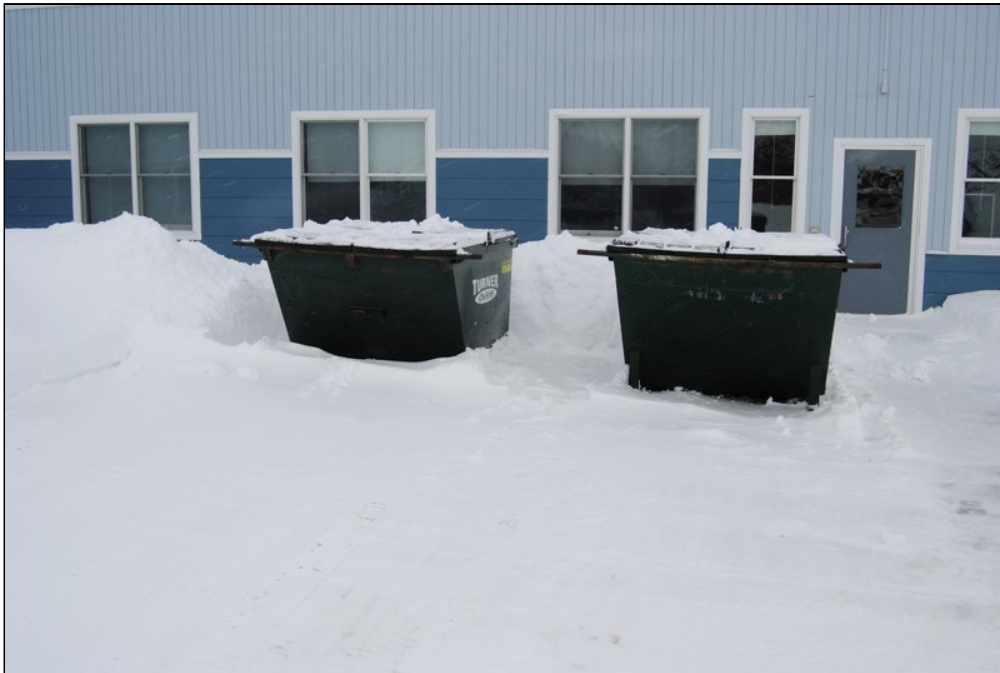
6 - dumpster

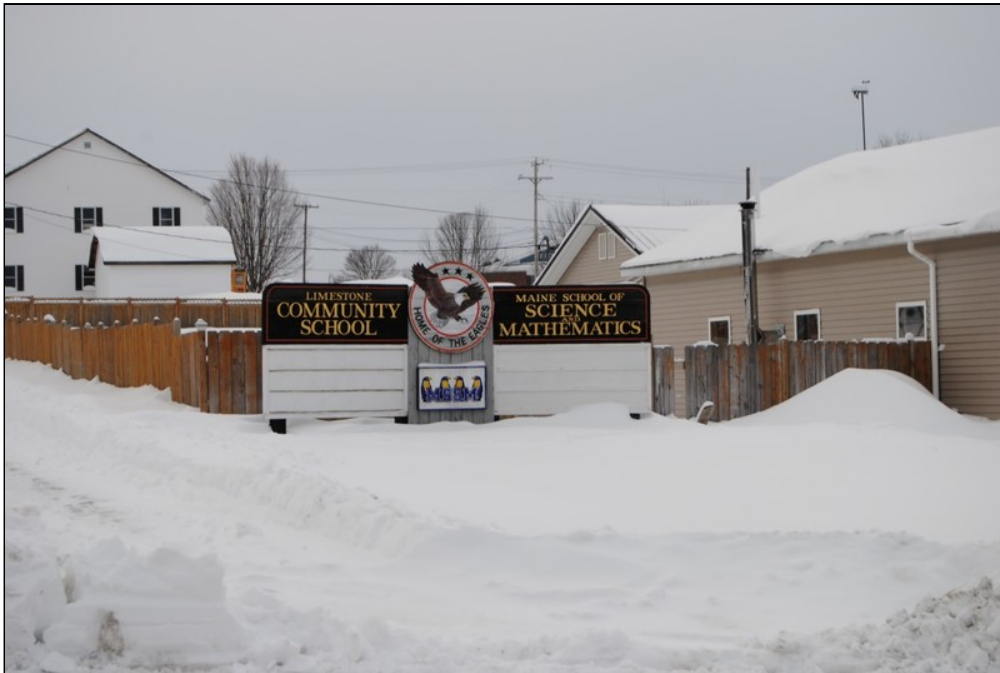
10 - monument sign

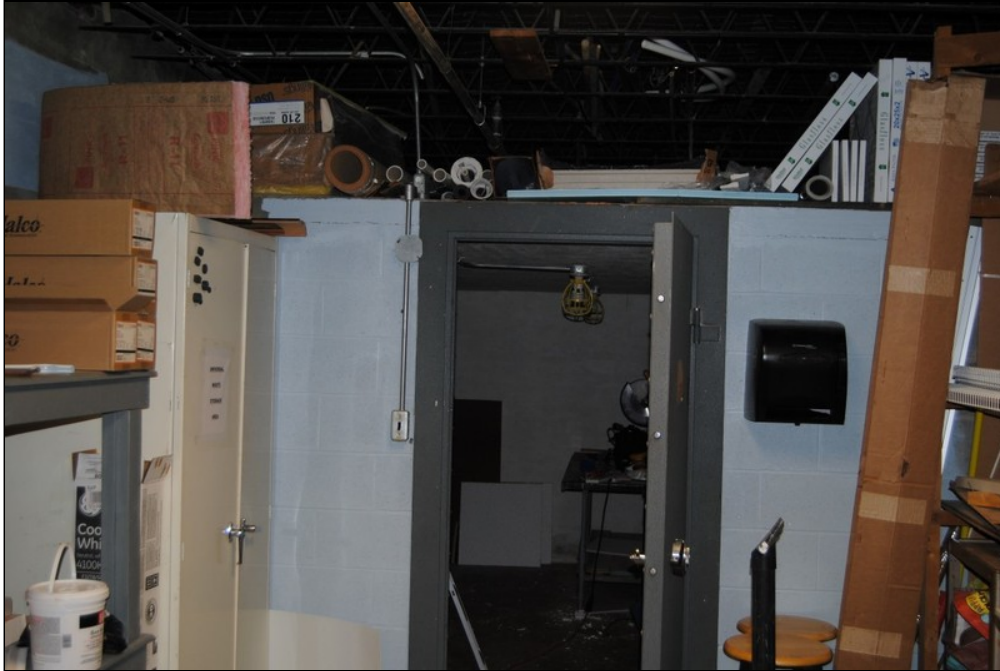
11 - vault

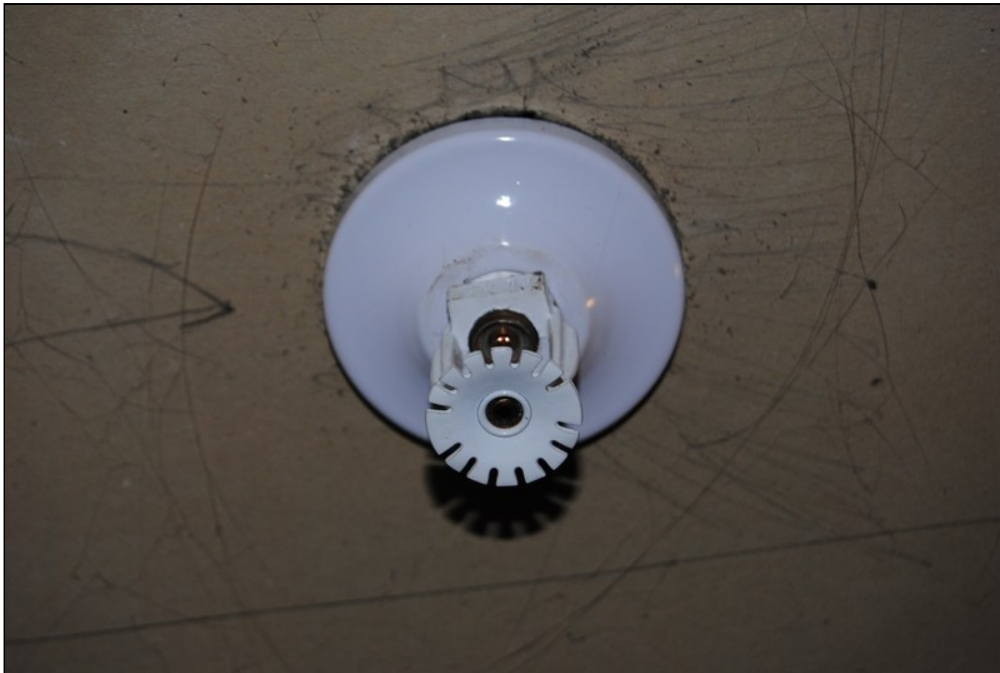
12 - sprinkler head

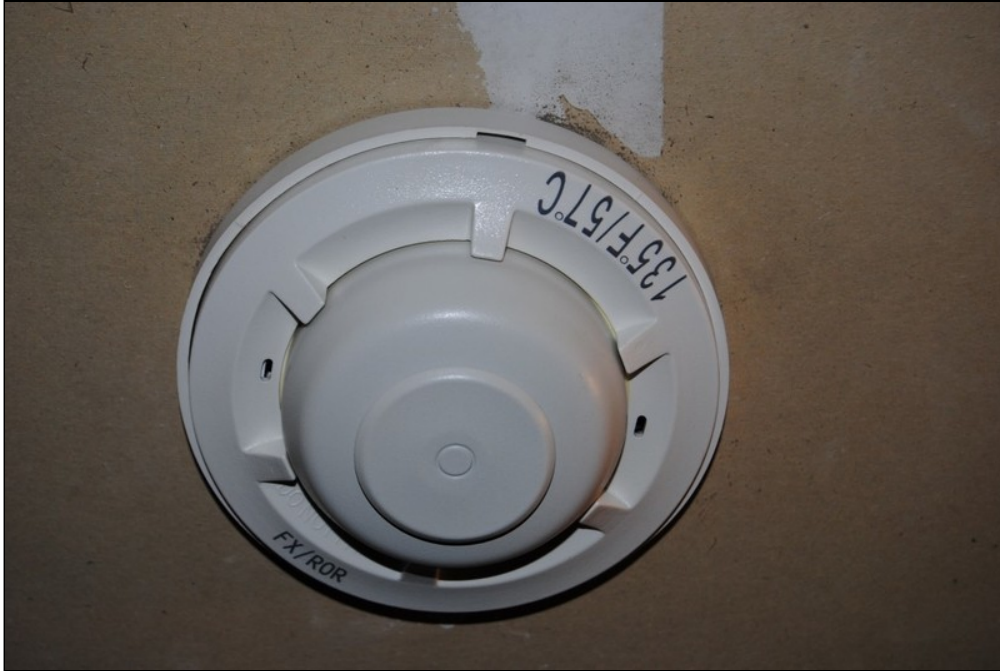
13 - heat detector

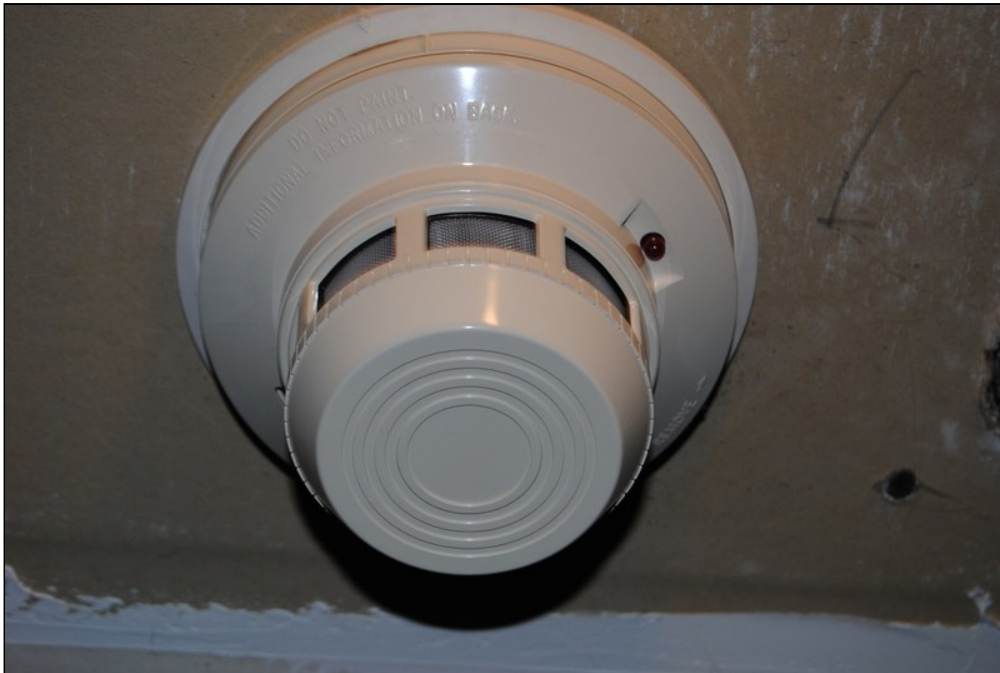
14 - smoke detector

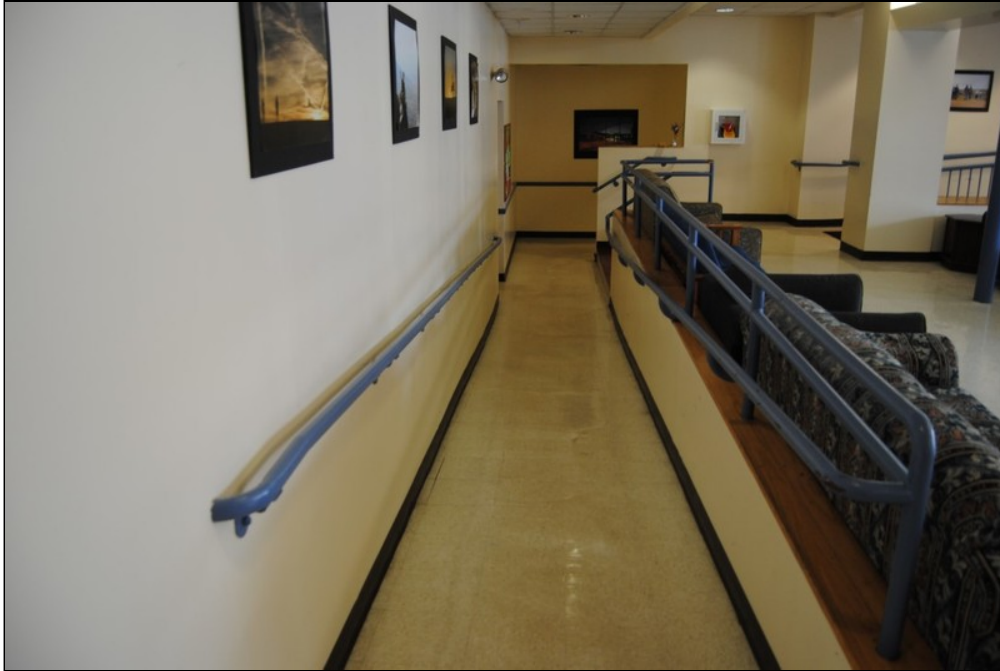
15 - interior ramp

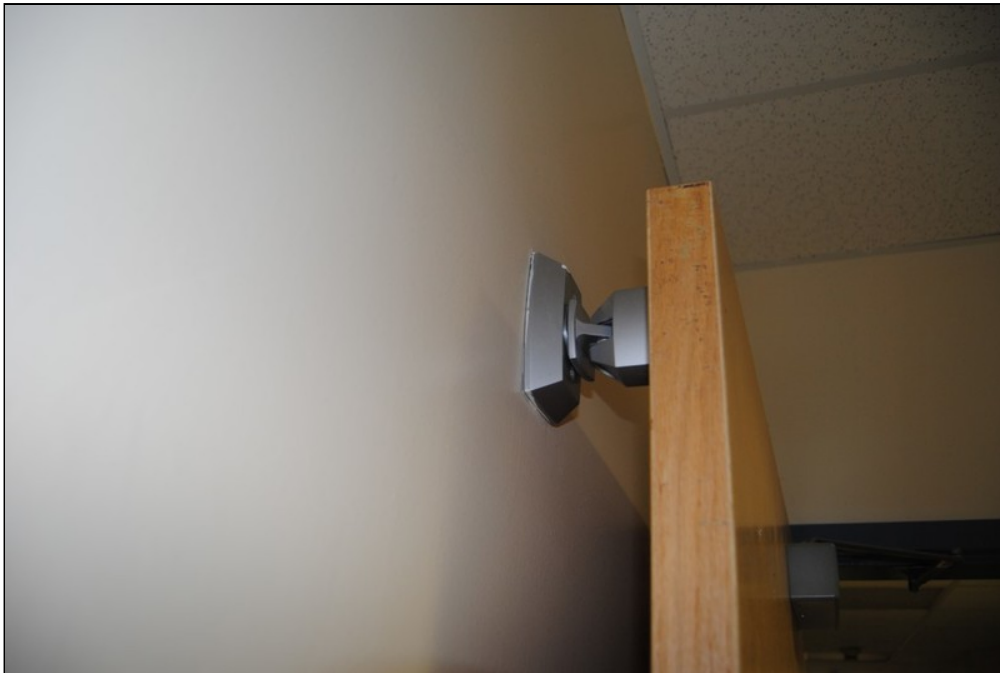
16 - fire door holder

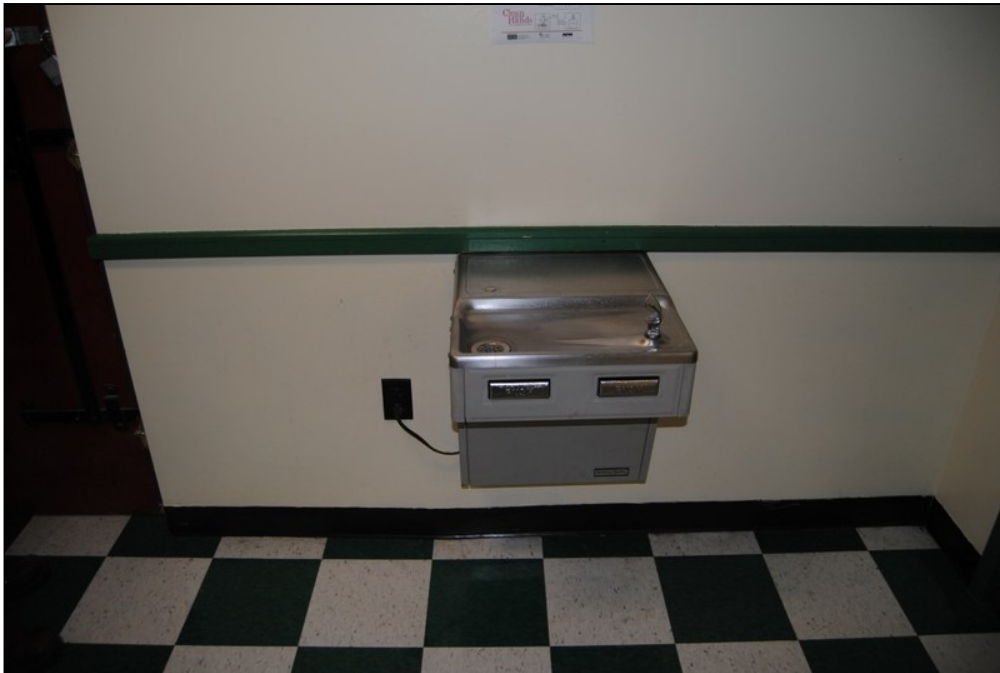
18 - water fountain

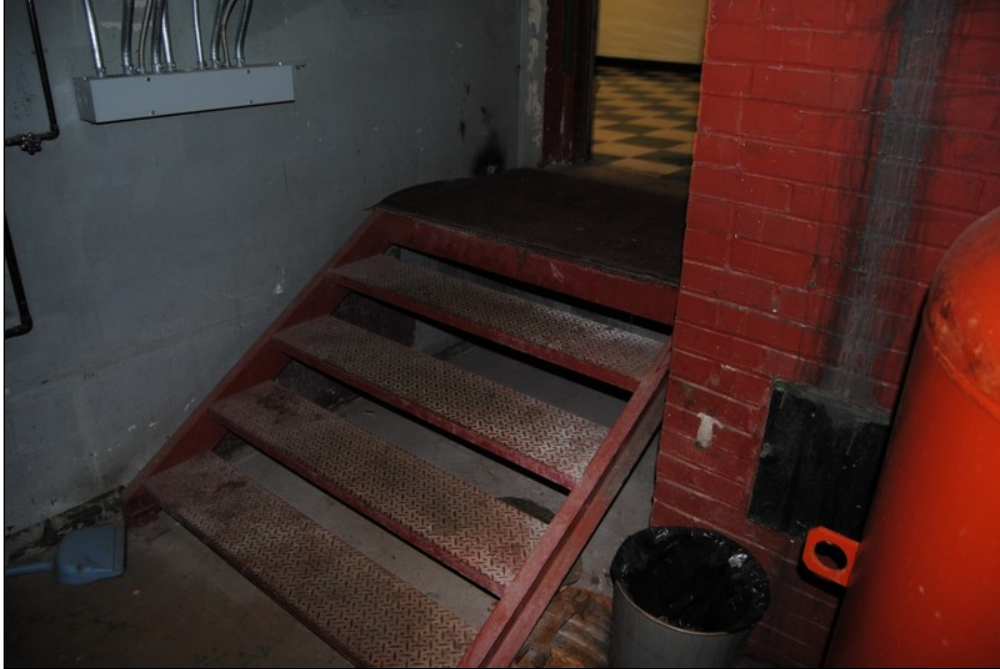
19 - stairs

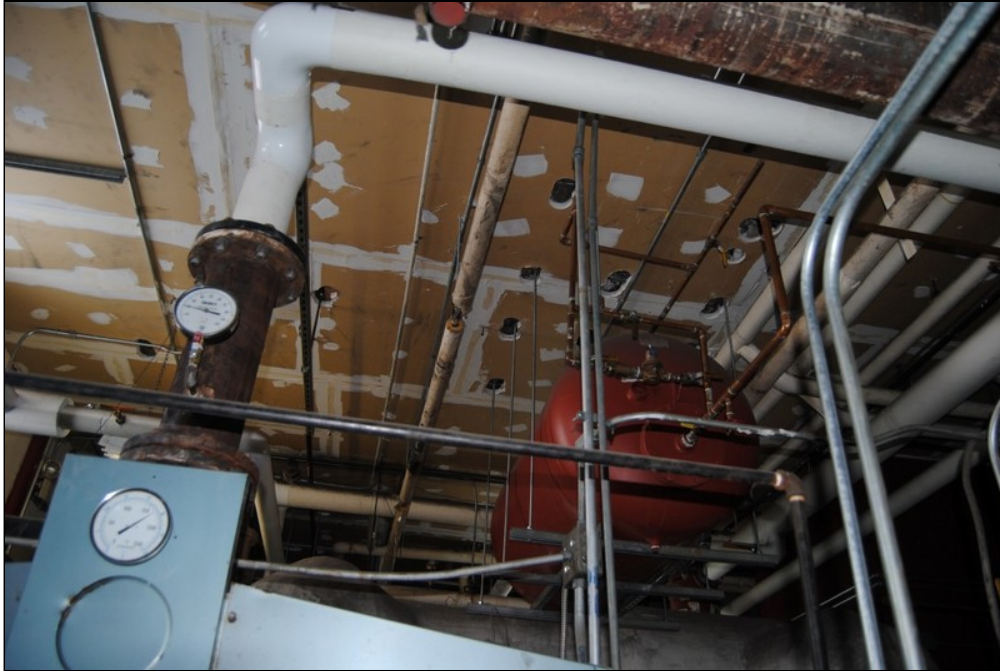
21 - water tank

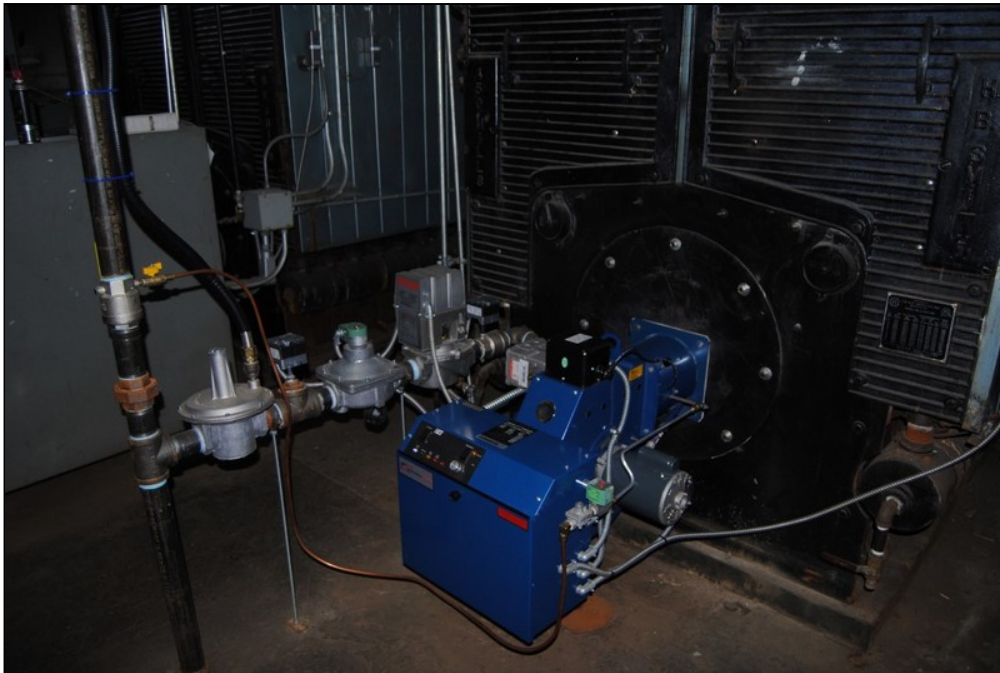
22 - propane boiler

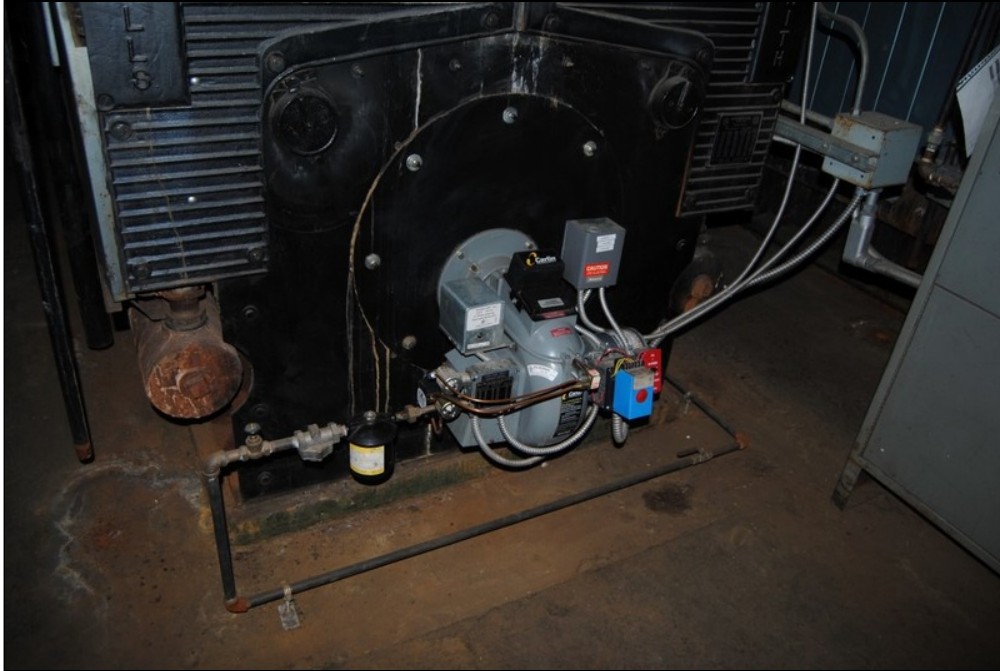
23 - oil boiler

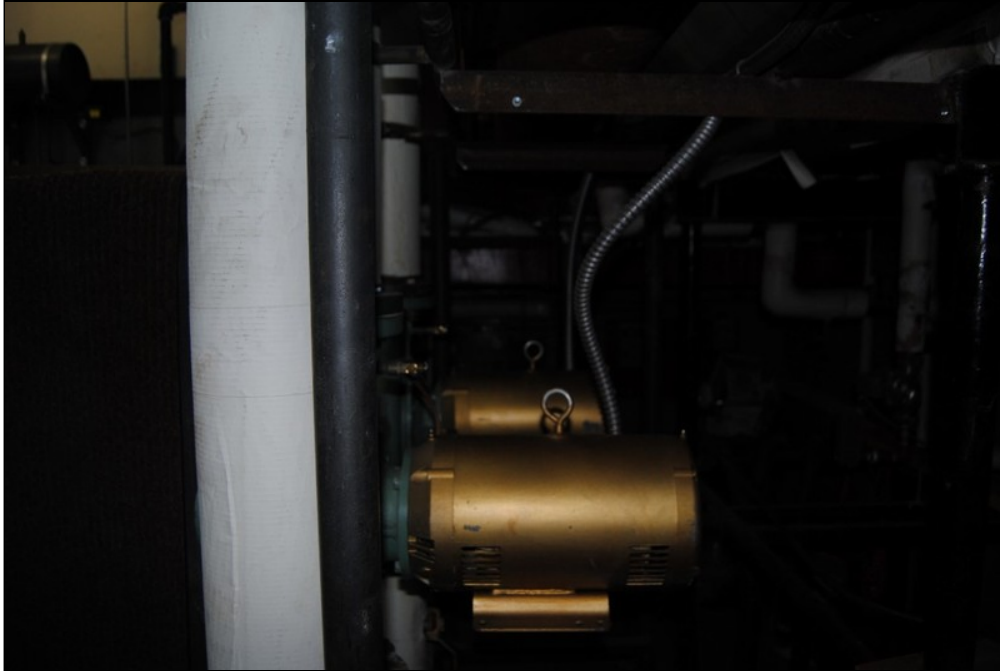
25 - water pump

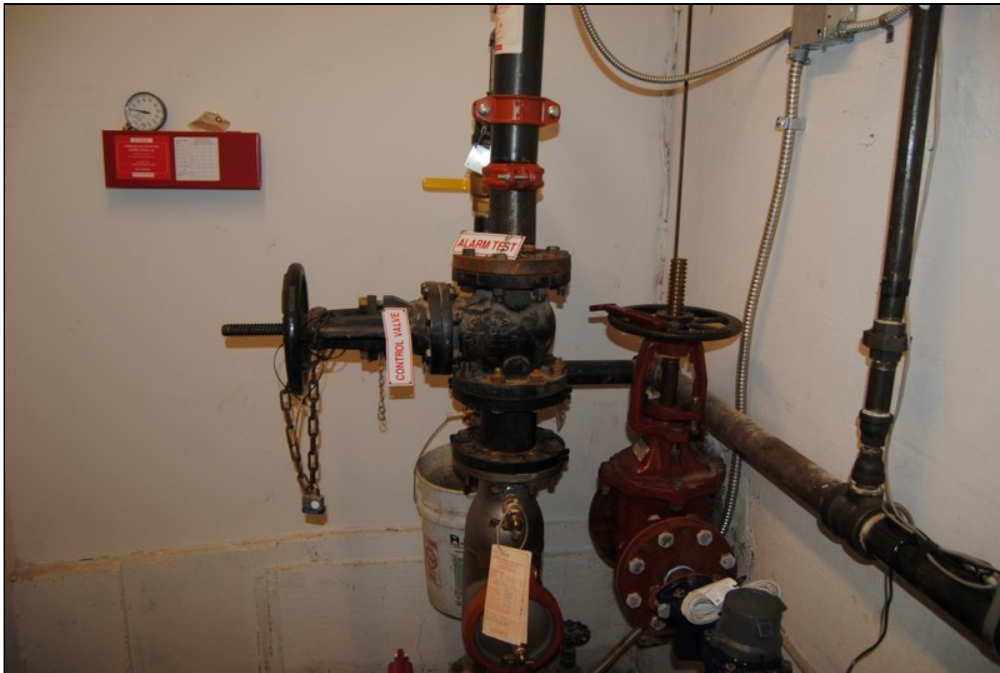
26 - sprinkler valve

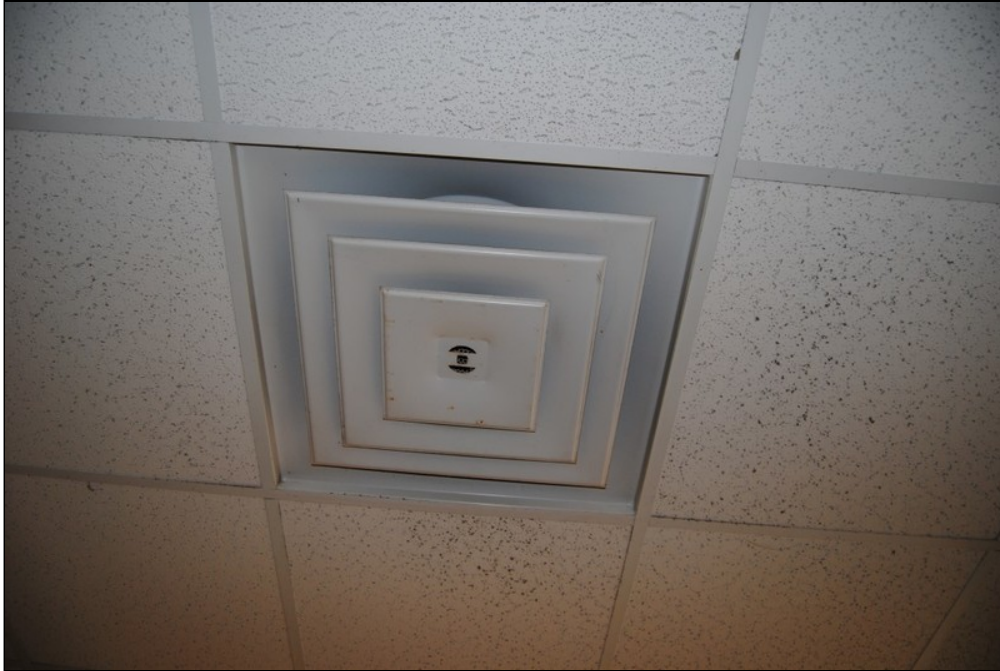
27 - air supply

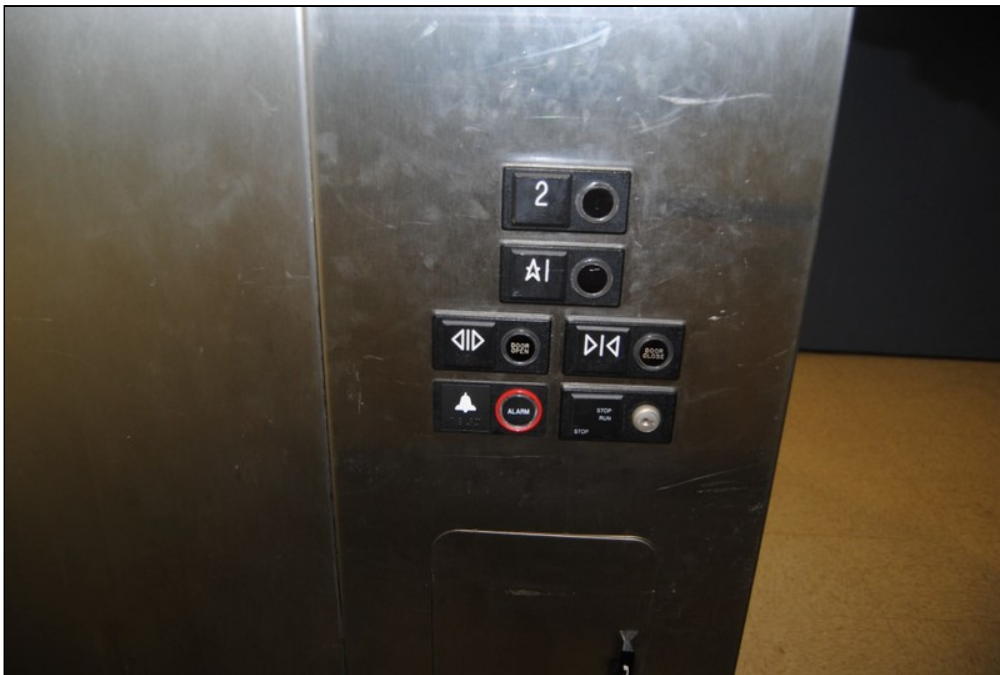
28 - elevator control

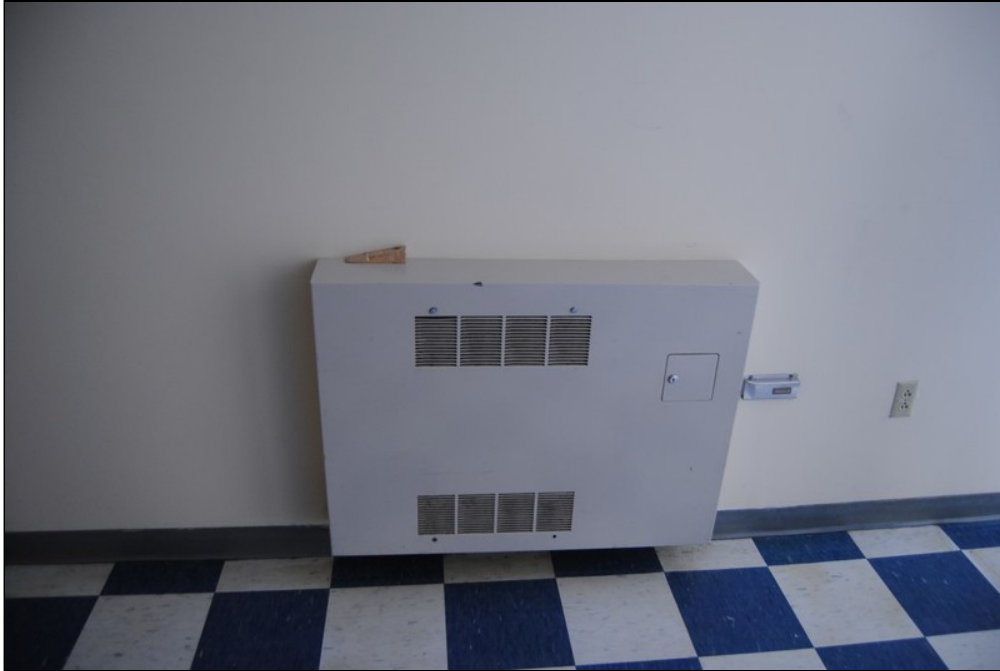
29 - radiator

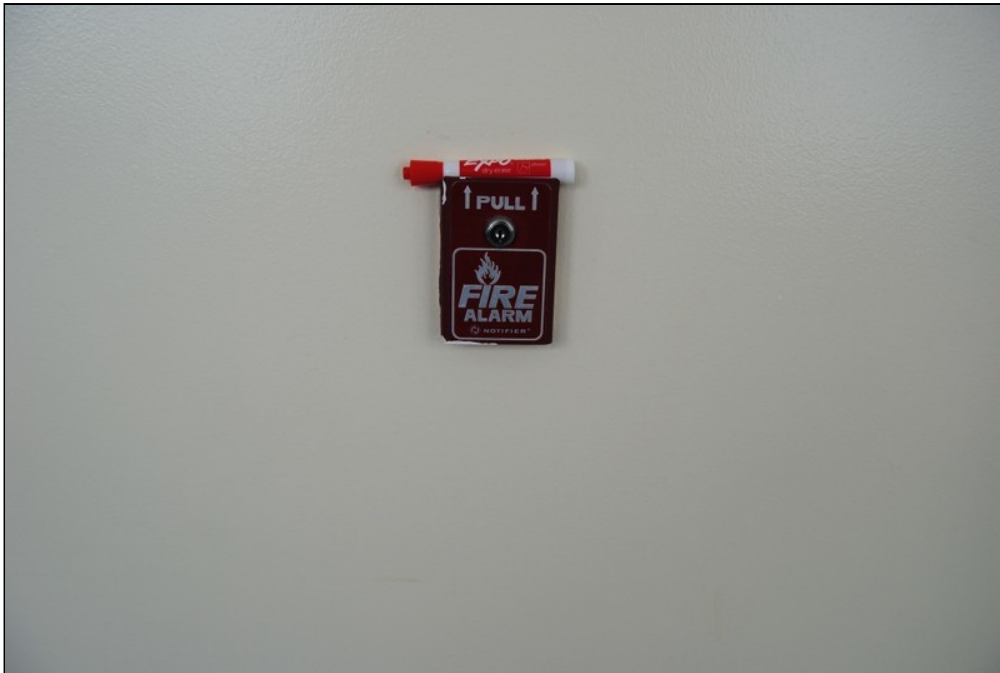
30 - pull station

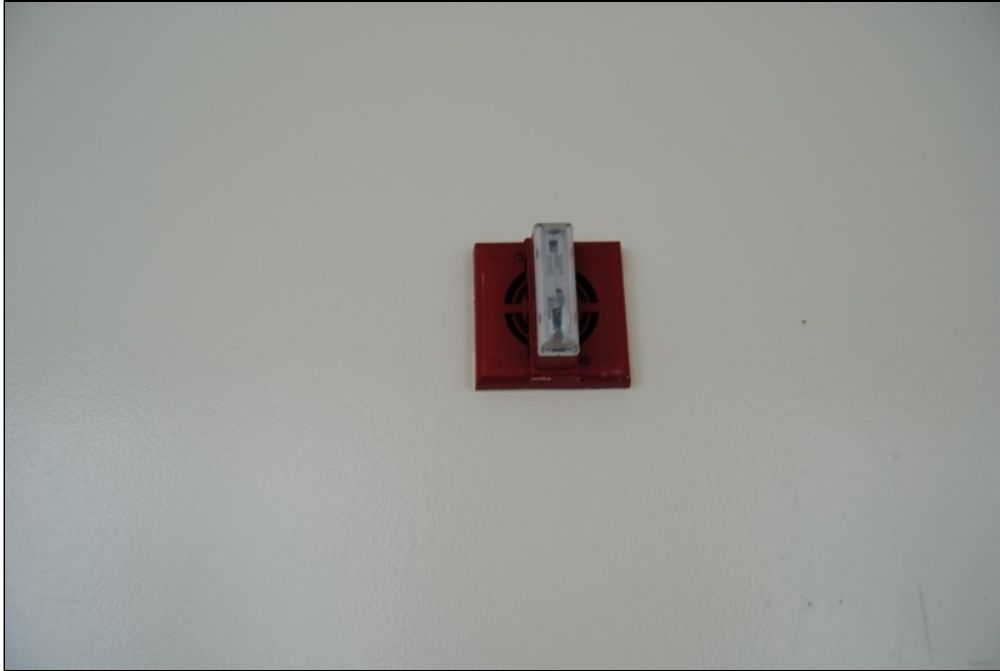
31 - strobe/horn

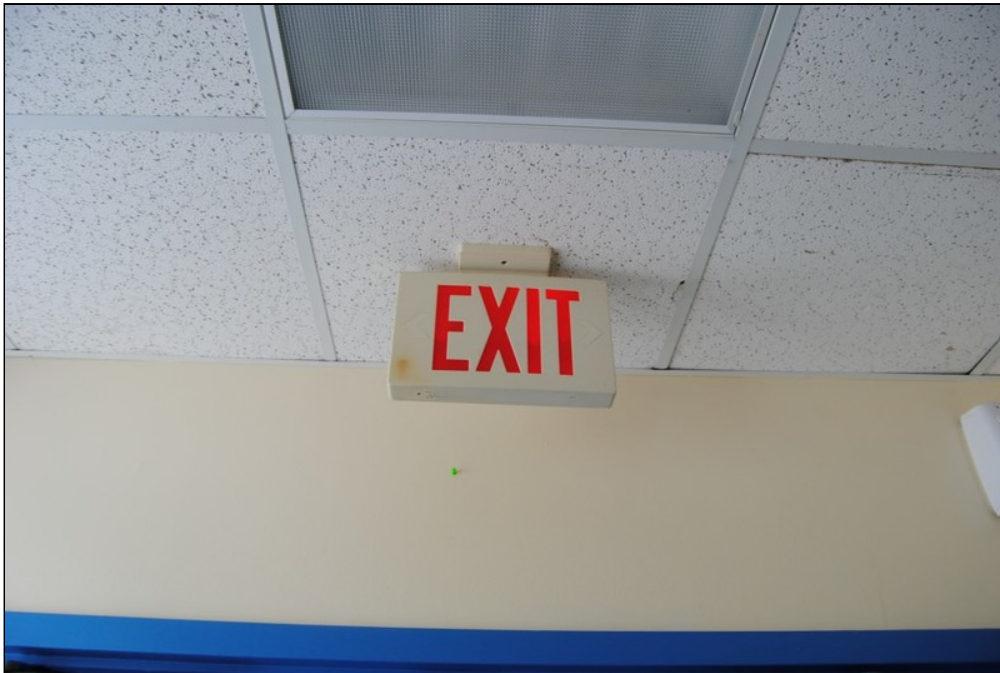
32 - exit sign

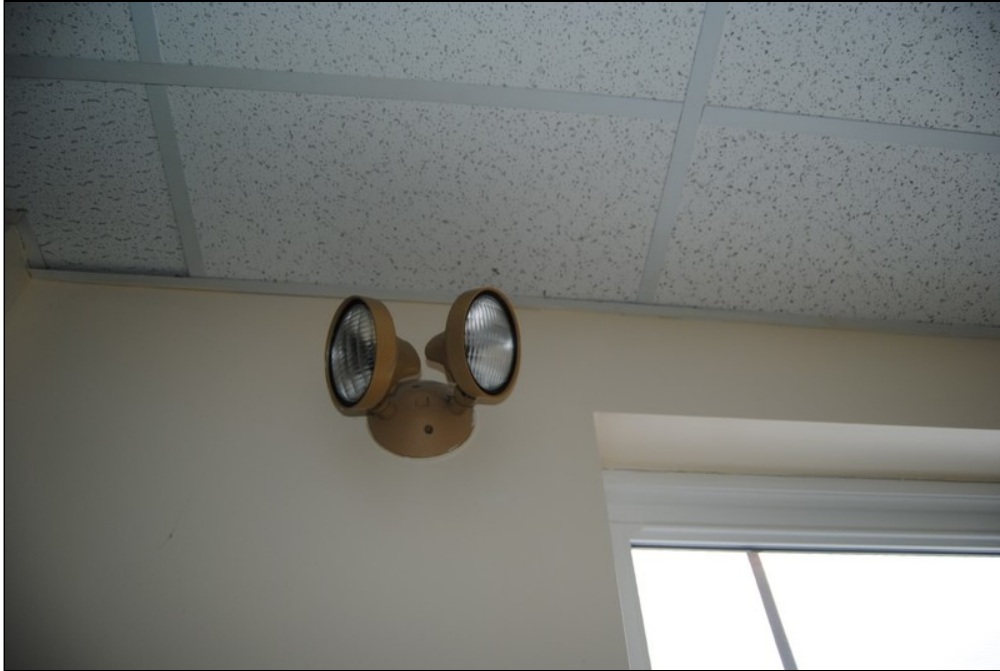
33 - emergency light

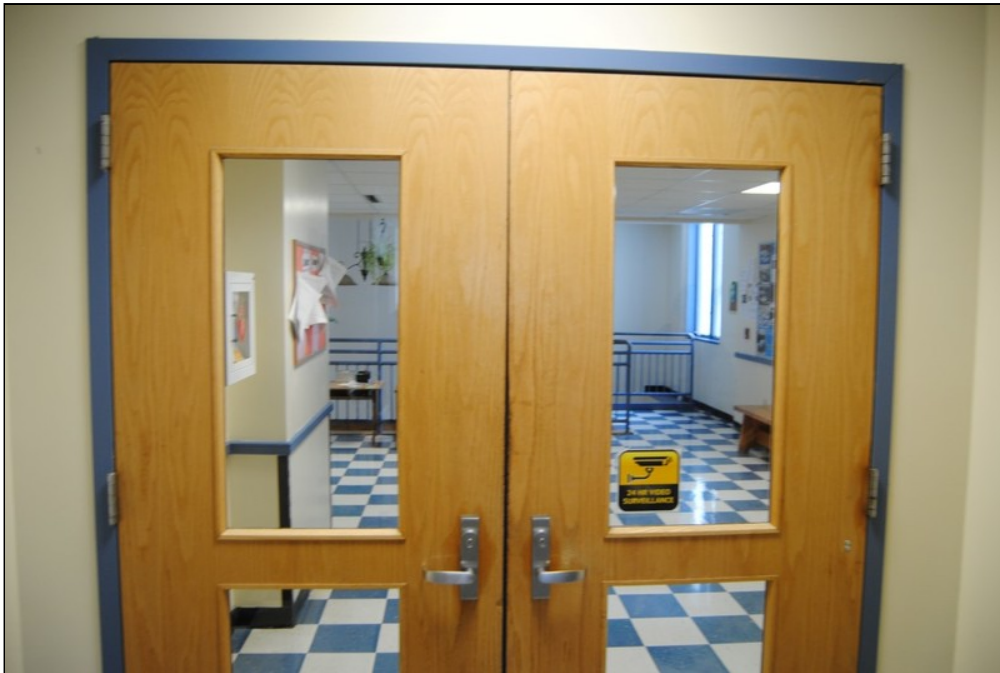
34 - interior door

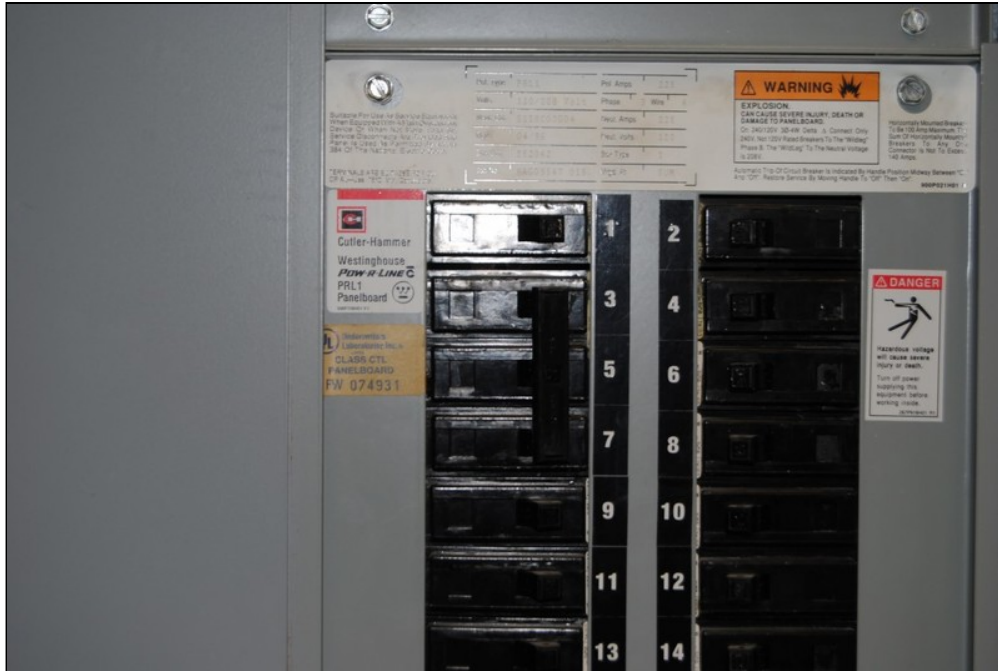
35 - sub panel

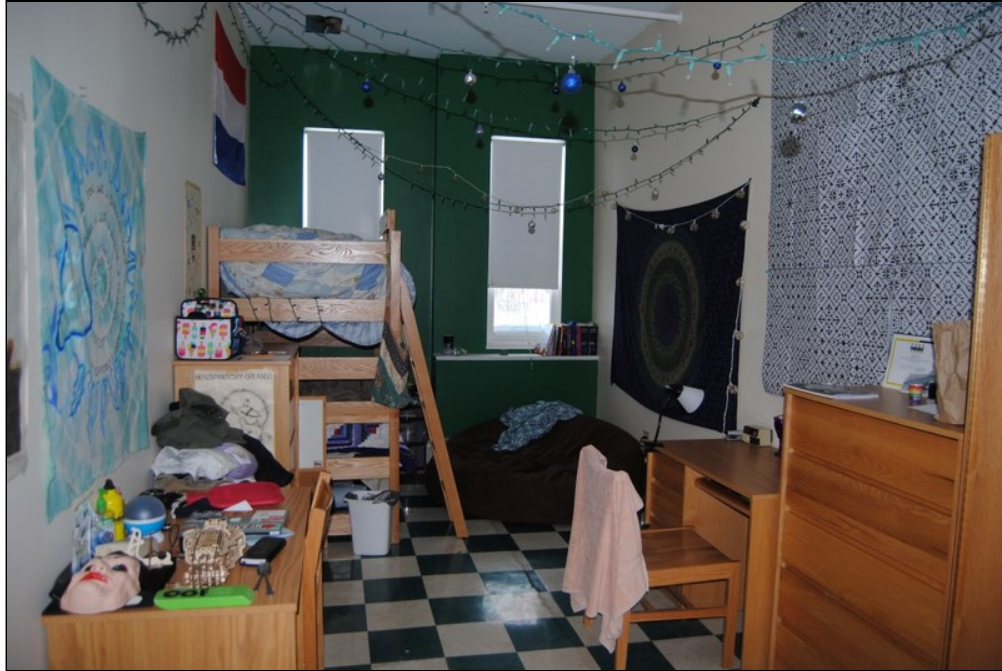
37 - room furnishing

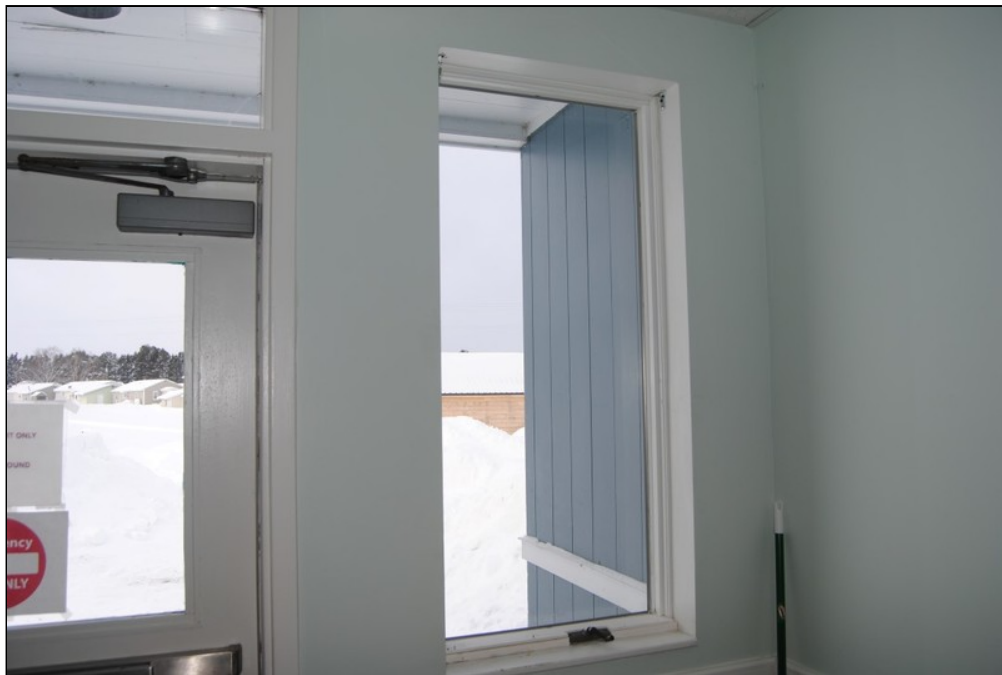
38 - casement window

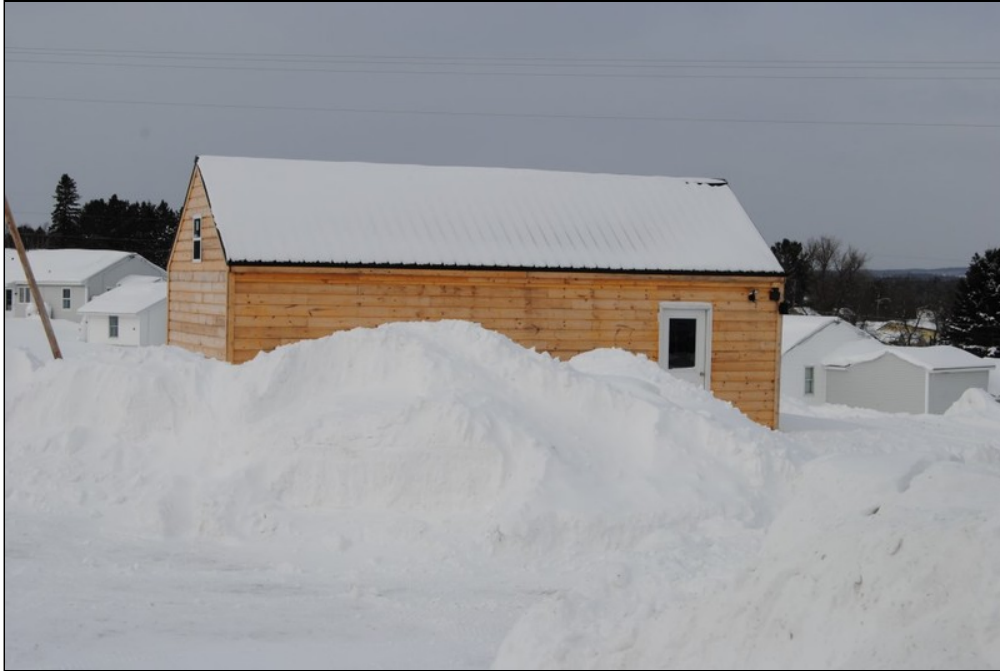
39 - shed

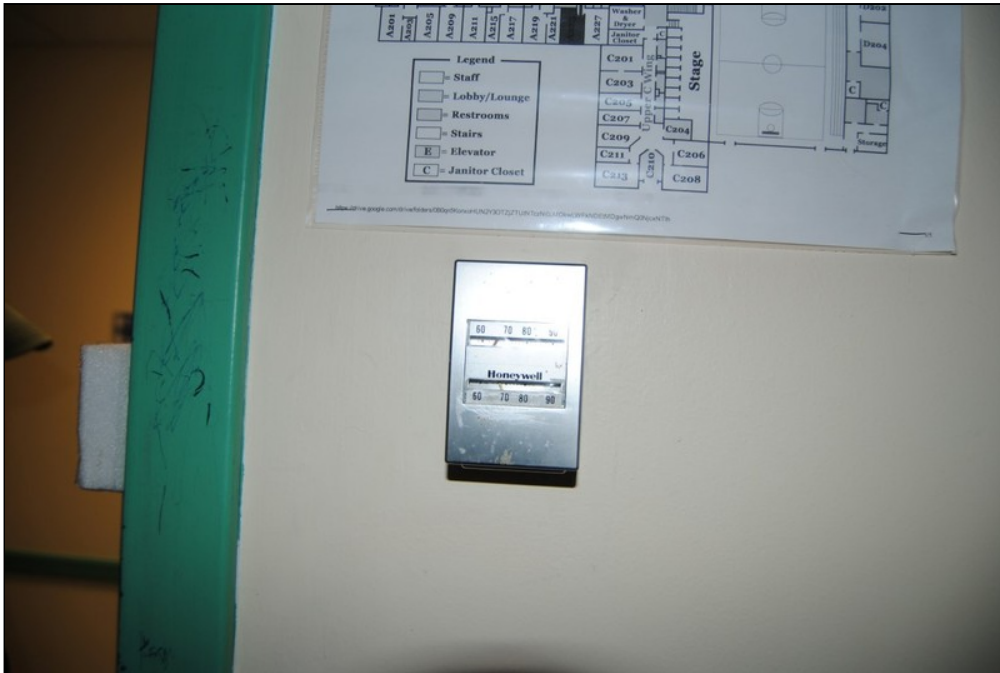
40 - thermostat

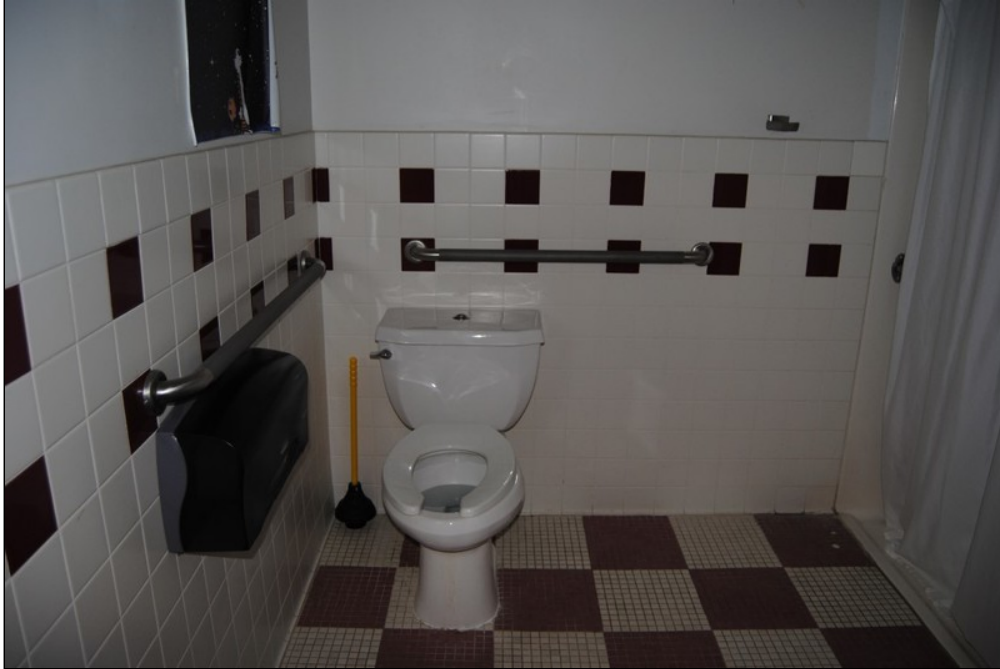
41 - toilet

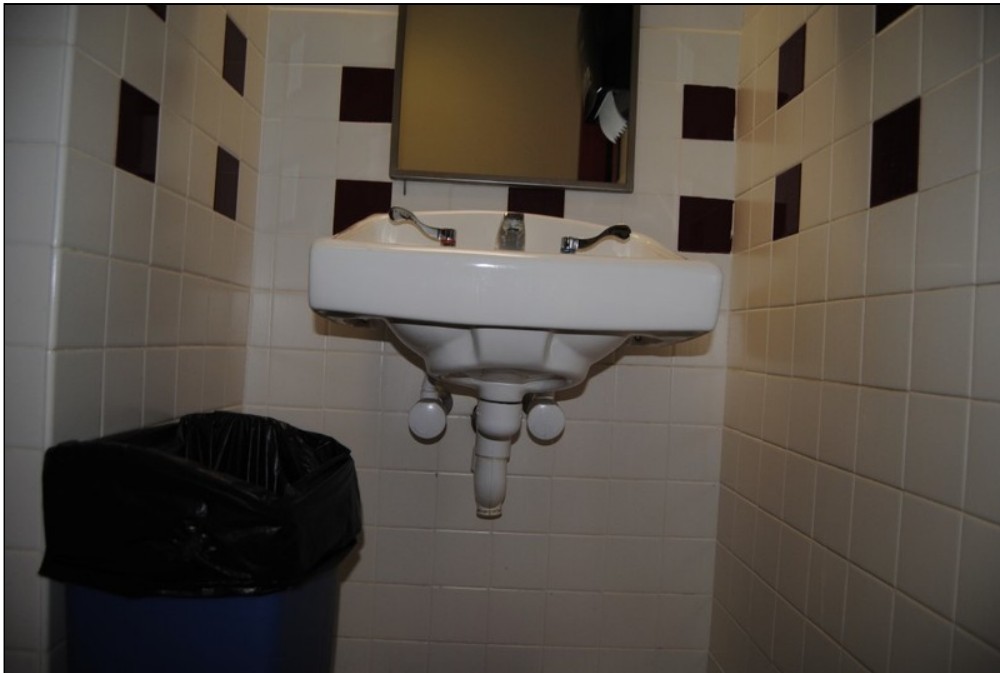
42 - sink

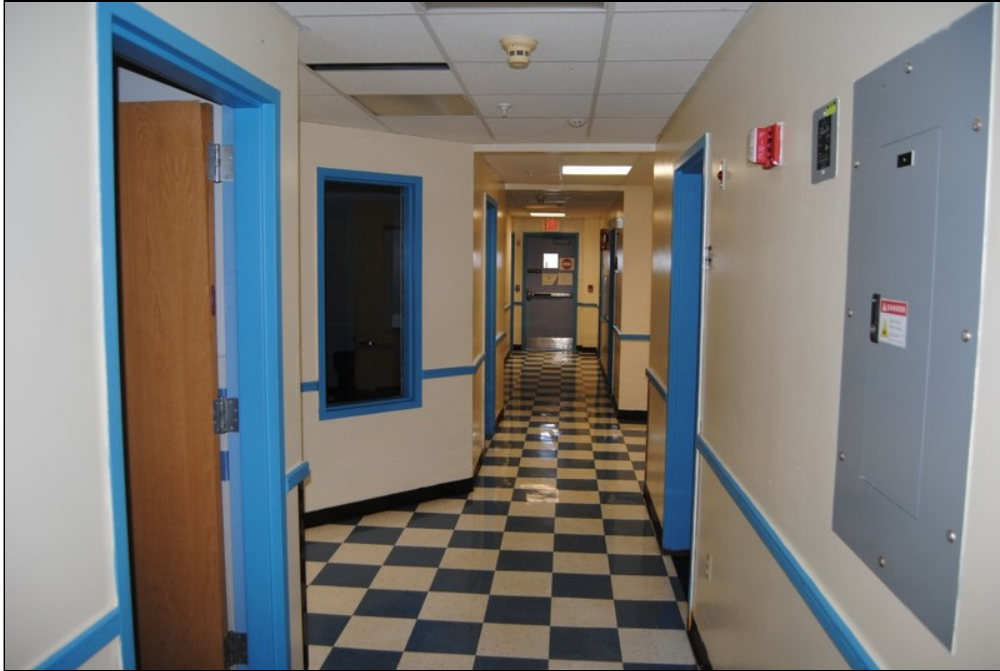
43 - interior finishes

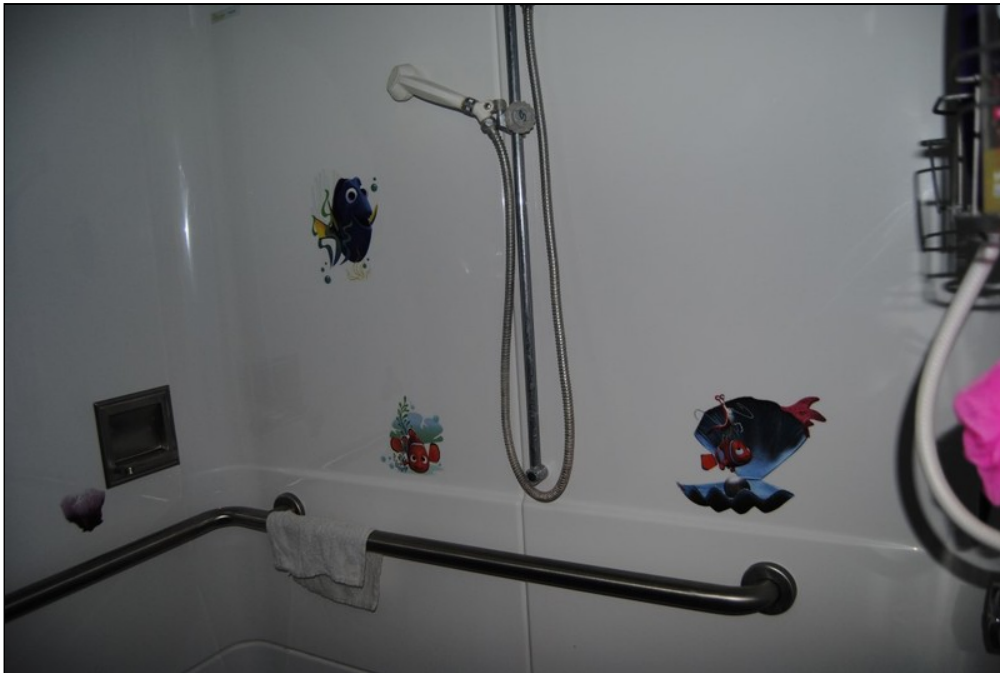
44 - shower
