# PROPERTY CONDITION ASSESSMENT

MAINE SCHOOL OF SCIENCE & MATHEMATICS DORMITORY  
77 HIGH STREET  
LIMESTONE, MAINE

ECS PROJECT NO. 50:1008

JANUARY 20, 2019

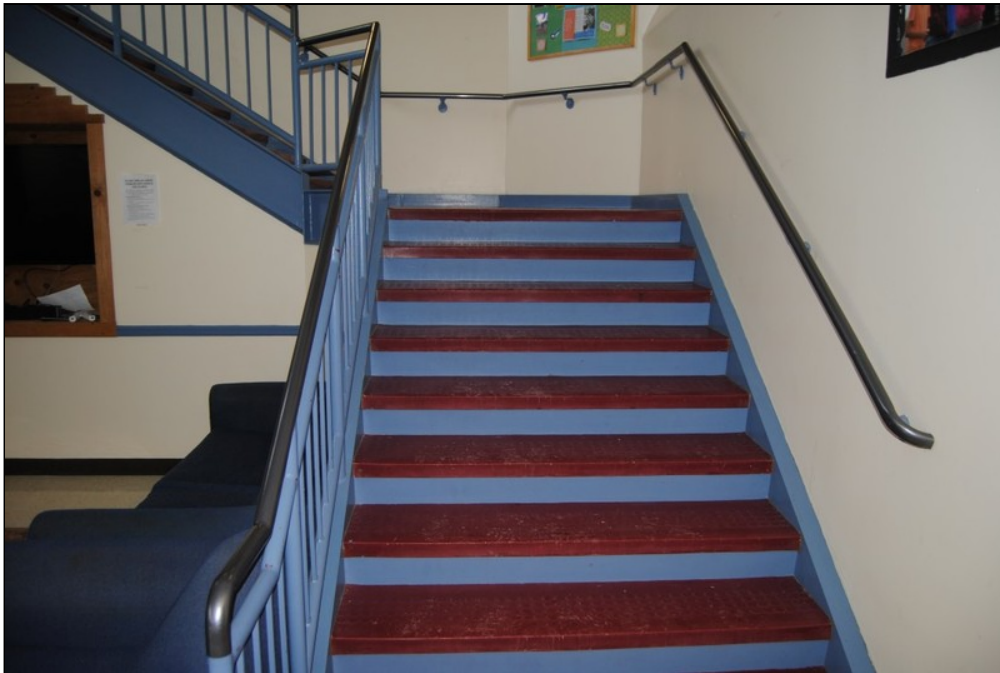
46 - stairs

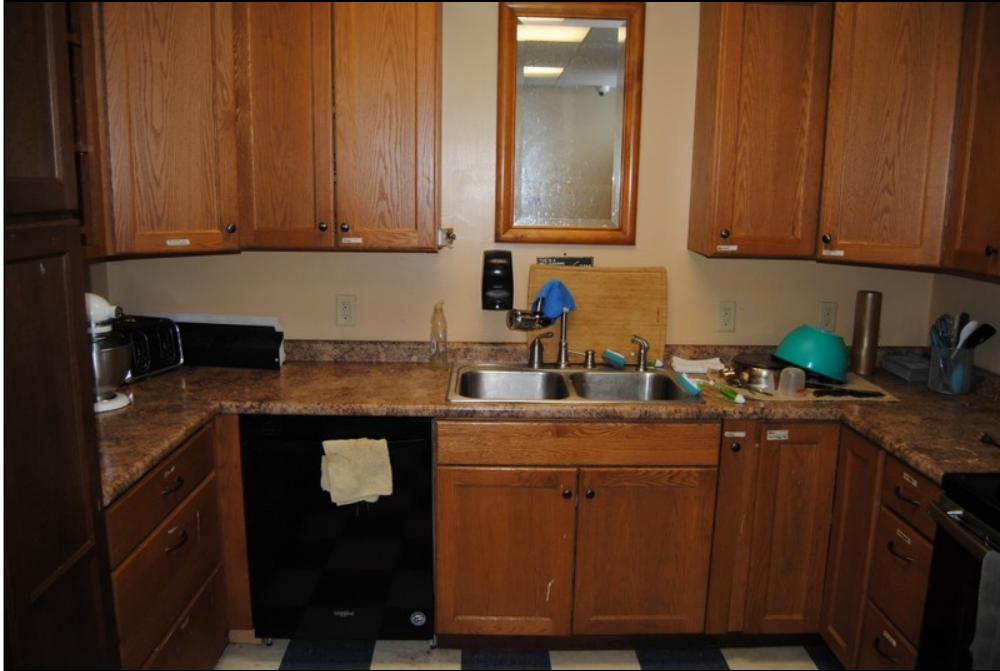
47 - kitchen

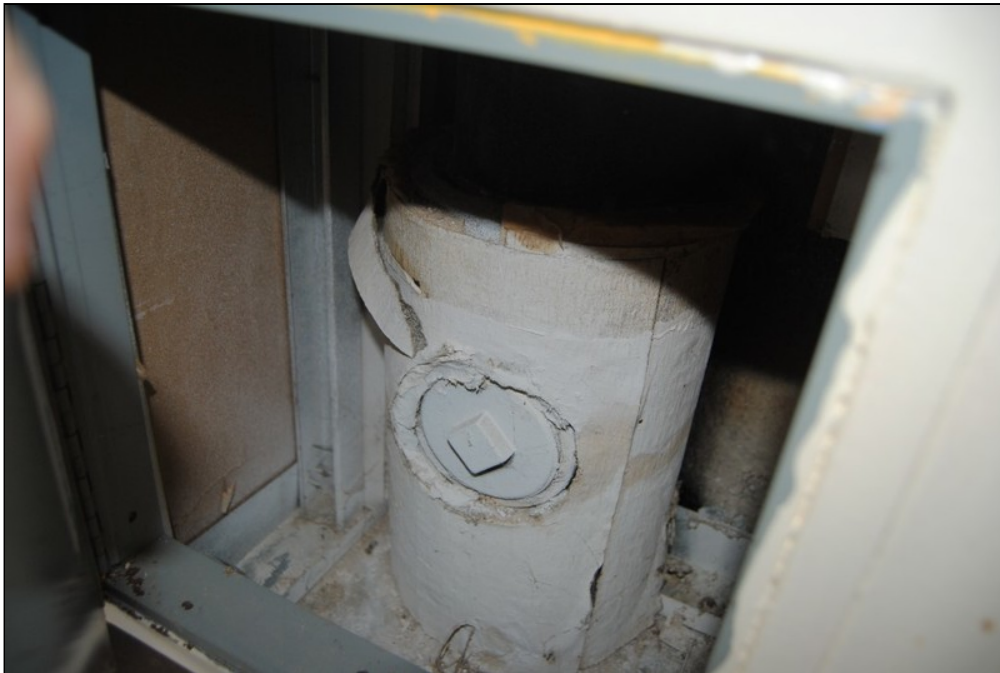
48 - clean out

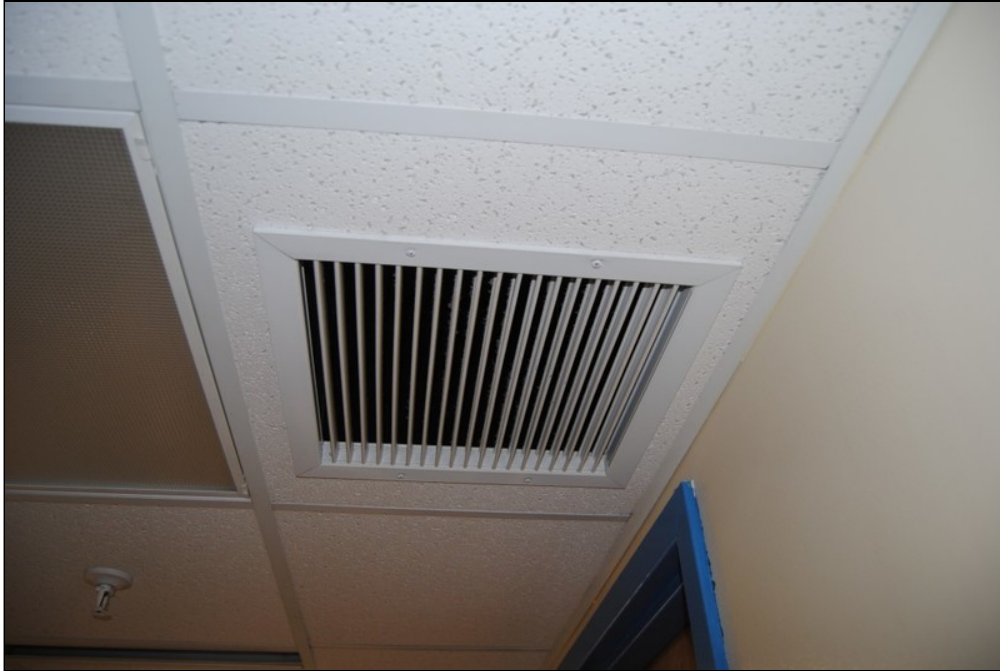
49 - air return

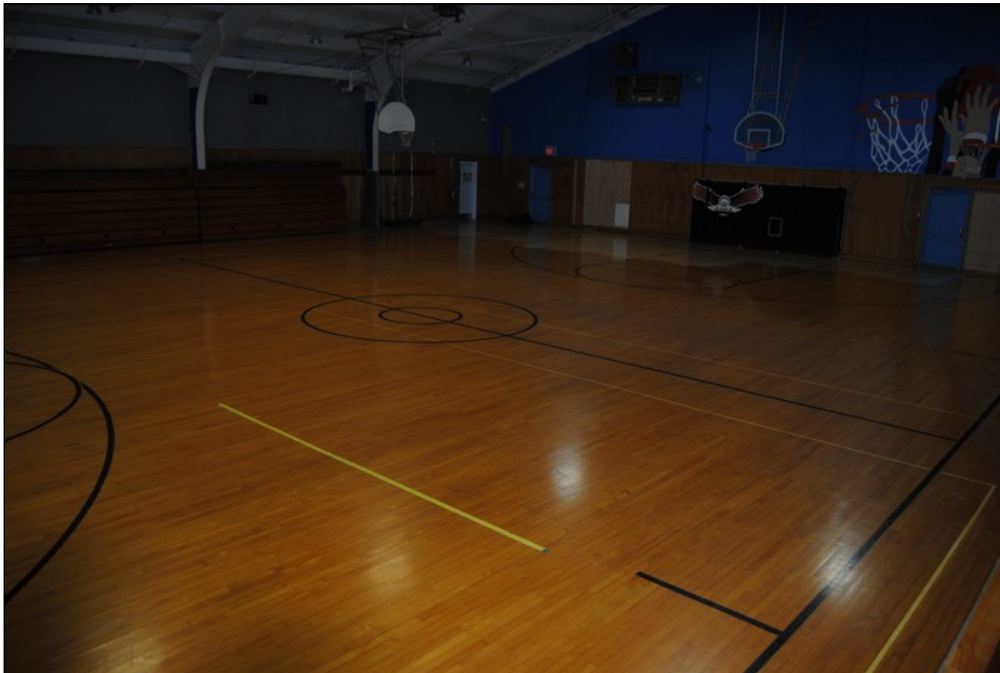
50 - gym floor

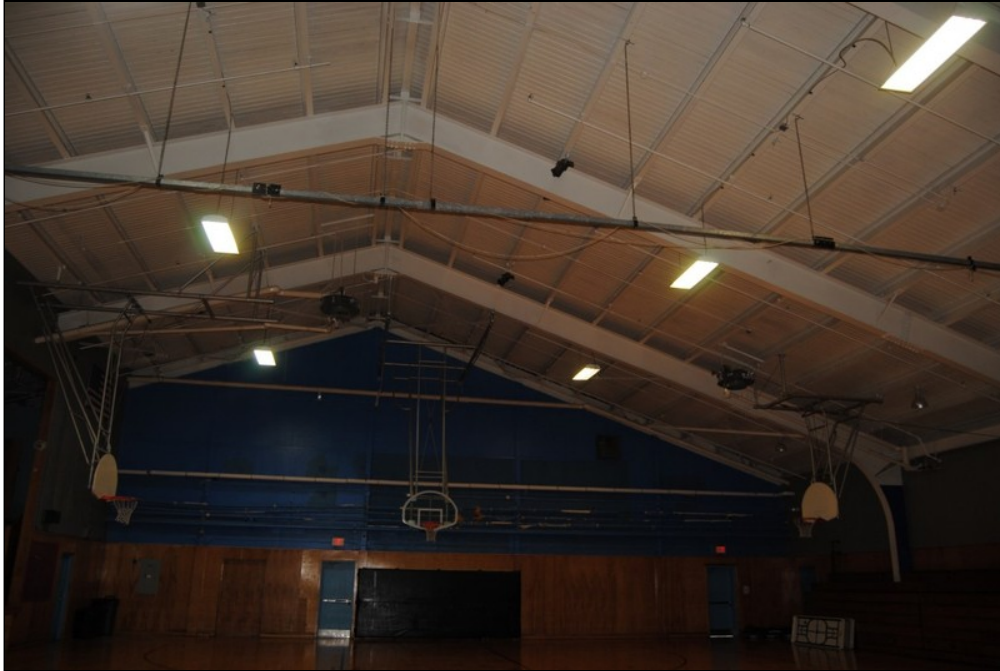
51 - gym frame

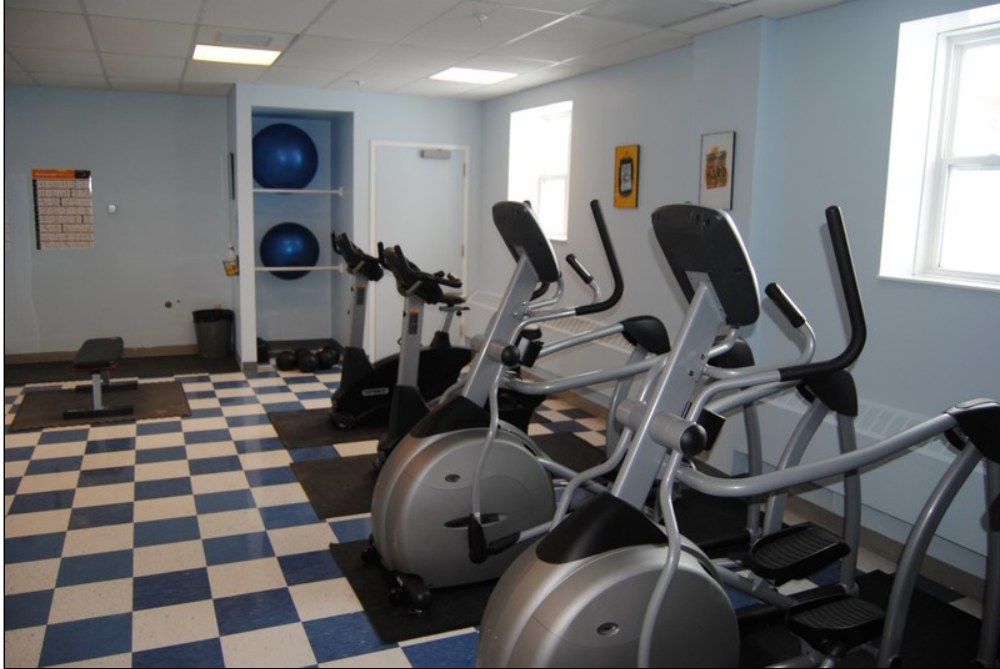
53 - exercise room

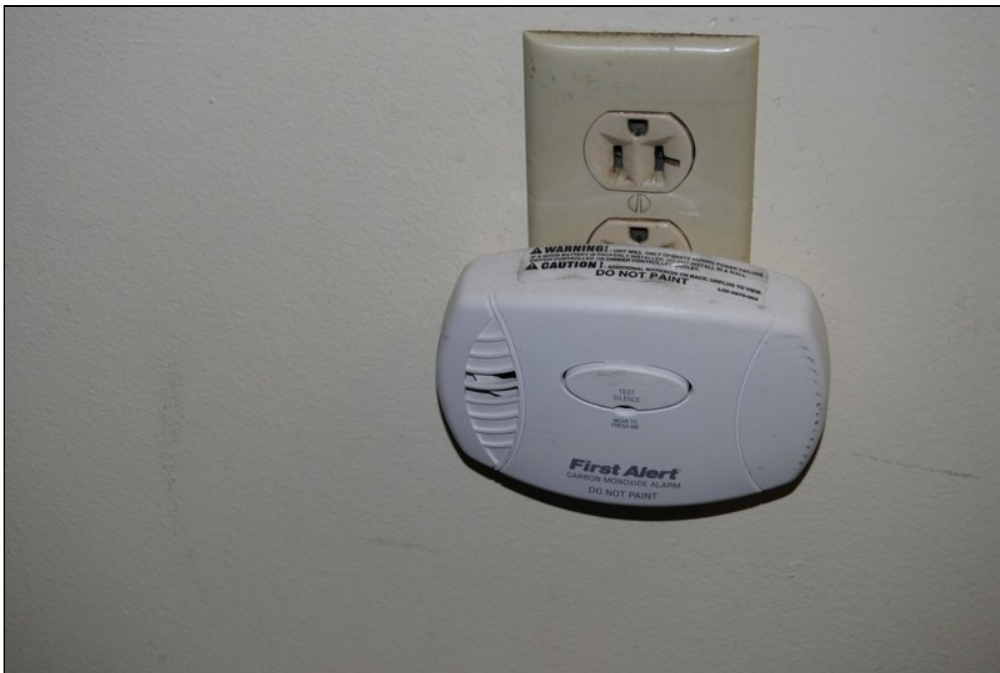
56 - CO detector

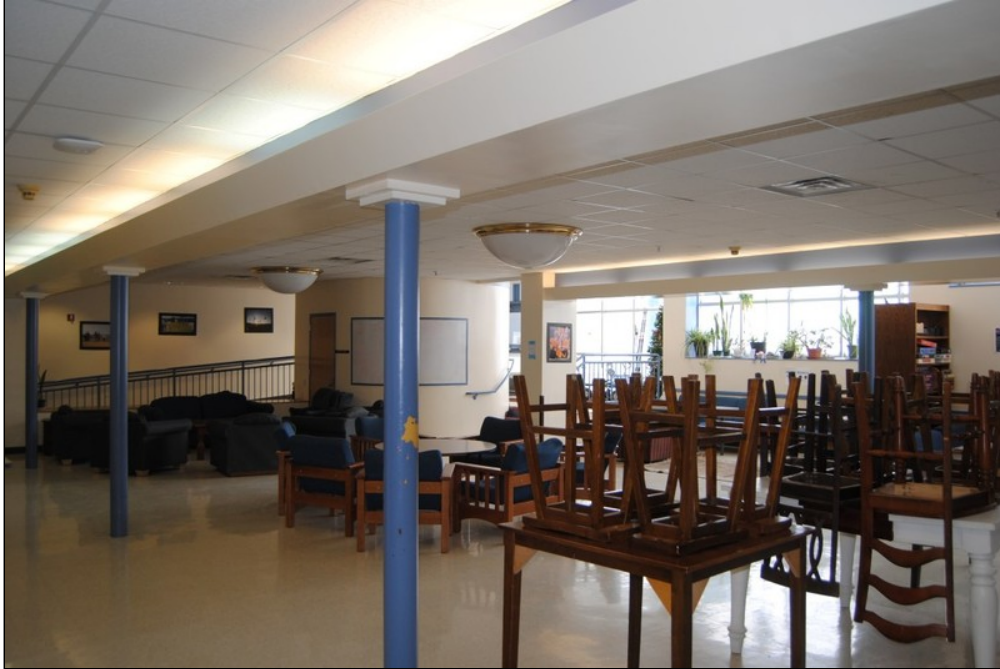
57 - lounge

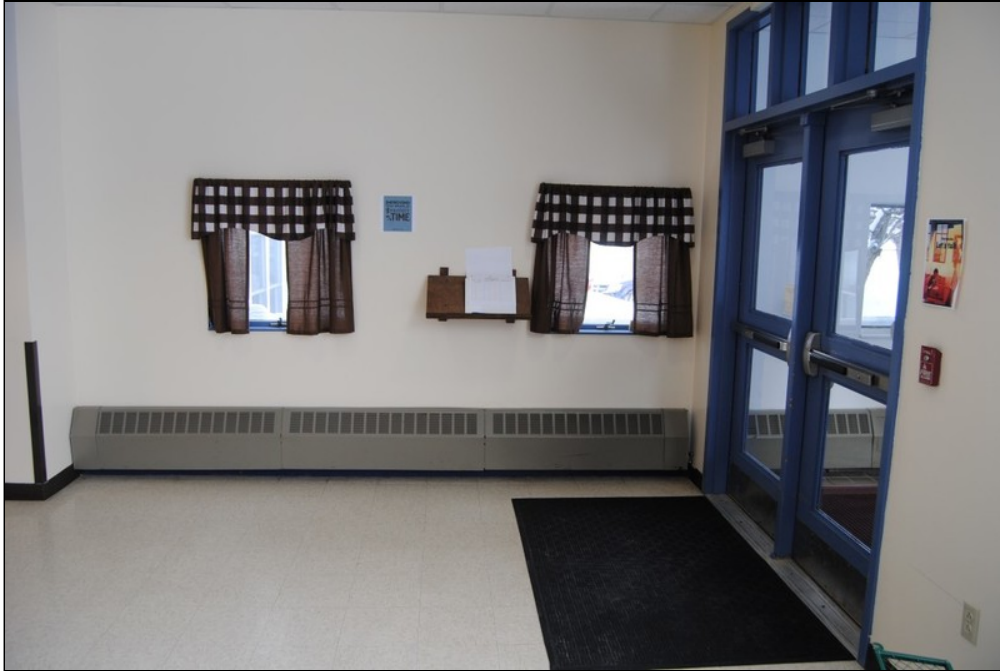
59 - entrance

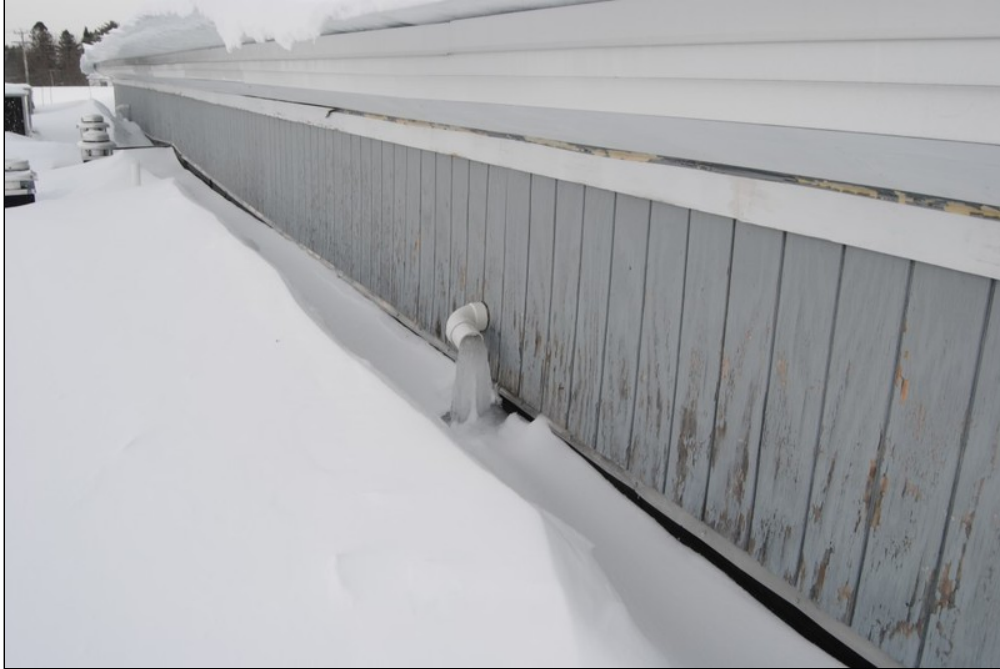
63 - parapet

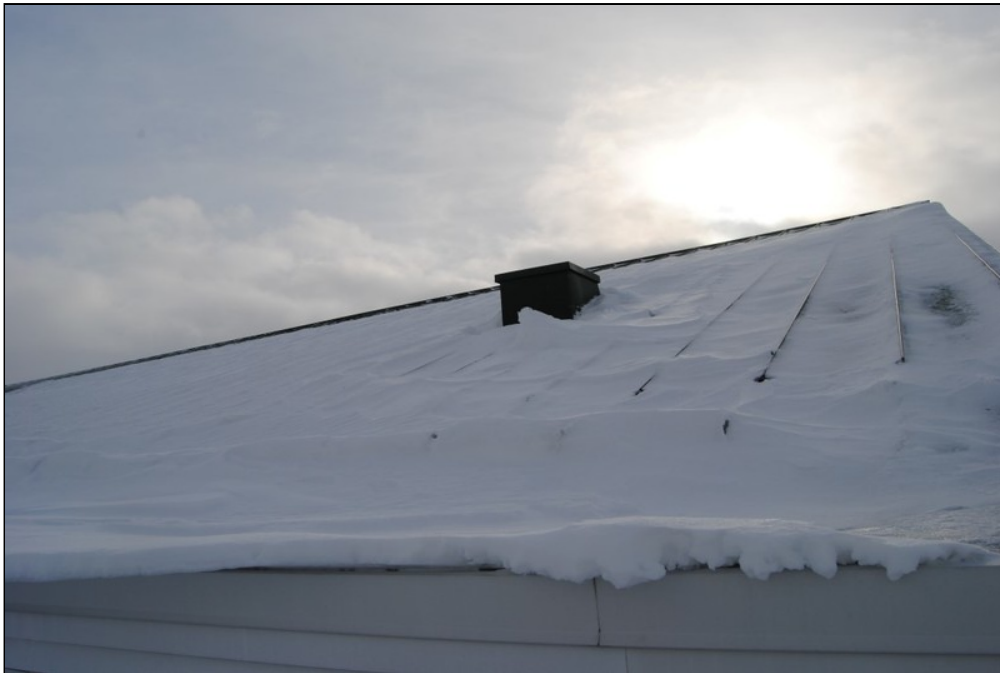
64 - gym roof

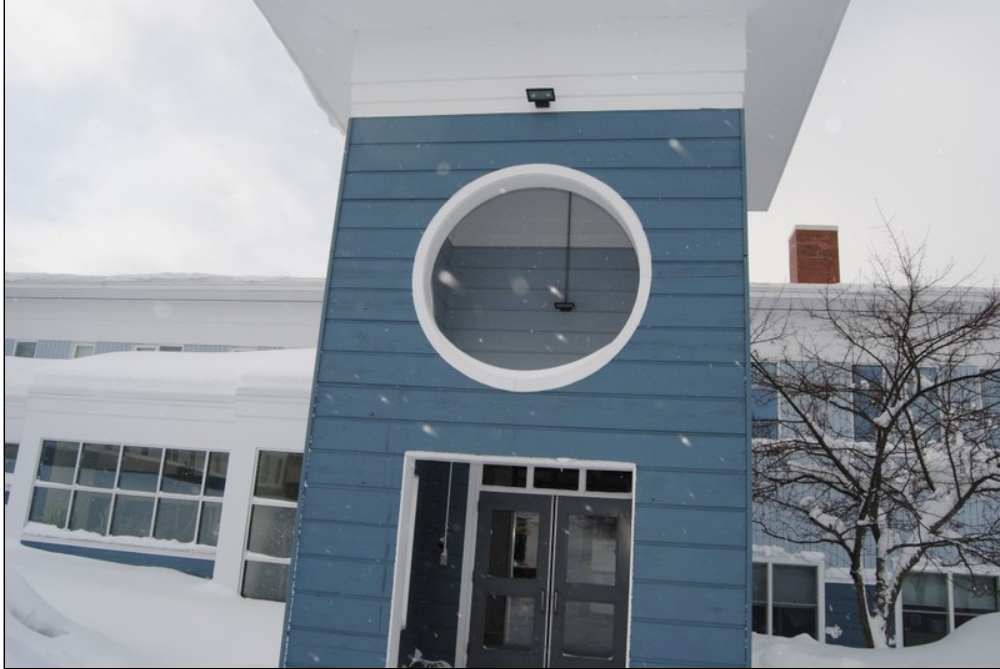
65 - entrance tower

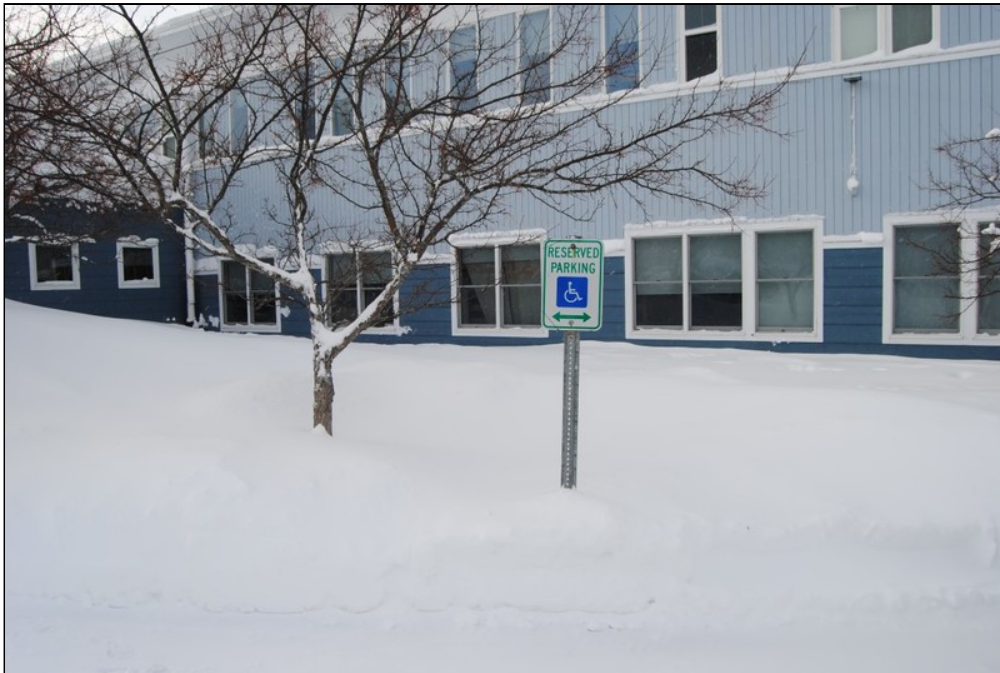
66 - ADA parking

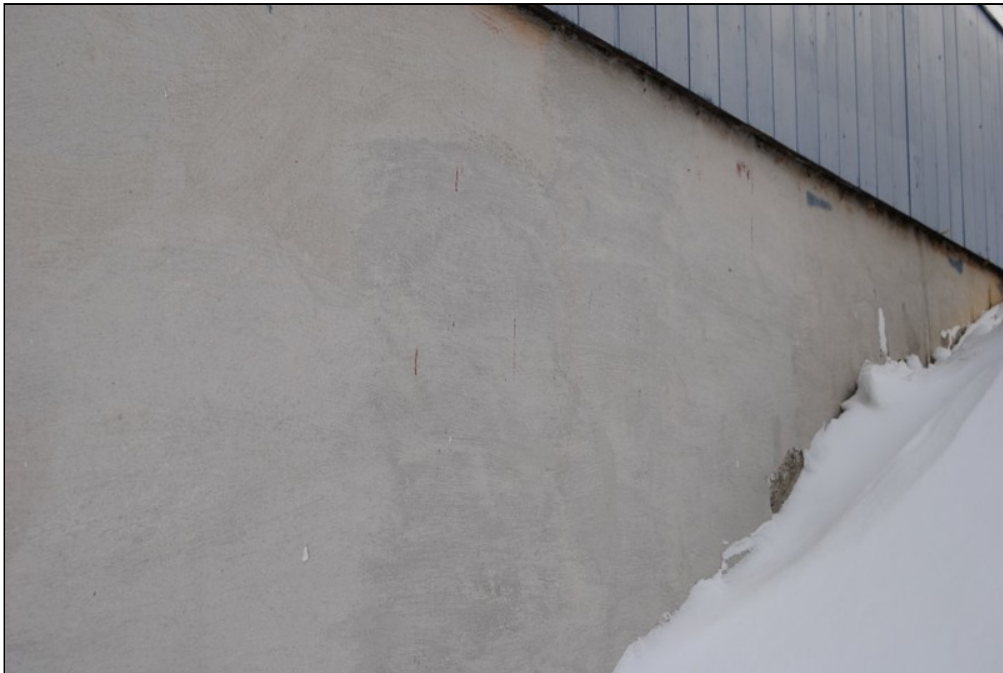
70 - foundation wall
