# **INFRARED ROOF INSPECTION**

LOCATION:  
STAPLES HIGH SCHOOL  
70 NORTH AVE  
WESTPORT CT 06880

This report summarizes the findings of our Infrared Roof Moisture Analysis of the roof at Staples High School, Westport, CT, performed on November 7, 2020.

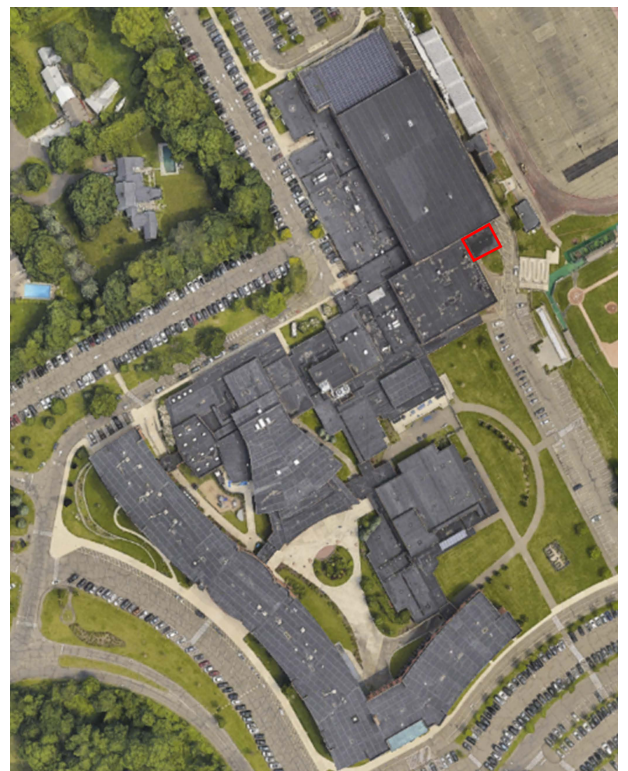
Area 1 ~ 270 sqft. Along the N portion of this roof that runs against the wall leading up to Roof A.

Area 2 ~ 251 sqft. Area to the E of the drain in the center of the roof.

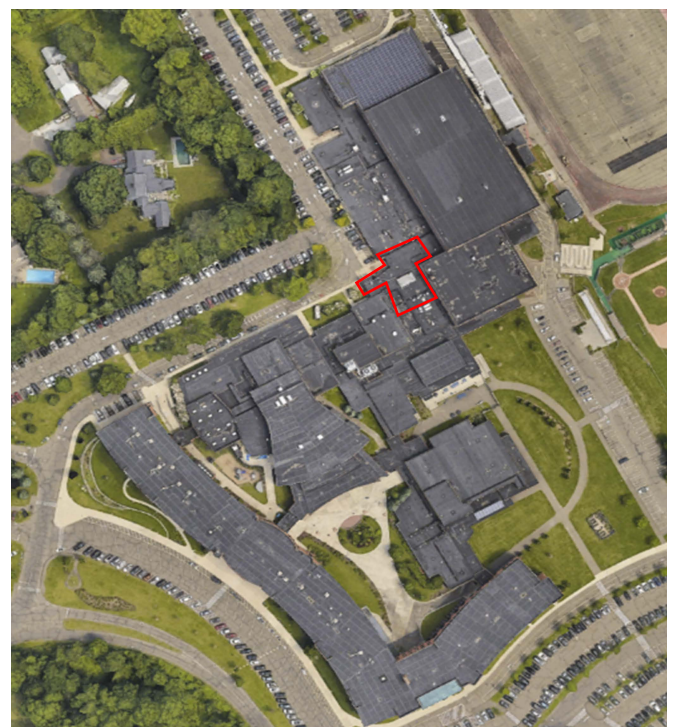
Roof J

Area 1 ~ 6 sqft. Small area in between roof vent/unit and pipe just S of what appears to be a roof patch.

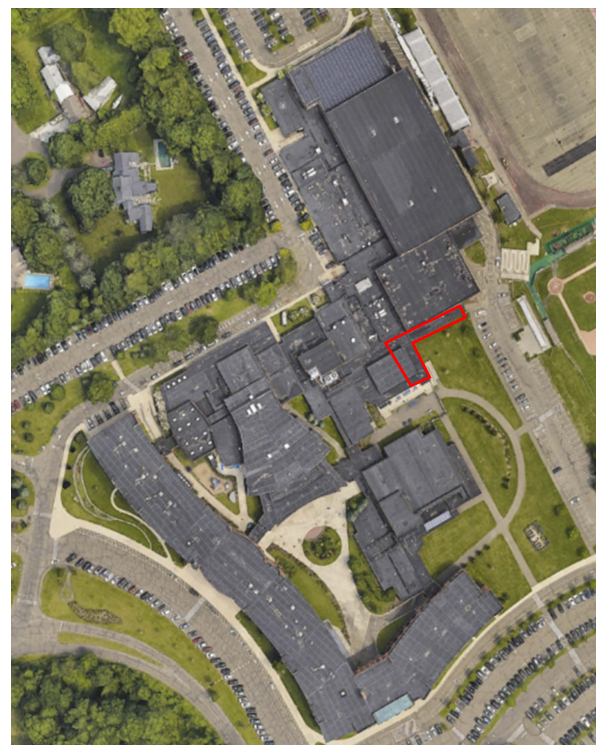
Roof M

Area 1 ~ 95 sqft. Area that runs along the base of the wall to Roof i.

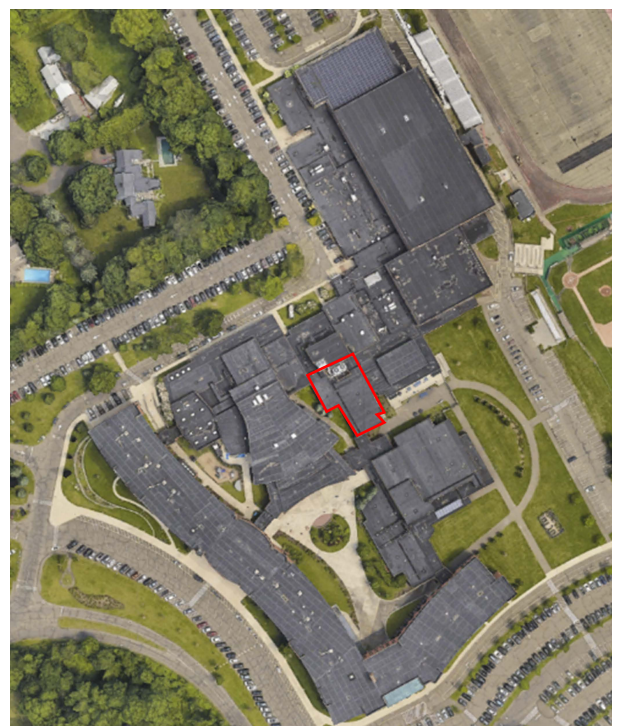
Roof O

Area 1 ~ 5 sqft. Small area on the S of the unit nearest the marked location.

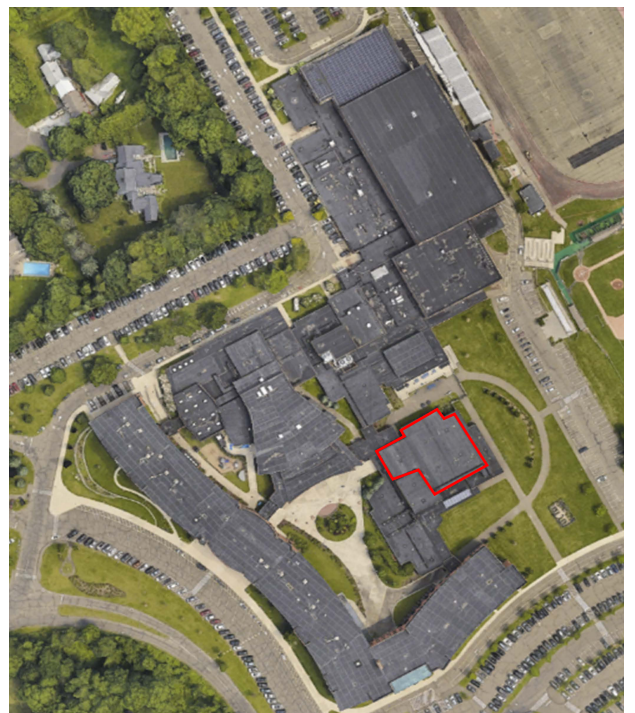
Roof P

Area 1 ~ 57 sqft. Small area near the base of the wall adjacent to roof area Q.

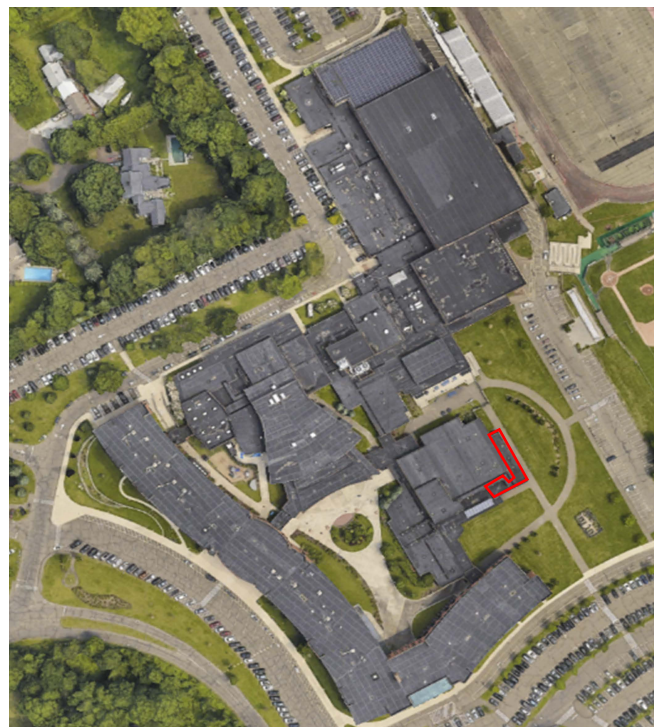
Roof R

Area 1 ~ 25 sqft. Small section at the base of the wall. Possible standing water or residue.

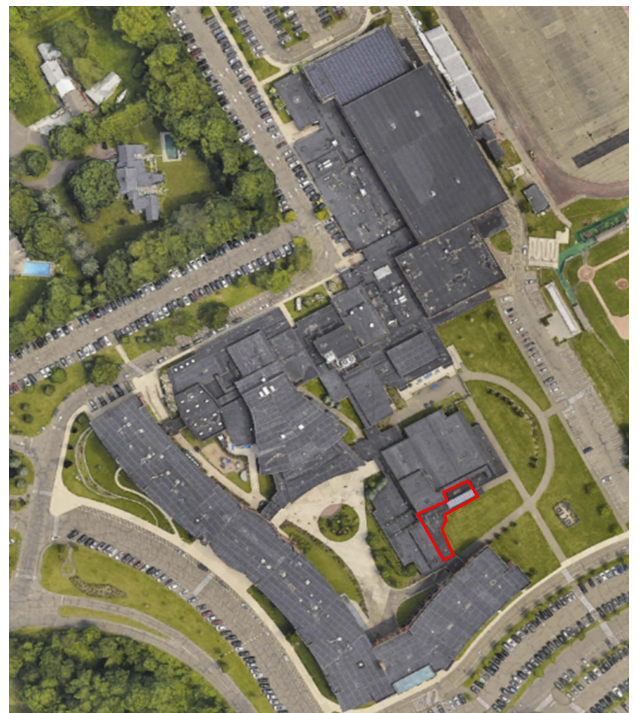
Roof S

Area 1 ~ 164 sqft. Area in between solar panels and corner of roof Q.

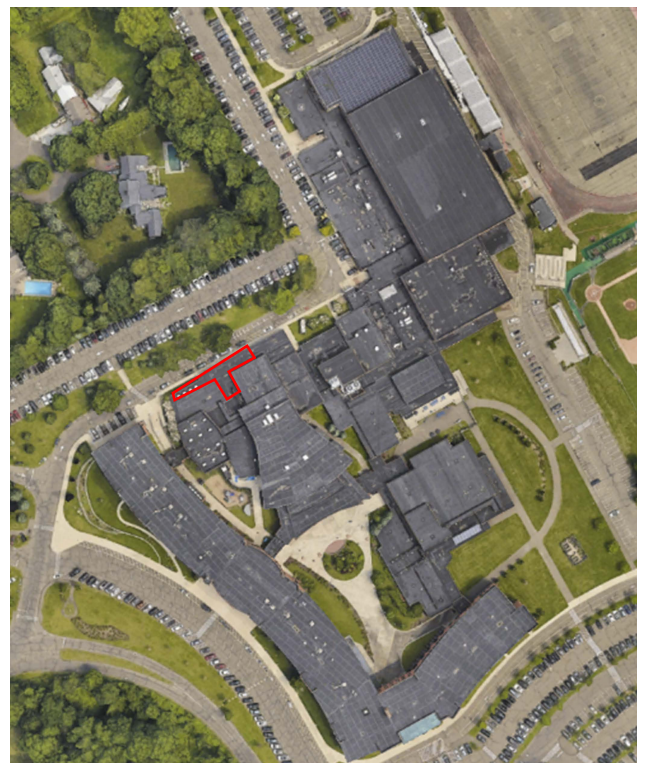
Roof U

Area 1 ~ 269 sqft. Area along the wall that is adjacent to Roof Area V.  
Area 2 ~ 199 sqft. Area in between hvac and Roof Area V.
