Town of Hamden

Feasibility Study for Northern/Central Hamden Schools Rebuild/Renovation Projects

FINAL Prepared for:
Town of Hamden
September 3, 2014

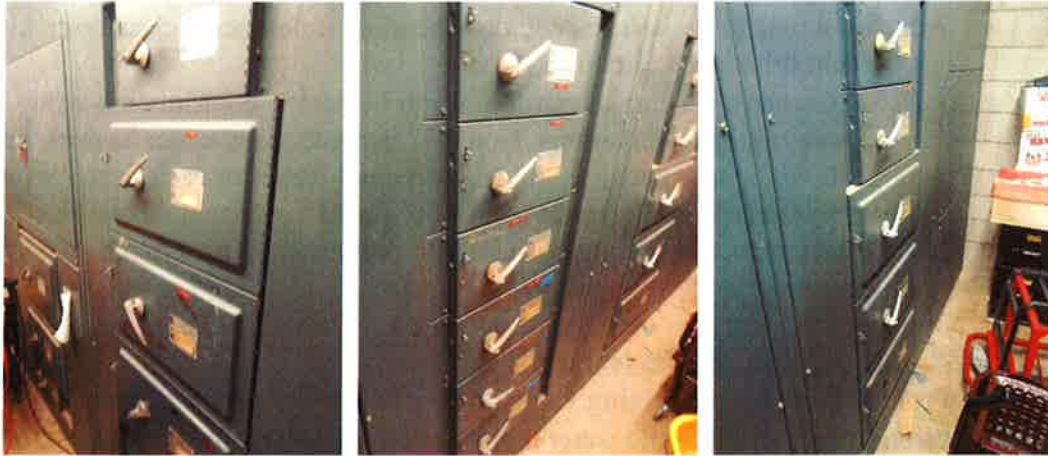
Figure 1

As mentioned above, the existing service is 3000 Amp, 120 / 208 volt 3-phase, 4-wire service, GE AV Line switchboard dated 1971 / 1972. It is good condition for its age but exceeds the design life of 30 years. (See picture figure 1) The incoming utility service is served from an exterior pad mounted transformer on the northwest side of the building. The existing main electrical service equipment is in good condition, and large portions of the branch panels are 80

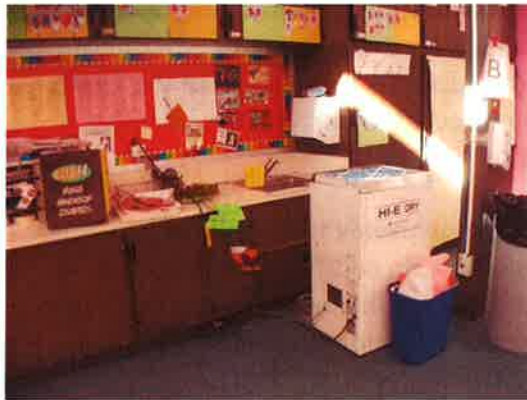
Most if not all of the casework throughout the building does not contain the minimum clear floor and knee space at administration, nurses office and the numerous sink workstations and storage as required by Federal law and the Connecticut State Department of Education. In addition, sink workstations in many classrooms do not have a clear approach, as they are blocked by storage items and mechanical units. The height and reach does not comply as well. The remaining wood casework, is in fair condition and replacement should be considered and anticipated as part of a long term plan.

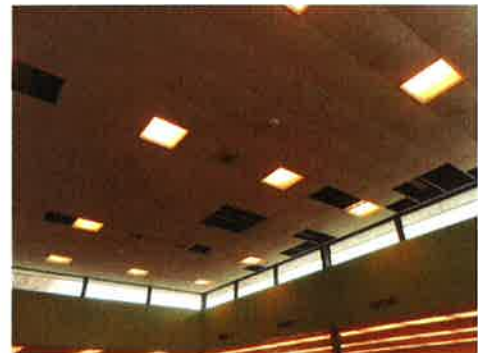
Acoustical ceiling tile (ACT) is in poor to fair condition throughout most of the school. The ceilings are 12x12 ceiling tiles in a suspended grid. Certain areas require replacement in the near future due to moisture infiltration as some tiles have fallen and have been removed. Fixing the roof and improving the humidity in the facility will help to avoid further deterioration.

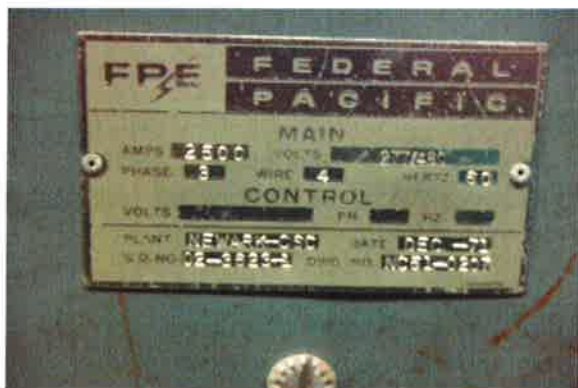
Figure 1

As mentioned above, the existing service is 2500 Amp, 277 / 480 volt 3-phase, 4-wire service, Federal Pacific Electric switchgear dated 1971. It is good condition for its age but exceeds the design life of 30 years. (See picture figure 1) The incoming utility service is served from an exterior pad mounted transformer on the northwest side of the building. The existing main electrical service equipment is in good condition, and large portions of the branch panels are 70 to 80 % full. There were areas found throughout the facility where extension cords were being used to access power in areas that didn't have a convenience outlet, any and all of these areas should be corrected so that this code violation is eliminated.

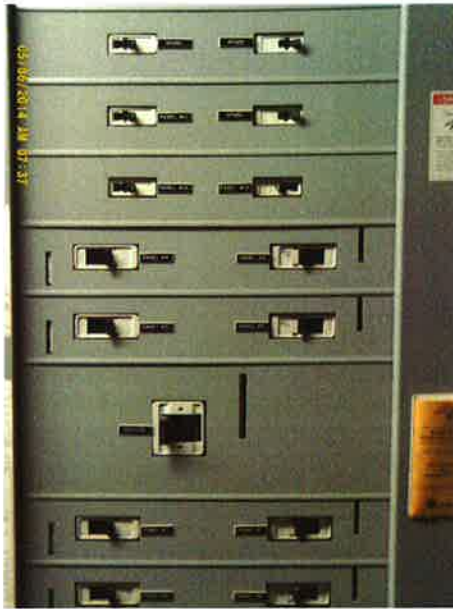
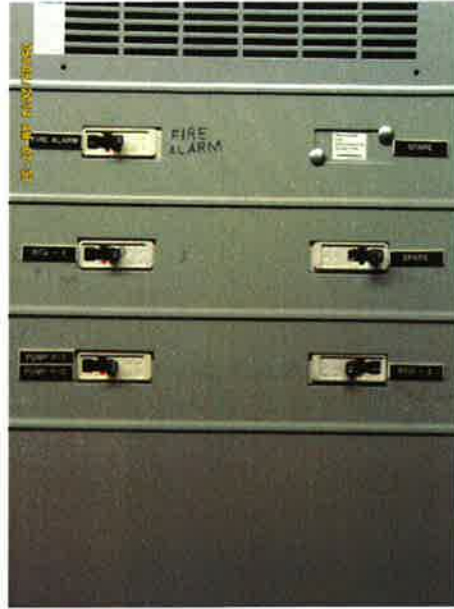
Figure 1

As mentioned above, the existing service is 1600 Amp, 120 / 208 volt 3-phase, 4-wire service, Cutler Hammer PowerLine dated 1996 and it is great condition. (See picture figure 1) The incoming utility service is served from an exterior pad mounted transformer on the southwest side of the site. The existing main electrical service equipment is in good condition, and large portions of the branch panels are 65 to 75 % full. There were a few areas found throughout the facility where extension cords were being used to access power in areas that didn't have a convenience outlet, any and all of these areas should be corrected so that this code violation is eliminated.

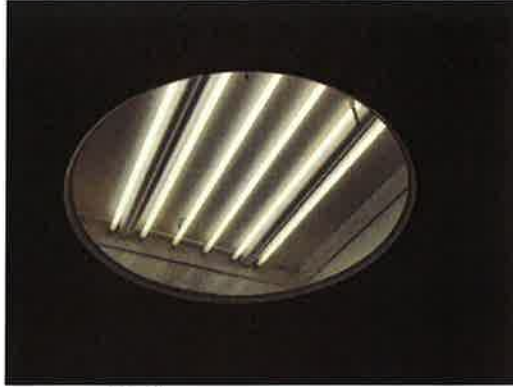
Hallway fixture needs lens

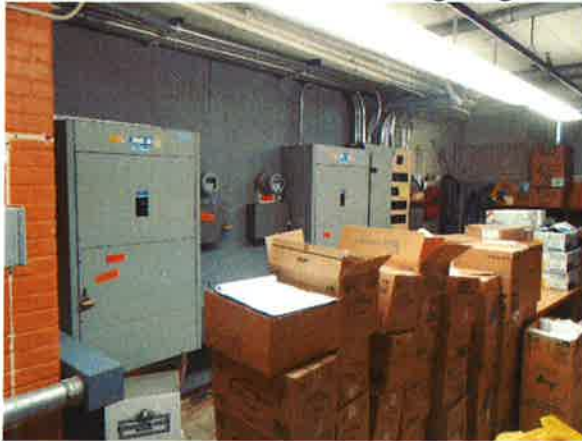
Service #1 & #2

The remainder of the spaces: all lighting appears to have been current T8 technology. Some of the wraparound fixtures needed attention in the basement areas, lenses were found cracked, broken or missing. In the school outsource areas the emergency lighting appeared to meet current code requirements. It does not appear that they are being tested per the NFPA Life Safety code requirements on a one a month schedule. Recommendations are to install self-diagnostic, self-testing single point emergency and exits sign product throughout the building.

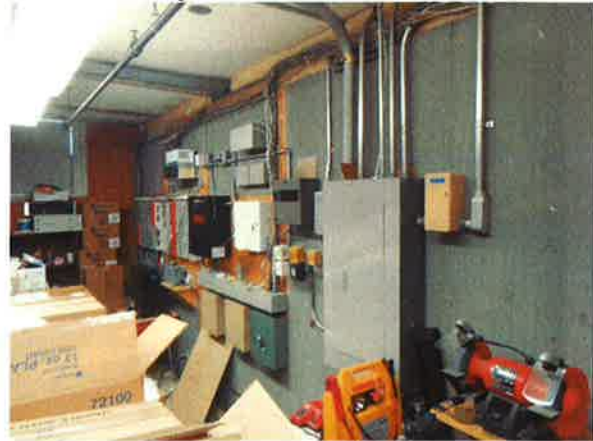
The existing electrical system for the entire building is two separate 600 Amp, 277/480 3-phase, 4-wire services (one for the school & one for the office section) dated 9/83 which were found to be in good shape and appear to be adequate for the facilities current functions and use although the distribution panels seem to be full, an added one for future requirements should be considered at this point. This electrical system is most likely more than capable of handling modifications and minor expansions to the existing building, as the majority of new systems are very efficient compared to what is currently installed. The interior fluorescent T8 F17 / F28 watt saver lighting was found to be current; some lenses were damaged and should be replaced. The existing exterior lighting is largely outdated and very inefficient compared to current LED fixtures and should be considered to be replaced one for one. The Fire alarm panels are an FCI Model FC-72 and a Fire-Watch 411 UDAC (transmission to an offsite monitoring facility). After reviewing the service records it appears that appear to be both functioning properly. The emergency lighting for the most part was found to be nonexistent in the Board of Education spaces, all that was found was a couple of fluorescent lay-ins with battery pacs and battery

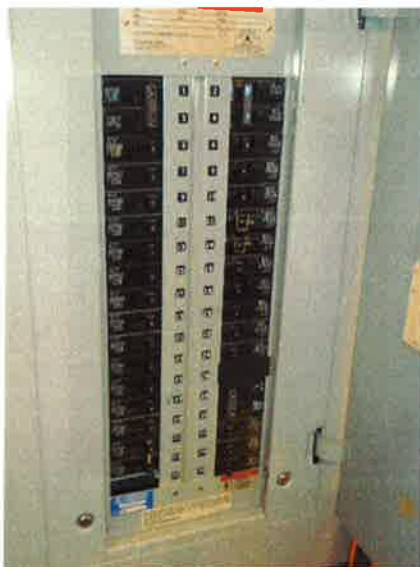
Electrical Pnl (Unlabeled)

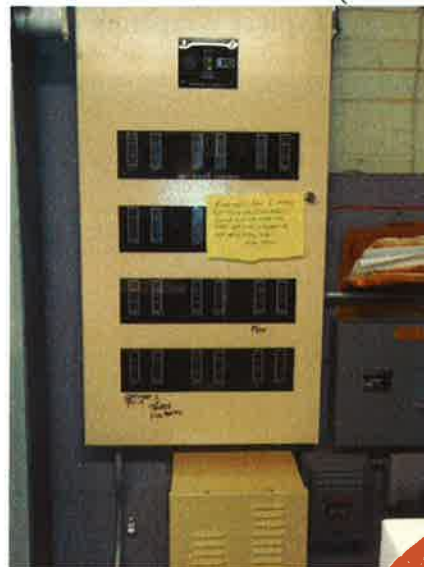
Electrical Pnl (Unlabeled) one circuit available

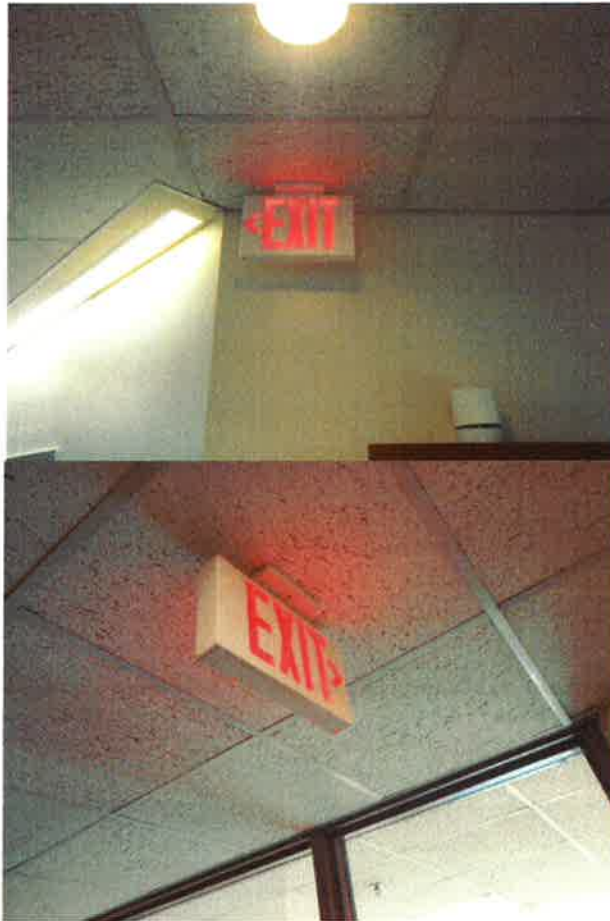
backed up exit signs. It does not appear that they are being tested per the NFPA Life Safety code requirements on a one a month schedule. Recommendations are to install self-diagnostic, self-testing single point emergency and exits sign product throughout the building. It was also noted that none of the bathrooms have call for aid equipment; all should be up fitted with same. In the board room the down lights were retrofitted with LED lamps, the 2x2 fluorescent lighting is 1 inch low glare paracube lensed fixtures that are designed for computer rooms, not general lighting.

Exit Sign Lighting (typical throughout the office building)

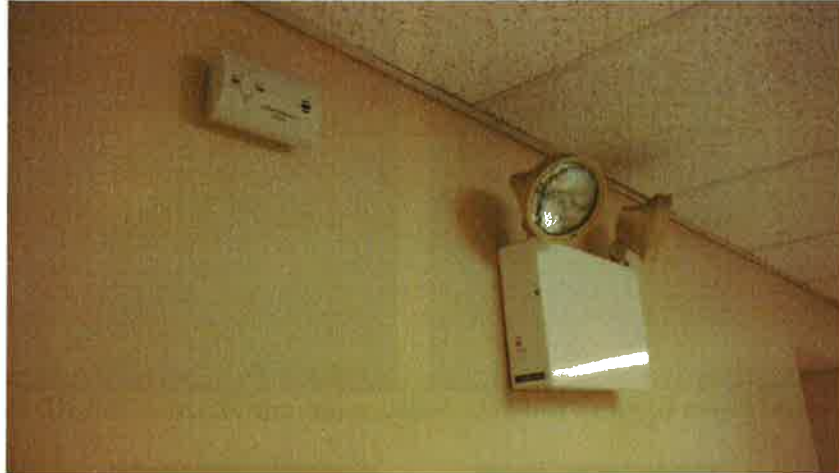
Emergency Lighting (typical throughout the school outsource areas)

- Upgrade some electrical panels and add convenience power as required for HVAC.
- Install new emergency lighting & exit signs throughout the building.
- Add / replace smoke heads as required by current code requirements.
- Install new security / camera equipment.
- Replace (in kind & added locations as required) building lights with current LED technology.
- Replace pole and lighting fixtures in parking areas (4 setups) with current LED lighting; some tree trimming / pruning will be required when lighting is upgraded.

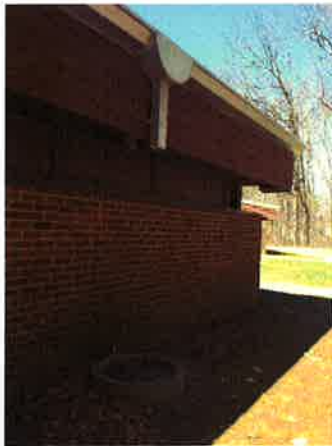
Custon leader and drywell

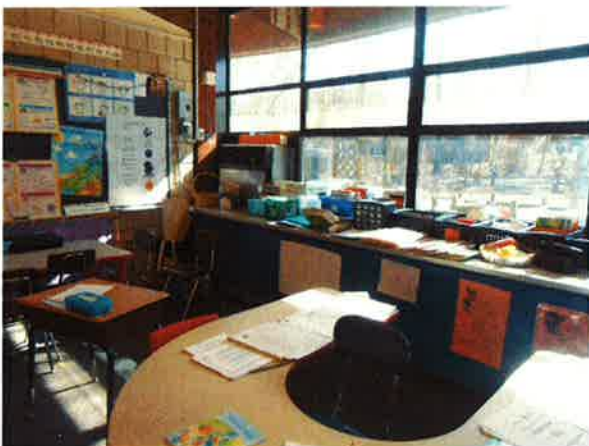
Thru window mechanical & abandon unit ventilator

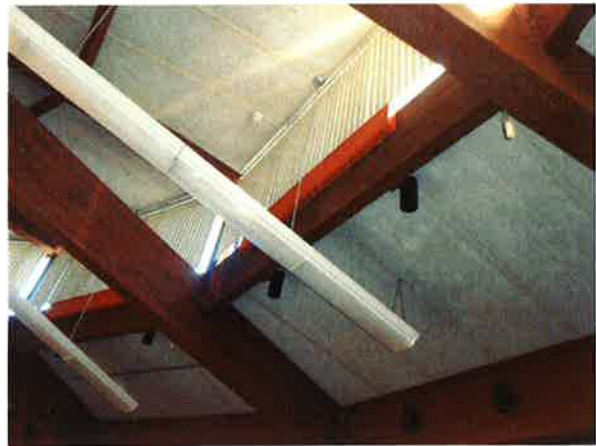
Clearstory "ring" at Library

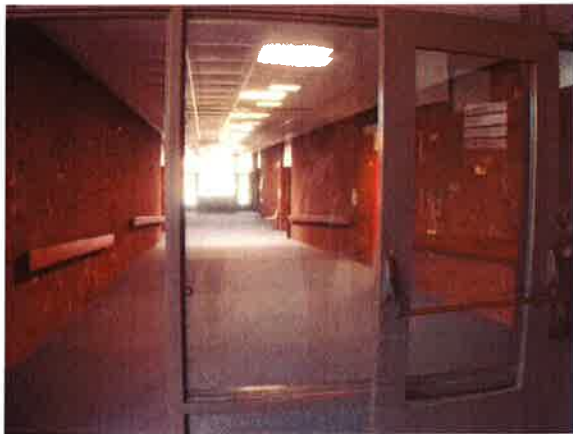
Corridor glass, some wire glass

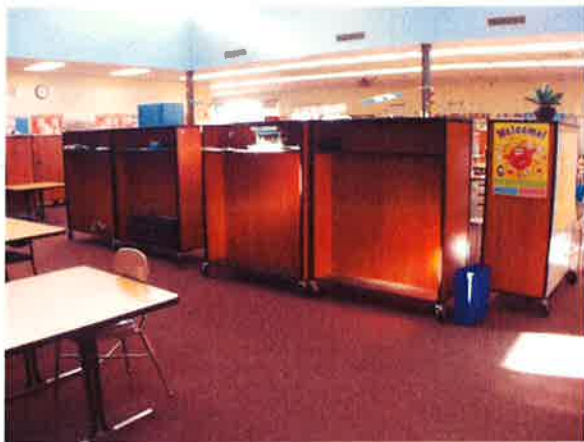
Cubbies subdividing open classrooms

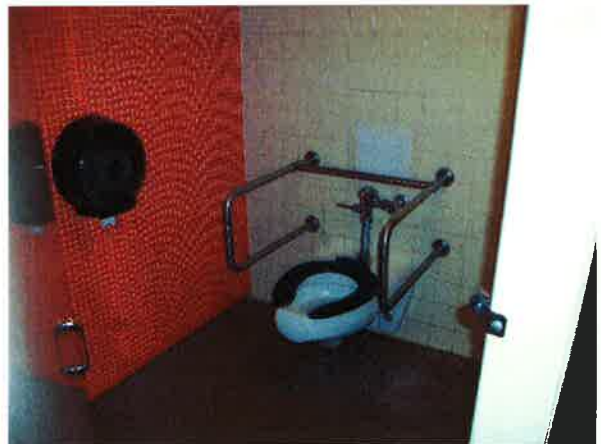
typical toilet, smaller unit adjacent

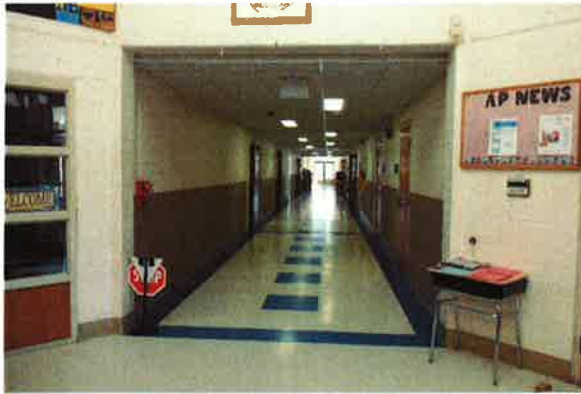
Main entry, right corridor, admin left.

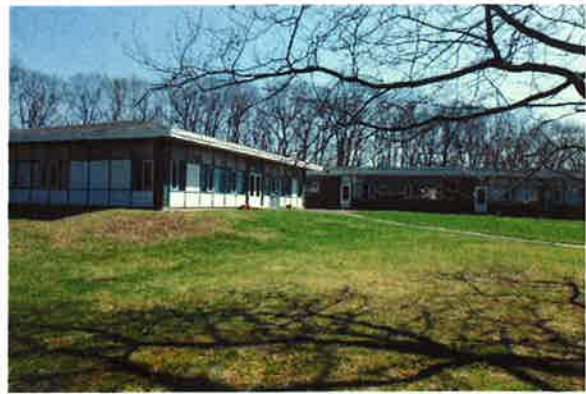
Media/Library addition

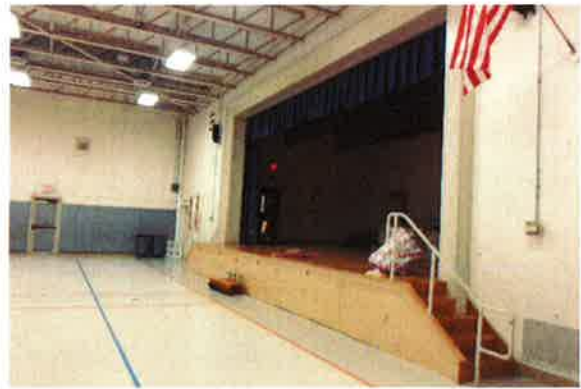
Gym & stage

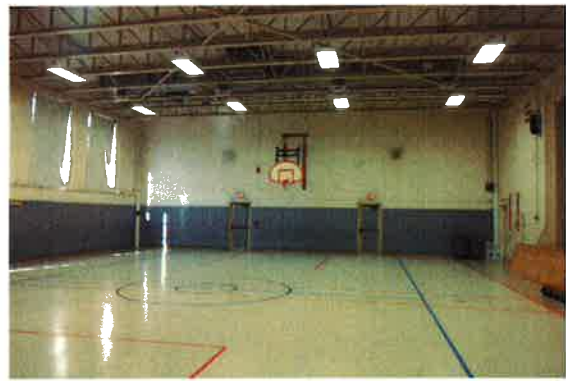
Gym

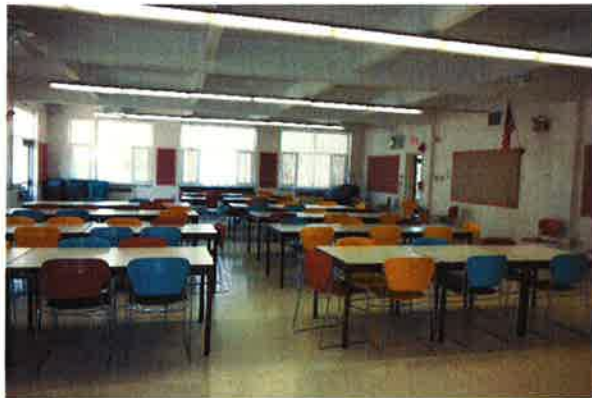
Cafeteria

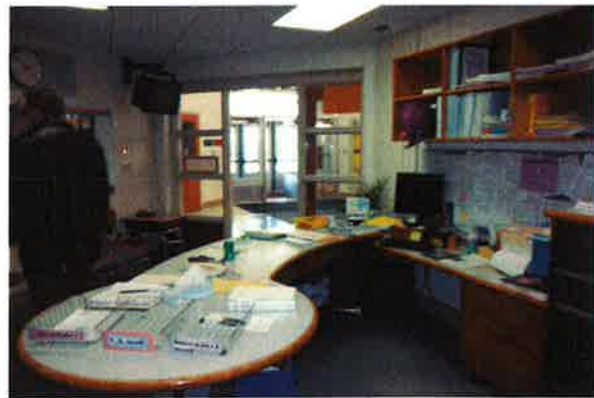
Administration/office

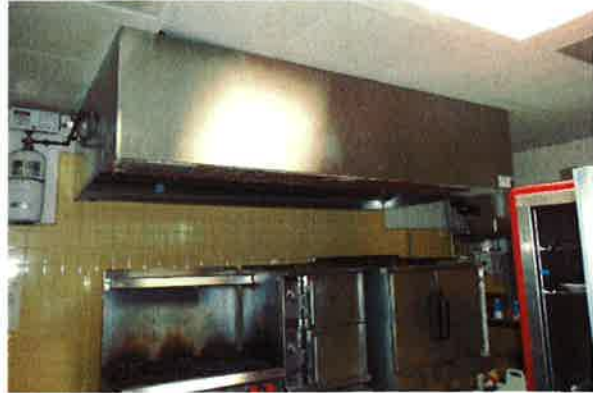
Kitchen

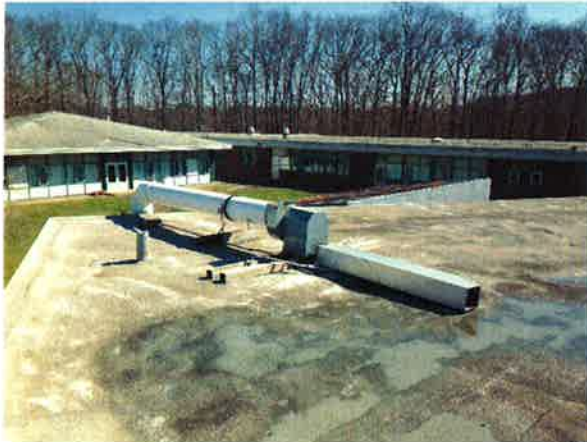
Roof and vent system

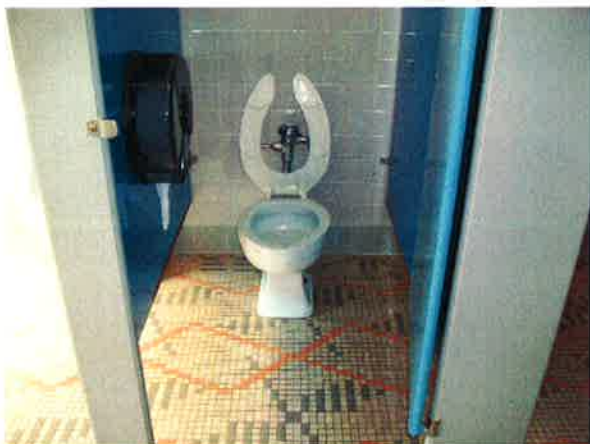
Typical toilet room
