**ROCHESTER COMMUNITY SCHOOL DISTRICT
ADMINISTRATION BUILDING**

**KINGSCOTT ASSOCIATES, PC
CLARK CONSTRUCTION COMPANY
STRATEGIC ENERGY SOLUTIONS INC.
CBRE
BUR VALUATION GROUP**

**FACILITIES NEEDS ASSESSMENT
September 2019**

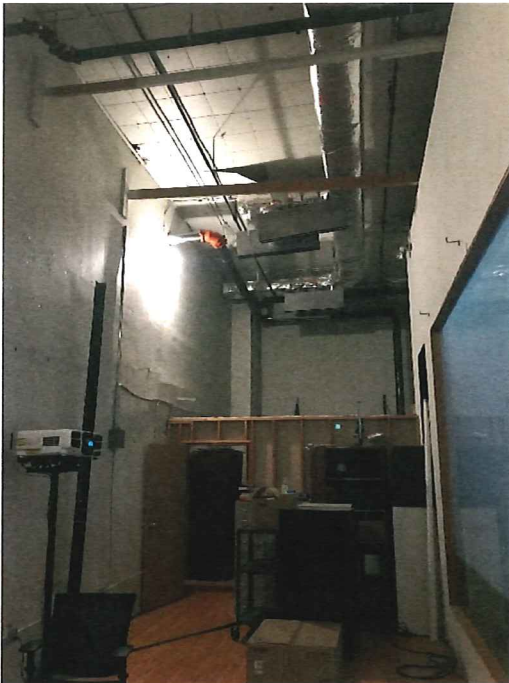
Picture #34: Projection Room for the Board Room.

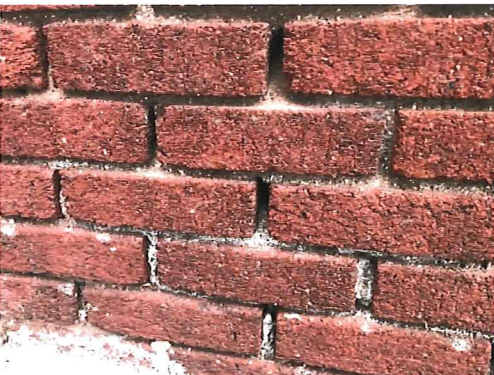
Picture #37: Exterior brick face requiring re-grouting. Limited areas of requirement.

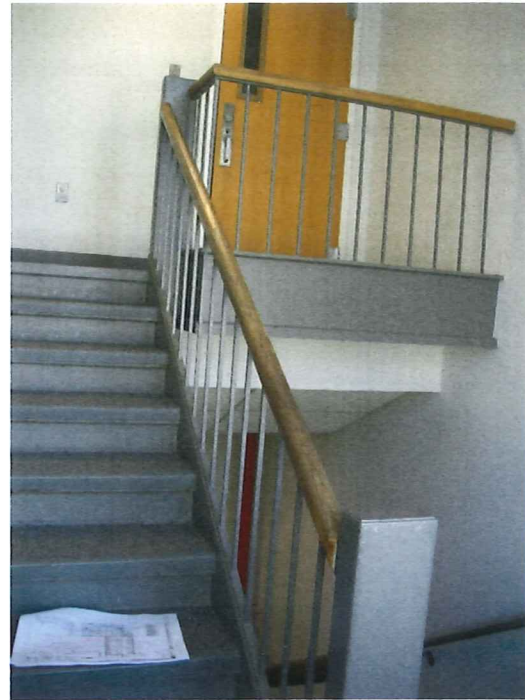
Picture #39: Stair #2-Guardrail not meeting Code. No continuous handrail.

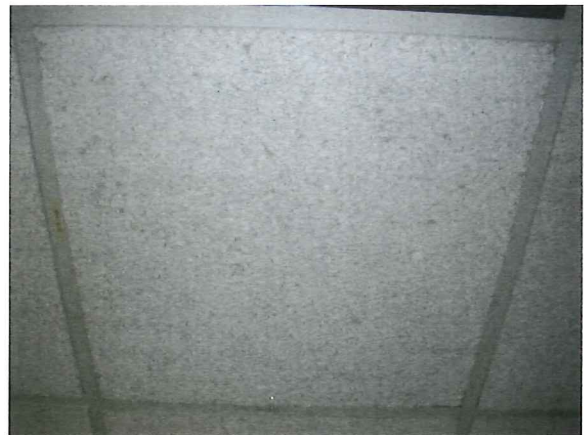
Picture #40: Typical ceiling grid and tile. North Section of building

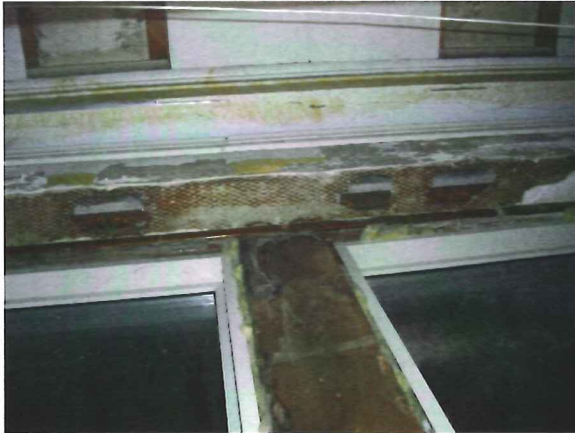
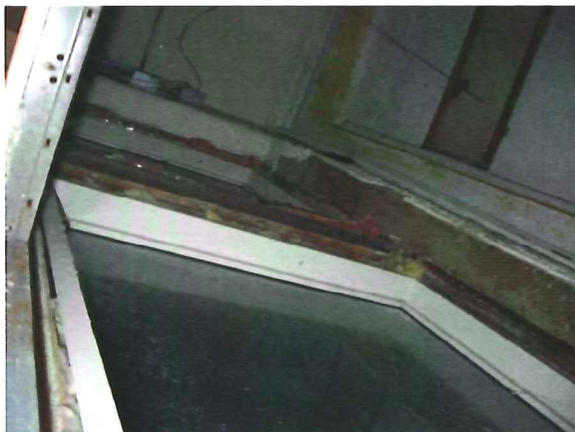
Pictures #43

Pictures #42 & 43 (#52 & 53 Similar):
Typical Level 3 window head above ceiling.

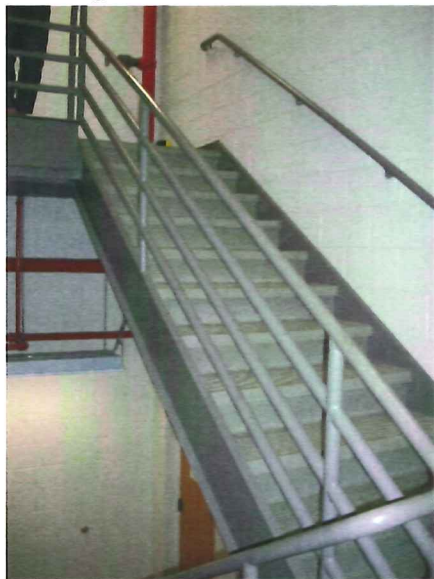
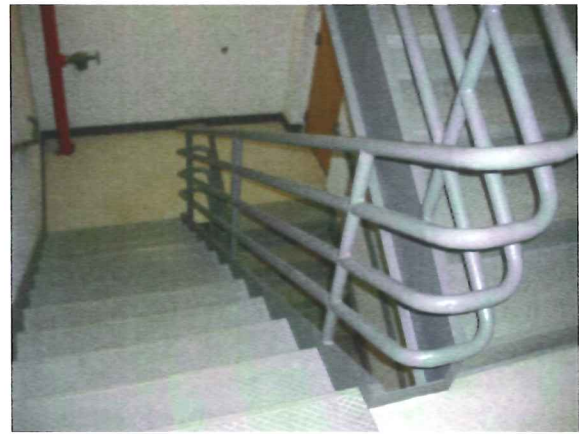
Picture #45

Picture #44 & 45: Stair #1 guardrail not meeting code. No continuous handrail.

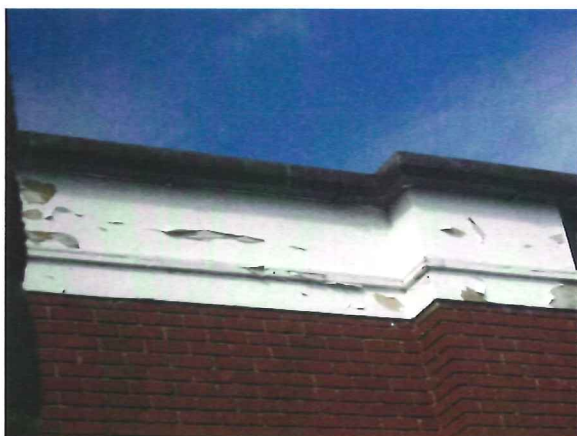
Picture #58: Wood trim peeling paint at the top of the wall.

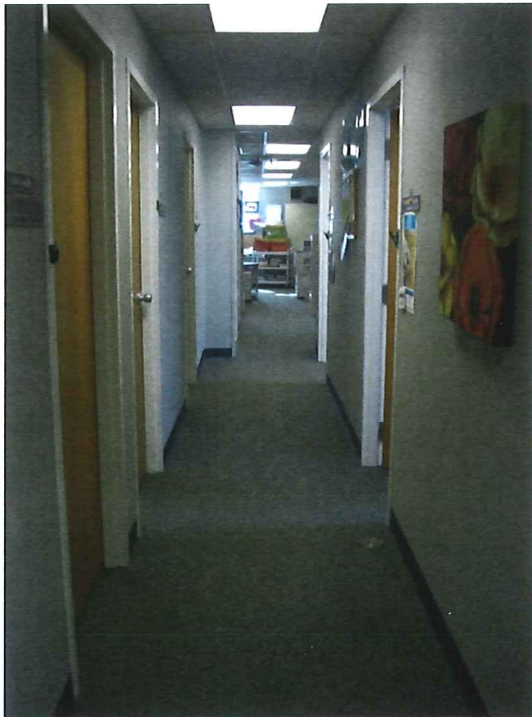
- 1) Combustible construction material, I.E. shelving, wood infill etc. Not acceptable in corridors for this facility.
- 2) Corridors shall remain free from all moveable objects.
- 3) Above ceiling may have non-sealed wall penetrations as seen in other areas.

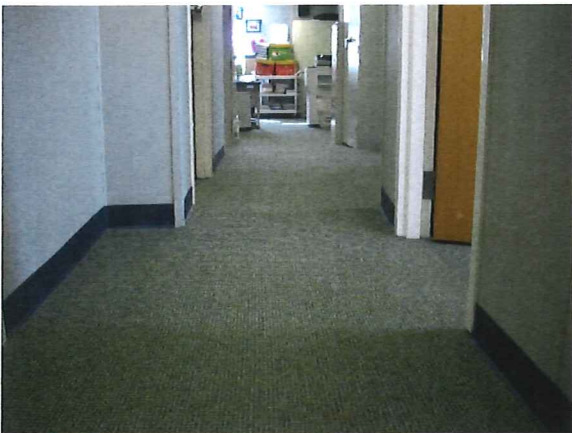
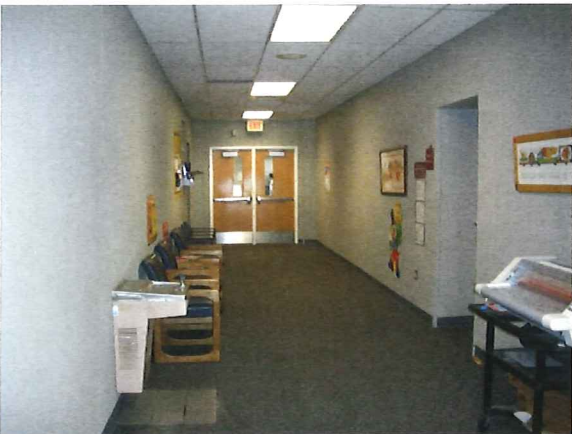
Picture #67:

Picture #66 & #67: Uneven floors throughout office area.

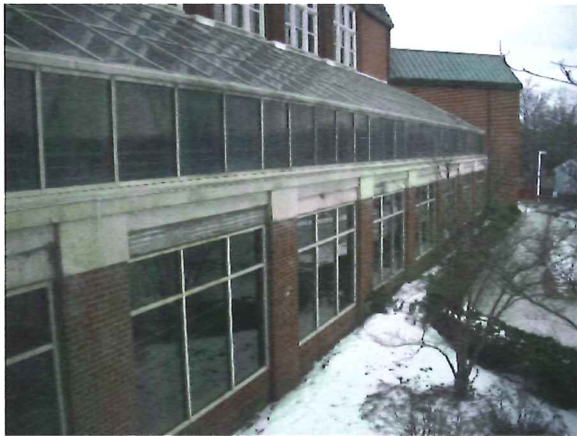
Picture #72: Example of various circumstance where finish materials would be upgraded/changed in a renovation.

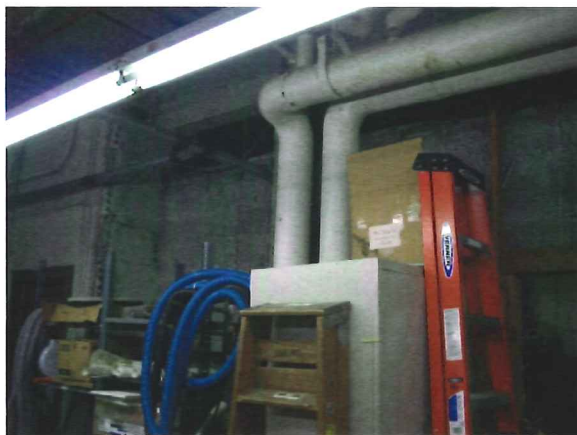
#76

Pictures #76-#80: Penetrations through ceiling and walls that must be sealed.

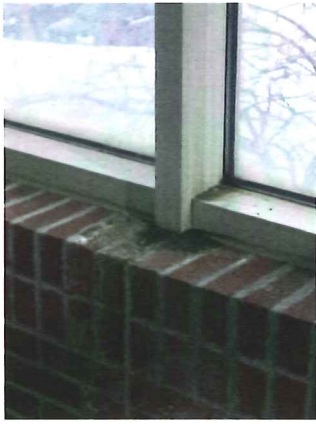
Picture #89

Pictures #89-#93: Current glass sloped roof of the corridor "Atrium" has significant water penetrations problems. There is staining to finishes and damage to the system. As well as damage to the underlying structure below.

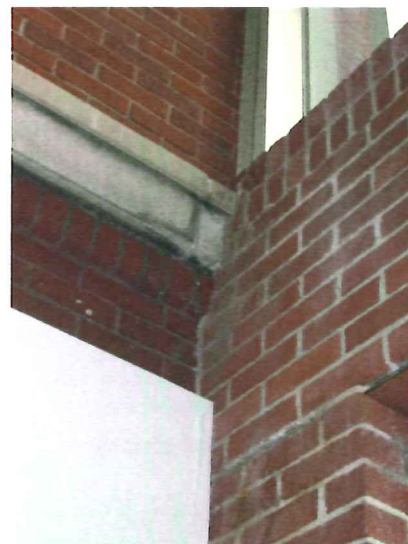
Picture #97

Pictures #97-#104: Various locations of damage, including structural, of the leaking sloped windows in the "Atrium". Although currently not an extreme hazard, it would become a danger in the not to distant future.
