PROPERTY CONDITION ASSESSMENT Long Lots Elementary School

PREPARED BY:
Colliers Project Leaders USA NE,
LLC
12/16/21

PREPARED FOR:
Westport Public
Schools,
Town of Westport CT.
Long Lots Elementary
School

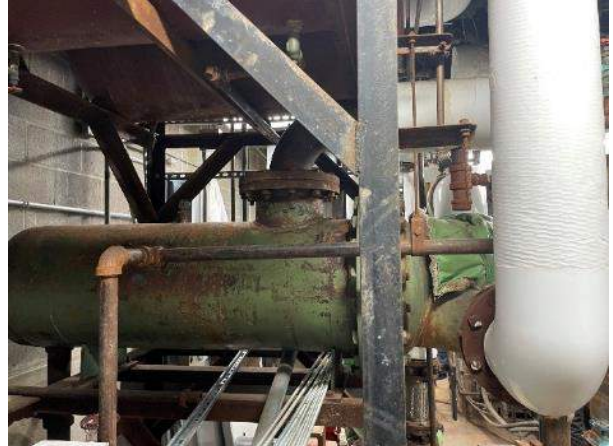
Figure 4: Steam to hot water HX in the boiler room

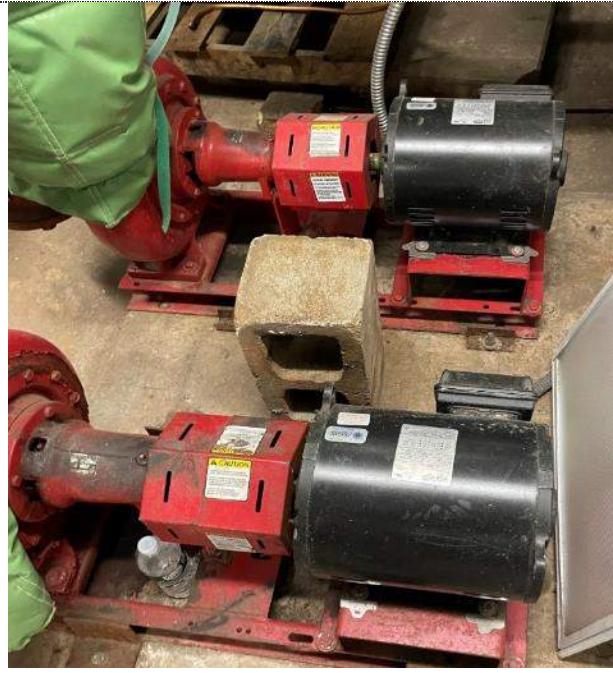
Figure 6: Heating HW pumps in boiler room

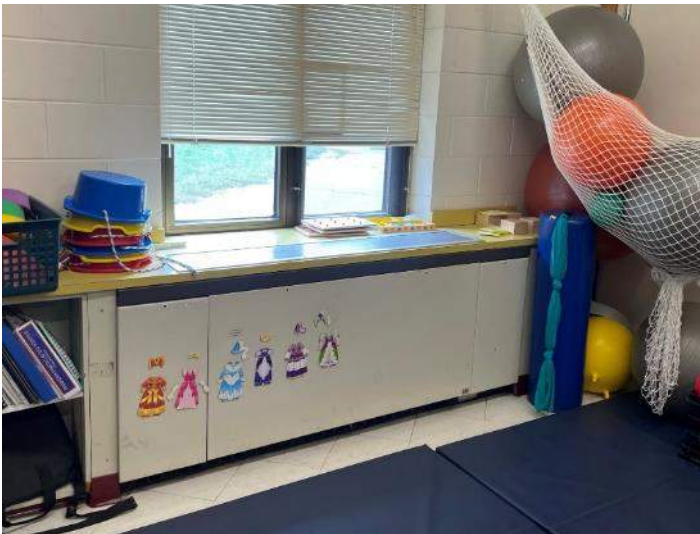
Figure 8: Unit ventilator with hot water heat and DX cooling original to the 200-Wing construction.

All of the unit ventilators for 200-wing have pneumatic control valves for heating hot water. The valves are controlled by electric thermostat using EP switches. The units can be controlled and monitored from the BMS.

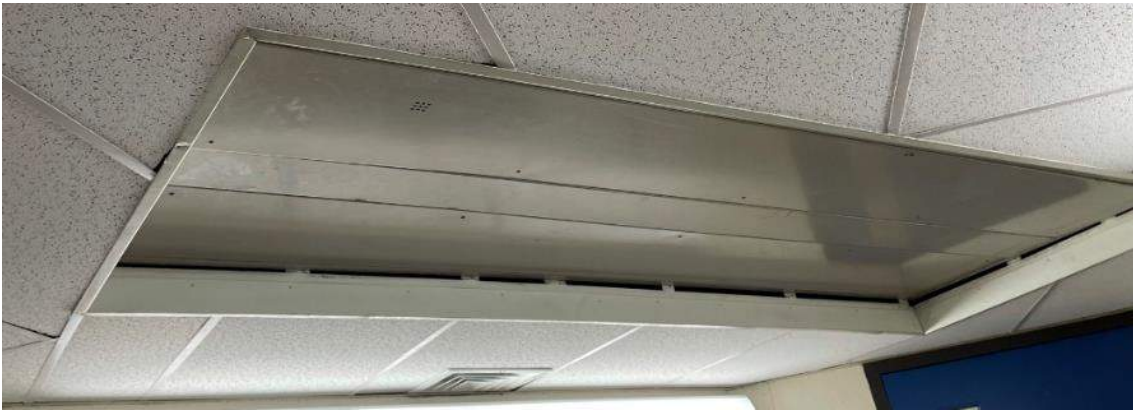
The South-West classrooms (room 5, 6, 7, 101, 103 and 105) are served by 4-pipe fan coil units with outdoor air damper for ventilation. The heating and cooling are provided by hot water and chilled water respectively.

Figure 9: Four-Pipe Fan Coil Unit.

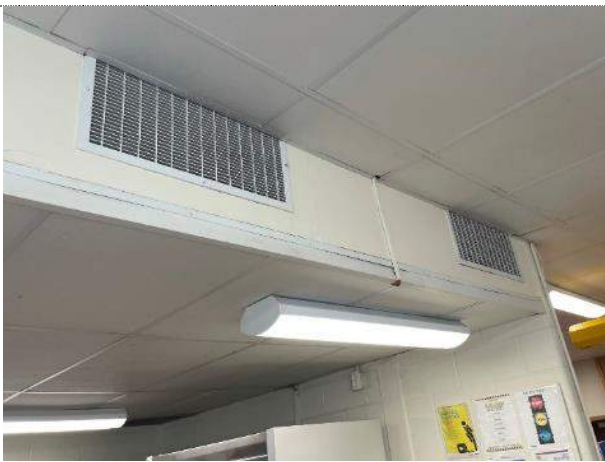
The kitchen is served by a 100% outdoor air unit with pneumatic controls and steam heating coil. The unit serves the kitchen and café area. It is reported that the kitchen hood exhaust unit is not interlocked with the make-up unit.

Figure 10: Kitchen Make-up Air Unit above ceiling.

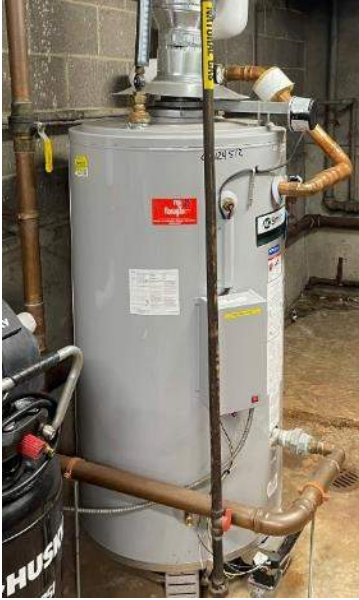
Domestic hot water (DHW) is generated by an AO Smith manufactured BTR-120 gas fired water heater. The heater has an input capacity of 120MBH and recovery rate of 120 gal/hr. The DHW is circulated by a Bell & Gossett recirculating pump. The DHW heater appears new and has a built year of 04/2019.

Figure 12: AO Smith 120MBH domestic hot water heater.

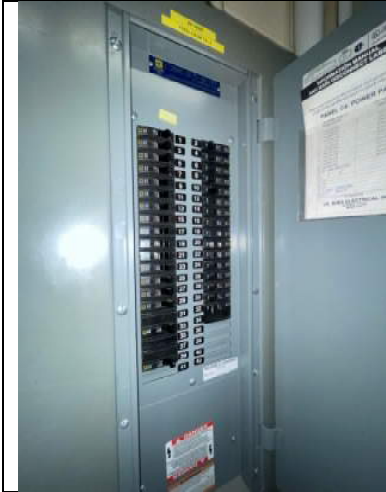
Figure 13: Newer Square D panel serving the 200 wing

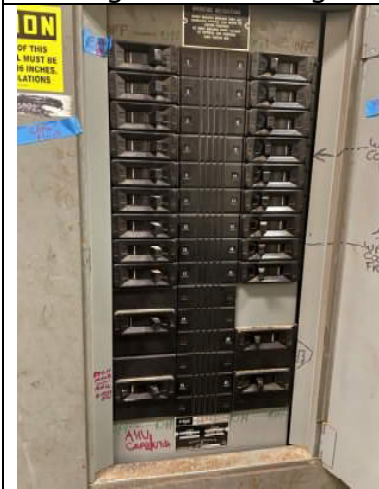
- a) The electrical distribution serving the building consists of a variety of aged panels. Due to the varying age, some of the existing equipment is at the end of its useful life, some is approaching the end of its useful life and some of the existing equipment is in acceptable condition. Some of the older panels are Federal Pacific Electric (FPE) and should be replaced immediately due to known problems with the equipment.

Figure 15: Old FPE panel serving the kitchen area

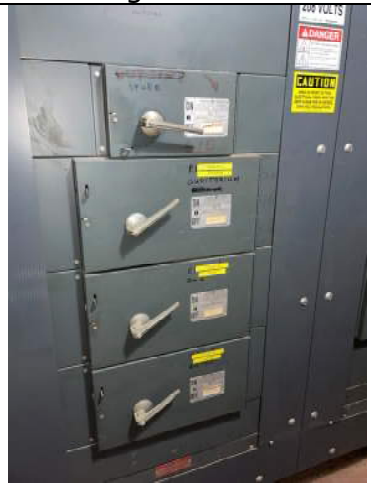
Figure 16: Older General Electric switchboard serving 100 wing

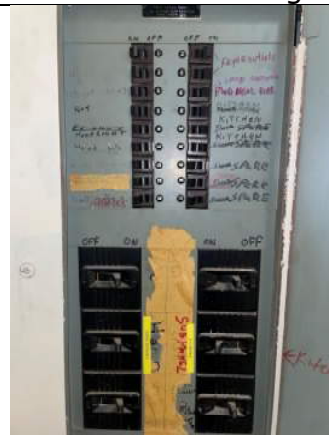
Figure 18: Old FPE panel outside the boiler room

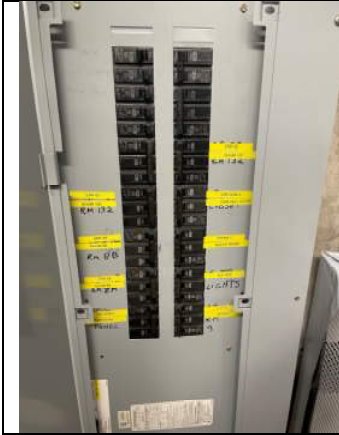
Figure 19: GE panel located in the electrical room

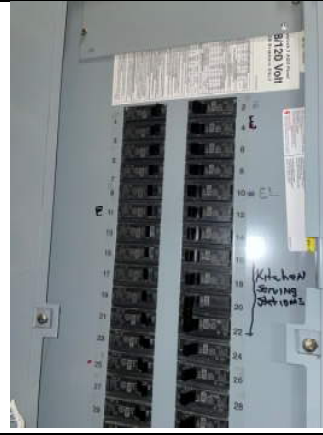
Figure 20: GE panel near the gym

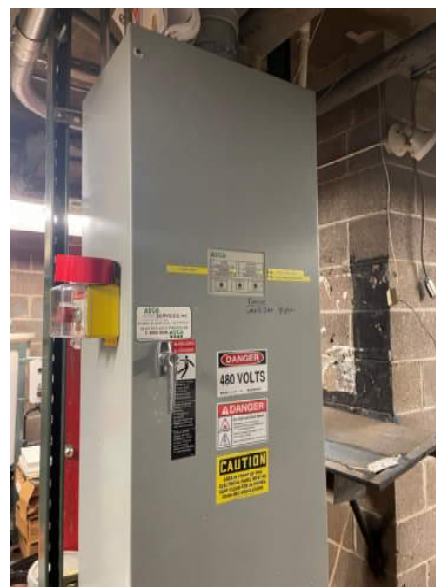
The emergency generator is connected to a 400 amp 480 volt ASCO automatic transfer switch (ATS). The ATS is in new condition and should be relatively maintenance free for a number of years.

Figure 22: New 400amp ASCO Automatic Transfer Switch

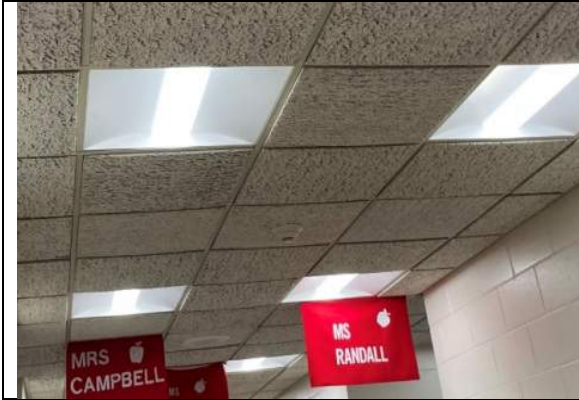
Figure 23: Recessed LED fixtures in classrooms, library, and office spaces

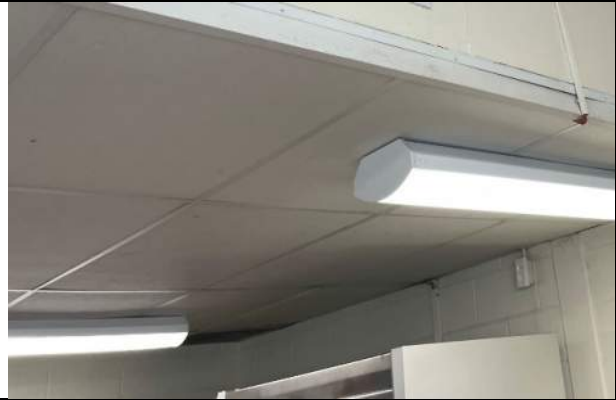
Figure 24: Surface mount LED fixtures in kitchen

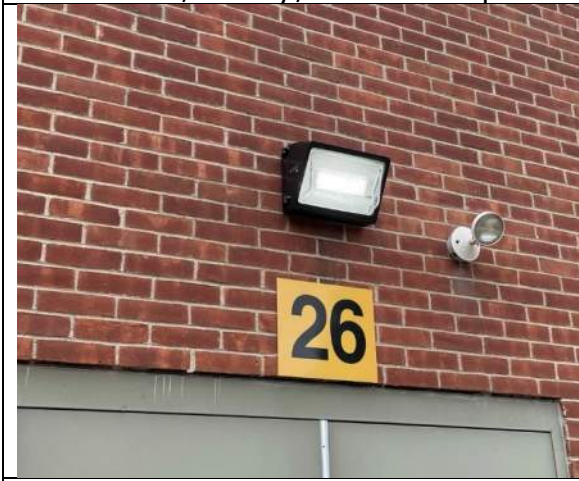
Figure 25: Exterior LED WallPak fixture

The building exterior lighting was observed to be LED WallPak fixtures. Some of the interior and exterior canopy can light fixtures appeared to be older fixtures and may consist of incandescent or metal halide light bulbs. Several of the exterior light fixtures were observed to be operating during daytime. The exterior lighting is controlled by a timeclock.

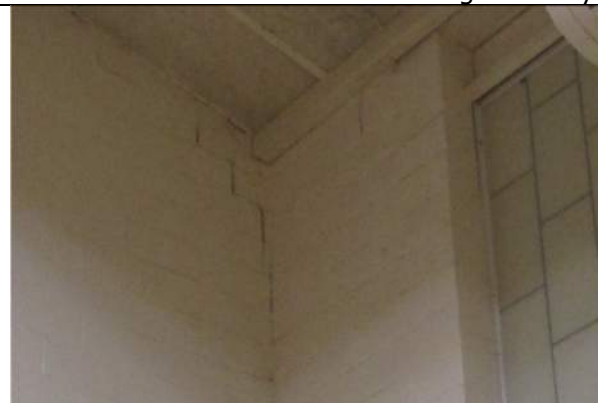
Cracking in the gym masonry wall and heat transfer from the building chimney observed visually and in the thermal scan. These cracks are a major concern both from a structural perspective and a water infiltration concern. These cracks should be evaluated by a structural engineer.

Cracks in the gym wall up to the roof level. Cracking in the masonry wall in the gym at the roof line.

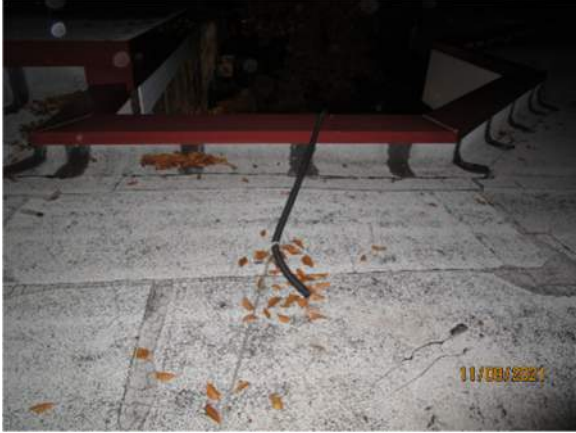
The sump pump discharges onto the roof as there is no drain in the courtyard.

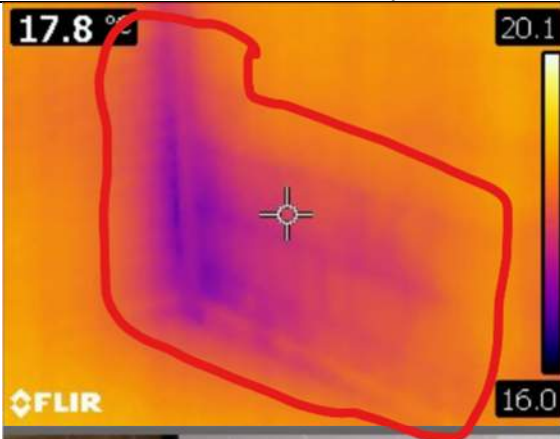
Thermal patterns show cooler temperatures at the foundation wall. This thermal pattern is consistent with missing foundation insulation, wet block, condensation. Efflorescence can be seen on the brick which is an indication of moisture in the masonry wall.

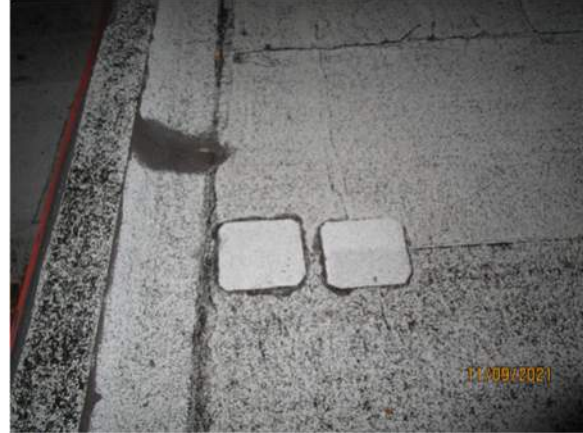
Annual and semi-annual roof inspections are performed on Long Lots. The maintenance of the roof is evident. Leaks have been chased for years with new sealant observed at cracks, joints, pitch boxes and repairs.

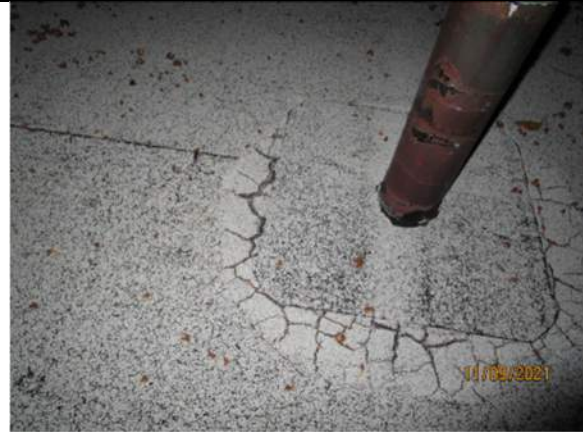
This roof is not impact resistant to falling branches. As mentioned above some trees overhang this building and should be removed.

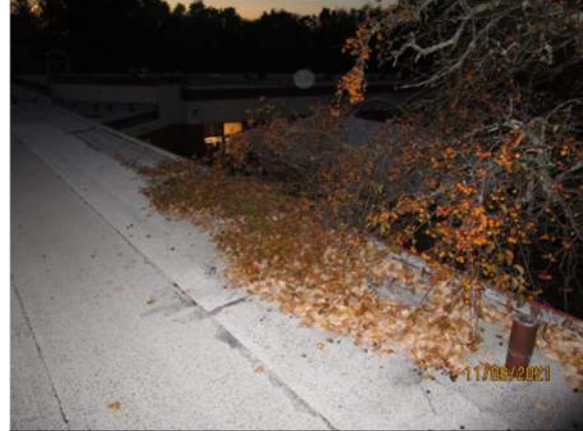
Puddling will cause a modified bitumen roof to wear down faster. The building maintenance team is doing an excellent job of preventing puddling by keeping the roof drains clean. No leaf clogged roof drains were observed during the site visit despite leaves actively falling on the roof from overhang trees.

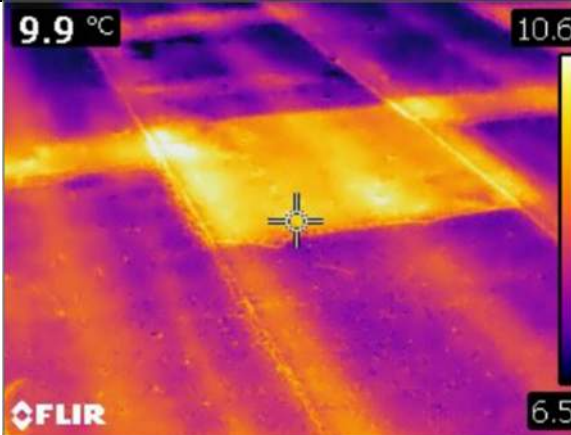
This location appears to be an infilled roof curb roofed over flush to the roof with no insulation.

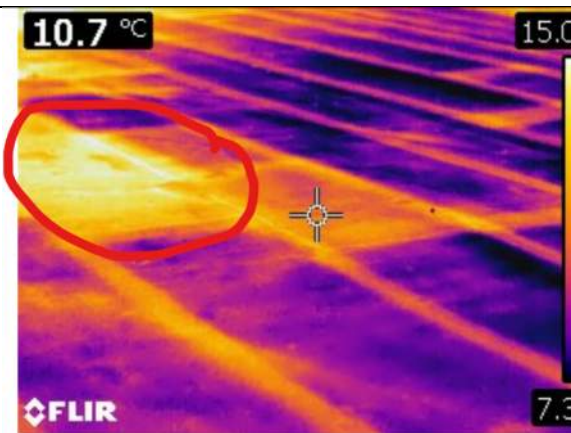
The brighter colors are thermal patterns consistent with wet insulation below the roof membrane.

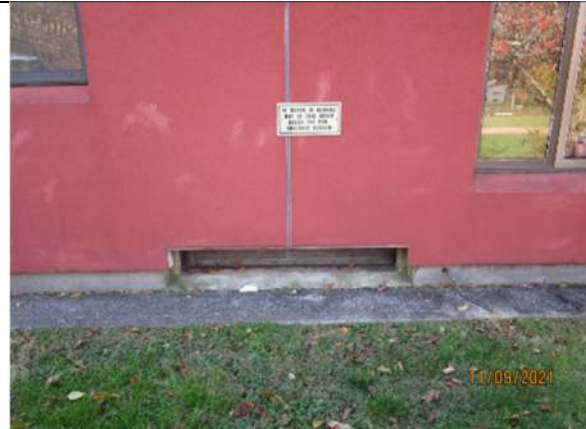
The openings and the clogged dampers allow moisture into the building – snow blows through the ventilators.

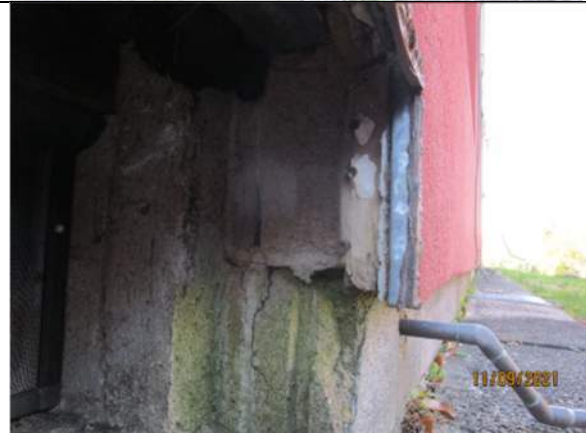
Unit ventilator in place at ground level. Cold air and surface water have an open pathway into the building.

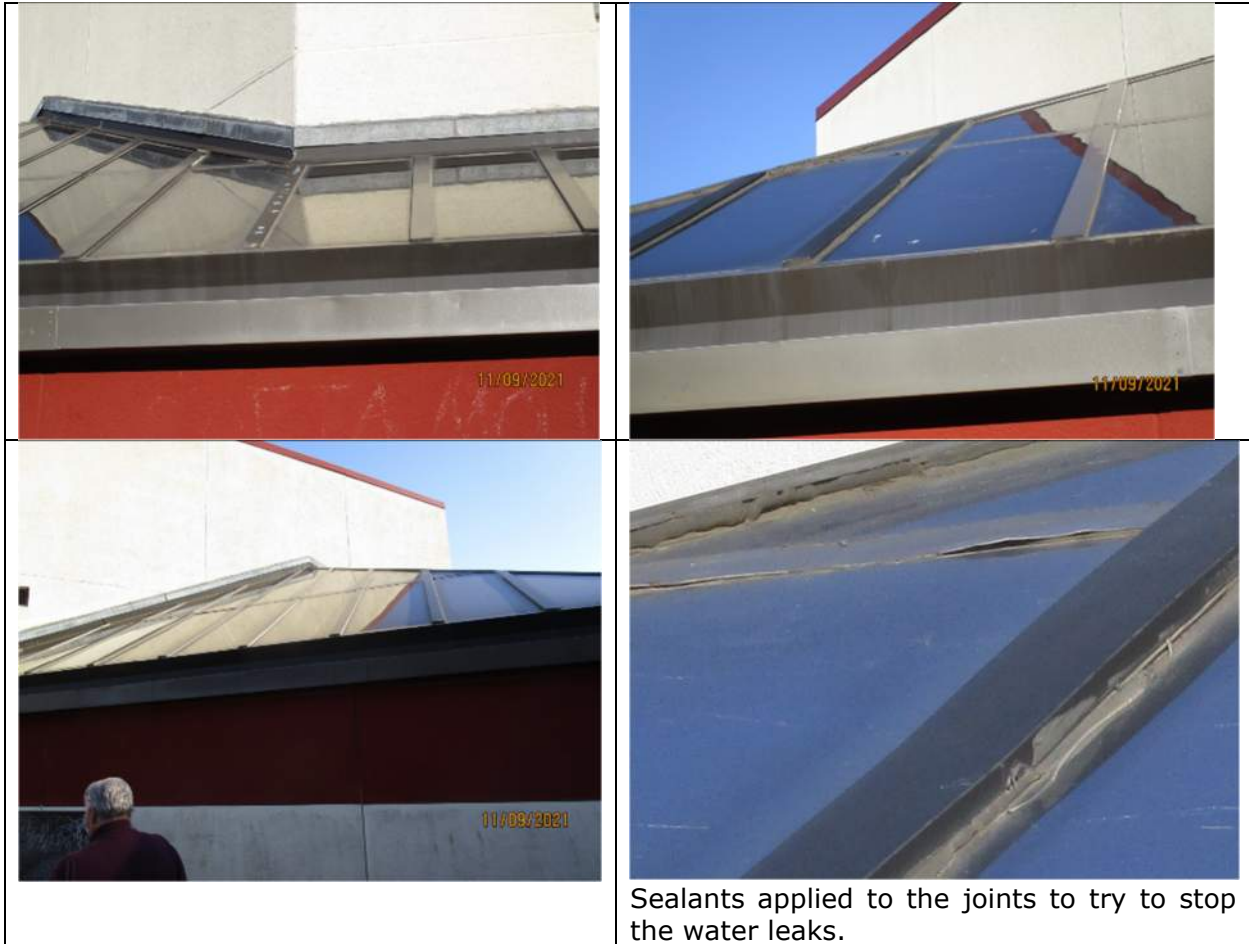
On-going issue with the skylights. Water infiltration issue has been on-going, and several attempts have been made to mitigate the water leaks. Sealant has been applied to the skylight joints. Solar heat gain issue – the skylight has been whited out to try to reduce the amount of solar heat gain in the space.

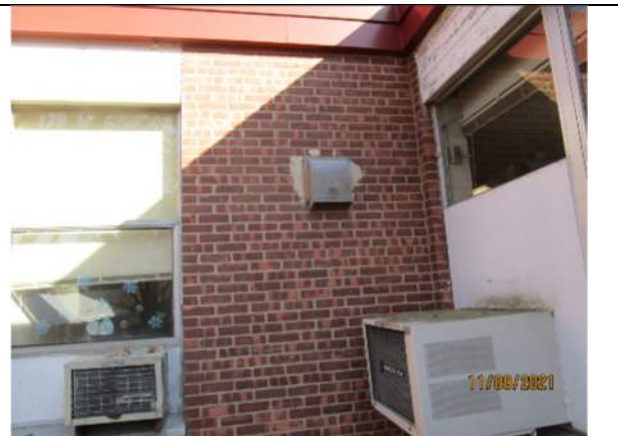
Approximately half the building has window units.
These are large 3-ton window units.

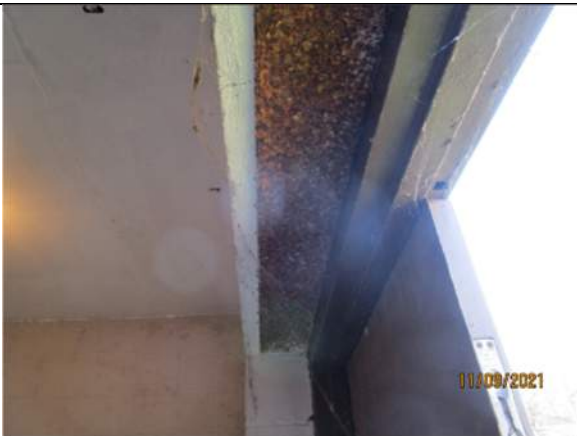
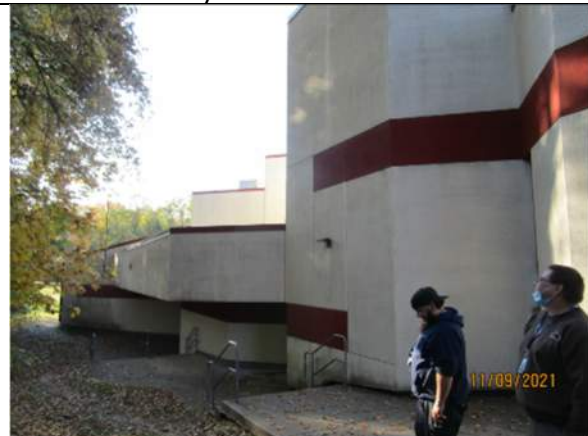
Organics appear to be growing on the surface of the finish system. Water being trapped behind the system has been observed at the unit ventilators and the base of the finished system walls.

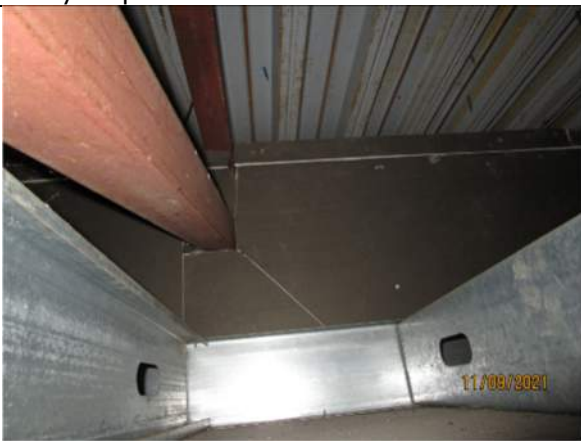
View inside the finish system soffit reveals that the gypsum sheathing on the exterior wall has no vapor barrier allowing drafts of outside air into the building.

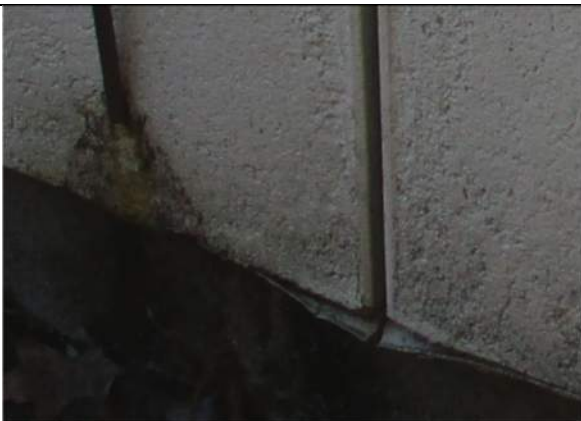
Ice damage at base trim and control joint.

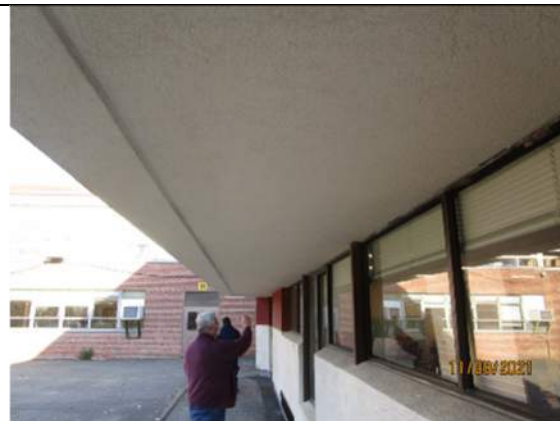
Little to no ventilation in the soffits.
