Greenwich Central Middle School Systems Evaluation

DTC Project No. 17501.B07

**SUBJECT: GREENWICH CENTRAL MIDDLE SCHOOL SYSTEMS EVALUATION
DTC PROJECT NO. 17501**

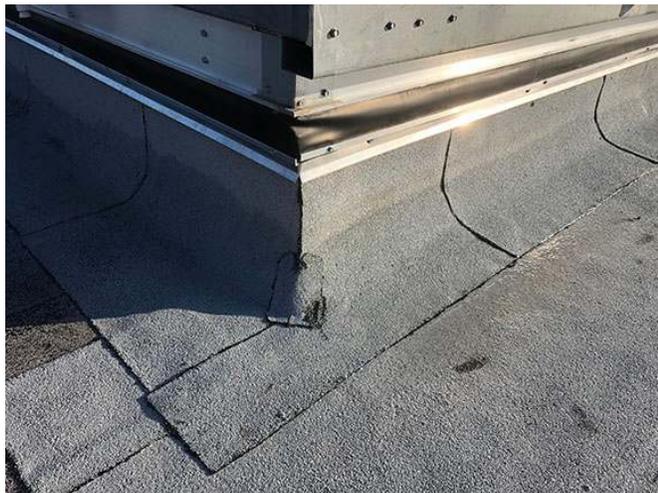
Photo 3. Roof Top Unit (RTU) base flashing using SBS membrane

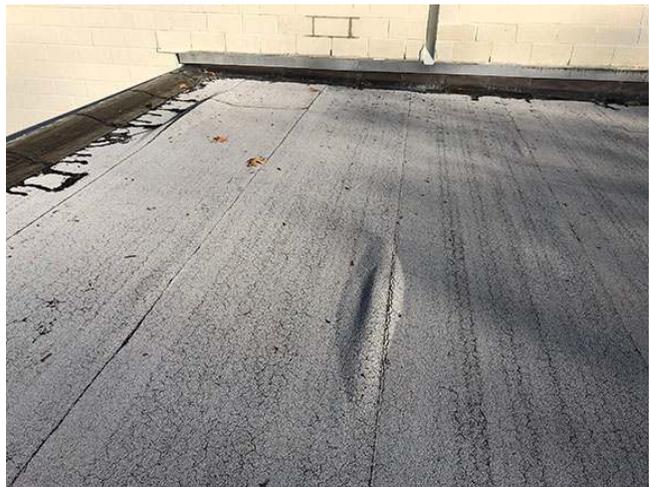
Photo 4. Blister and ridging of membrane - typical

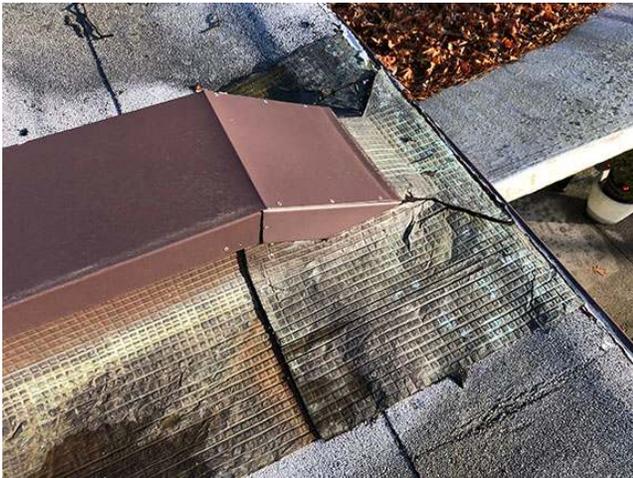
Photo 7. Expansion joint with aluminum cover - joint does not continue to roof edge

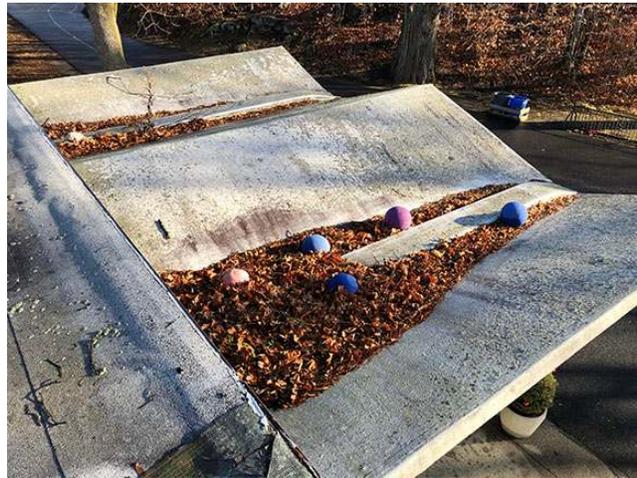
Photo 8. Sawtooth roof at entry with liquid roofing

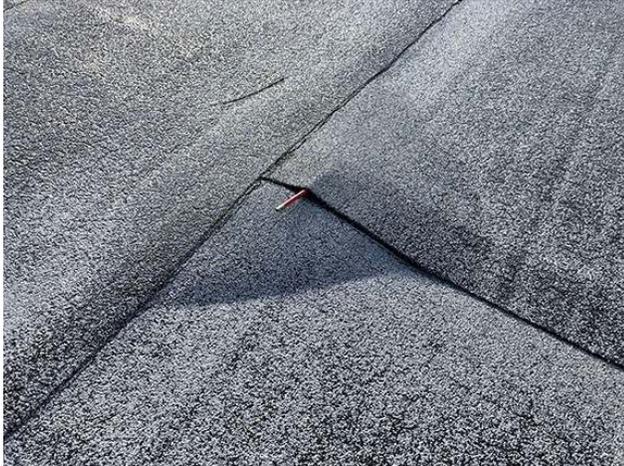
Photo 19. Typical blister in SBS roofing membrane

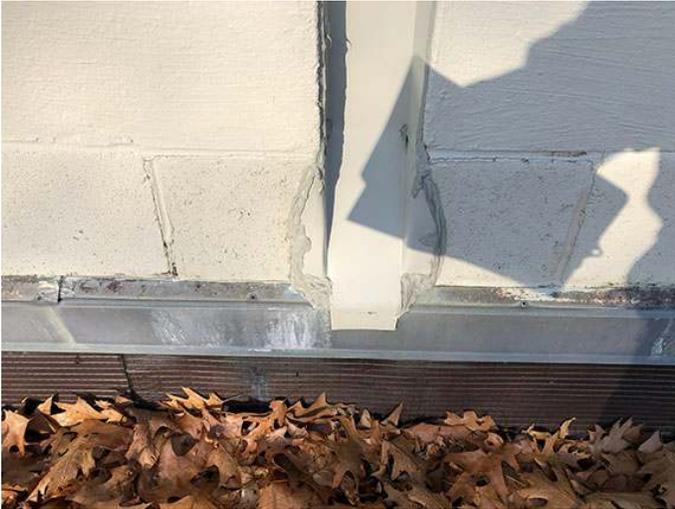
Photo 25. Base flashing detail along Auditorium wall with cover plate added to recess

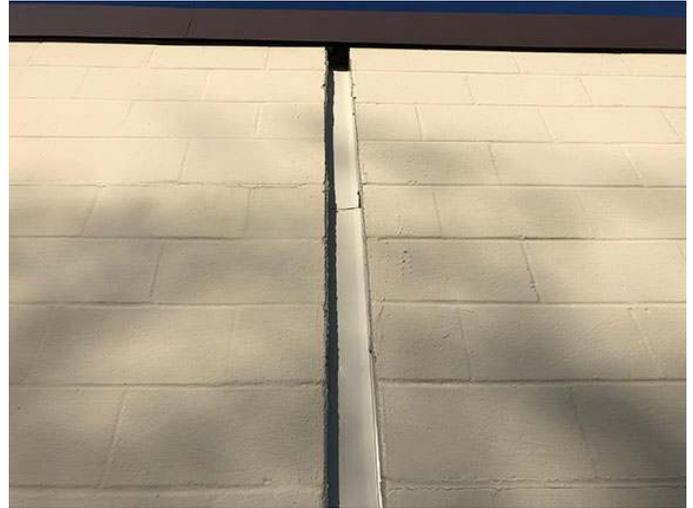
Photo 26. Roof line showing cover plate added to recess in Auditorium wall

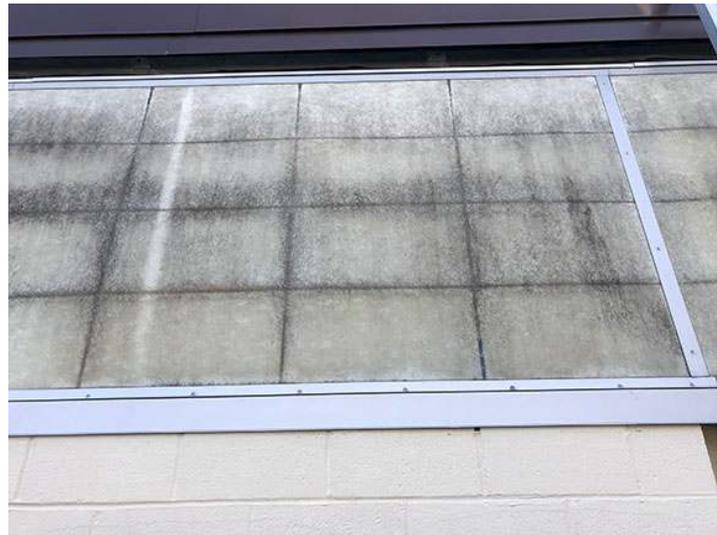
Photo 31. Translucent panels in Gymnasium wall

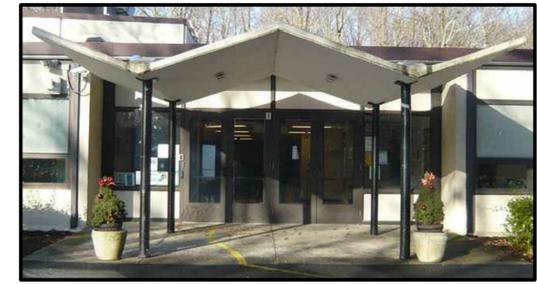
PHOTO 3: MAIN ENTRY CANOPY. NOTE LIQUID FLASHING MATERIAL APPLIED TO TOP SURFACE AND EVIDENCE OF WATER OVERFLOW AT EXPOSED EDGE OF CANOPY.

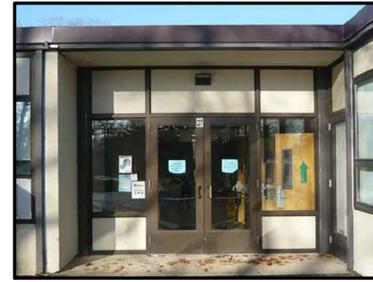
PHOTO 4: TYPICAL RECESSED SIDE ENTRY DOORS.

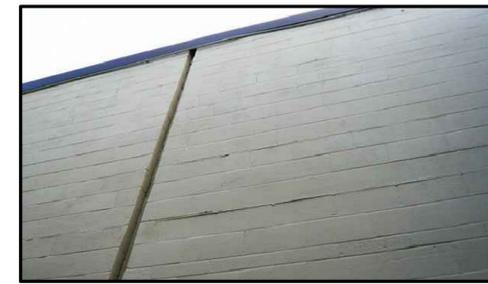
PHOTO 17: GROUT DISPLACEMENT OVER LARGE AREAS INDICATE MOVEMENT IN MASONRY.

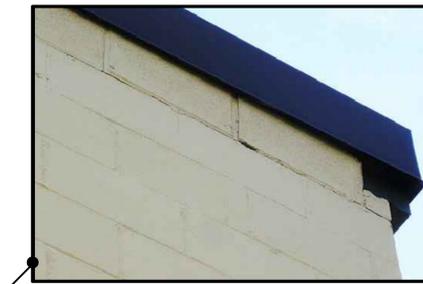
PHOTO 18: TYPICAL MASONRY DISPLACEMENT ALONG ROOF LINE.

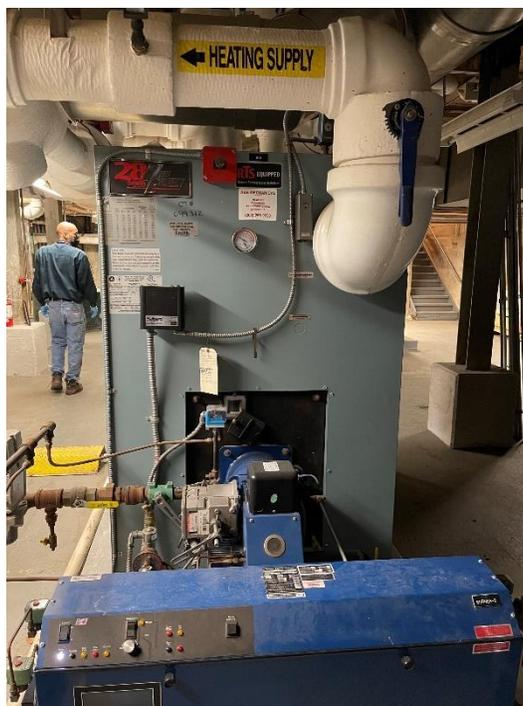
Gas-Fired Boiler No. 1

The school has a central hot water heating plant located in the lower-level mechanical room. The heating plant consists of three large Smith cast iron boilers that are approximately 2.2 million BTUH each and all appear to be in decent condition. The median service life of typical cast-iron boiler is 30 years. The boilers have dual fuel Power Flame burners that can use either natural gas or diesel oil for combustion but have been converted to natural gas only. We assume that the boilers generate hot water at 180 degrees, the system is designed to have a 20-degree temperature difference at the hot water coils and that the third boiler is operating as stand-by. Hot water is circulated through the building by two (2) hot water base mounted pumps, each pump has a variable speed drive to control flow and pressure based on the heating demand of the building, with a third pump on the supply header of each boiler. It is assumed that the base mounted pumps are configured as primary stand-by arrangement and that each is sized for 100% of the flow and the “third” pump on the boiler supply header acts as a booster pump to accommodate for pressure losses through the boiler itself. The median service life for base mounted pumps is 20 years. There are pressure sensors located out in the piping loops that measure the system pressure and modulate the pump speeds to match the system demand. It was noted during the time of our visit that there are no terminal heating devices, baseboard, fin-tube elements, etc. along the building’s exterior walls.

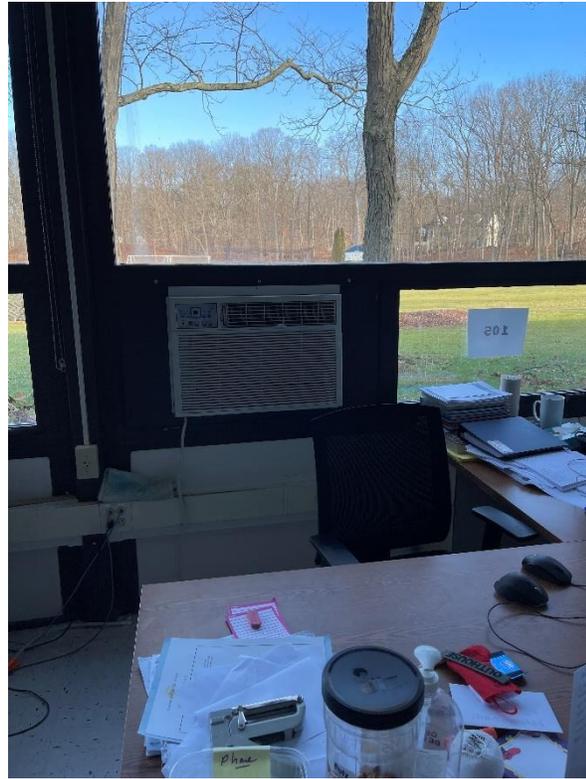
Approximately 90-95% of the building currently has air conditioning, with approximately 50% being comprised of in-window/through wall air conditioning units to be replaced. The theater/auditorium was recently provided with a brand-new Carrier RTU, the median service life of this type of equipment is 15 years.

Existing through wall AC Unit (typical)

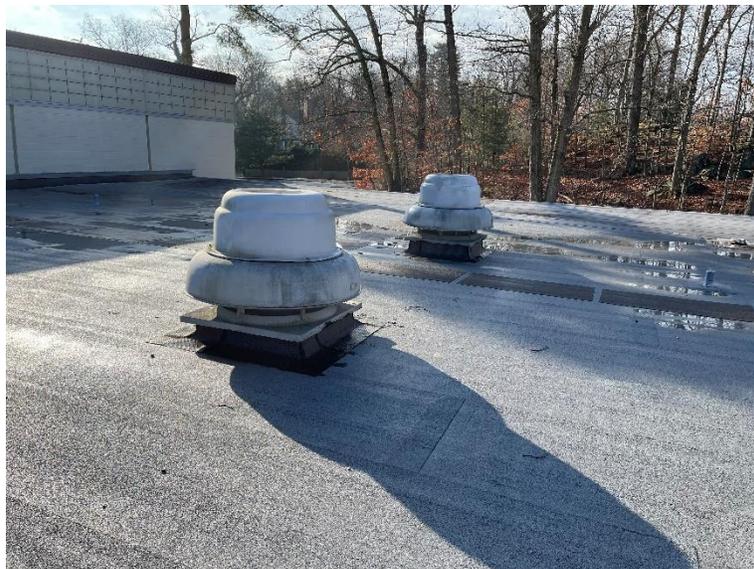
There are exhaust fans scattered throughout the building that serve toilets, MER's, science rooms, storage rooms, kitchens, and other similar spaces. Most are small mushroom style down blast type and are typical for a school application. Most appear to be quite weather worn, and replacement is suggested. The median service life of this type of equipment is 25 years.

Typical Mushroom Style Down Blast Fan

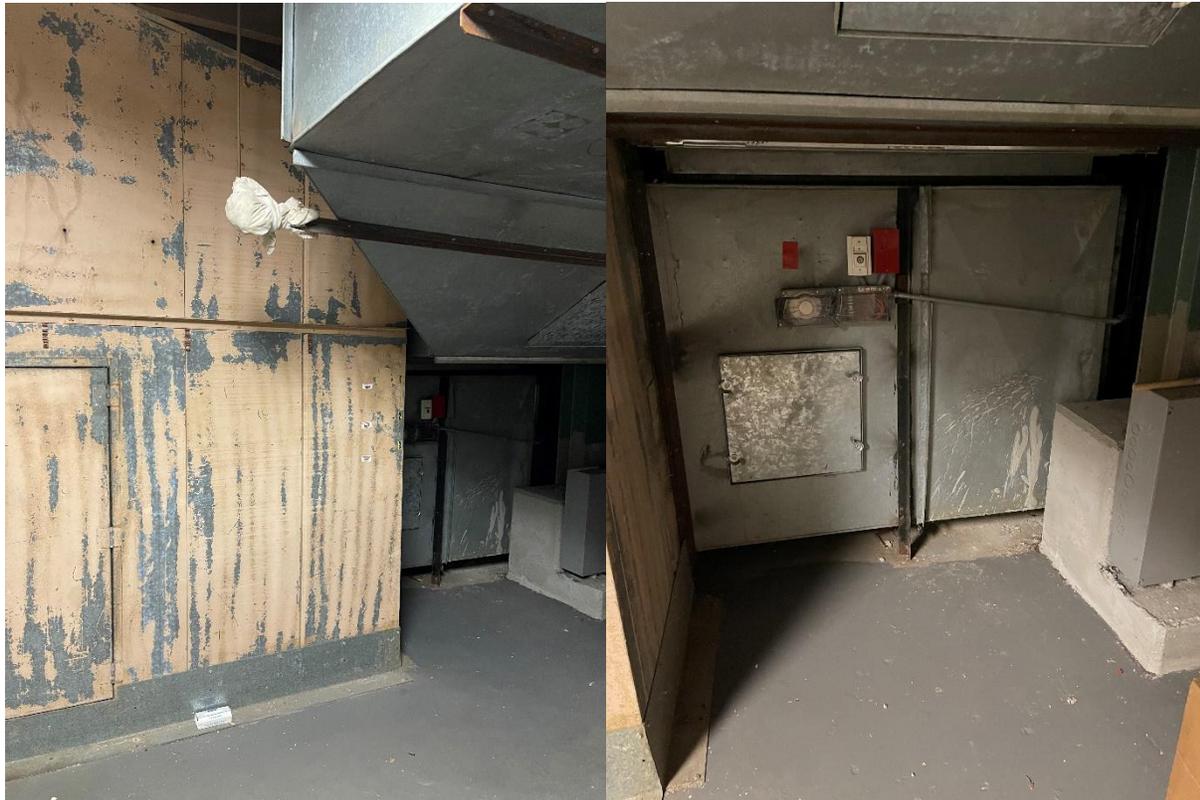
On the lower level of the building are the central station air handling units, which provide a means of ventilation air and heating to all areas of the school. There are a total of four (4) central station air handlers meaning the school is currently broken up into four (4) main heating zones. Each of the air handlers is outfitted with a large hot-water heating coil, with the hot water being supplied by the existing heating hot-water system in place. These air handlers pull fresh air into the system from a large outdoor air plenum that supplies fresh air to all four (4) air handlers. Each air handler then ducts out to individual zone ducts supplying fresh air and heat when called for to each room within the building. Every classroom is outfitted with two registers near the entrance, one for supply and one for return, refer to photos for reference. The existing outdoor air plenums need repair and some of the existing hot-water coils are in need of replacement. While on site it was noted that one coil appeared to be recently replaced. We would also advise for the replacement of the supply fans themselves due to their age and while on site we note “knocking” which is indicative of bearing failures.

Central Station Air Handler (S-1) and duct mounted smoke detector

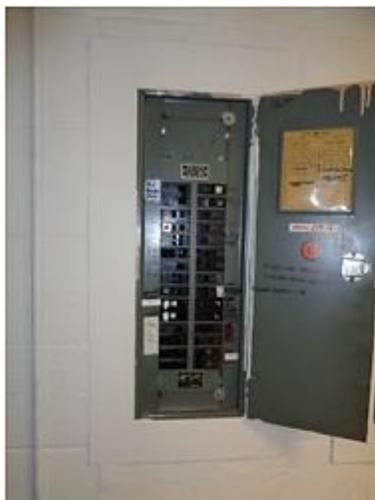
All emergency panels are in very poor condition and at the end of their useful life. See photos. We inspected observable conditions on all first-floor rooms without the advent of destructive inspection. Panelboard "LP-1C", GE, 30 CKTS is very old, and it was difficult to identify the amperage. I found out that Simplex Building Communication System was inoperative and appears to have been abandoned in-place.

Siemens Communication System

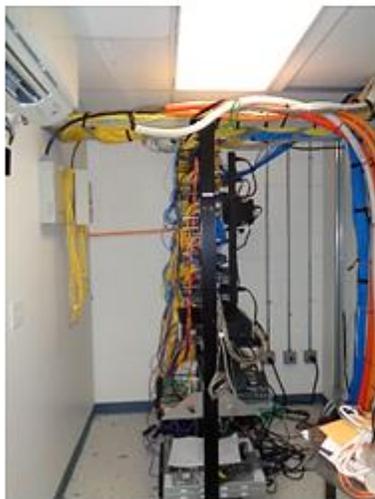
Second IT room, Main Office area.

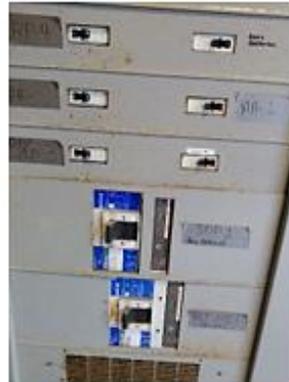
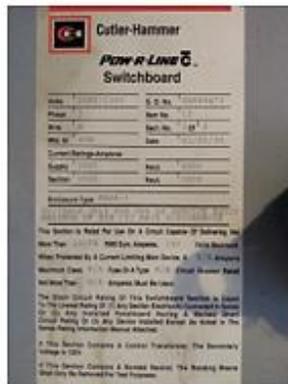
Science Room 117

Panelboard MLO 208Y/120V, 225AMPS, 42 ckts, 3PH, 4W located in science room 117, and the MDP panel in the electrical room, on the first floor, throughout the ground floor level entry stairs, 208Y/120V, 2,000 AMPS, 3PH, 4W, Cutler -Hammer Model: Pow-R-Line 'C'- are in serviceable condition. Sub-panel SMDP 208Y/120V, 800AMPS 3PH, 4W, in good condition and old SDP-1 an ALT SMDP.

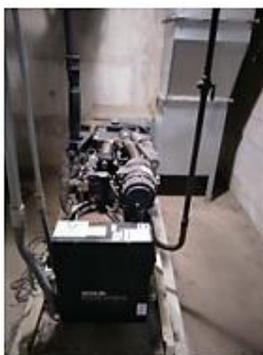
EM Generator

Kohler, Standby Generator Model "15RYG", (13.0-15.0) KW, (13.0-18.8) KVA, Voltage 120/208, 45 AMPS, functioning in good condition.
