REGIONAL SCHOOL DISTRICT 18

Facility Study – Middle School

August 15, 2021

Regional School District 18
Lyme & Old Lyme
Facilities Study & Educational Specifications

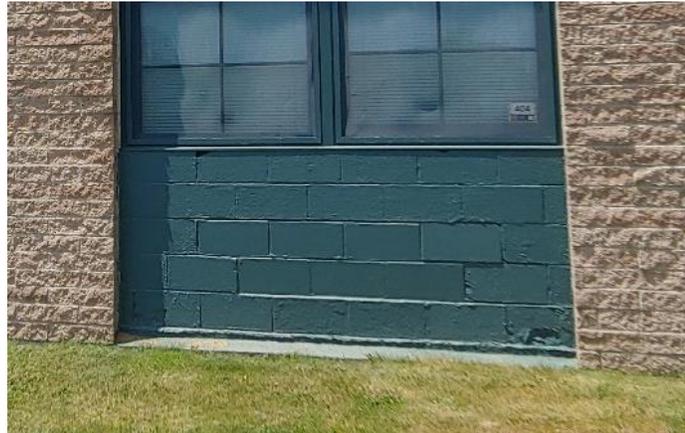
Masonry: The primary exterior wall assembly is consistent throughout the building. The exterior walls are typically a masonry wall with CMU backup and a Brick or CMU veneer. The CMU and brick have been maintained over the years however there are several areas where there are noticeable cracks and repair due to a lack of control joints in the veneer. At the CMU veneers specifically at the windows there appears to be a poor construction of the CMU with uneven finish and grouting, broken and chipped pieces, as well as improper flashing

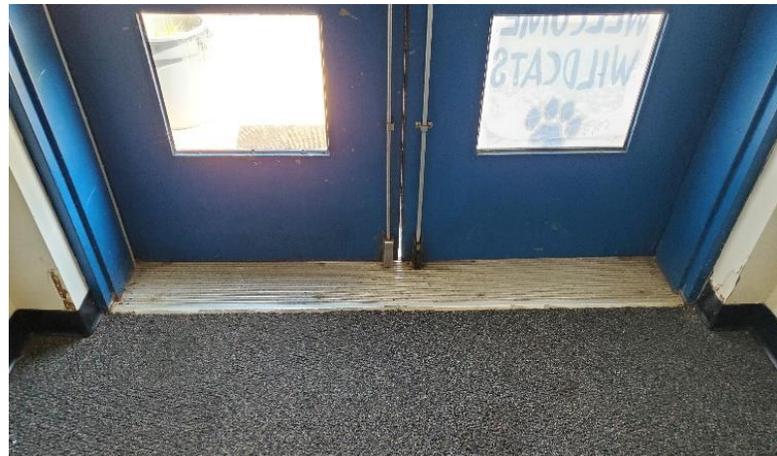
Interior doors appear to be in reasonable shape and are consistent throughout the building. Hardware and doors were updated as part of the 2002 project and are in reasonable shape. Exterior hollow metal doors have weathered more than the interior doors. Being exposed to the elements the hollow metal frames have started to rust at the base and weather seals are no longer continuous. The main entrance doors are an aluminum storefront system and are in good condition.

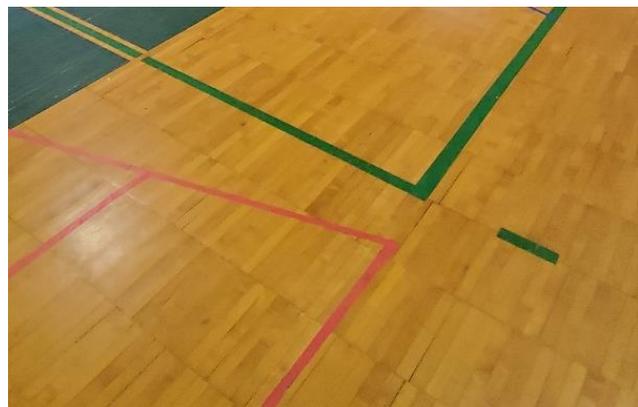
- *Vinyl Tile:* Much of the school is vinyl tile that appears to be in good condition. The tiles have been maintained with minimal cracking or damage noted.
- *Ceramic Tile:* In lavatories, the ceramic tile floors also appear to be in good condition with no noticeable cracked or broken areas. Grout damage or discoloration was minimal and consistent with the age of the tile.
- *Wood Floors:* The gymnasium floor is done in a parquet style of narrow wood slats laid in parallel lines. The striping is old and deteriorating as is the floor finish. This style of wood floor typically does not meet the newer updated standards for sports play in middle school or above play.
- *Entrance Mat Systems:* As per the Connecticut high performance building standards, 3-part entrance mat systems are required to minimize particulars and maintain indoor

air quality. The Middle School uses a mix of walk of carpet tile as well as portable surface mats. While some are doubled up a permanent full walk of system is suggested.

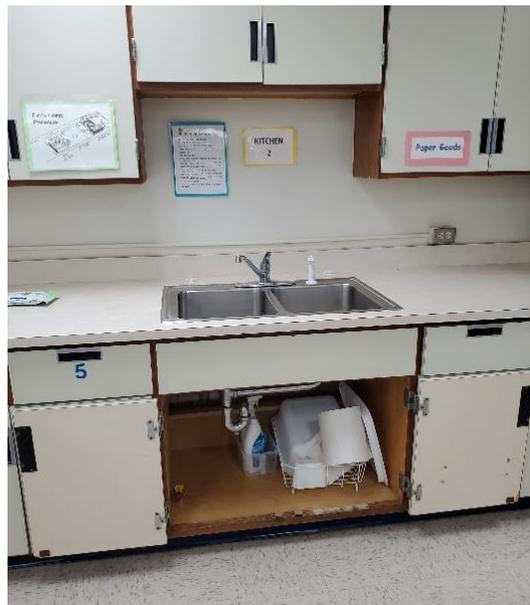
The condition of the existing cabinets and millwork in the building appears to be in ok condition and has been maintained well over the years. There are certain rooms and departments that seem to be more worn than others. Rooms such as the home economics space seemed to have cabinets that are starting to show their age with water staining, broken hinges, and weathered plastic laminate faces. Millwork in the more standard classrooms appear to have been replaced more recently and appear to be holding up and accommodating the needs of the spaces.

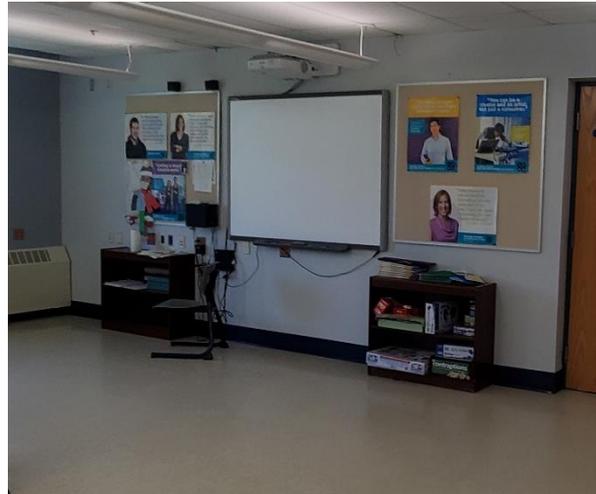
Visual Display Surfaces: The district maintenance and IT programs have updated the teaching walls in the classrooms to have smartboards and short throw projectors accessed by a desktop computer. As with all retrofits of a building this age, it is difficult to find a clean solution with power, data, and AV cables.

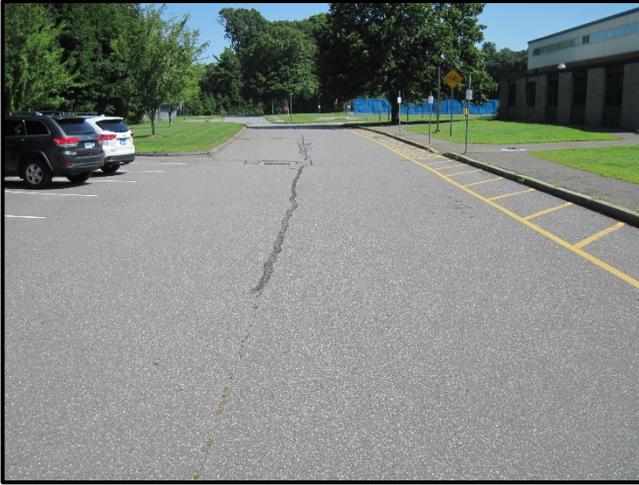
Area	Classification	Commentary
Drive 1	Fair	Crack repairs recommended.
Lot 1	Fair	Crack repairs recommended

Drive 1 looking north; Lot 2 at left of photo.

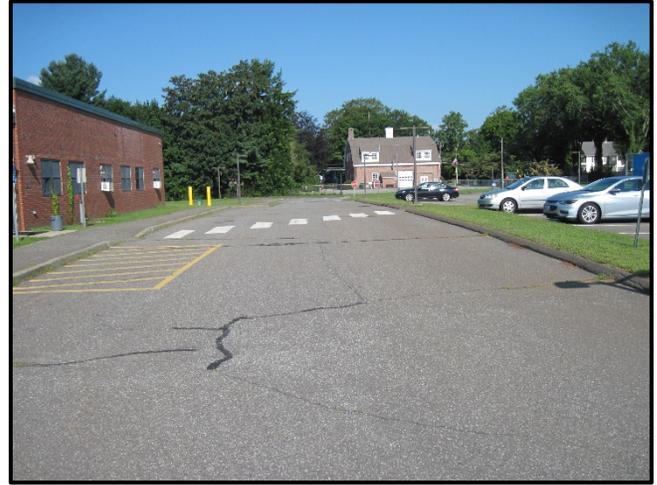
Drive 2 looking west; school building at left of photo.

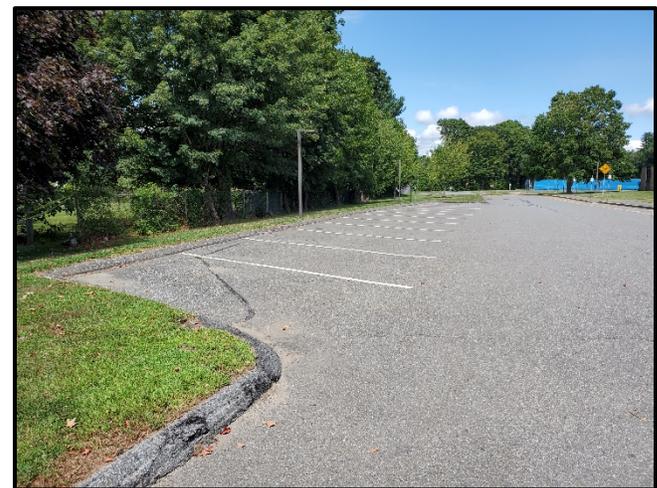
Lot 2 along the driveway, looking north.

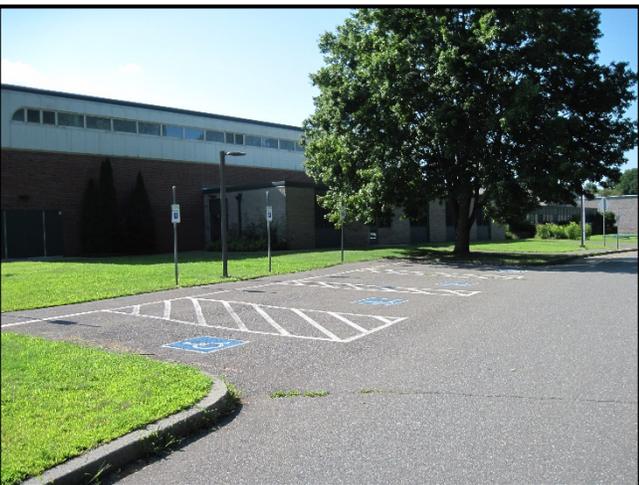
Lot 3 at front of school; HC parking only at this lot.

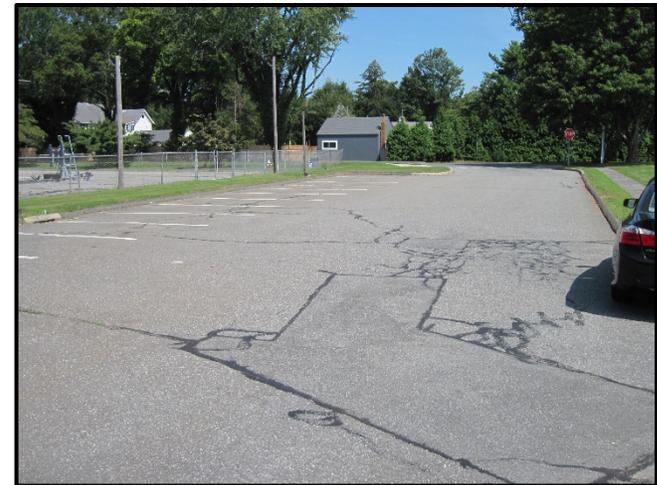
Lot 4 looking north.

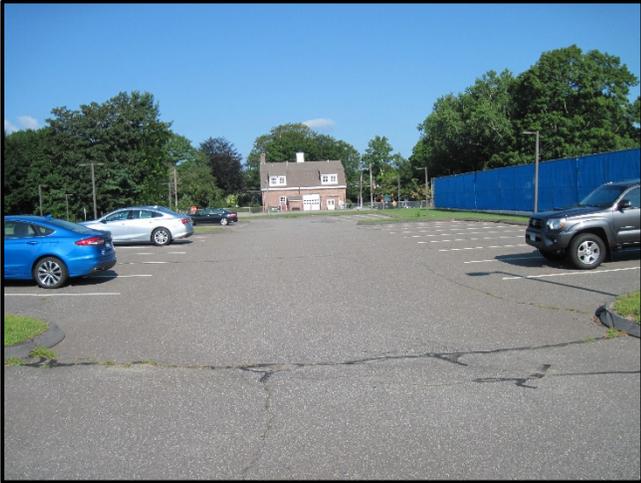
Lot 5 looking west.

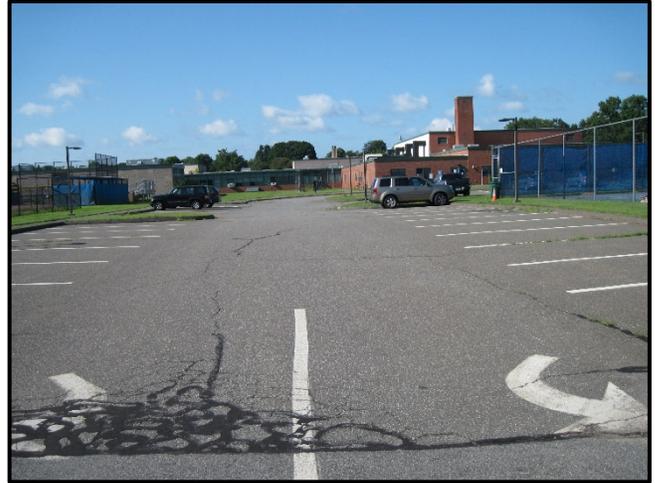
Lot 6 looking west.

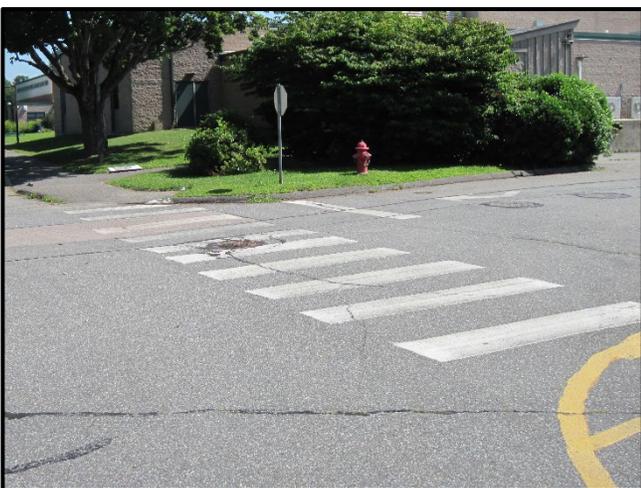
Typical site pavement markings.

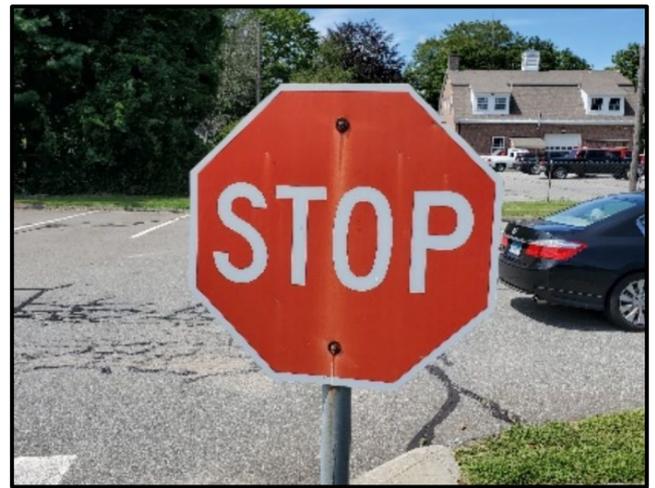
Typical site sign.

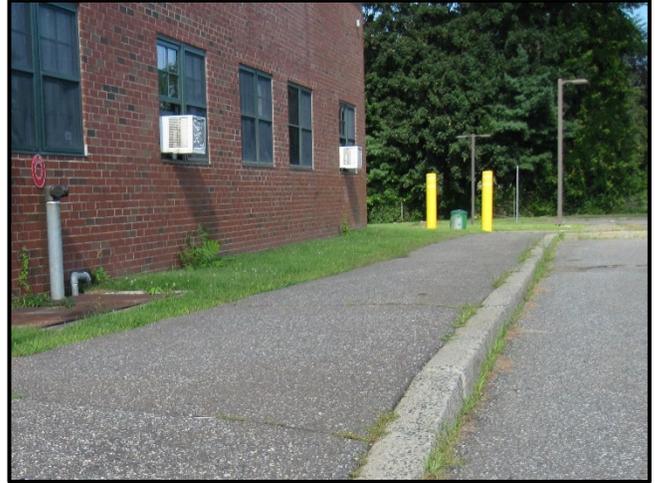
Typical bituminous sidewalk, north end of school Building.

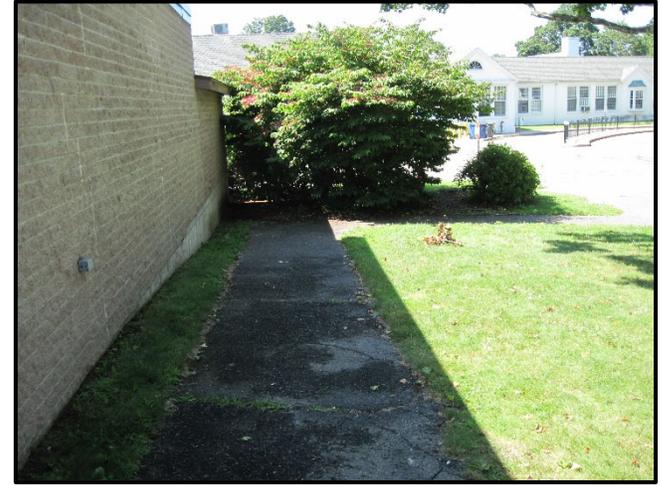
Walkway at cafeteria egress door, looking south.

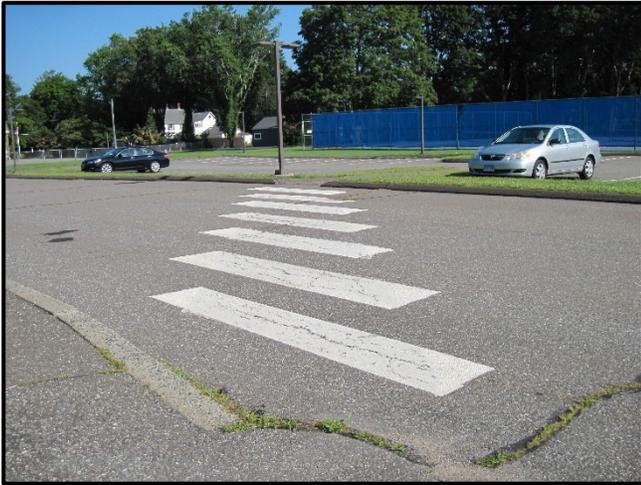
Crosswalk from Lot 5 to Door 6 at north end of school building.

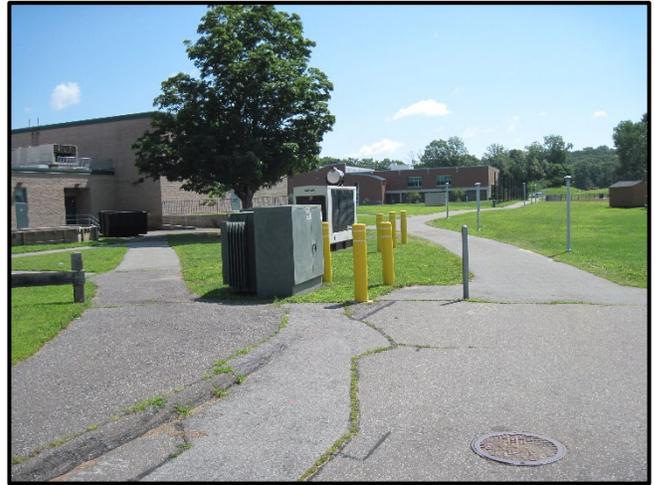
Bituminous walkway providing pedestrian access to and From south end of the school building.

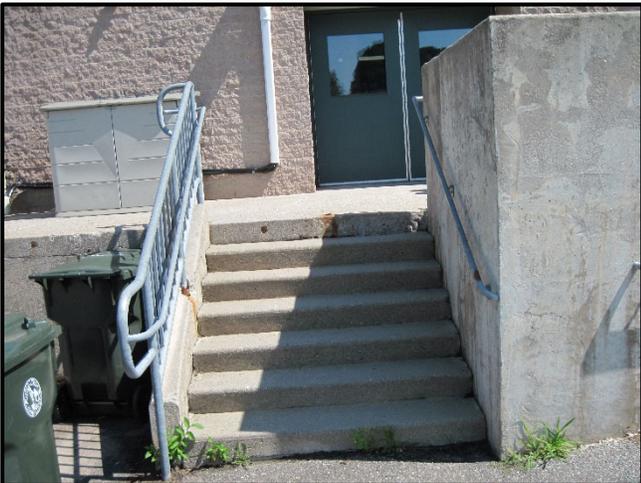
Stair 1 at south end of building.

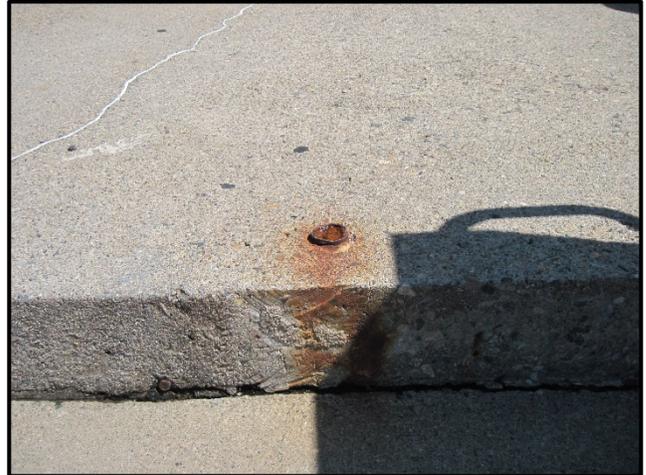
Stair 1, remnants of tubular post base in path of travel.

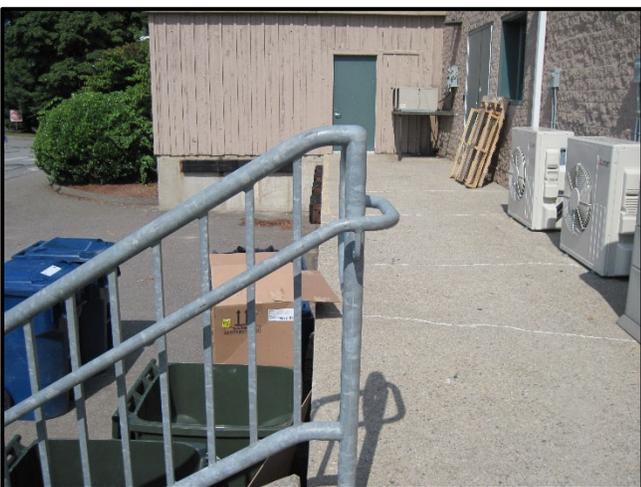
Stair 1, west rail, top rail extension.

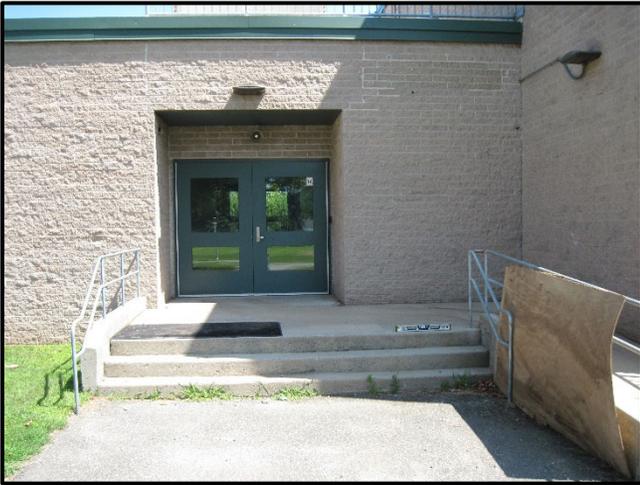
Stair 3 at south end of building, Door 16.

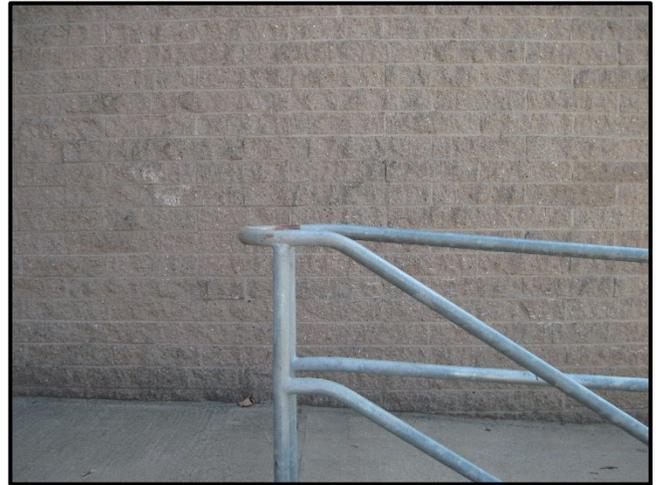
Stair 3, east rail, top rail extension.

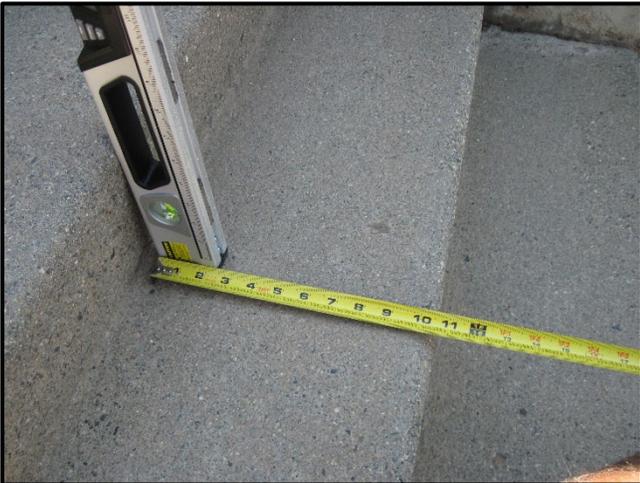
Measurement of tread depth.

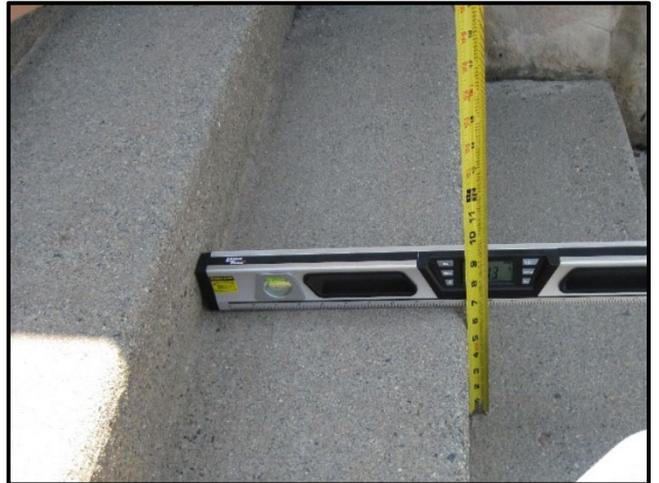
Measurement of riser height.

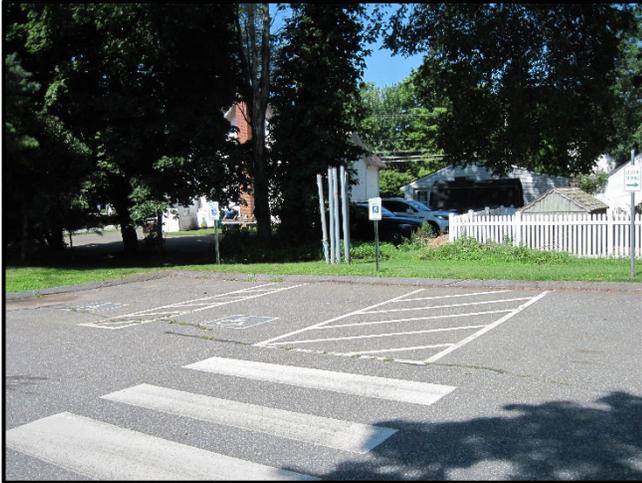
Accessible parking in Lot 1 (2 spaces). "Accessible Route" crosswalk to ramp at school sidewalk visible.

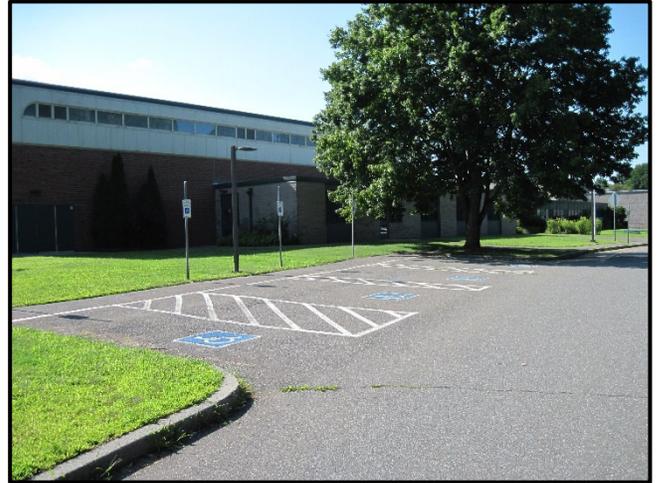
Accessible parking in Lot 3 (4 spaces). Bituminous "Accessible Route" adjacent to access aisles visible.

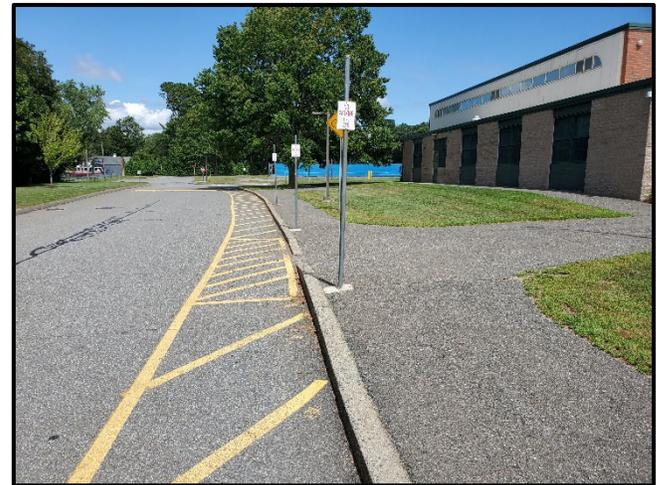
Passenger Loading zone 1 (PL1) at front of school, looking north. Main entrance at Door 1 to the right.

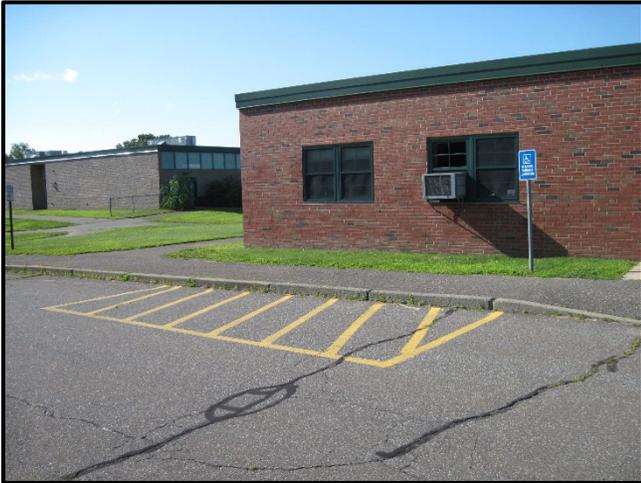
Passenger Loading Zone 2 (PL2) at north end of school in Drive 2, proximal to Door 6.

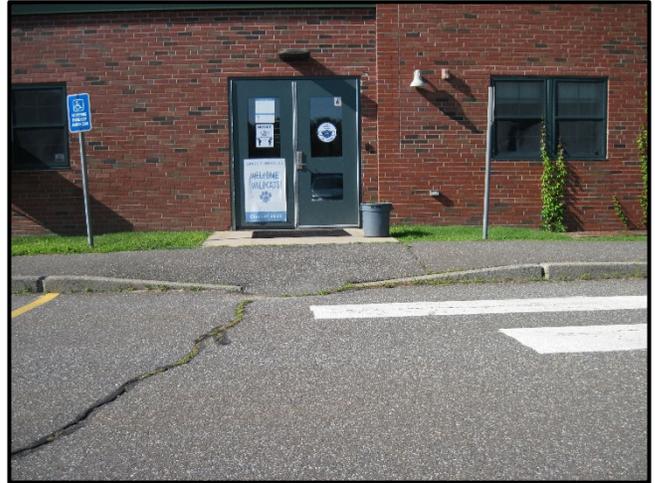
Curb ramp at Door 6, south of PL2 at terminus of Crosswalk from Lot 5.

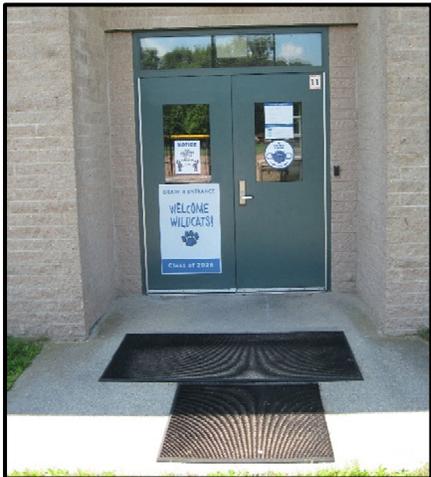
Typical ingress/egress door (Door 11) at north end of building.

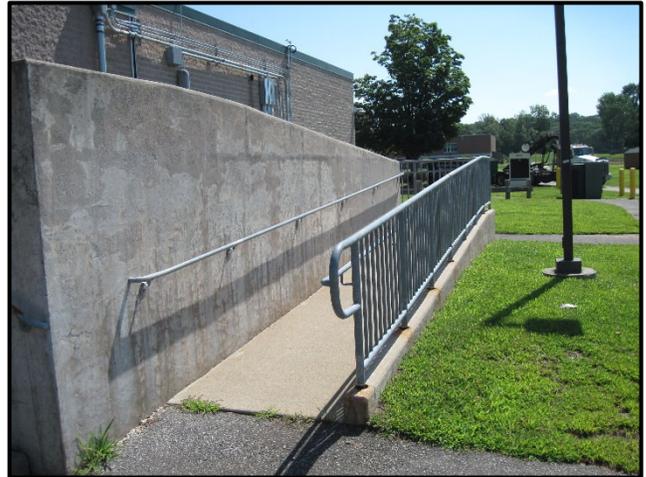
Pedestrian ramp 1 (R1) at south end of building. (Egress only).

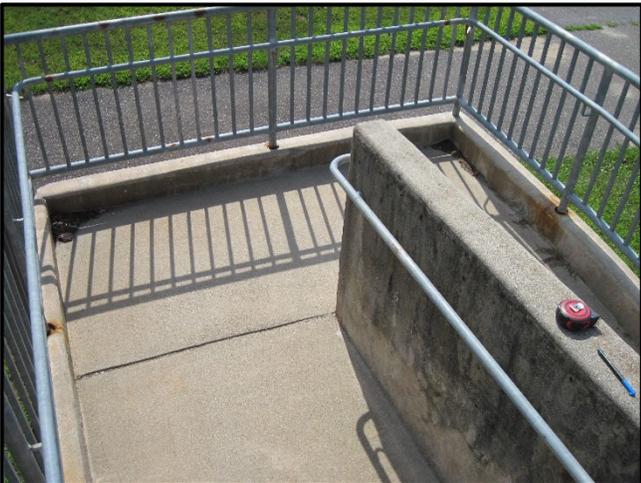
Pedestrian ramp 1 landing at change in direction.

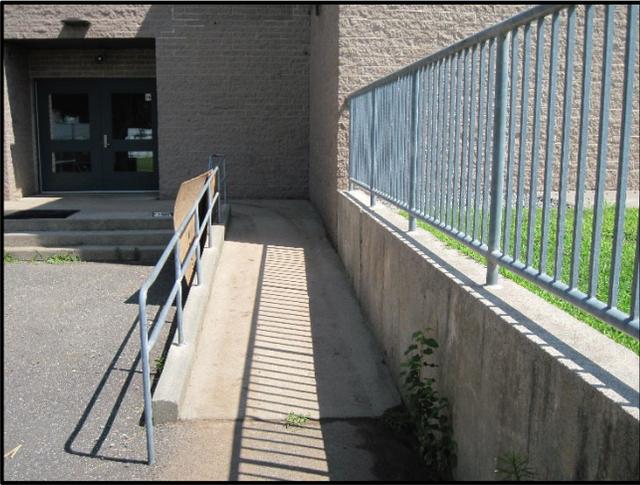
Pedestrian ramp 2 (R2) at south end of building, Door 18. Ingress and egress at Door 18.

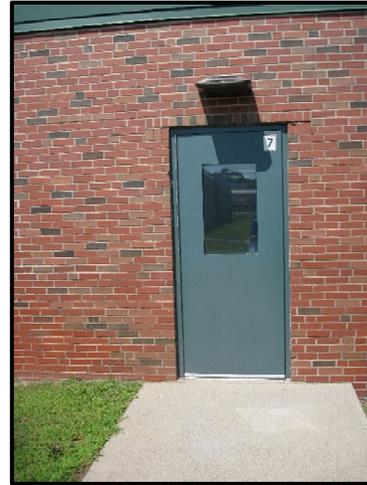
Typical "egress only" door with landing (Door 7).

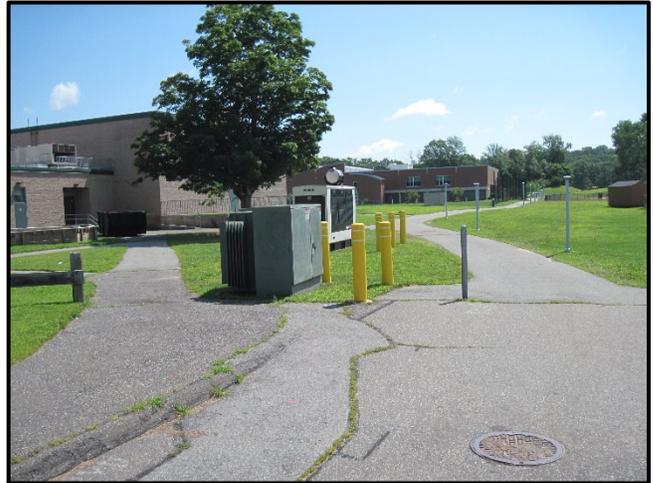
Bituminous sidewalk providing pedestrian connection

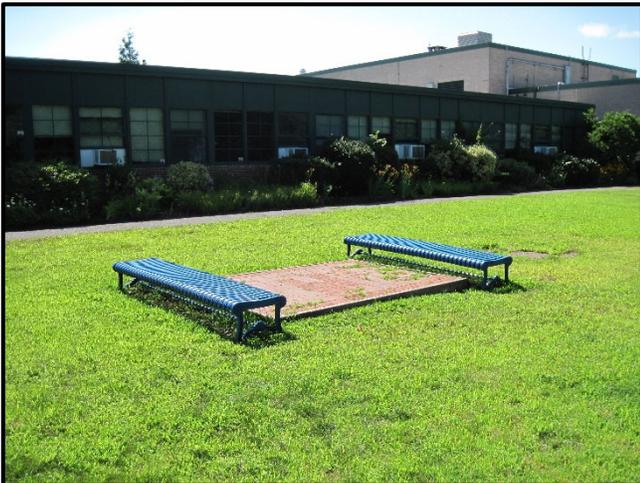
Seating area with memorial bricks at front (west side) of building. No accessible walkway.

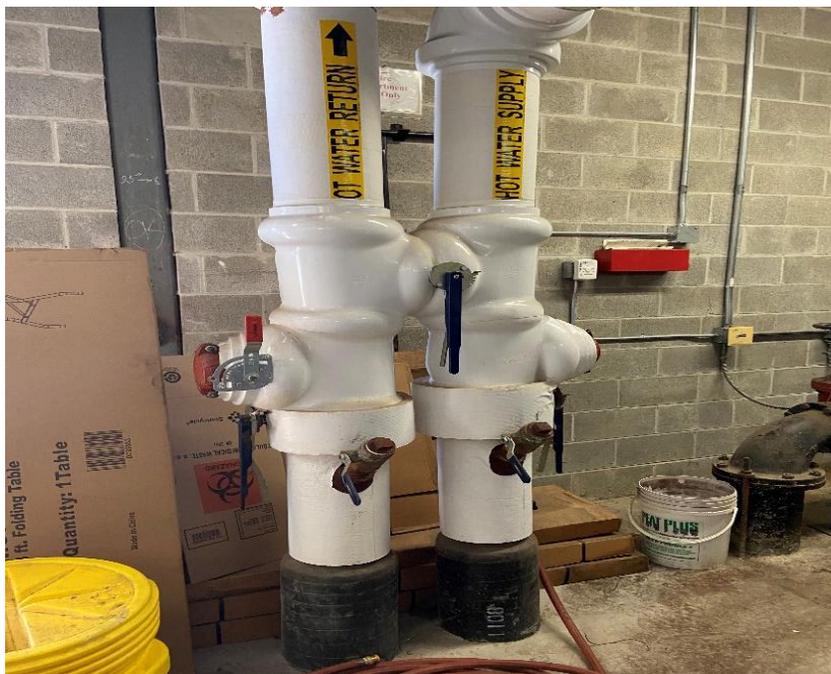
Hot Water Piping to Center School

4. Oil for the boiler and water heater systems is circulated through a duplex Webster oil pump set. This appears to be 19 years old and nearing its useful life expectancy.
5. Hot water piping for the building exists both in tunnels and above ceilings. The majority of piping was replaced 19 years ago and is fair condition. Heating piping has a useful life of 40-50 years which this may be coming close to.

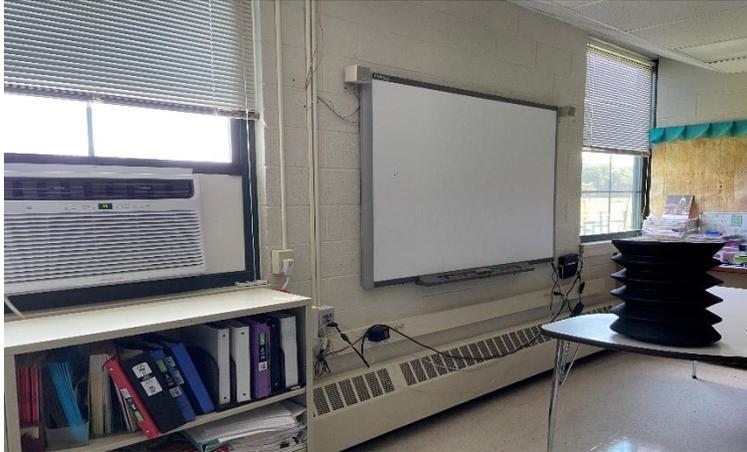
Radiation Serving a Classroom

1. Heating throughout the occupied portions of the building is provided by a combination of perimeter radiation, cabinet unit heaters and rooftop heating and ventilating units. The majority of the indoor heating devices are in fair condition, but cabinet unit heaters will need to be replaced in the near future. The outdoor rooftop units will be addressed in a later section.

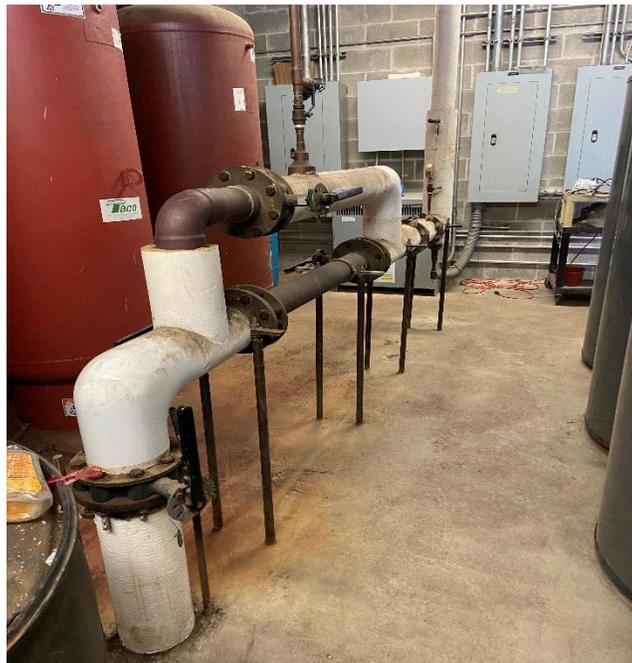
Domestic Water Service

1. Domestic Water is served from a central well pump on site which serves other buildings also. Water service enters the boiler room through the floor slab.

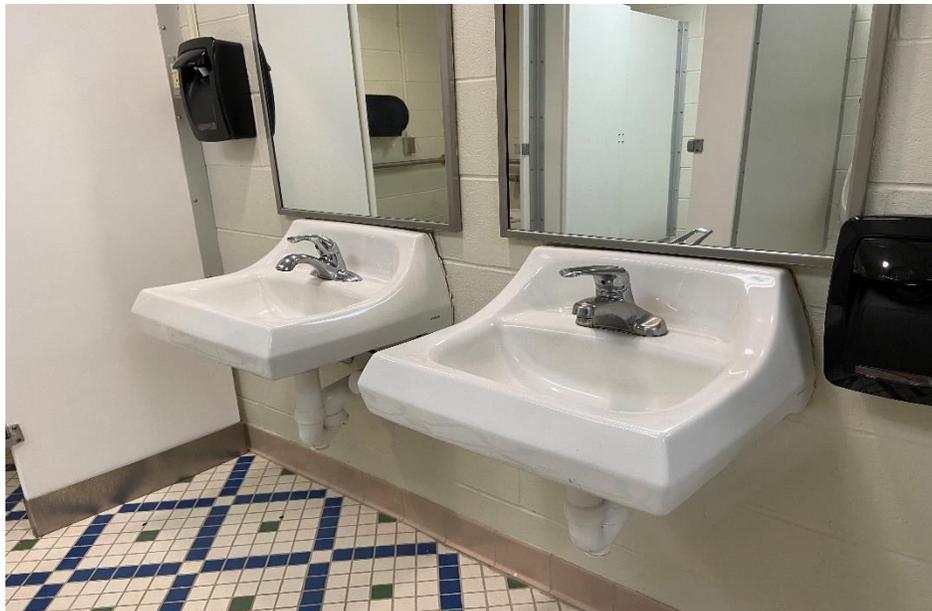
Typical Lavatories

1. Plumbing fixtures within the building are generally of the 19 year age from the previous renovation. Fixtures appeared to be clean, well maintained, and in fair condition with a 30 year useful life.
2. In general plumbing fixtures are as follows:
 - Water Closets in gang bathrooms are wall mounted, vitreous china with manual flush valves.
 - Urinals are wall mounted, vitreous china with manual flush valves.
 - Lavatories serving single use bathrooms and in gang bathrooms are wall mounted vitreous china with manual faucets.
 - Electric drinking fountains are surface mounted and appear to be in good condition.
 - Classroom sinks are top mount stainless steel, with manual faucets. These fixtures appear to be in good condition.
