MASSACHUSETTS SCHOOL BUILDING AUTHORITY 2022 STATEMENT OF INTEREST

BROCKTON HIGH SCHOOL 470 FOREST AVENUE BROCKTON, MA 02301

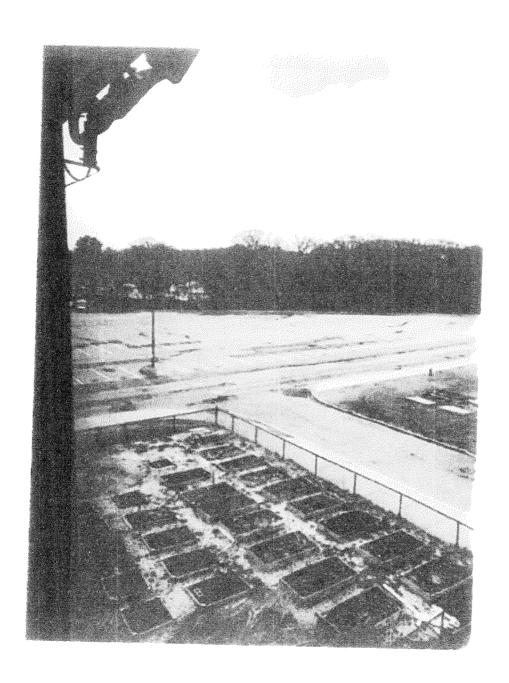
Parking lot

(Typical)

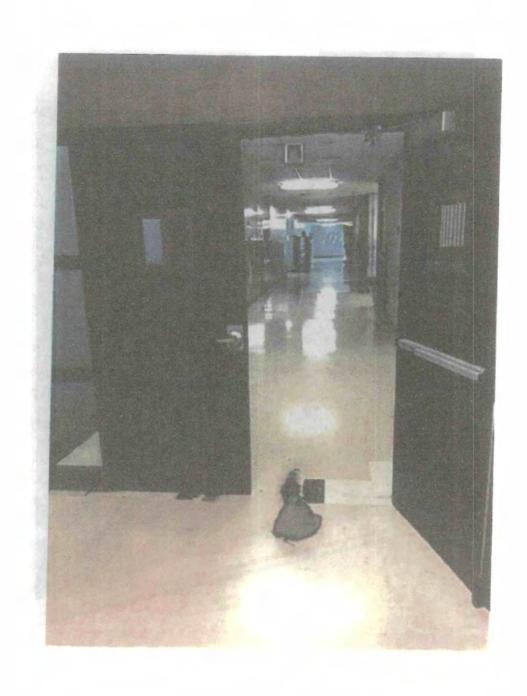
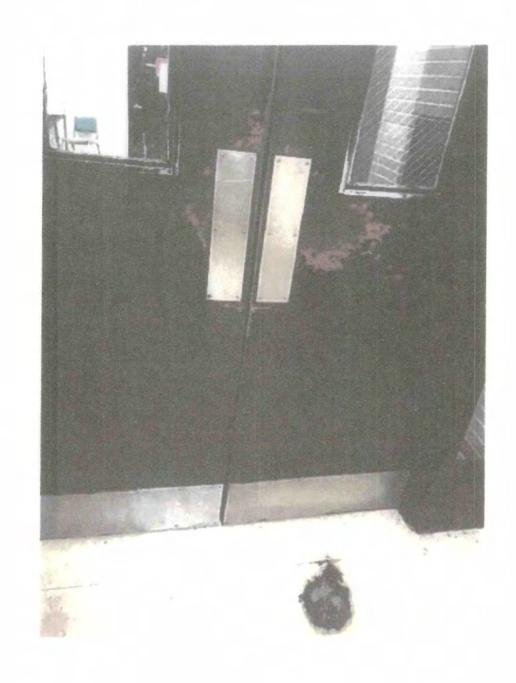
2-D

any future renovation and maintenance. Nine-inch by nine-inch floor tiles located throughout the building are worn and chipped. The flooring should be tested for asbestos prior to any renovation or maintenance that would disturb or remove the

Worn Floor Tiles

(Typical)

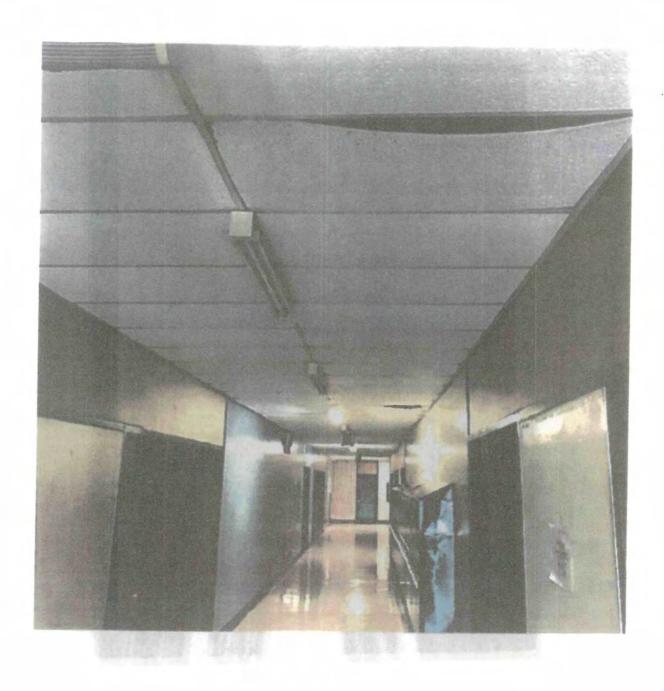
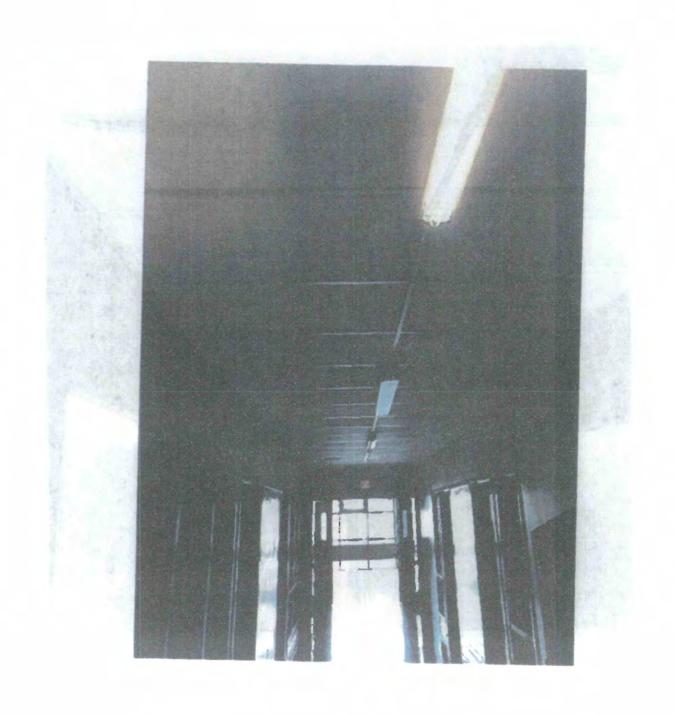
Missing/Damaged Lighting

(Typical)

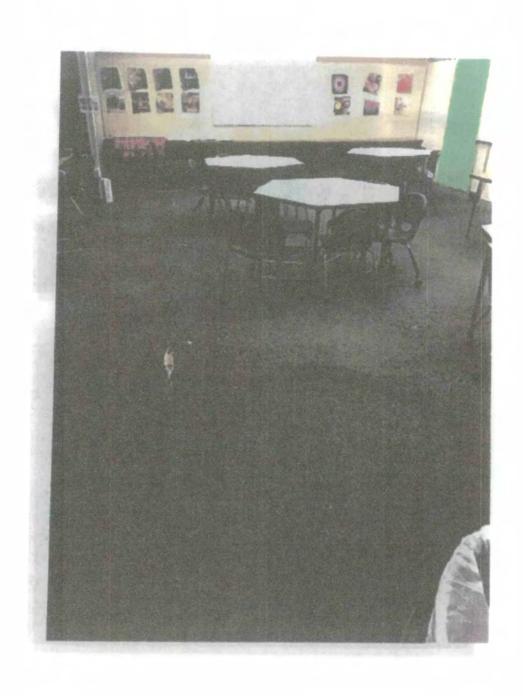
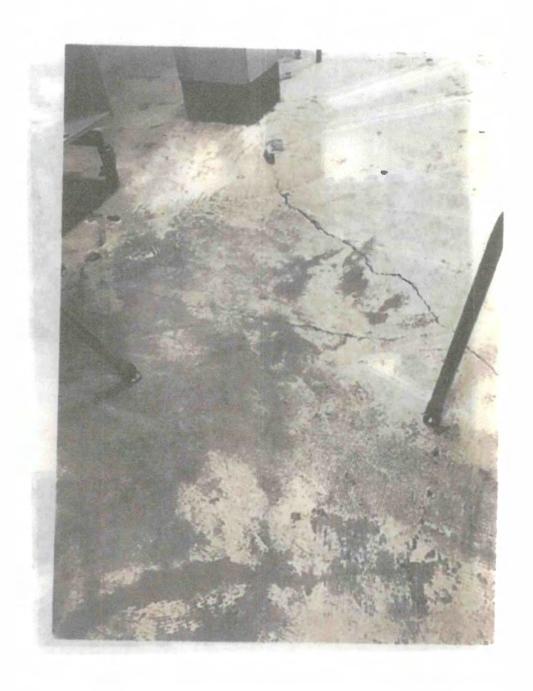
2-F

Missing/Damaged Flooring

(Typical)

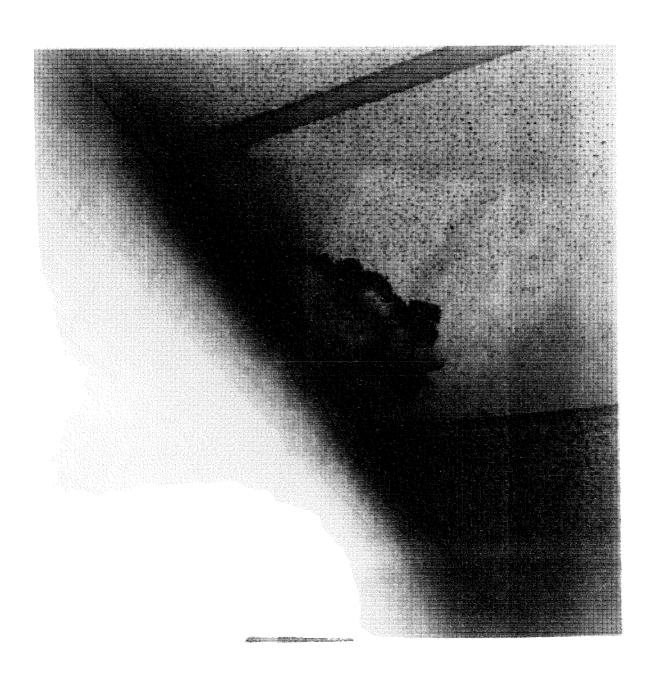
2-6

During significant rain events and snow melts the roof leaks in several areas, particularly the Fine Arts building. This

causes ceiling tiles to become water soaked and introduces potential mold issues, as well as tripping hazards due to wet floors.

Missing/Water Damaged Ceiling Tiles

(Typical)

We line up buckets to capture leaks, place safety cones, and mop areas until the leaks subside. We frequently replace

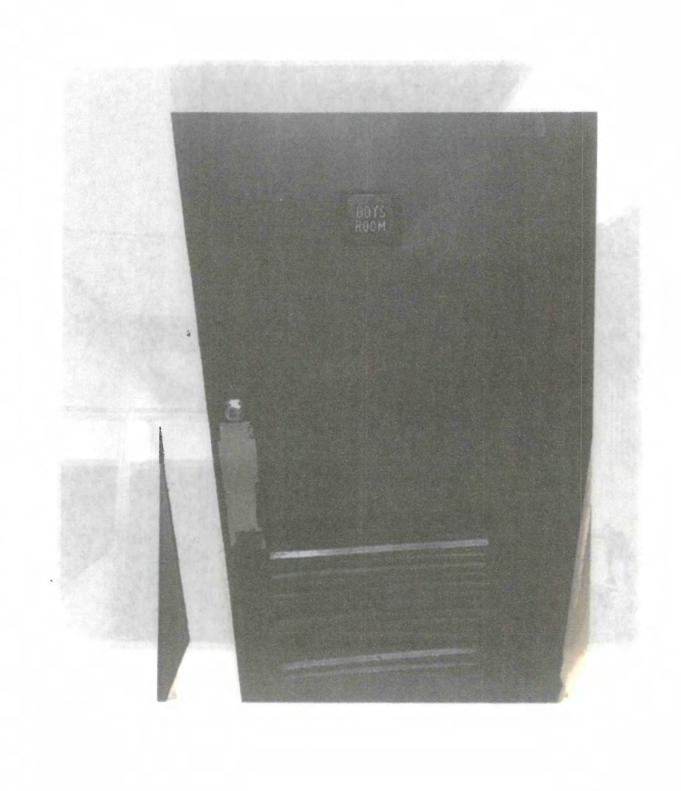
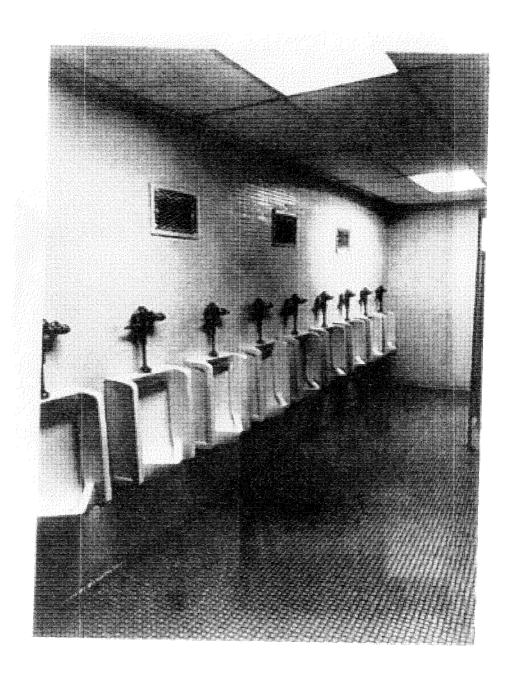
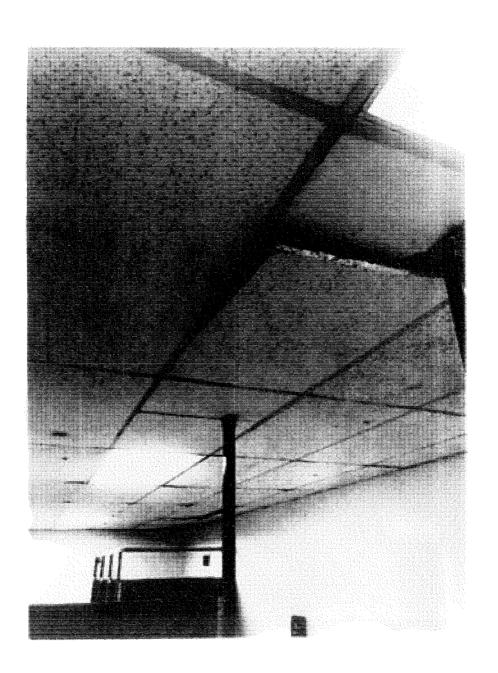
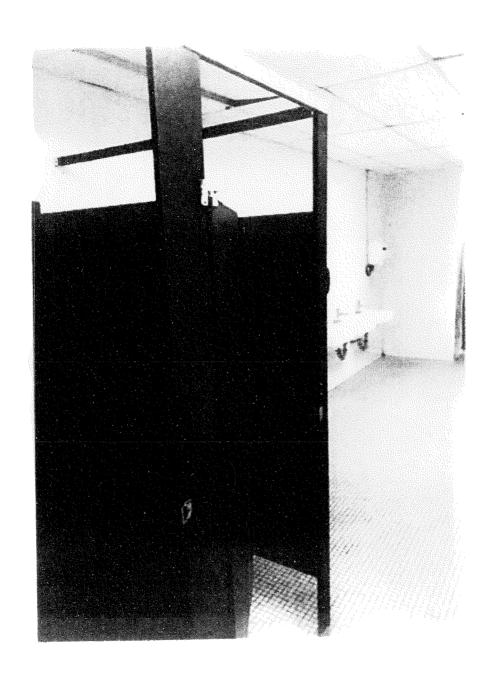
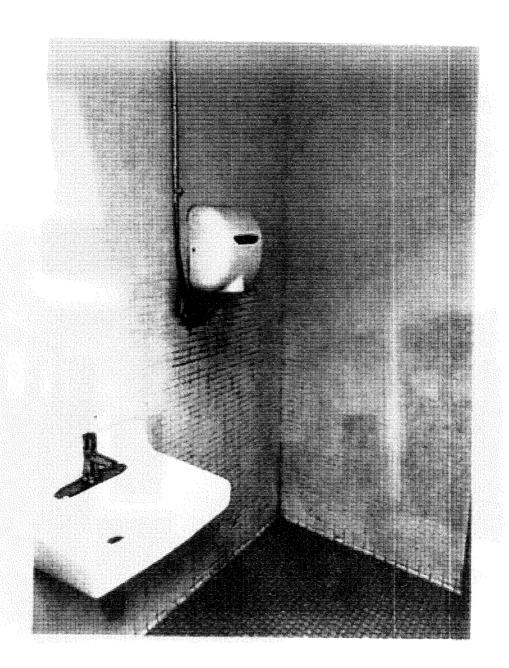
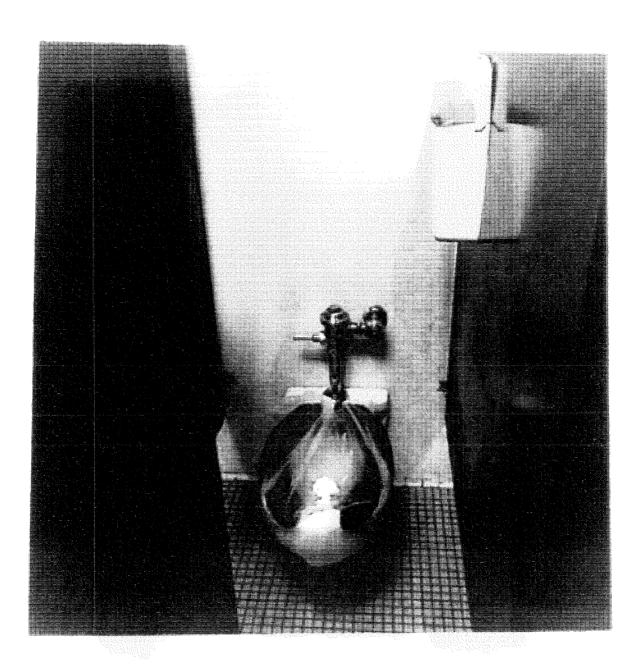
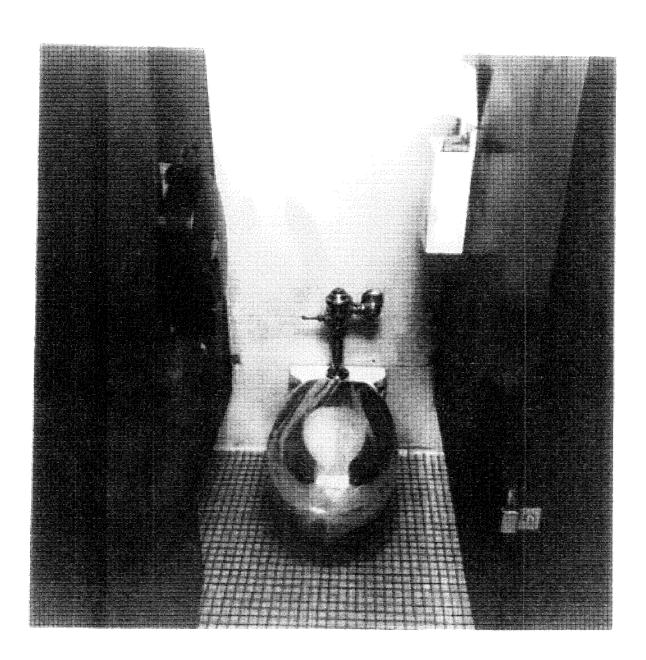
2-1

Student Bathrooms

(Typical)

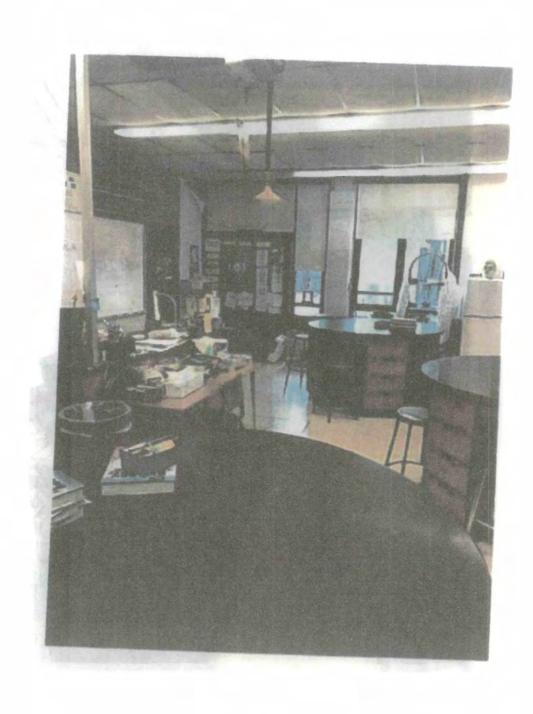
2-K

Science Labs/Classrooms
