Report on Geotechnical Pavement Investigation

# **Larson Middle School** 2222 East Long Lake Road Troy, Michigan 48085

G2 Project No. 220949 December 27, 2022

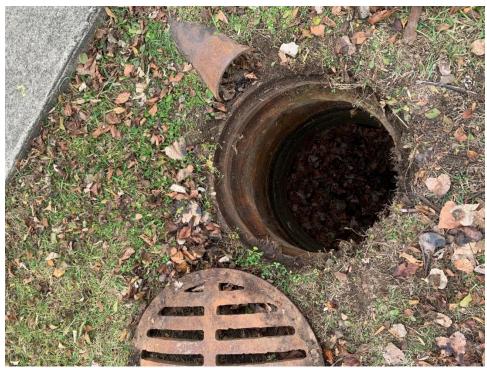
Photograph No. 16: Catch basin adjacent to drain.

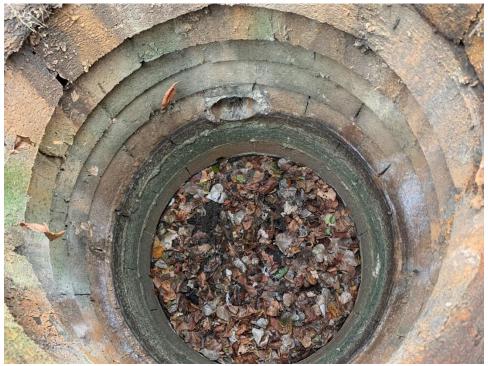
Photograph No. 17: Interior of catch basin adjacent to drain.

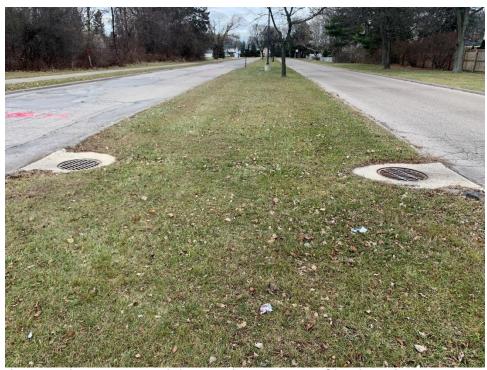
Photograph No. 18: Catch basins along interior of boulevard. Note newer concrete collars.

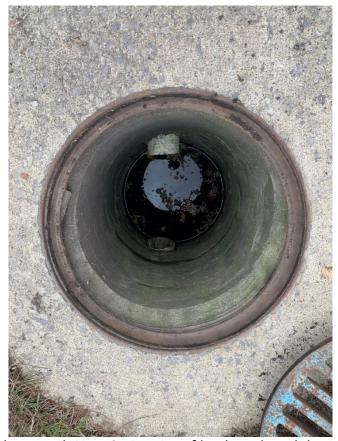
Photograph No. 19: Interior of boulevard catch basin.

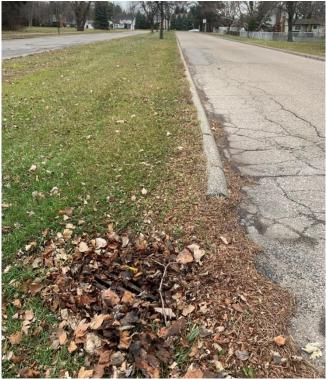
Photograph No. 20: Catch basin along interior of boulevard at south end of drives.

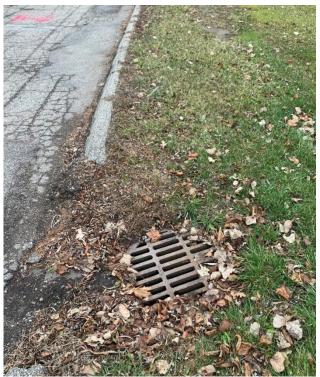
Photograph No. 21: Catch basin along interior of boulevard at south end of drives.

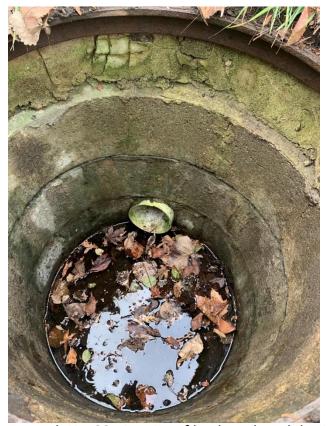
Photograph No. 23: Interior of boulevard catch basin.

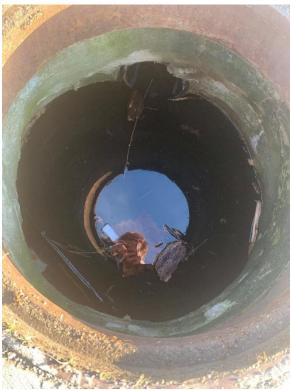
Photograph No. 15: Interior of precast storm structure with standing water.

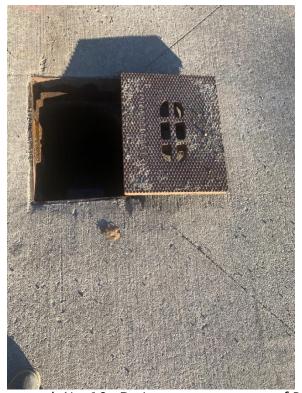
Photograph No. 18: Drainage structure east of B-2.

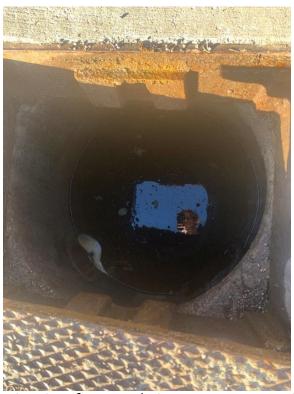
Photograph No. 19: Interior of precast drainage structure near B-2, holding water.

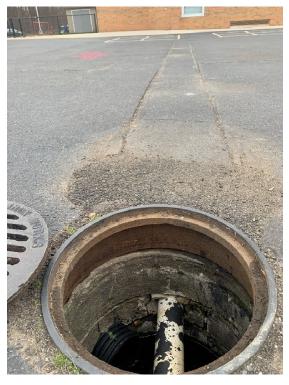
Photograph No. 12: Catch basin with sediment around structure. Note previous sawcut patch south of B-6, in east/west direction.

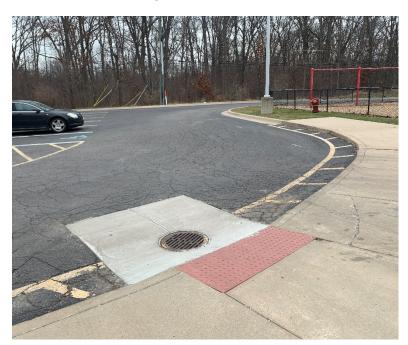
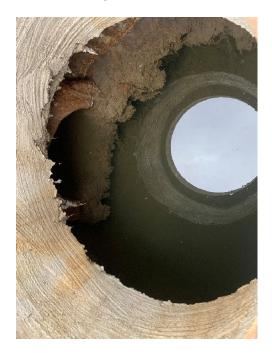
Photograph No. 18: Catch basin with newer concrete collar.

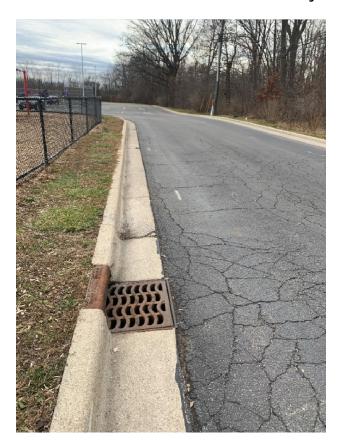
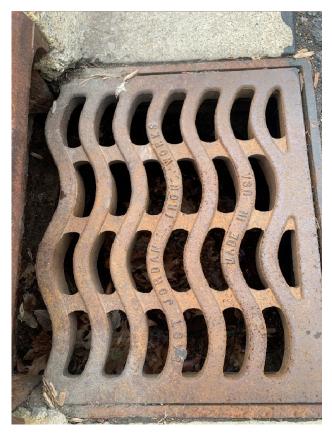
Photograph No. 19: Drainage structure in gutter along south side of drive.

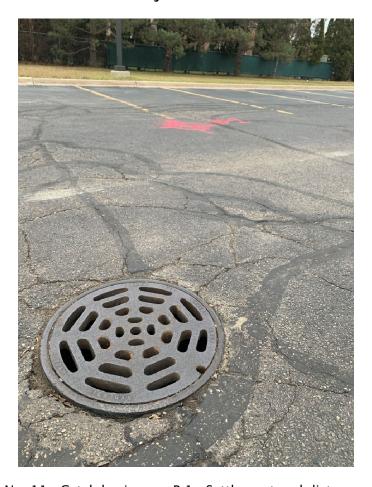
Photograph No. 11: Catch basin near B-1. Settlement and distress around basin.

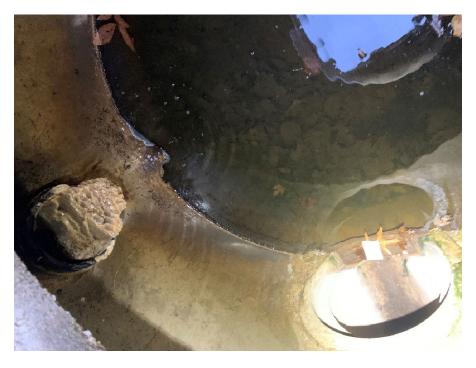
Photograph No. 12: Interior of basin, holding water.

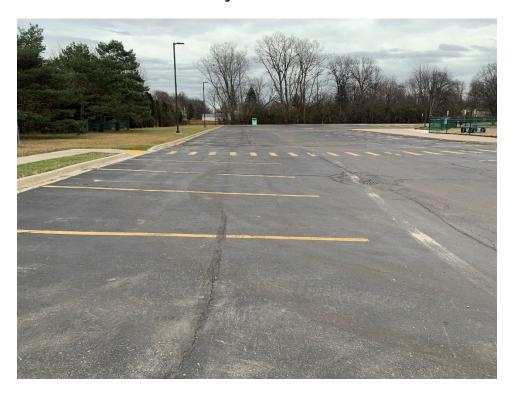
Photograph No. 13: Pavement west of areas to be reconstructed. Note settlement around drainage structure.
