TEXARKANA ISD

Facility Assessment Capacity Analysis Presentation

March 23, 2022

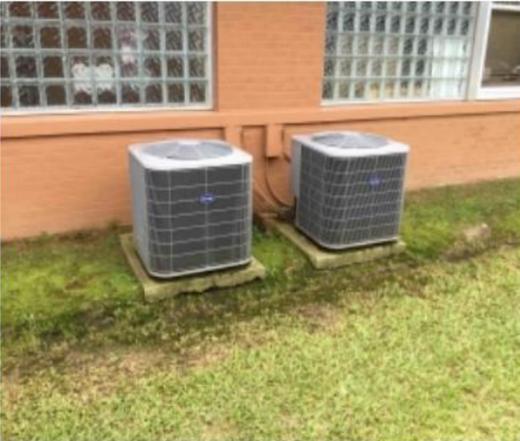
Erosion present at mechanical pads

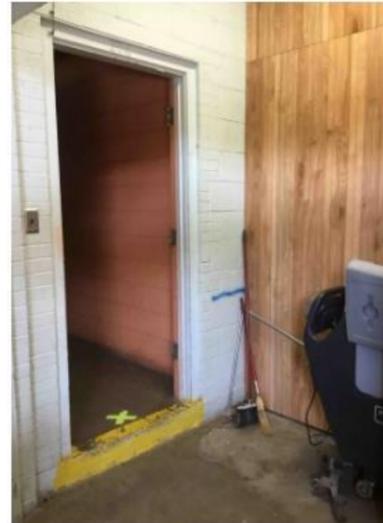
Inaccessible paths of travel throughout.

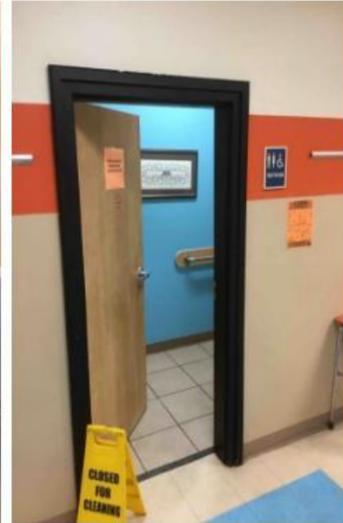
Non-compliant door signage, typical throughout (sign type, mounting height).

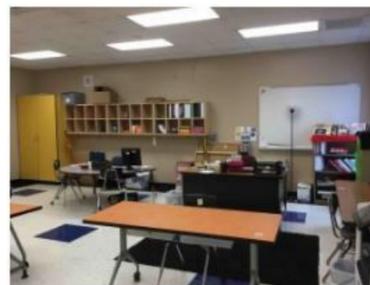
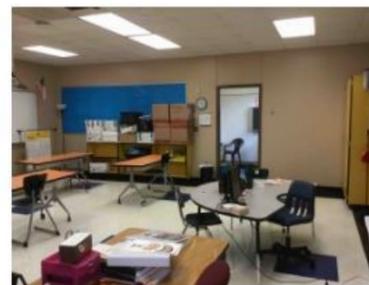
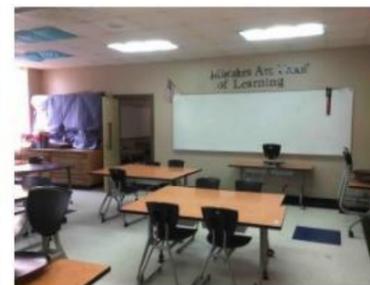
Core Classroom – Typical North Wing Classroom

Minor wall and floor scuffs. One centrifugal unit.

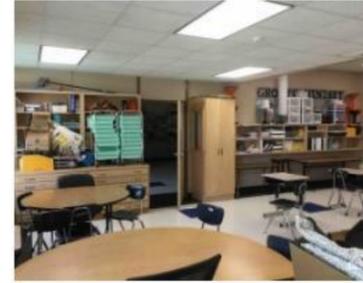
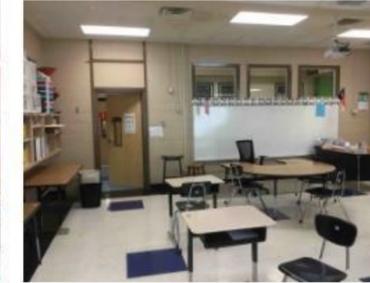
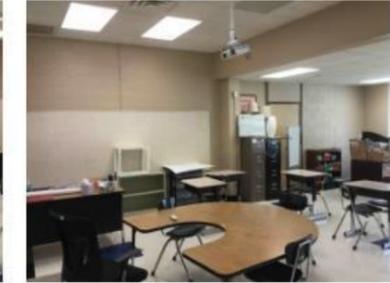
Core Classroom – Typical East Wing Classroom

Minor wall and floor scuffs.

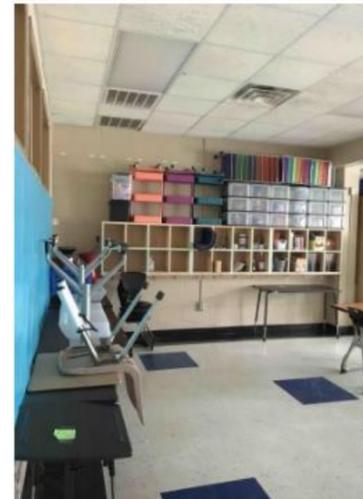
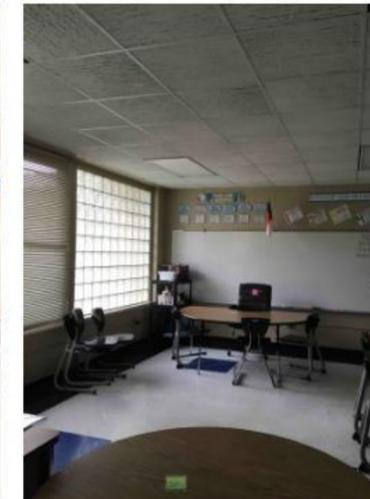
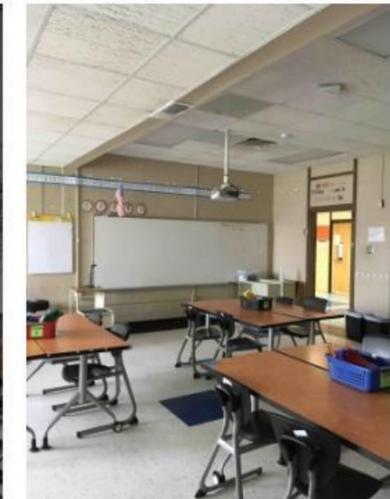
Core Classroom – Typical West Wing Classroom

Minor wall and floor scuffs.

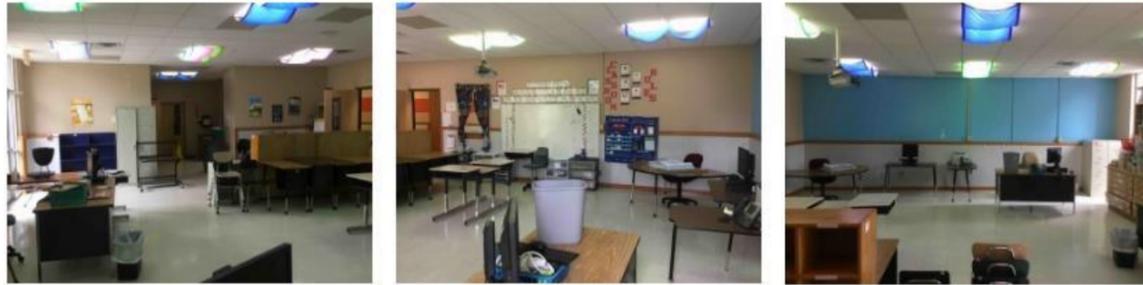
Typical SPED Classroom

Overall good condition, updated finishes. Staff noted that recent flooding in this room seems to be from adjacent kitchen.

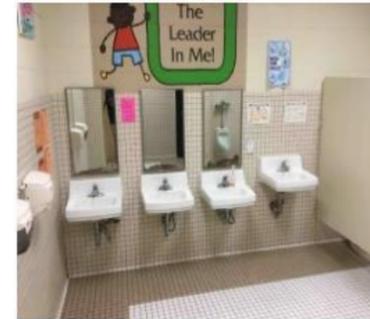
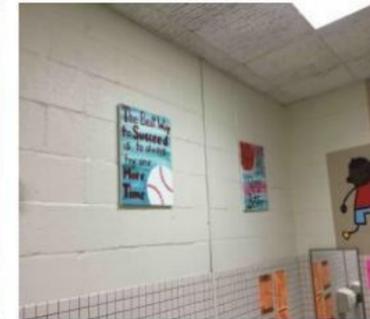
Group Restroom (near front entry)

Missing proper latch clearance on stall interior. Ceiling in poor condition.

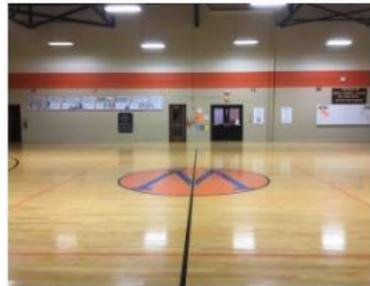
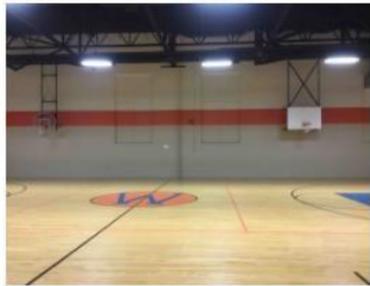
Gymnasium

Original gym detached from main building with no awning connection. Staff noted gym is lacking storage. Exposed ductwork in need of refinishing.

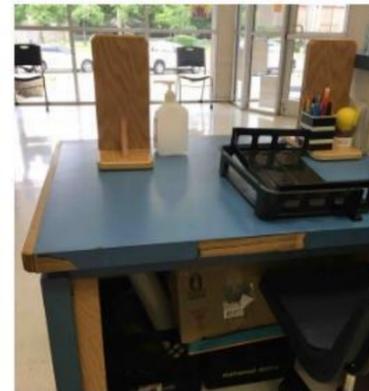
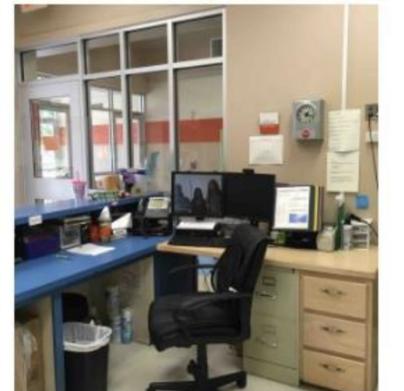
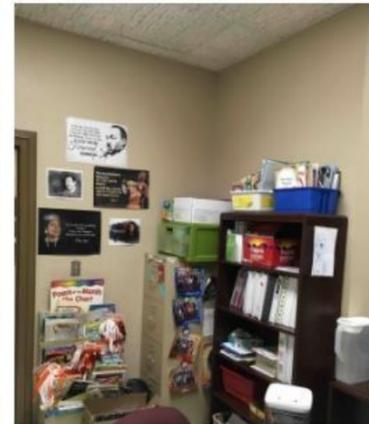
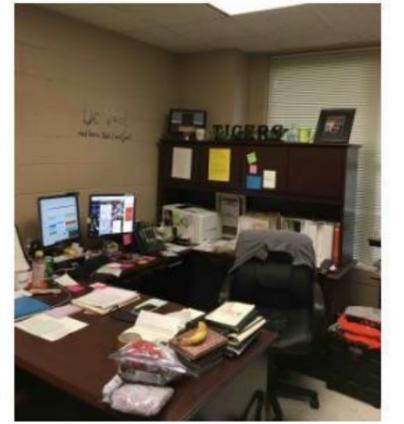
Typical Office

Overall fair condition. Offices appear undersized.

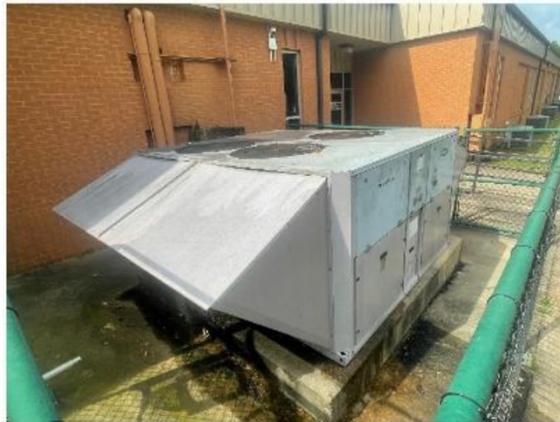
2004 Carrier Air Cooled Chiller

Westlawn Elementary School mechanical systems consist of Carrier 2004 chilled water equipment and 2012 Carrier Dx equipment. The 2004 Carrier air cooled chiller and chilled water air handler unit is in poor condition. It is recommended that the chilled water equipment/system be replaced during the next renovation. The 2012 Dx equipment is in good condition and has approximately 5-10 years of useful life remaining.

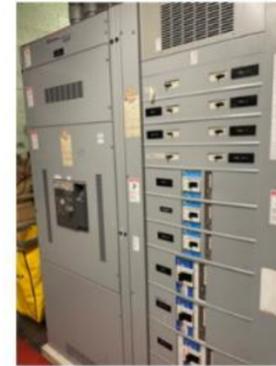
3000 Amp 120/280 MSB – Cutler Hammer 2000

The main switch boards, panels, transformers, etc. are in good to moderate condition. The main switch gear and many of the panels were replaced in 2000. There are some older ITE, GE and Square D panels located in some areas of the campus. Replacing the older panels throughout the campus is recommended during the next renovation. The interior lighting was observed to be in good working condition. Upgrading the interior lighting to LED with a modern controls system during the next renovation is recommended. The exterior lighting on the site is recommended to be upgraded to LED to reduce energy usage.

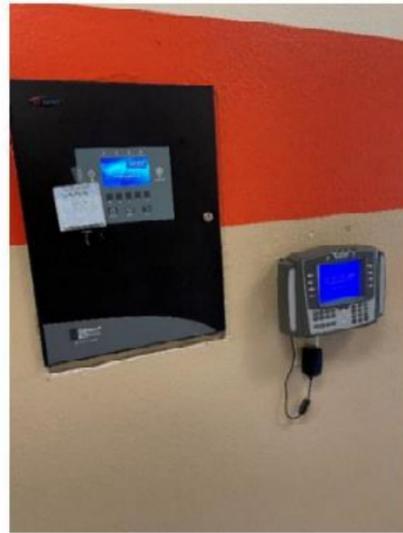
Fire Alarm Panel

The building fire alarm system was installed in 2017 and appears in good working condition. The facility is not equipped with a fire sprinkler protection system. It is recommended that a sprinkler system be installed during the next renovation.
