ICON
ARCHITECTURAL GROUP

FACILITY ASSESSMENT FOR GRAND FORKS PUBLIC SCHOOLS

Grand Forks, ND

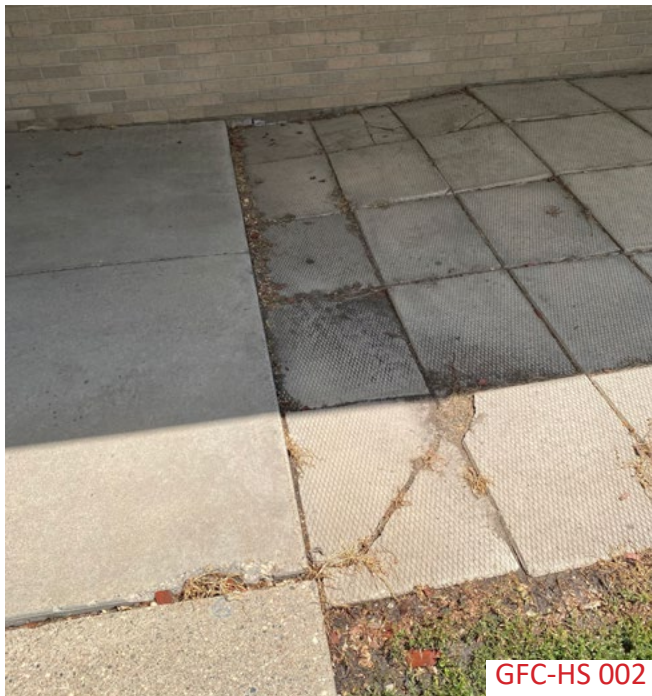
The exterior sidewalks, curbs, and pavement are deteriorating in certain areas (002). On the outside of Door 4, pavers are worn and cracked, exposing the roof and the space below (003).

The exterior sidewalks, curbs, and pavement are deteriorating in certain areas

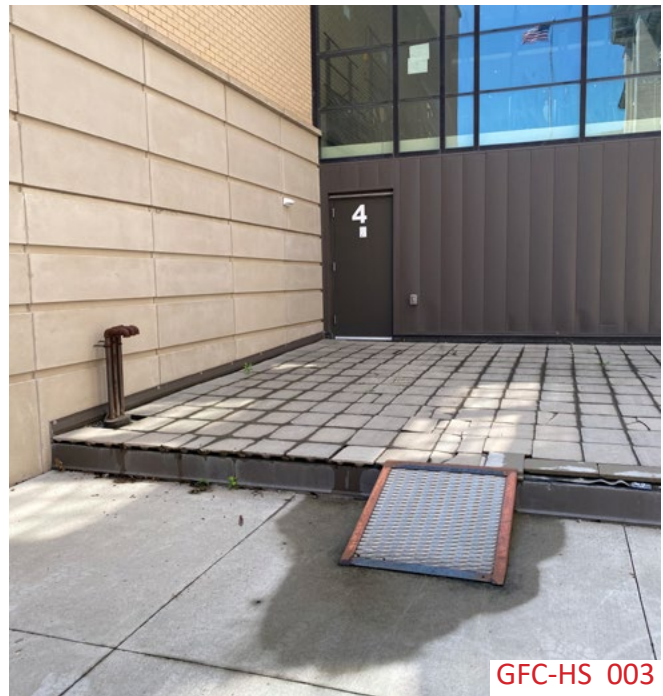
On the outside of door 4, pavers are worn and cracked, exposing the roof and the space below.

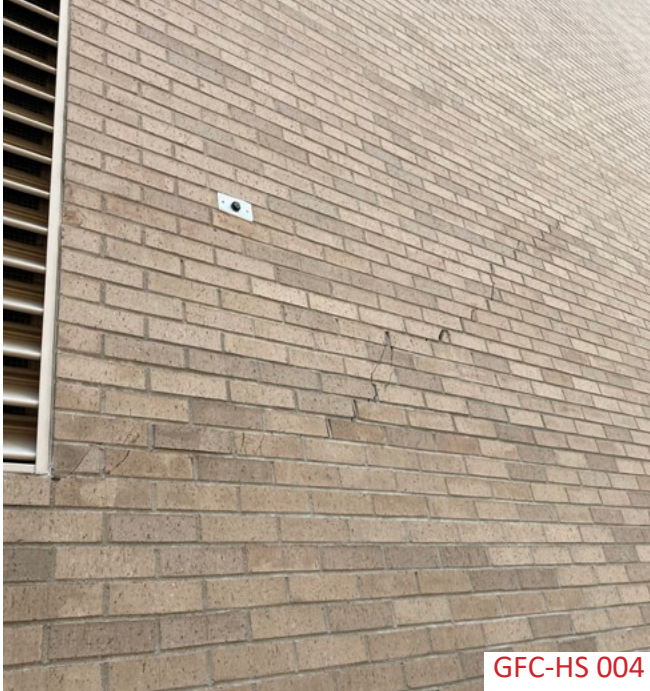
GFC-HS 004

There are several cracks in the brick on the athletics portion of the building and the caulking in this area needs attention.

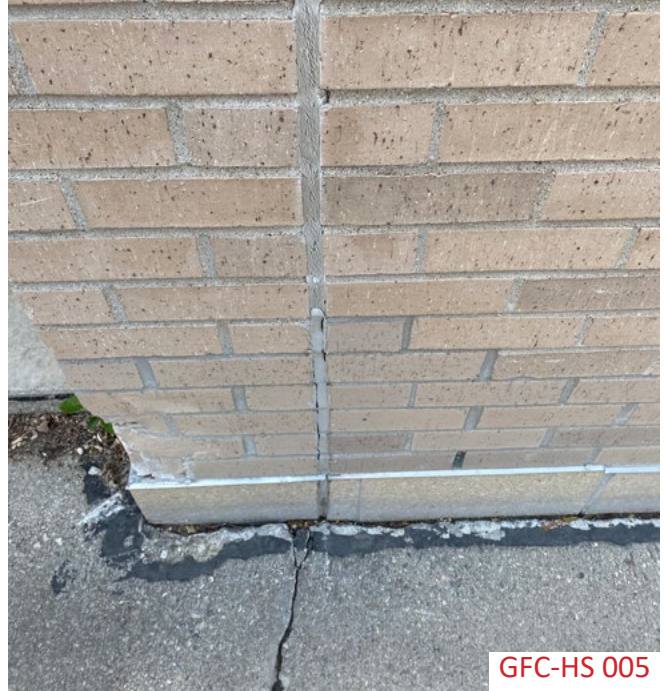
GFC-HS 005

There are several cracks in the brick on the athletics portion of the building and the caulking in this area needs attention.

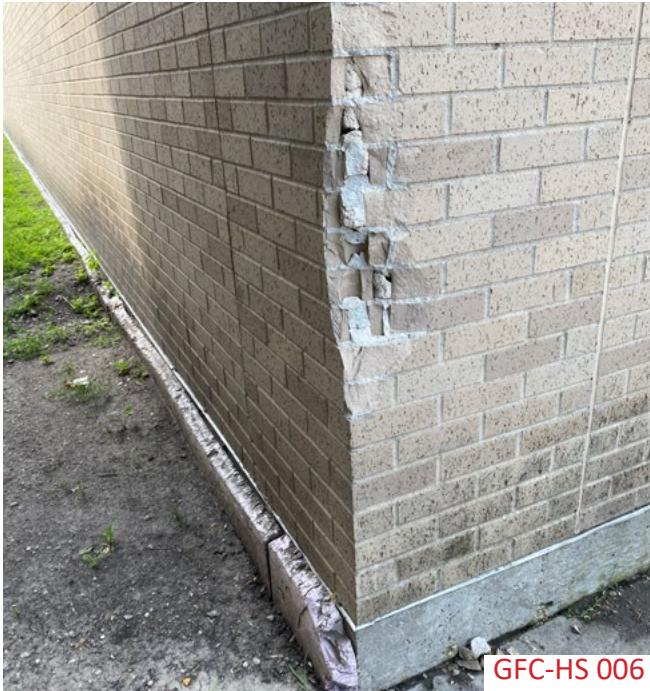
GFC-HS 006

There are several cracks in the brick on the athletics portion of the building and the caulking in this area needs attention.

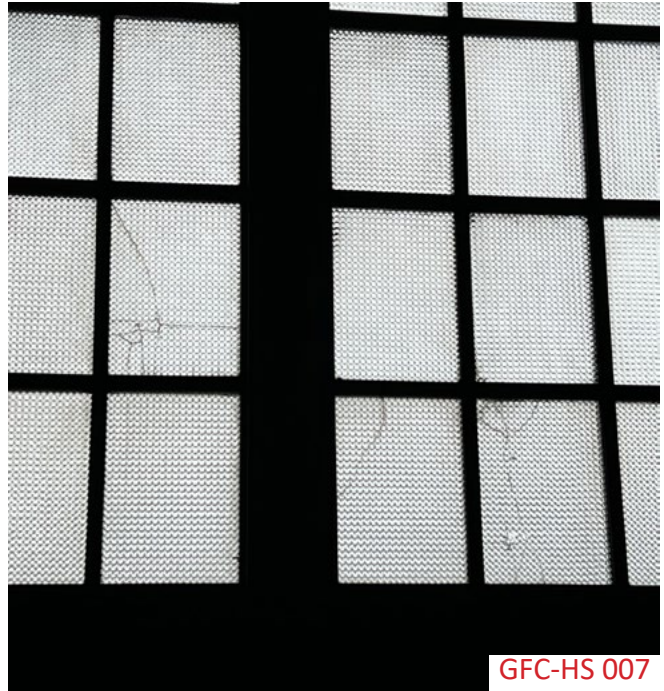
GFC-HS 007

General maintenance of the windows is needed as most windows seem to be leaking in the frame. There are some cracked windows in the basement that can be seen from the exterior and the glass panels over Door 13 have broken panels (007). Overall, the doors are in good condition and have the proper hardware required. The only doors with issues are those that have a traditional knob, which need to be switched to ADA compliant handles, and those that do not have proper maneuvering clearances for accessibility.

There were some cracked windows in the basement that could be seen from the exterior and the glass panels over door 13 had broken panels.

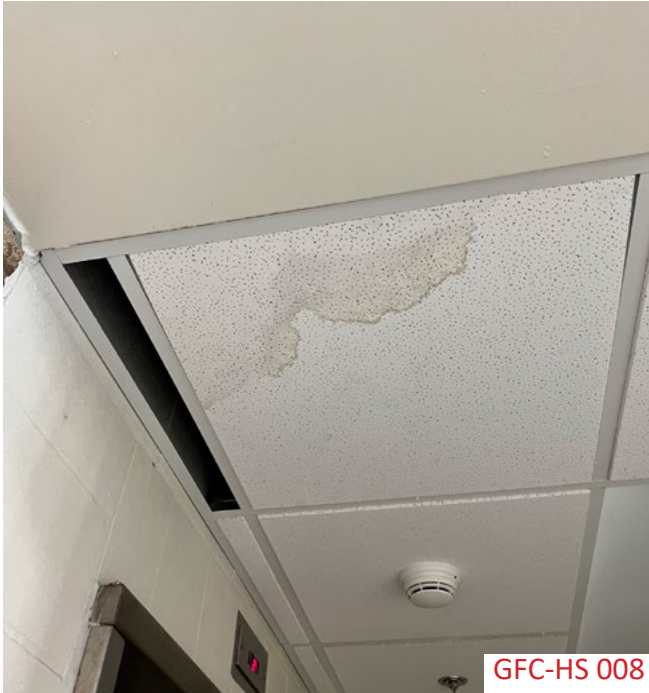
GFC-HS 008

The ACT is generally in good condition in most of the classrooms, but there are some areas with water damage.

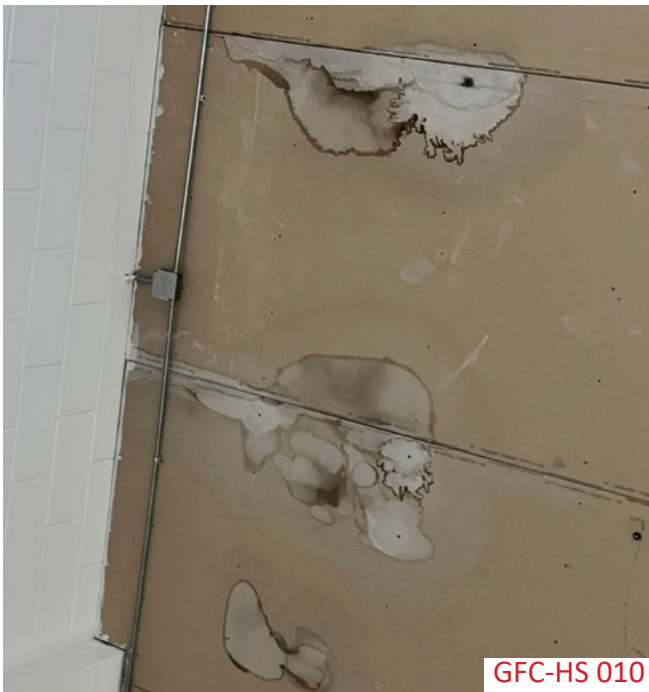
GFC-HS 010

Portions of the unpainted gypsum board in the gymnasium also have water damage that is visible.

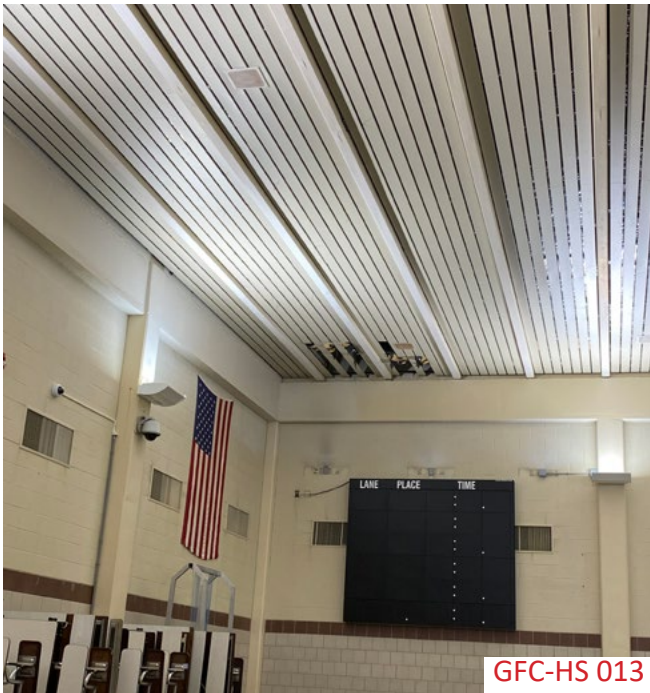
GFC-HS 013

A portion of the ceiling in the pool area was taken out to examine the moisture damage to the roof.

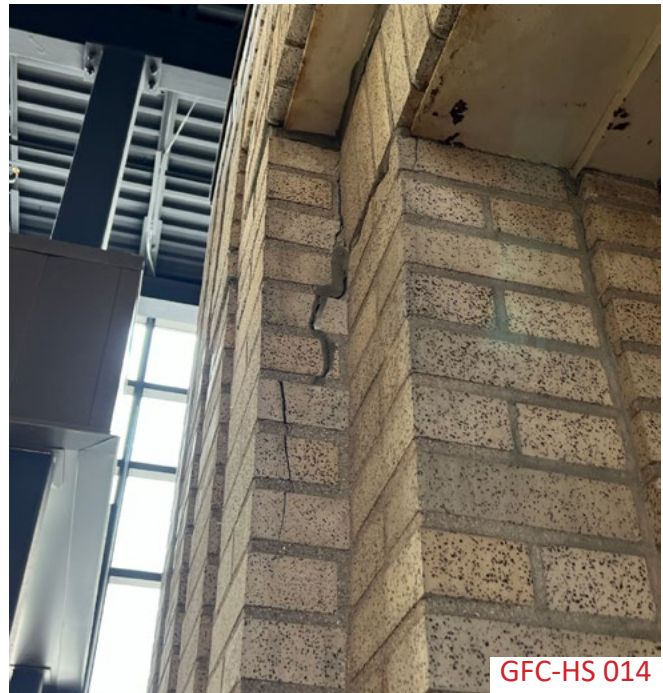
GFC-HS 014

Several cracks appear to be caused by minor structural shifting.

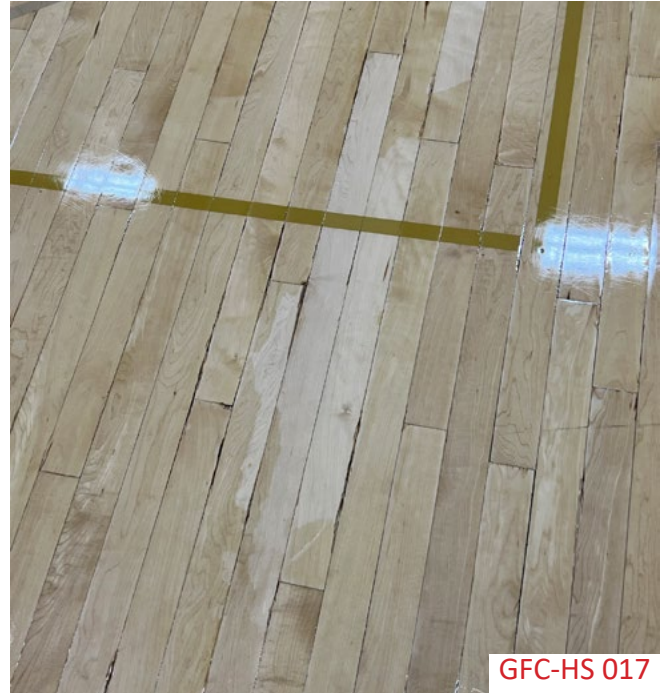
GFC-HS 017

The main gym floor is also very old with uneven patches of the sealant and replacement should be considered.

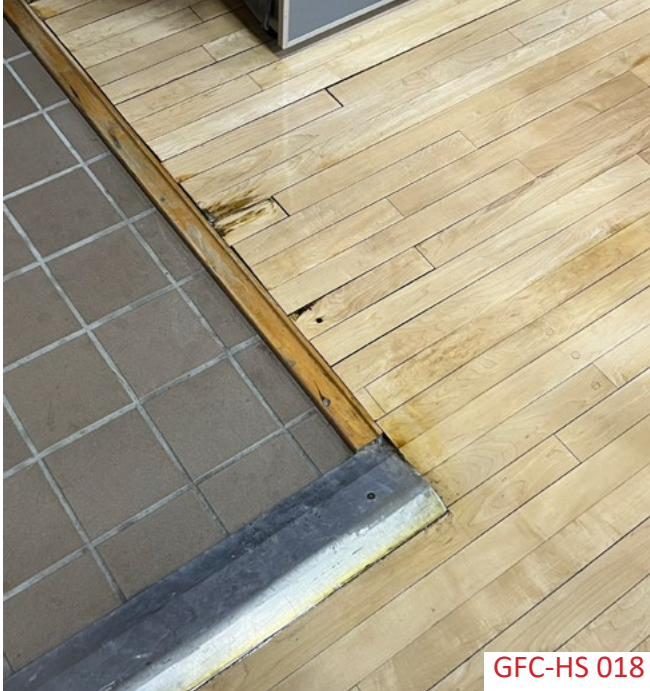
GFC-HS 018

The main gym floor is also very old with uneven patches of the sealant and replacement should be considered.

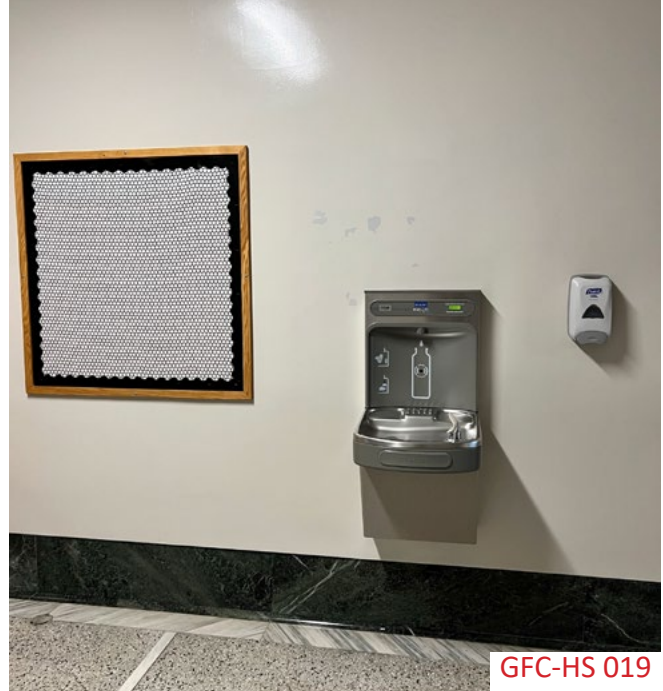
GFC-HS 019

Drinking fountains throughout the building do not meet the required ratio of wheelchair accessible fountains to standing person accessible fountains.

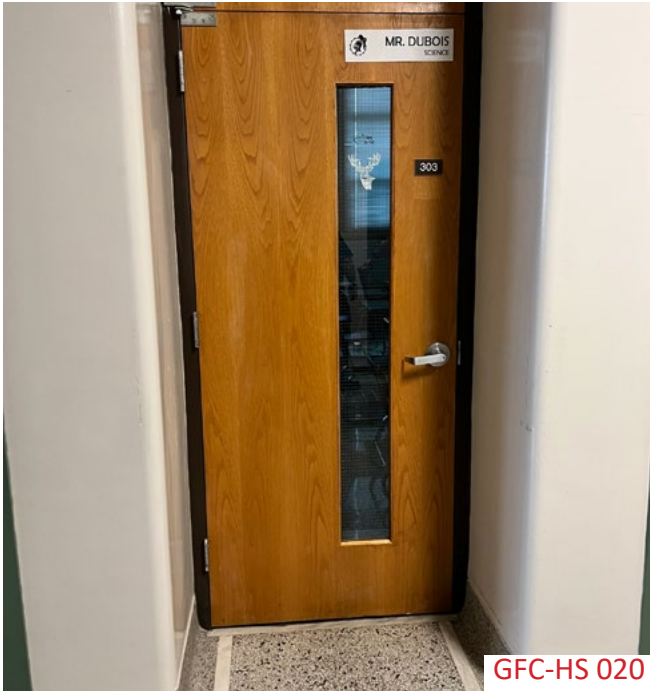
GFC-HS 020

Most classroom door approaches in the original portion of the building fail to meet required maneuvering clearances for accessibility.

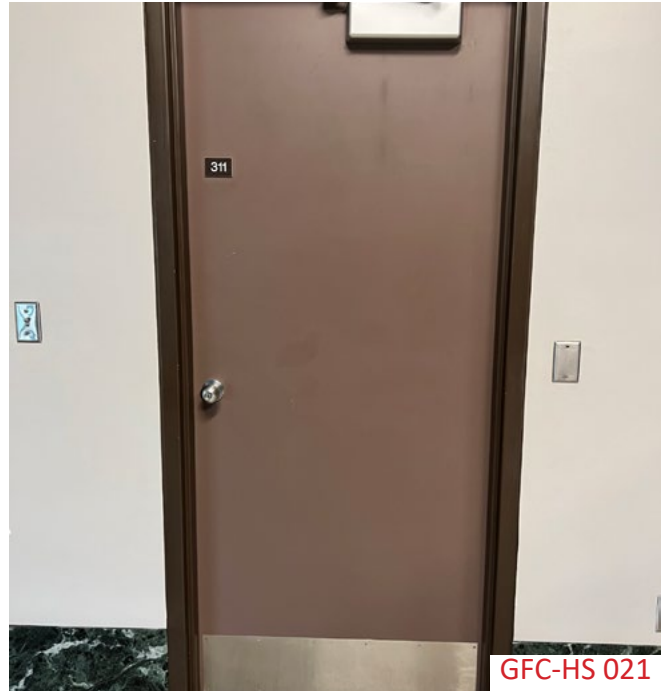
GFC-HS 021

Door hardware throughout the building is not accessible. Most of the non-compliant hardware is on doors in storage areas, janitor closets, mechanical rooms, etc. All classrooms have sufficient door hardware.

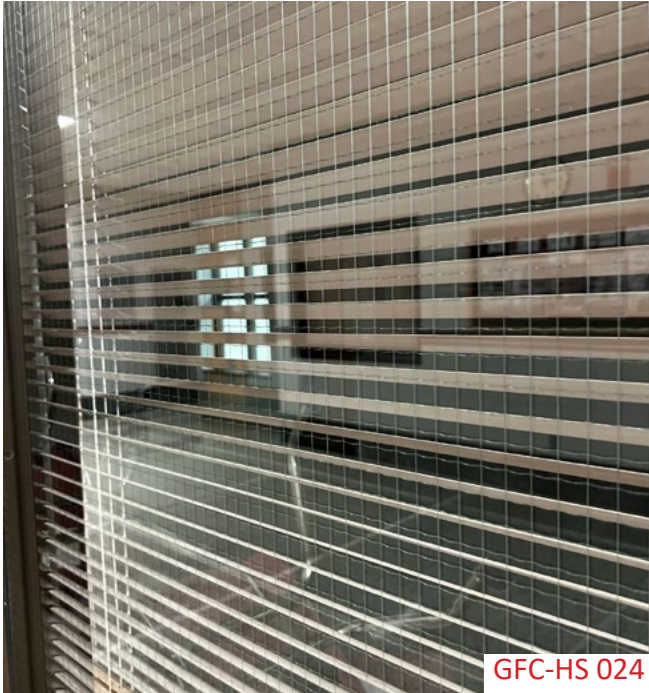
GFC-HS 024

Traditional wire glass throughout the building is no longer to code as an acceptable type of safety glass.

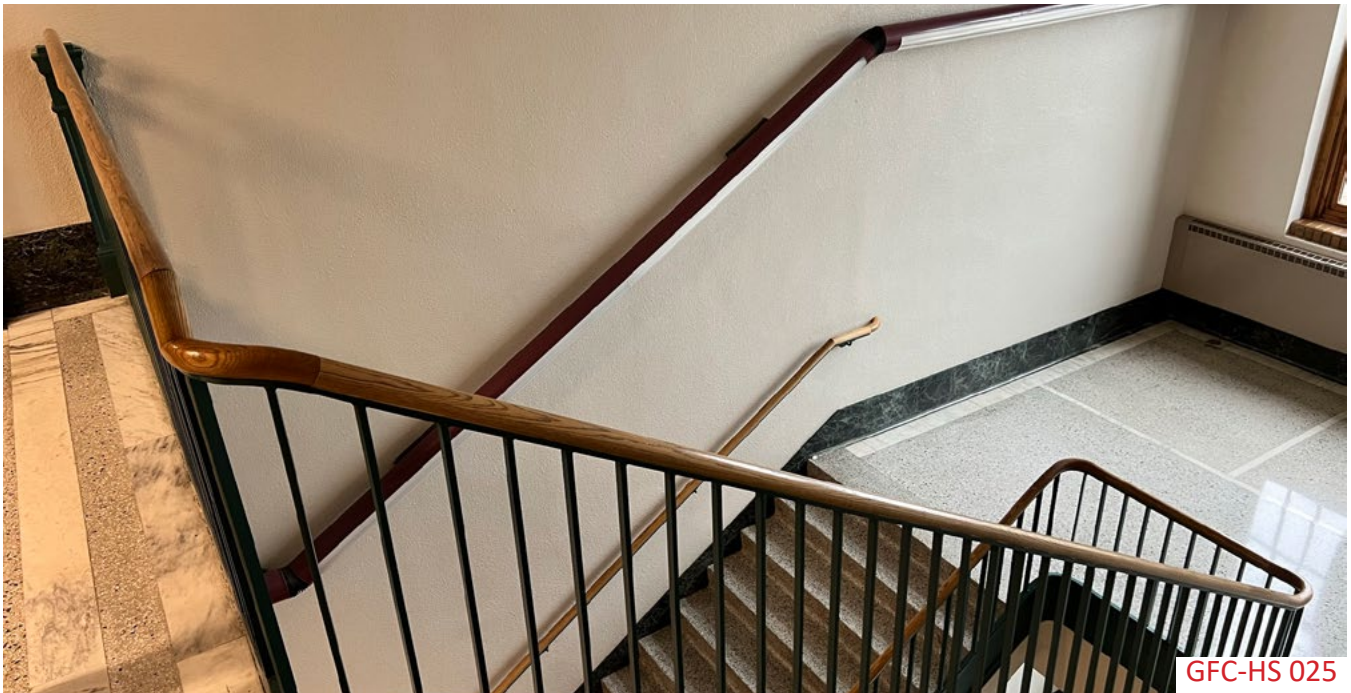
GFC-HS 025

All stairs in the original areas of the school are lacking a separate handrail from the guardrail.

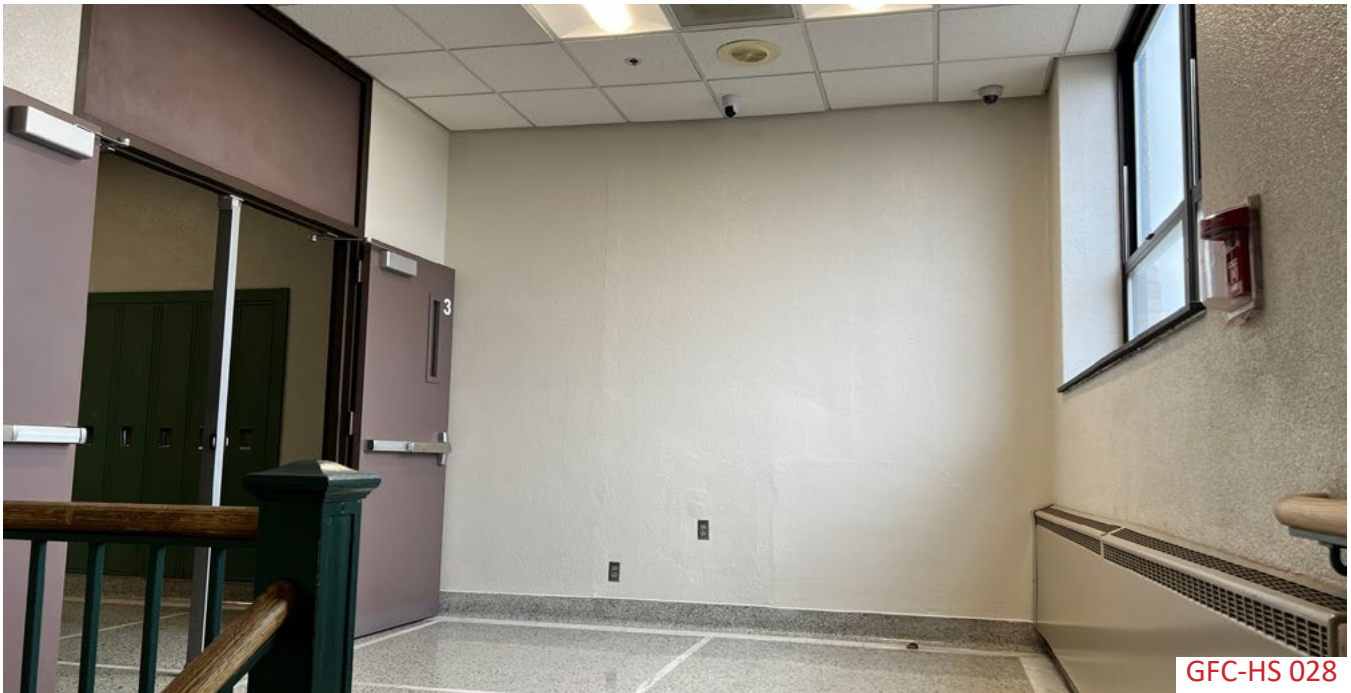
GFC-HS 028

Stairwells lack proper signage within them to show which level someone is on at the landings.

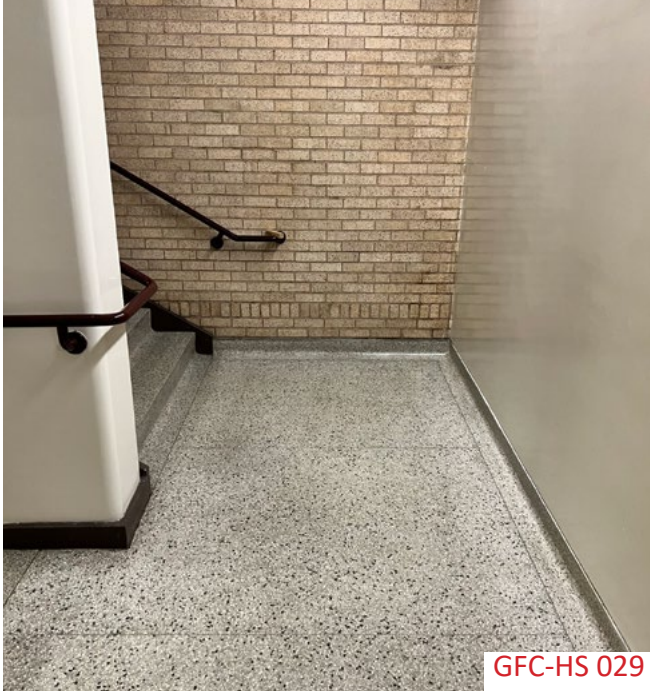
GFC-HS 029

Landings in the stairwell adjacent to the commons are not deep enough. They need to be as deep as the staircase width.

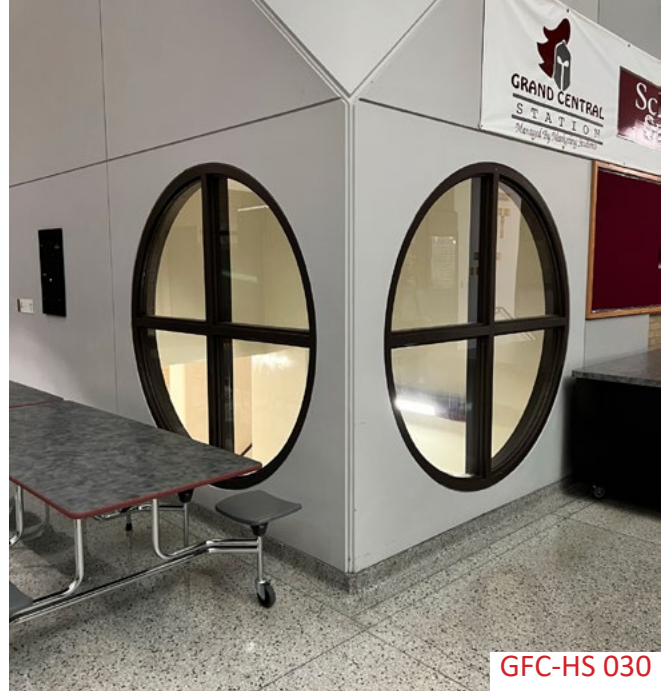
GFC-HS 030

Stairwell to the south of the commons/cafeteria has windows on the main level that are not fire-rated, meaning the stairwell is not properly enclosed.

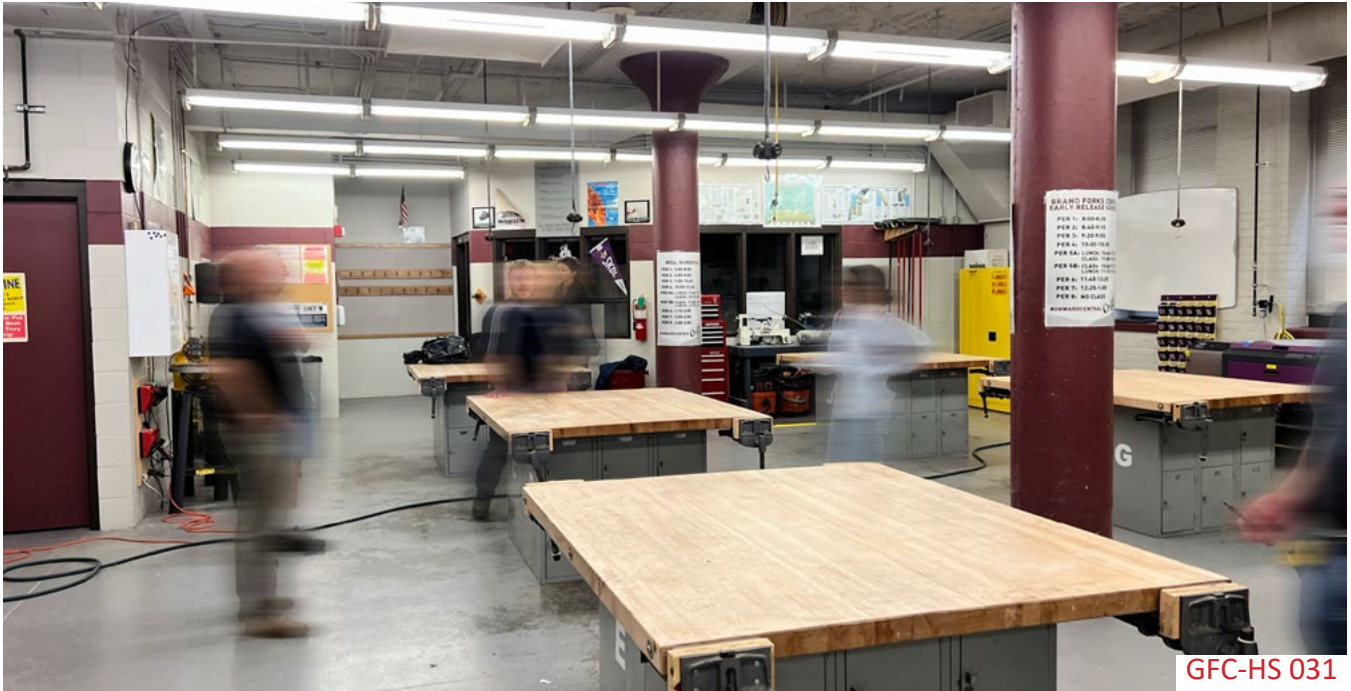
GFC-HS 031

Woodshop has no ADA compliant workstations, no accessible sinks, and no accessible eyewash station.

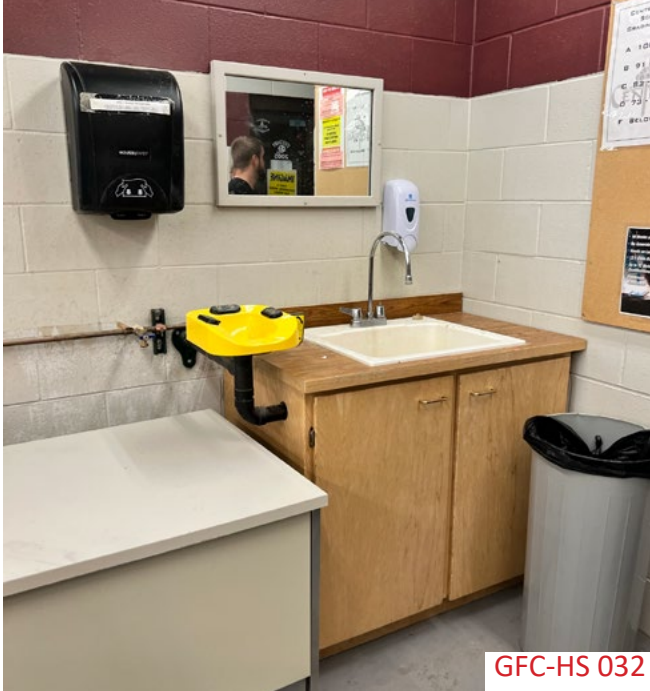
Woodshop has no ADA compliant workstations, no accessible sinks, and no accessible eyewash station.

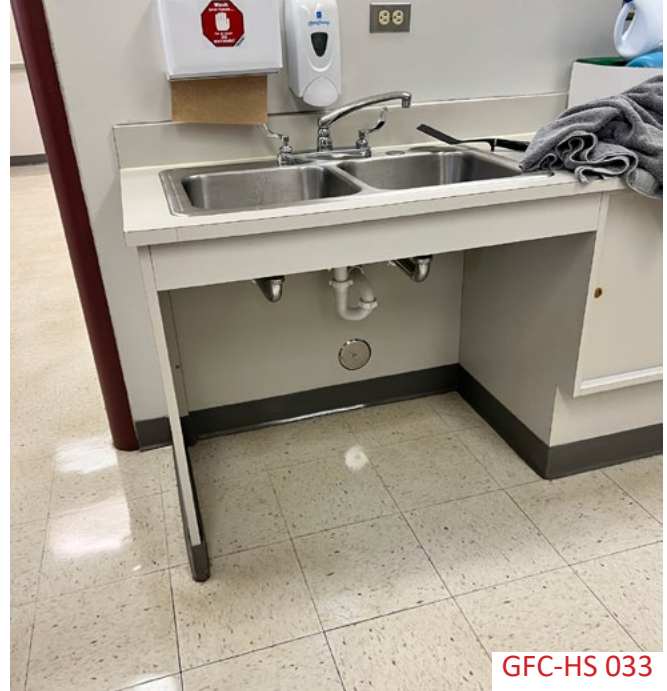
The pipes underneath the accessible sink in Room 24 are not protected.

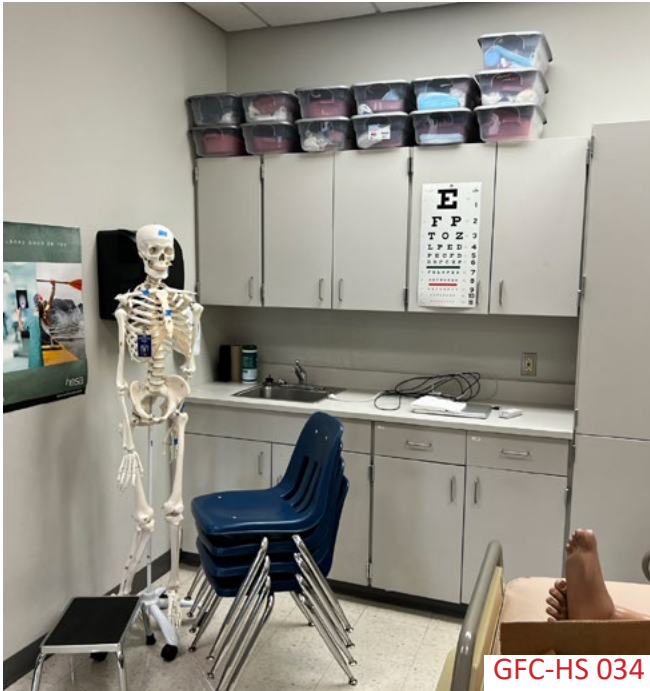
The health professions class (Room 30) does not have an accessible sink.

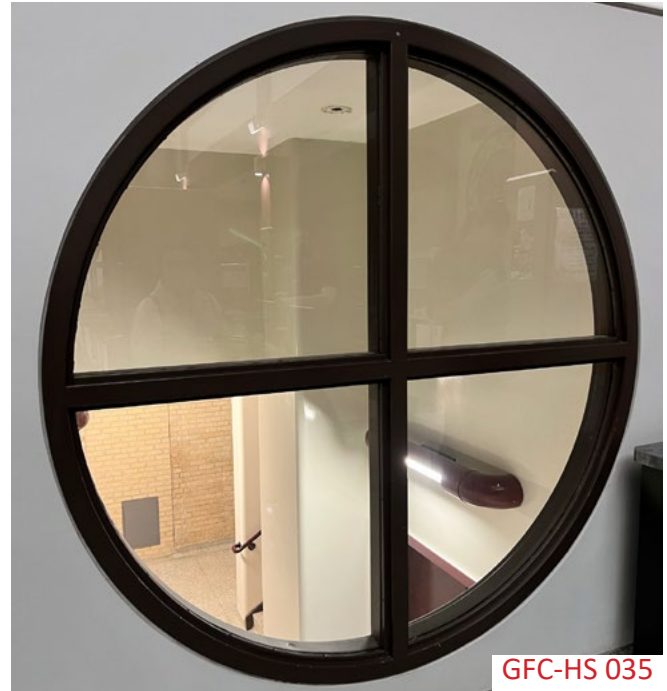
Interior windows in the commons/cafeteria that face the adjacent stairwell do not have the required safety glass.

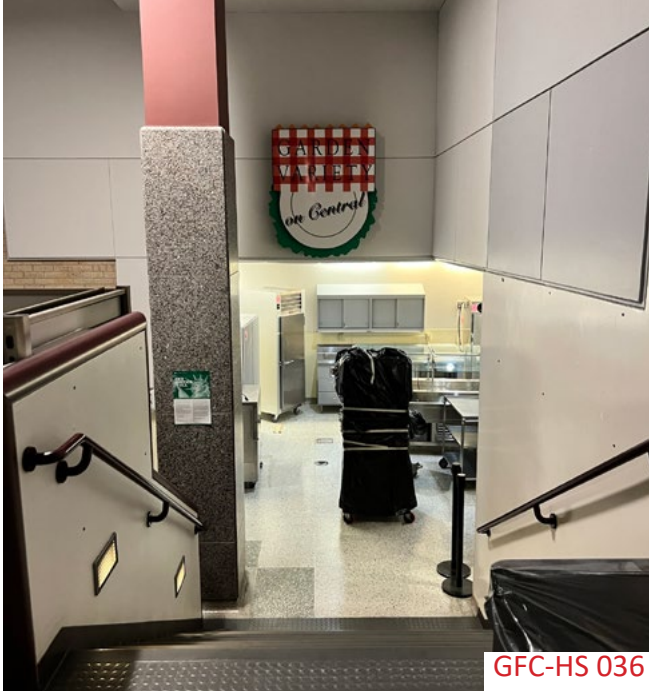
GFC-HS 036

Food service area has many stairs without accessible ramps and most areas lack the sufficient clearances needed.

Description	Item Number	Takeoff Qty	Total Cost/Unit	Critical	5 yrs Deferred Maint	10 yrs Deferred Maint	Educational Adequacy	Synergistic with other needs	Total Cost
Add wheel chair lifts in the food service area that has many stairs without accessible ramps	28	1 Ea	\$81,556.74 / Ea	\$81,557					\$81,557
Replace the ceiling in the kitchen with a scrubbable surface (including serving line and serving)	29	2,875 SF	\$10.53 / SF	\$30,283					\$30,283
Remove the toilet partitions to make the faculty restrooms ADA accessible	30	2 Ea	\$7,110.30 / Ea	\$14,221					\$14,221
Replace doorknobs in the main office on the main level with ADA compliant hardware	31	20 Ea	\$908.51 / Ea	\$18,170					\$18,170
Create one accessible station/desk area in the main office	32	1 Ea	\$8,018.49 / Ea	\$8,018					\$8,018
Replace casework (9 lf of base, top, and upper cabinet) in the conference room (Room 141) to make the sink accessible	33	1 Ea	\$16,102.05 / Ea	\$16,102				X	\$16,102

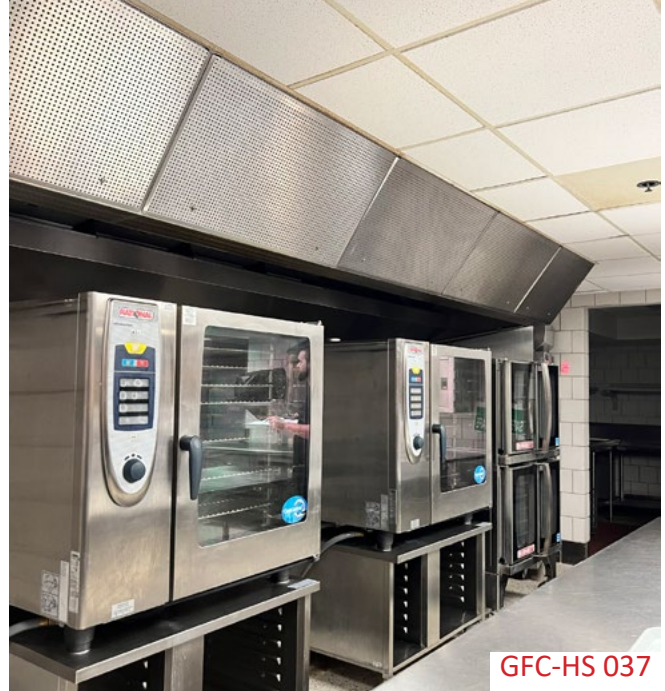
GFC-HS 037

The kitchen ceiling tile is not a scrubbable surface, as required by code.

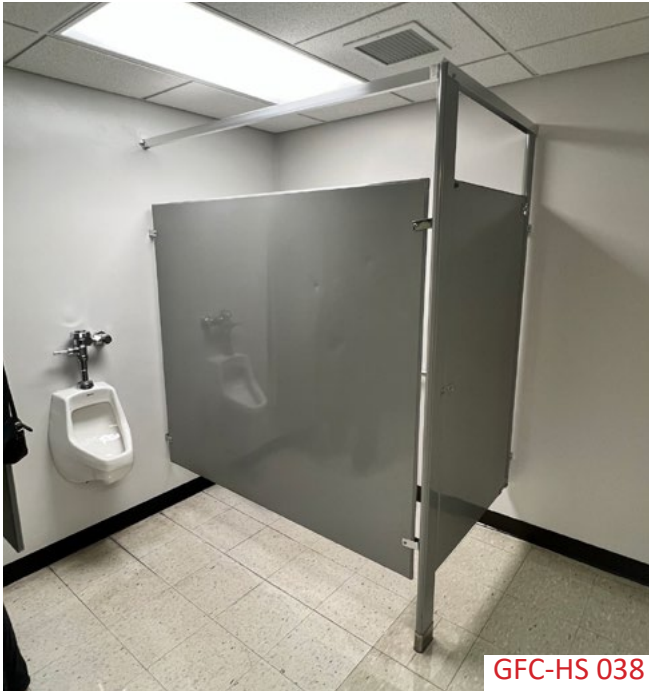
GFC-HS 038

Both faculty restrooms are not accessible due to the absence of an accessible stall.

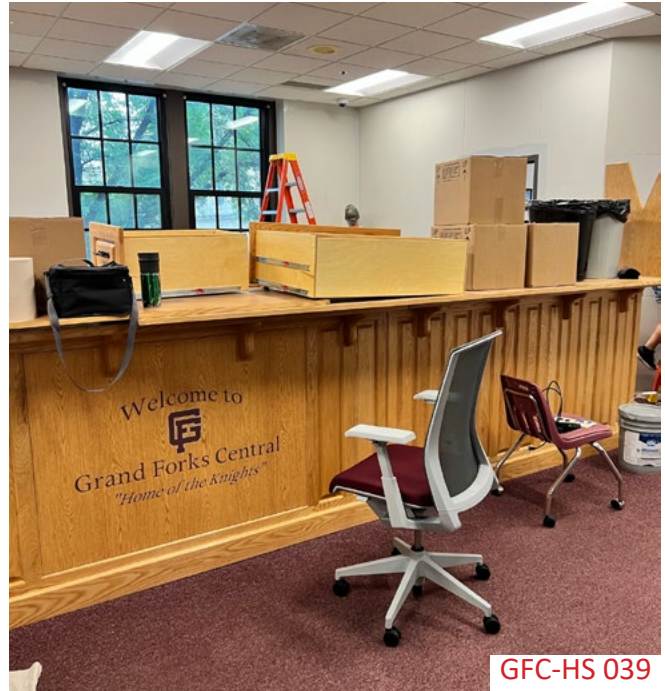
GFC-HS 039

Main office lacks an accessible station/desk area.

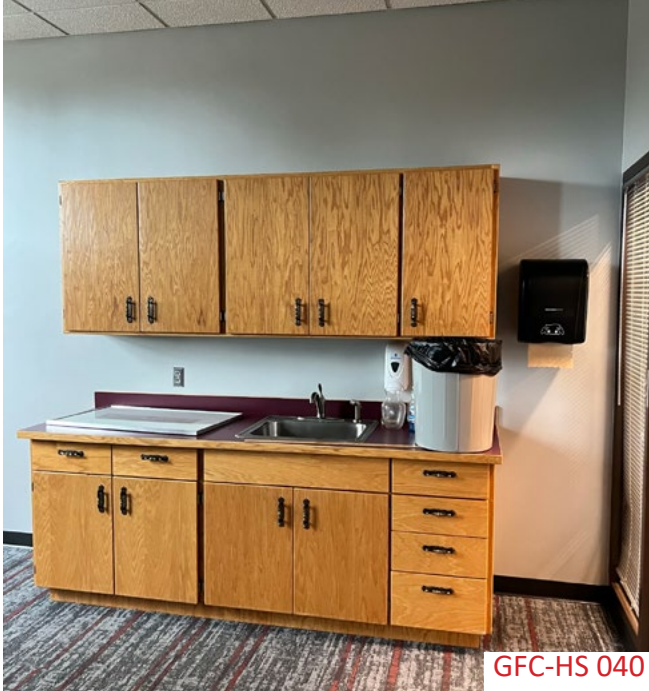
GFC-HS 040

The conference room (Room 141) sink is not accessible.

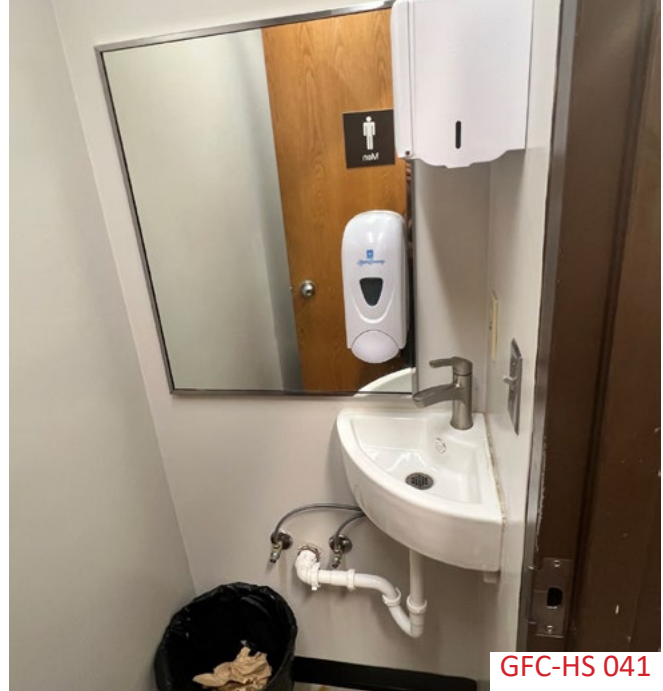
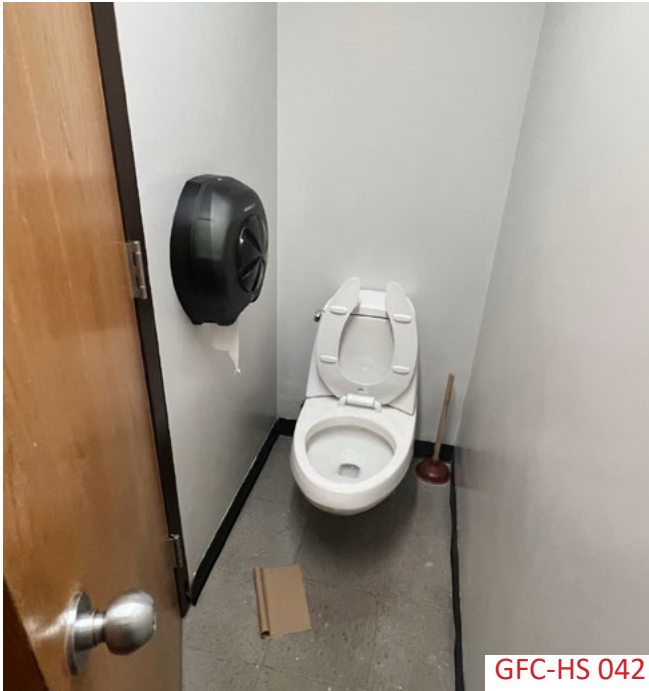
Both men's and women's restrooms in the main office are not accessible.

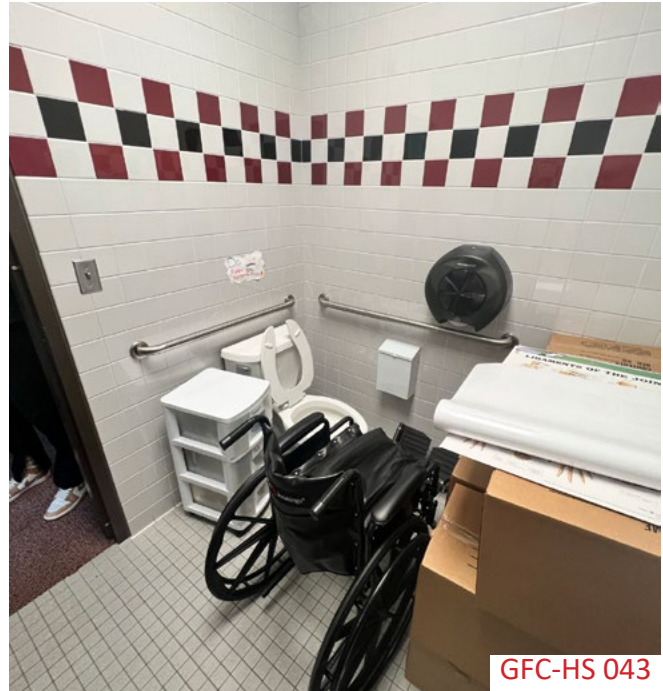
GFC-HS 043

The nurse's office restroom is not accessible as it is lacking sufficient clearances.

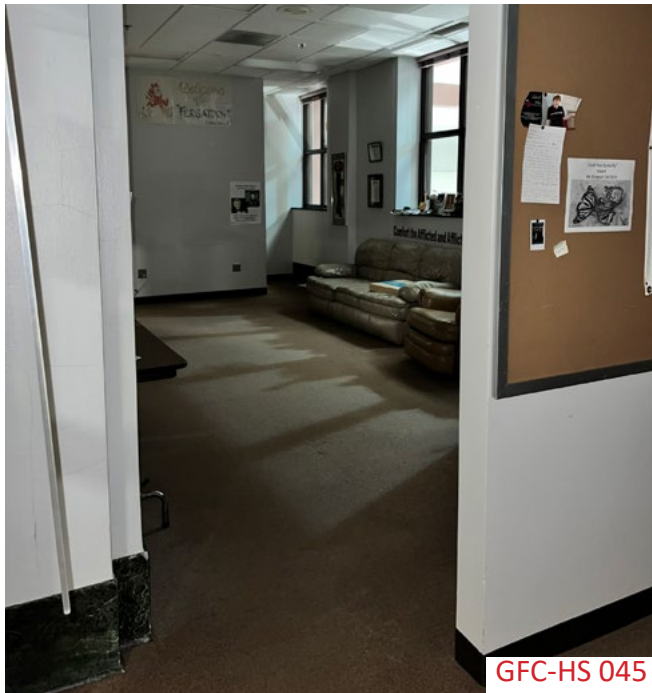
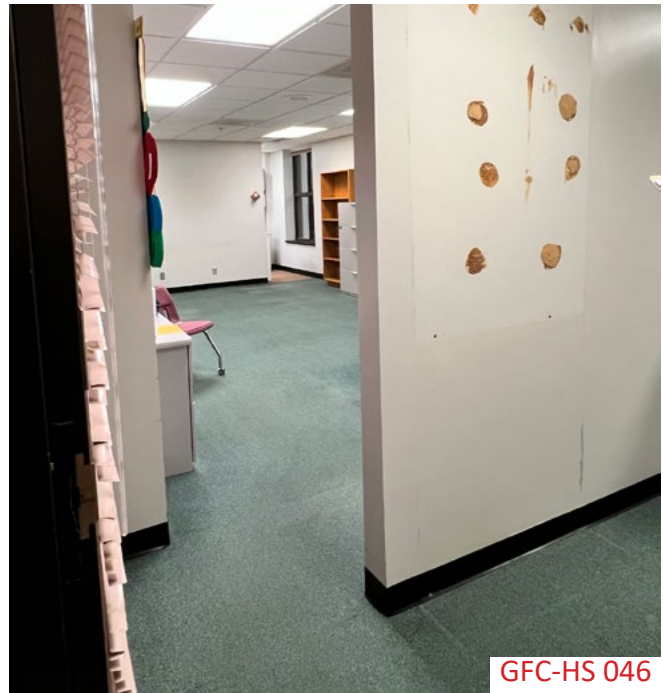
The walls in the offices in Rooms 228 and 317 do not allow sufficient clearances for accessibility.

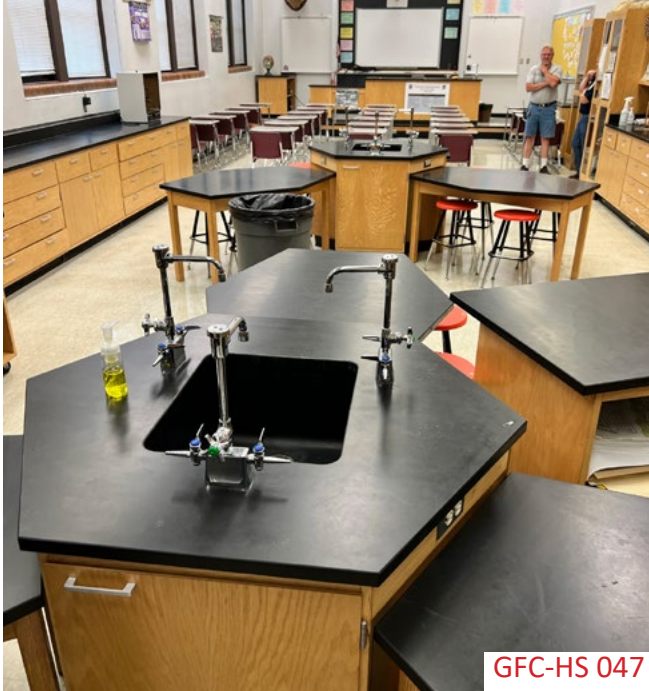
GFC-HS 047

All science labs in the building and the biology office in Room 306 are missing an accessible sink.

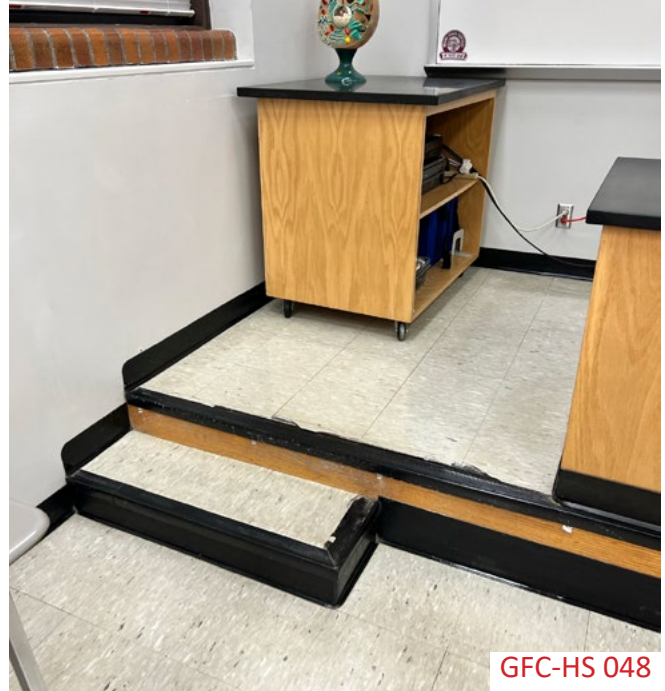
GFC-HS 048

Platforms in the science classrooms only have stairs and are not accessible.

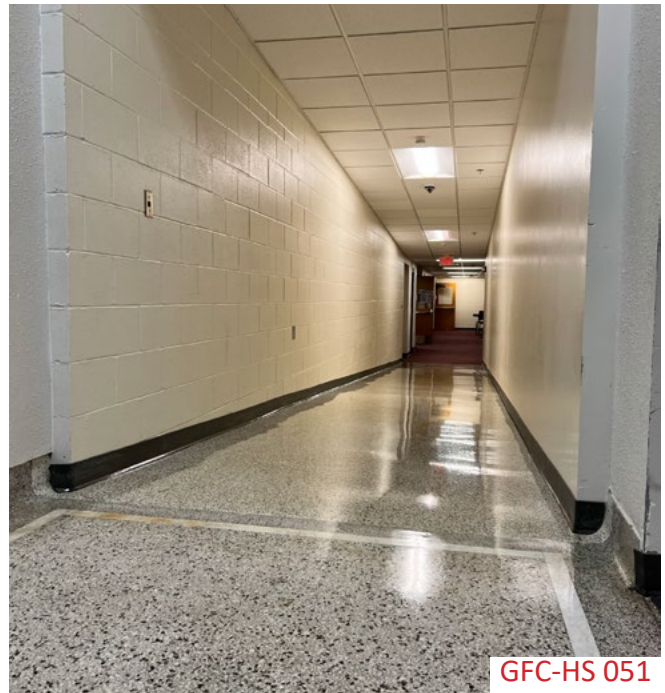
GFC-HS 051

Ramp in the basement that leads to the renovated fine arts area is missing handrails on both sides of the ramp.

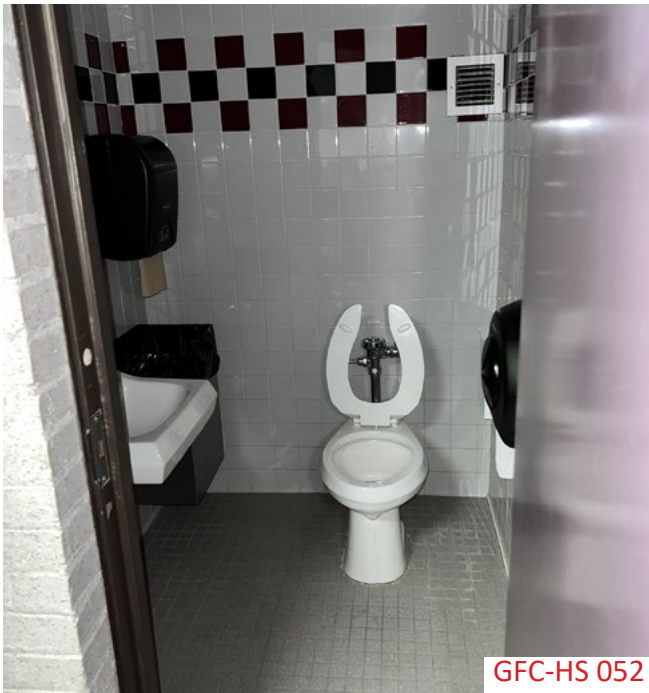
Both restrooms adjacent to the dressing rooms are not accessible

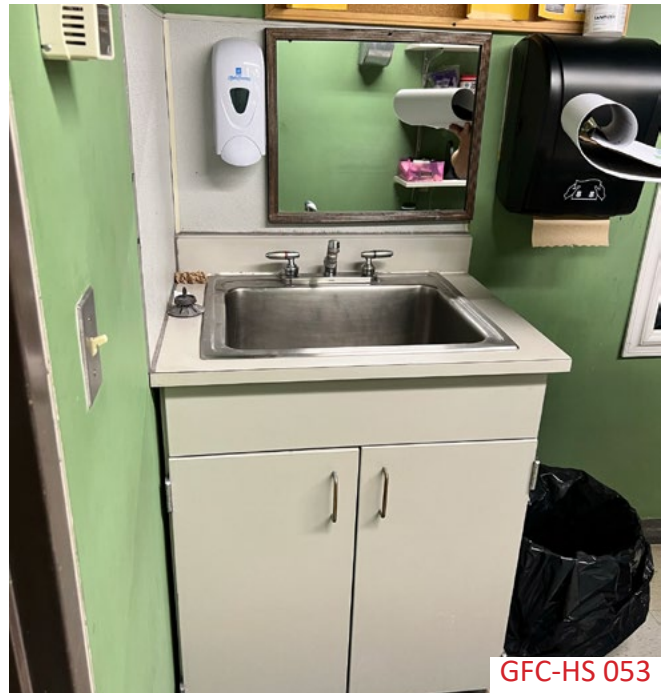
Sinks in all the dressing rooms are not accessible.

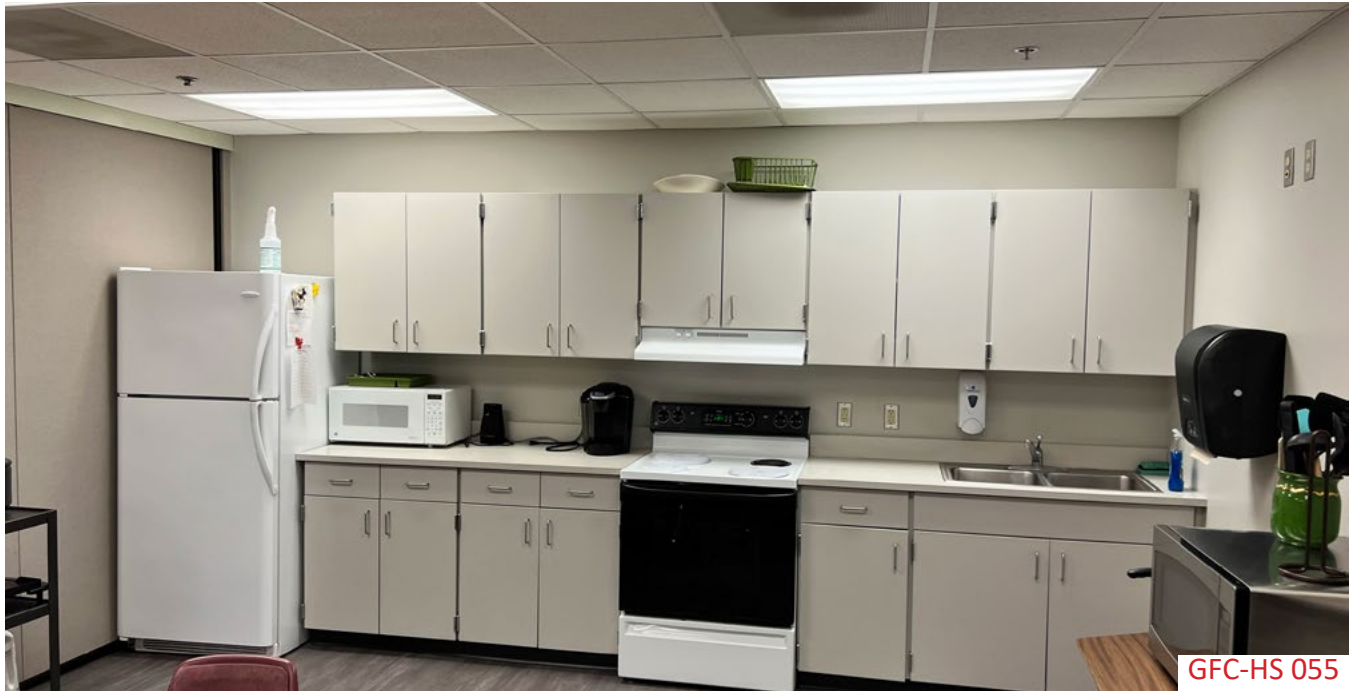
Cultural kitchen (Room 83) lacks an accessible workstation.

Replace casework (12lf of lower cabinets, top, and upper in cultural kitchen to create an accessible workstation	53	1 Ea	\$18,598.10 / Ea	\$18,598				X	\$18,598
Replace casework (10 lf of base cabinet and top) and sink in the staff lounge in the basement to make it ADA accessible	54	1 Ea	\$14,077.83 / Ea	\$14,078				X	\$14,078

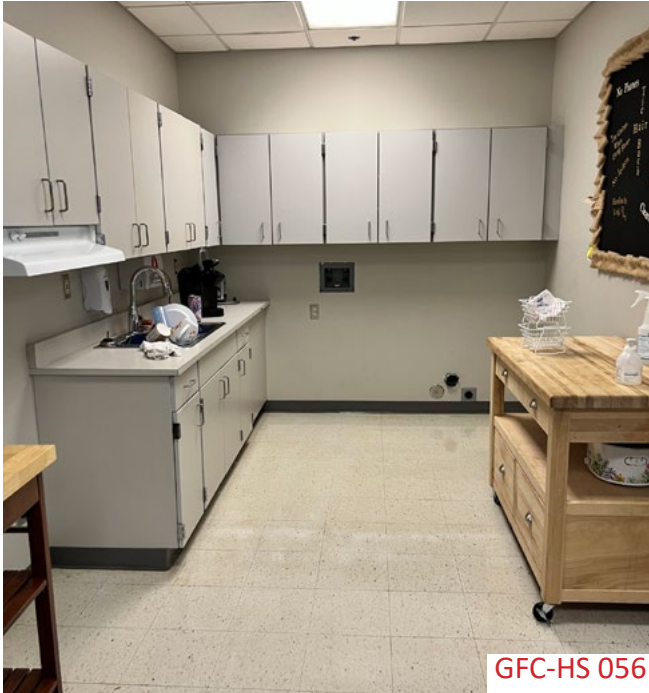
GFC-HS 056

Sink in the staff lounge in the basement is not accessible.

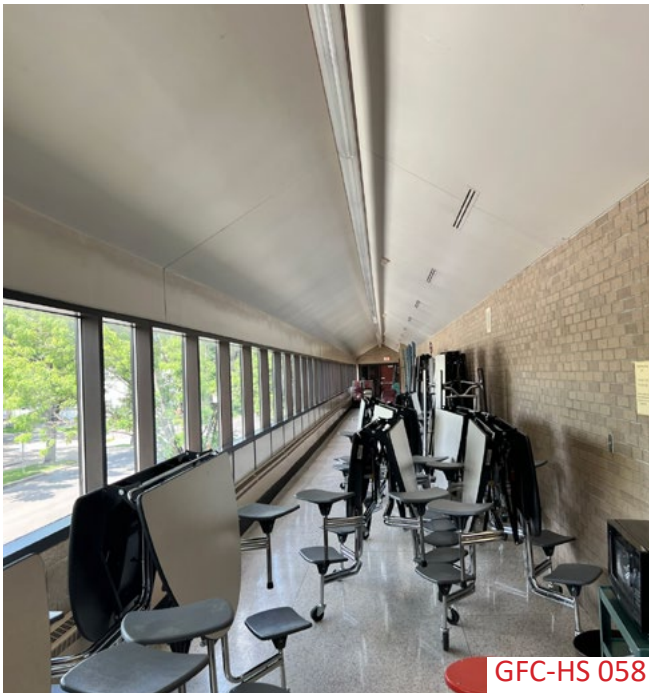
GFC-HS 058

Walkway to the athletics wing is not sprinklered.
