ICON
ARCHITECTURAL GROUP

FACILITY ASSESSMENT FOR GRAND FORKS PUBLIC SCHOOLS

Grand Forks, ND

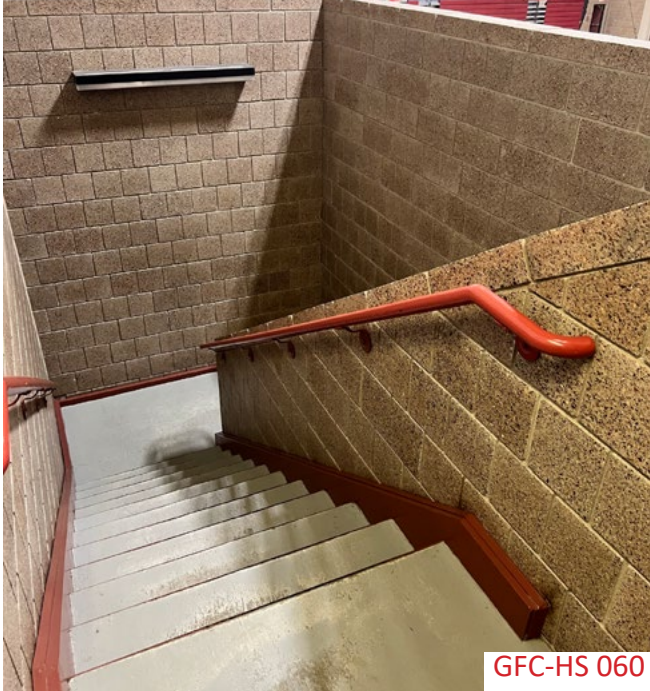
GFC-HS 060

The guardrail and handrails on the stairs leading up to the wrestling room do not meet height requirements.

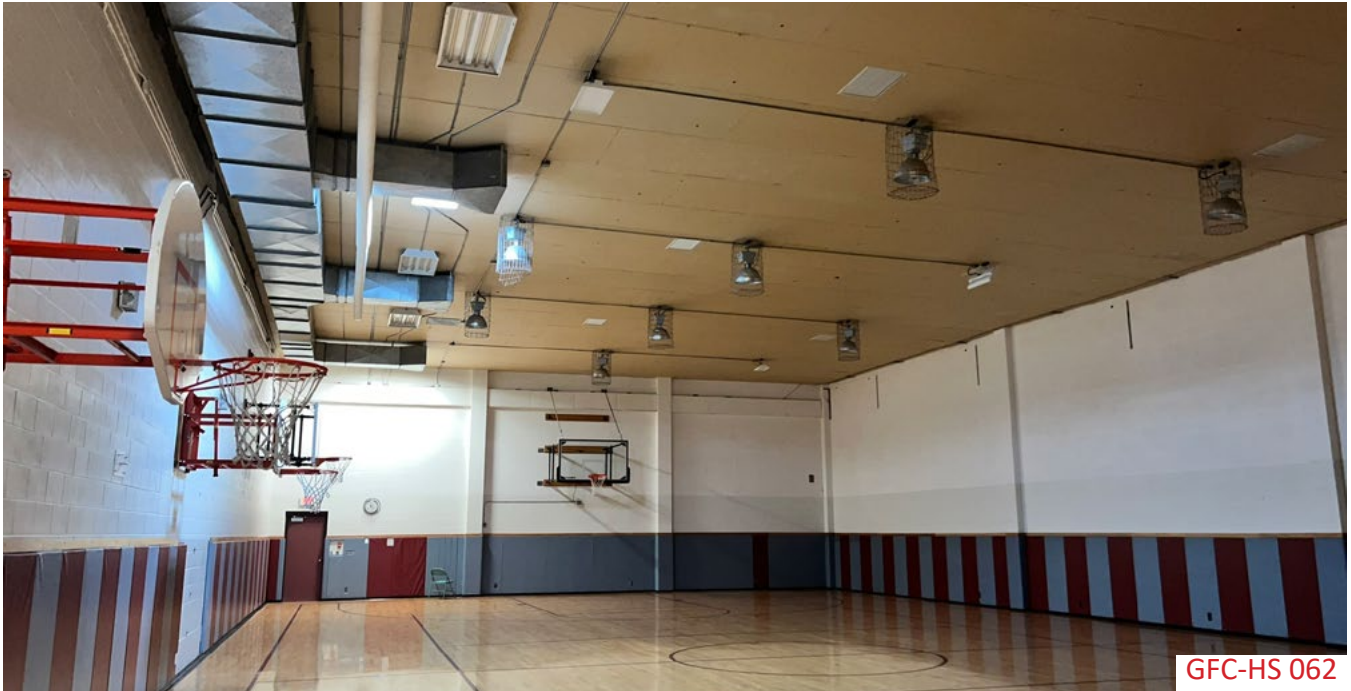
GFC-HS 062

Wrestling room and auxiliary gym are not sprinklered.

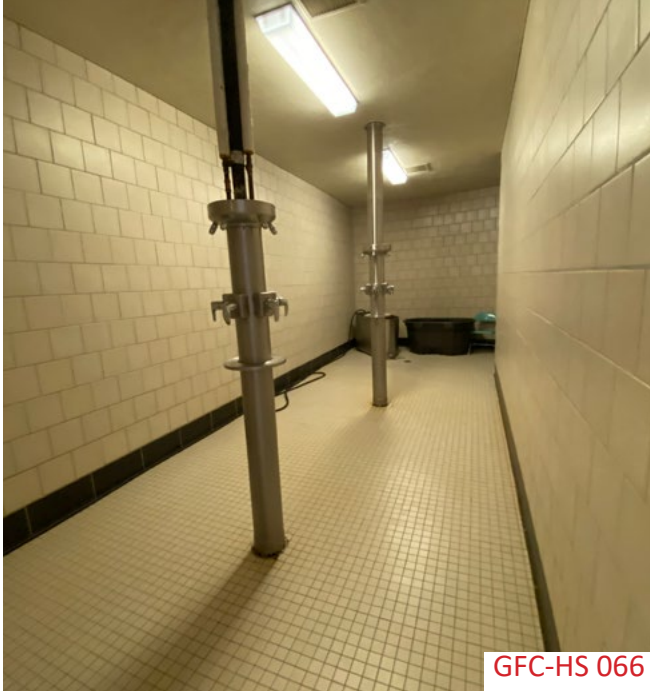
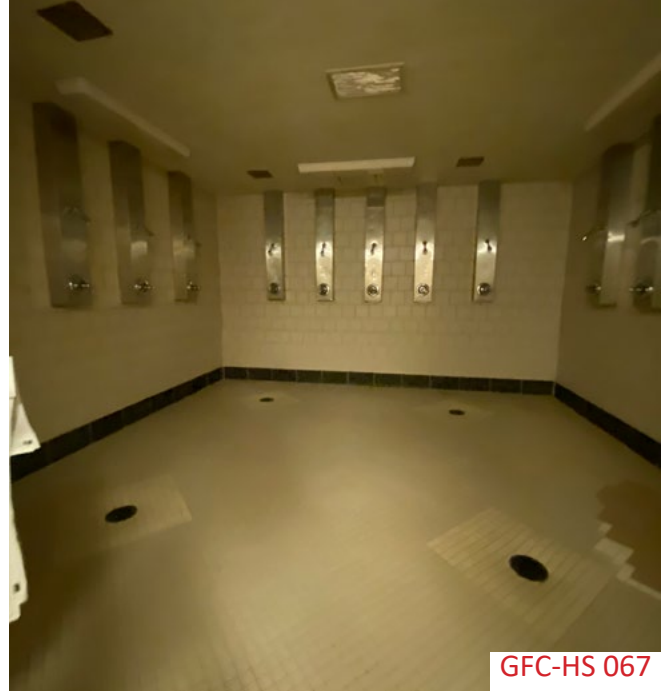
Showers in locker rooms do not have sufficient drains as required by code to prevent wastewater from one bather passing over areas occupied by other bathers.

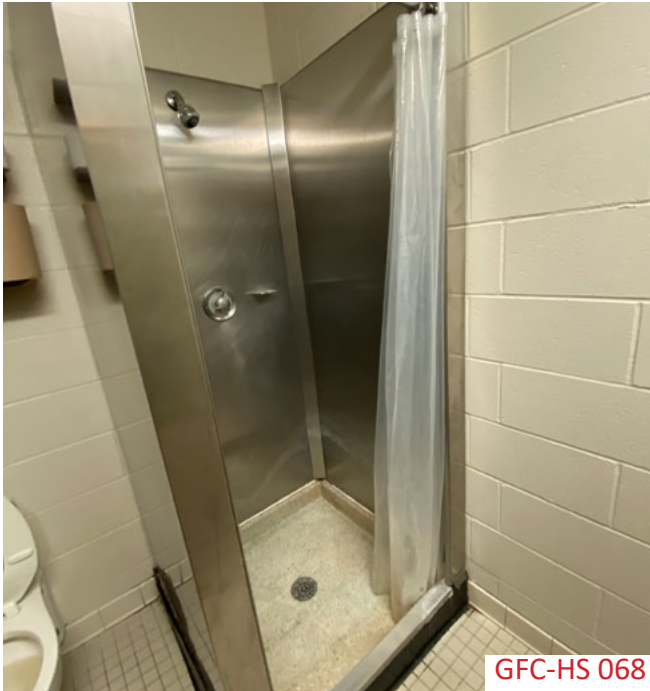
GFC-HS 068

Physical education staff bathrooms and showers are not accessible and do not meet clearance requirements.

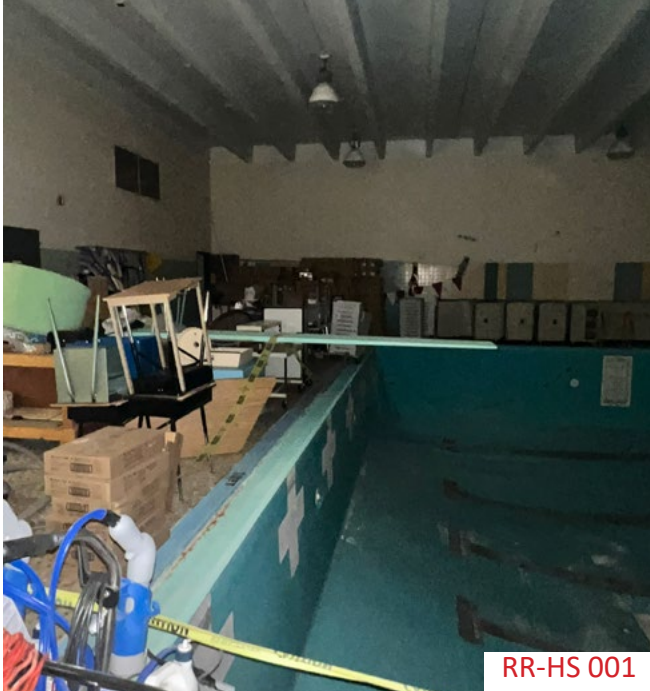
RR-HS 001

The aquatics room is currently being used as storage.

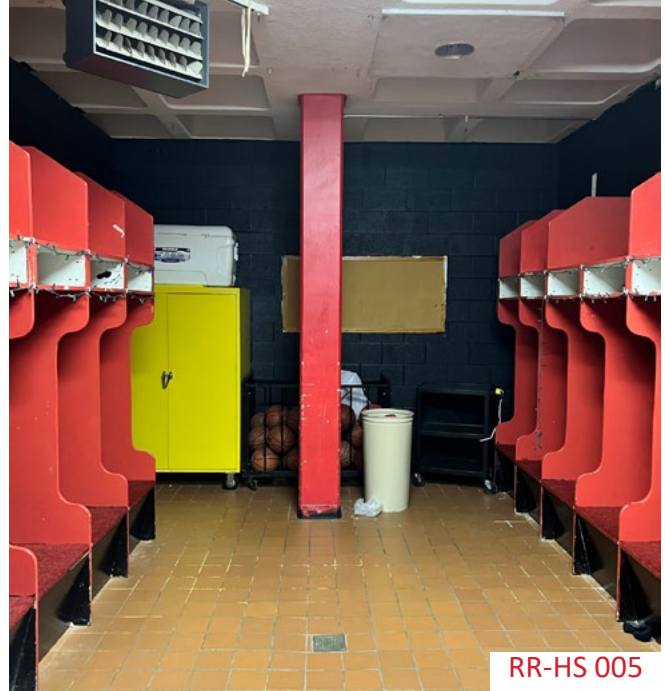
RR-HS 005

Renovation is recommended for the training room (Room 603) and the coaches office.

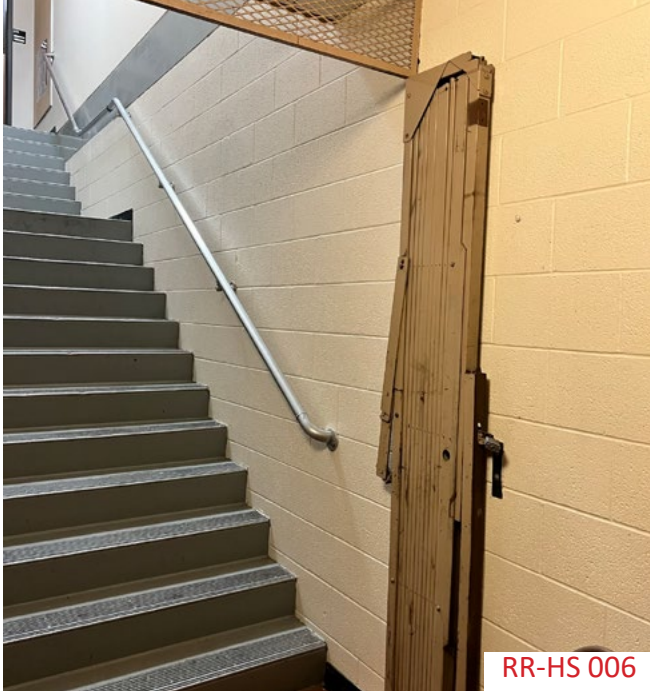
RR-HS 006

Metal partitions near the main gym should be removed to ensure the stairwell always stays open.

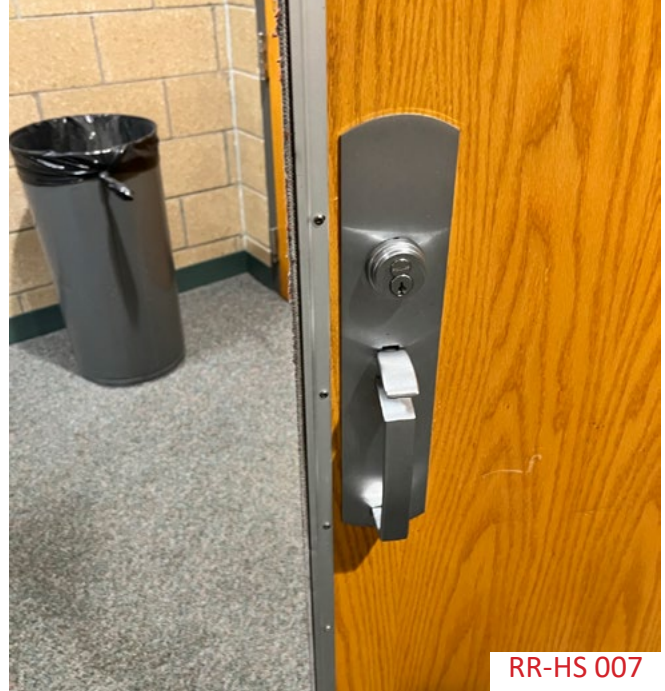
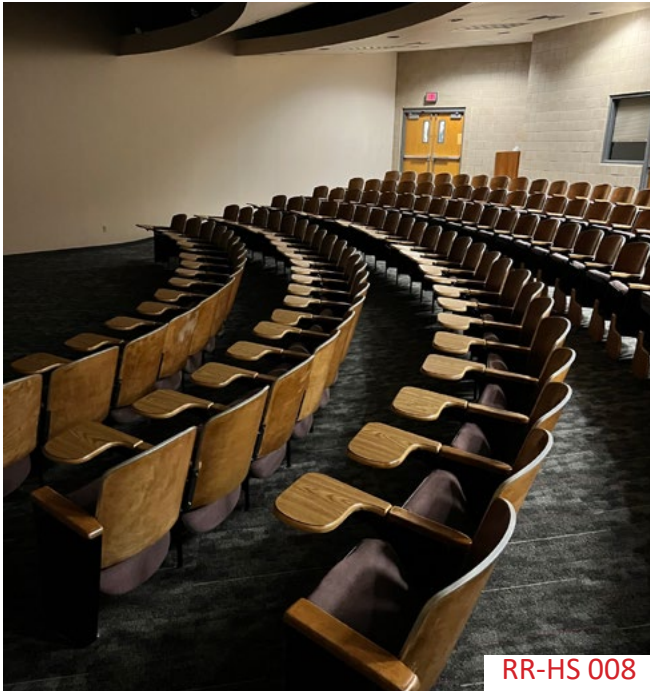
The Rider Room needs new hardware and seating as it is currently out of date.

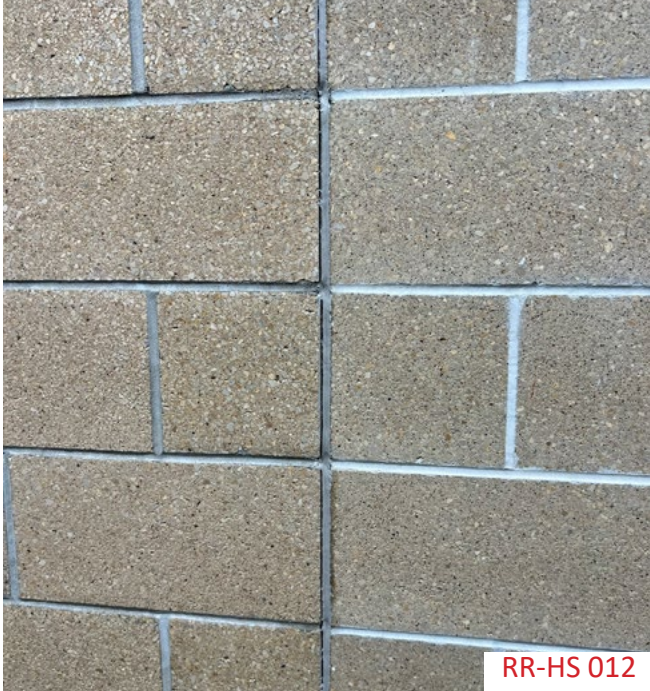
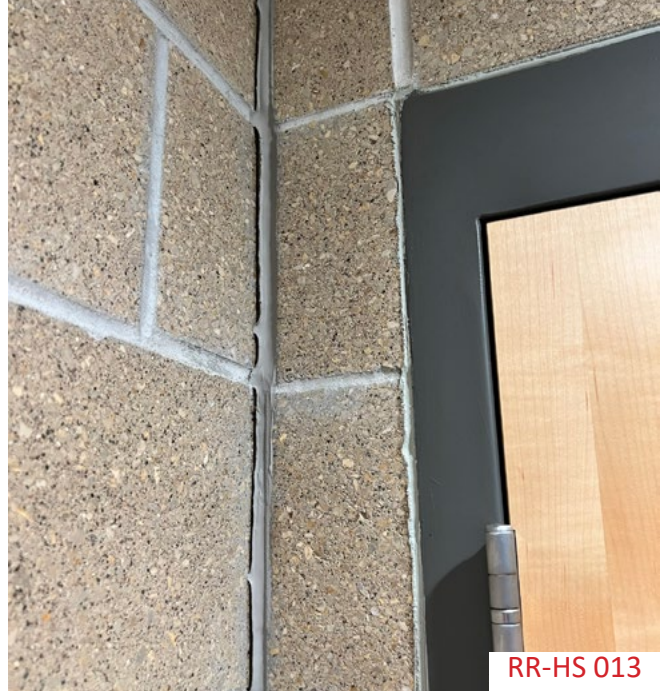
The caulking in the CMU near the music rooms appears to be lifting and should be redone.

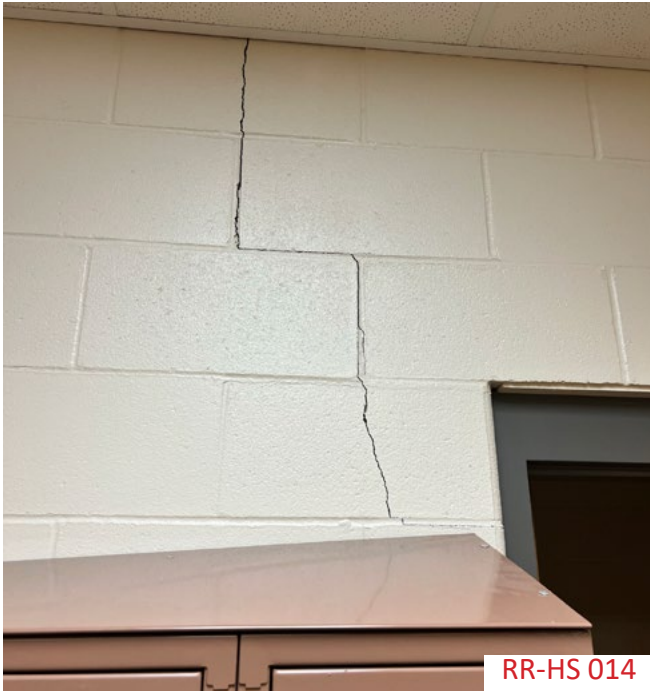
RR-HS 014

There is cracking in the CMU wall in the locker rooms that can be seen from both sides.

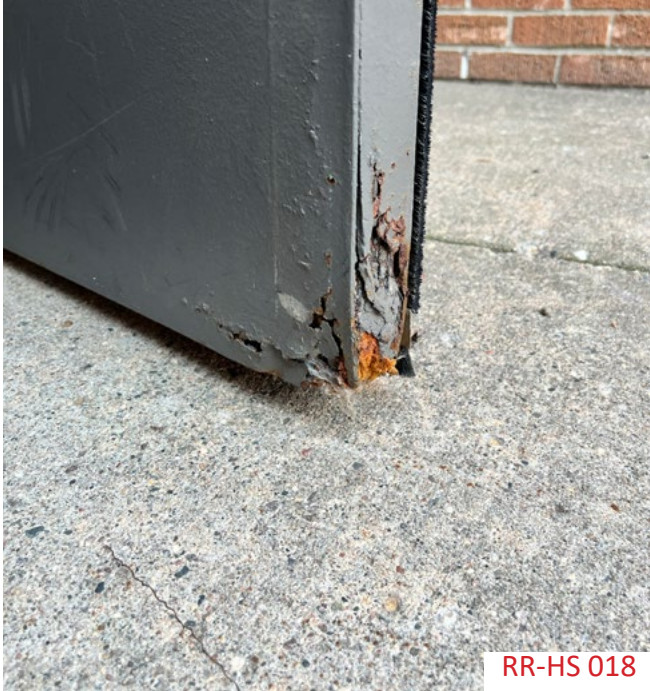
Many of the metal doors to the exterior are rusted badly on the bottom and should get replaced.

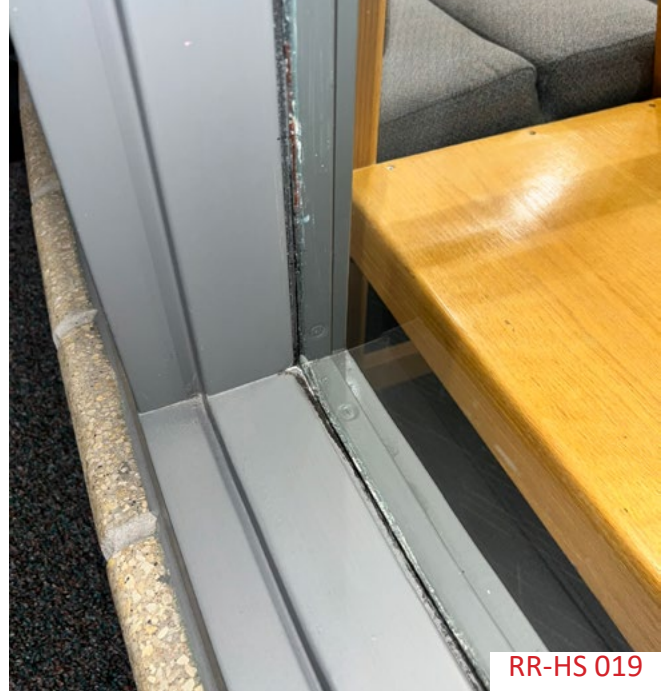
The interior windows to the main office have poor sealing that needs retouching.

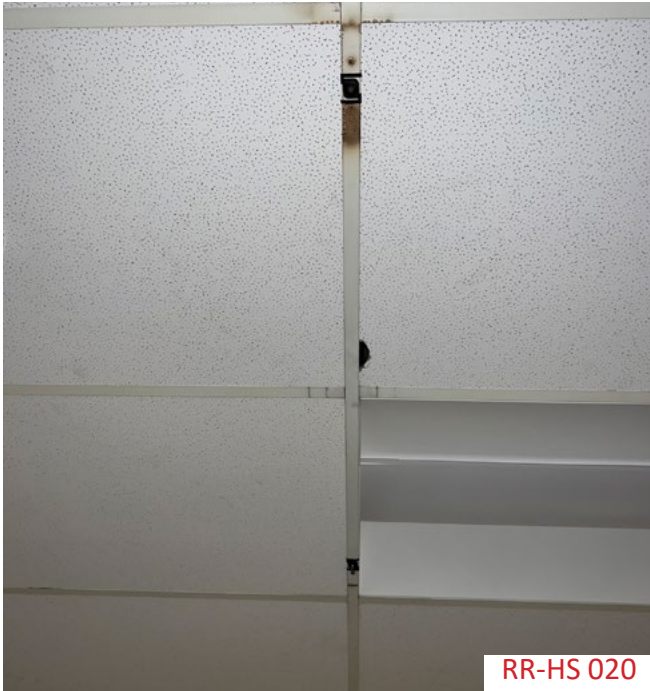
Rusting can be seen in the grids in the health classroom and numerous spots have noticeable water damage.

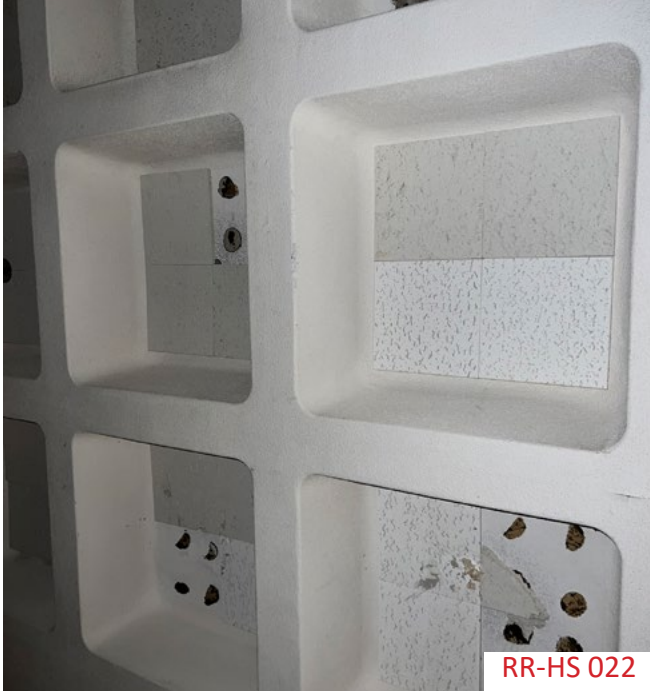
RR-HS 022

There are portions of ceiling that are damaged and falling off in the locker rooms and the original auditorium (Locker).

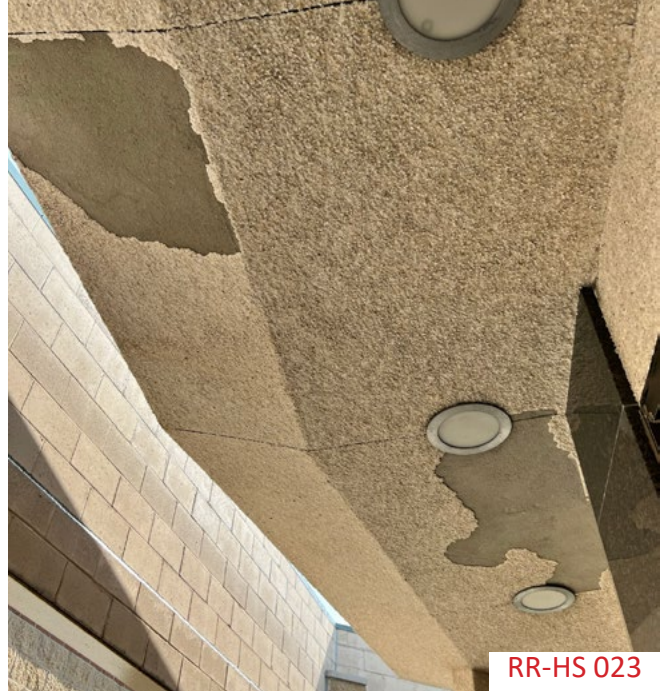
RR-HS 023

The soffits on the exterior portion of the main entrance are deteriorating and the gypsum board in the vestibule is also compromised.

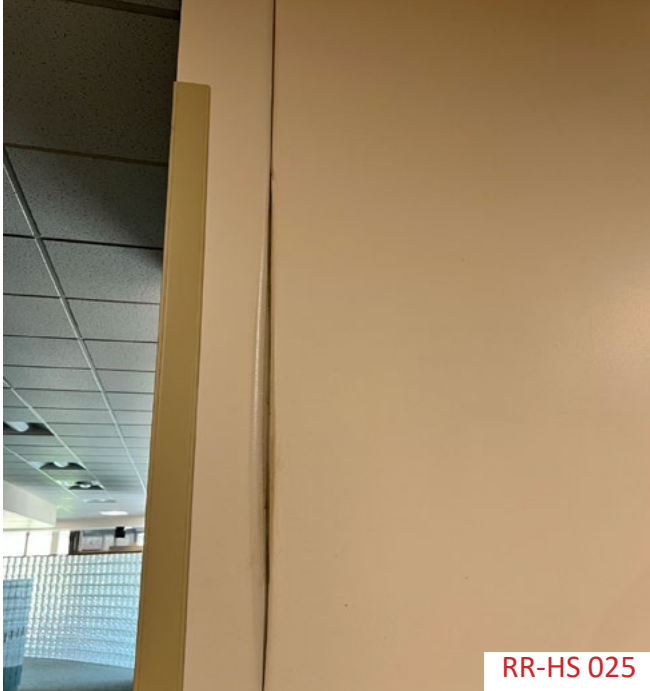
RR-HS 025

The vinyl wall covering should be removed as it is peeling up throughout the school.

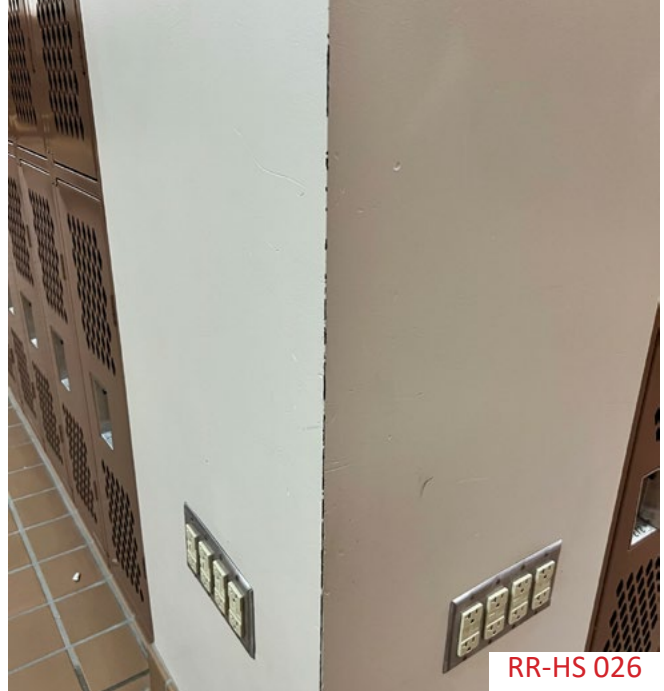
RR-HS 026

The women's physical education locker room could use corner guards and other corners should be inspected to see where future damage can be prevented.

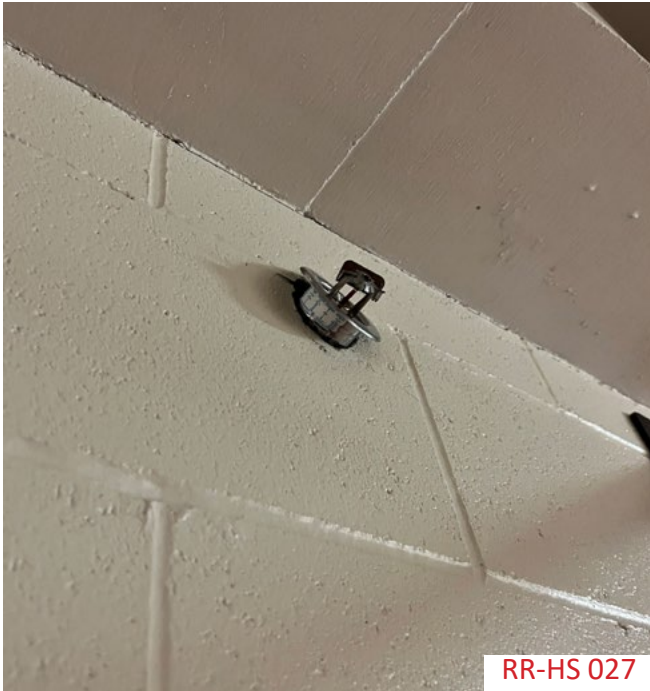
RR-HS 027

The piping and fire sprinklers in the basement walls have deteriorated the CMU walls where they are inserted.

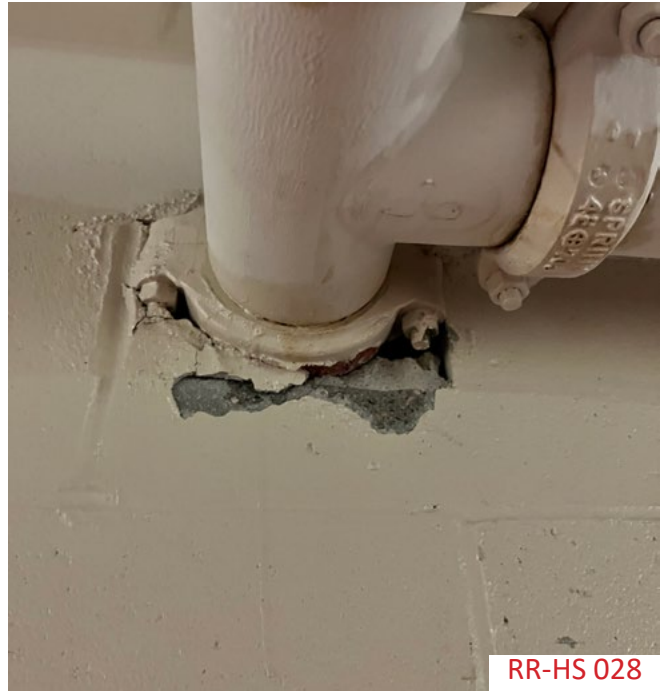
RR-HS 028

The piping and fire sprinklers in the basement walls have deteriorated the CMU walls where they are inserted.

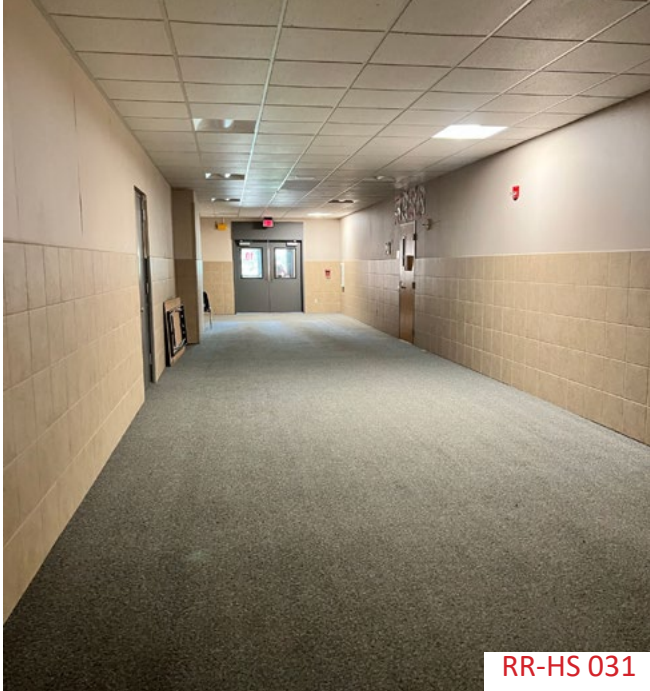
RR-HS 031

Much of the carpeting in the classrooms has been replaced, but the corridors still need to be redone.

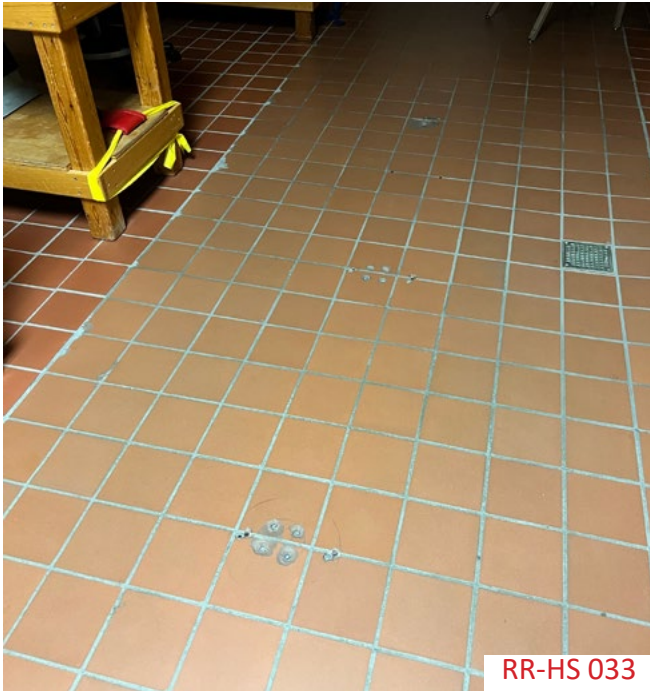
RR-HS 033

All of the brown ceramic and vinyl composition tile in the building is outdated and should get replaced.

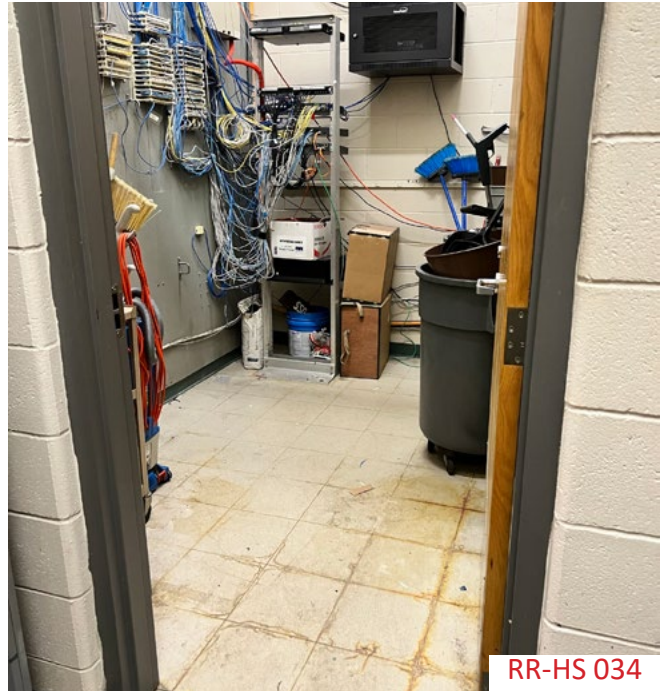
RR-HS 034

All of the brown ceramic and vinyl composition tile in the building is outdated and should get replaced.

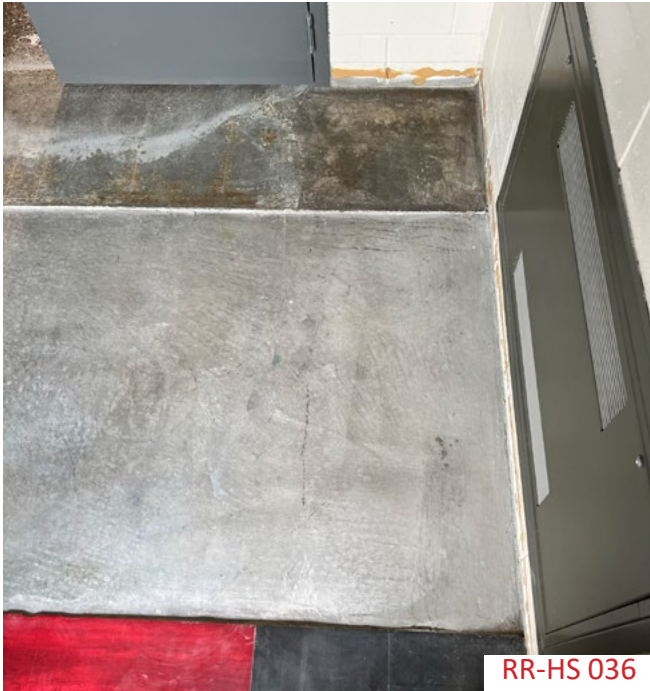
RR-HS 036

The vestibule tiles are especially in bad condition and the door 7 vestibule is partly missing tiles.

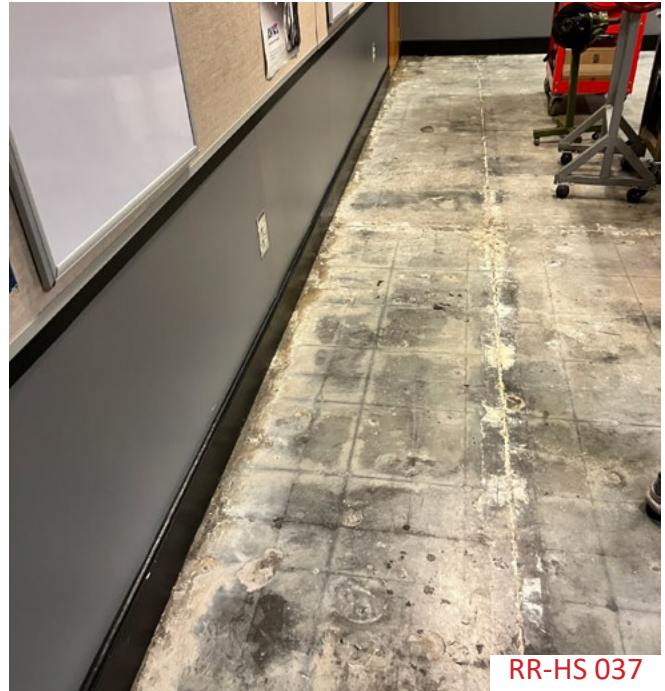
RR-HS 037

The tile is ripped up in numerous art and technological education classrooms because there was a chemical issue.

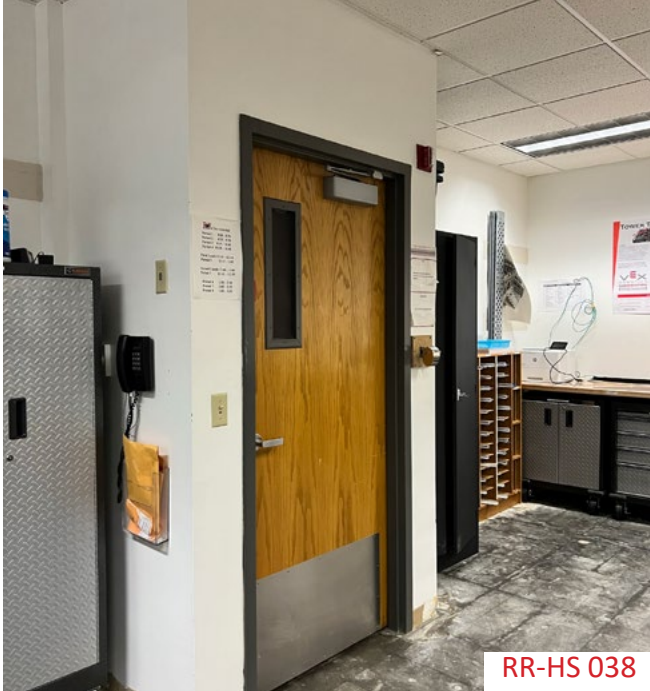
RR-HS 038

The tile is ripped up in numerous art and technological education classrooms because there was a chemical issue.

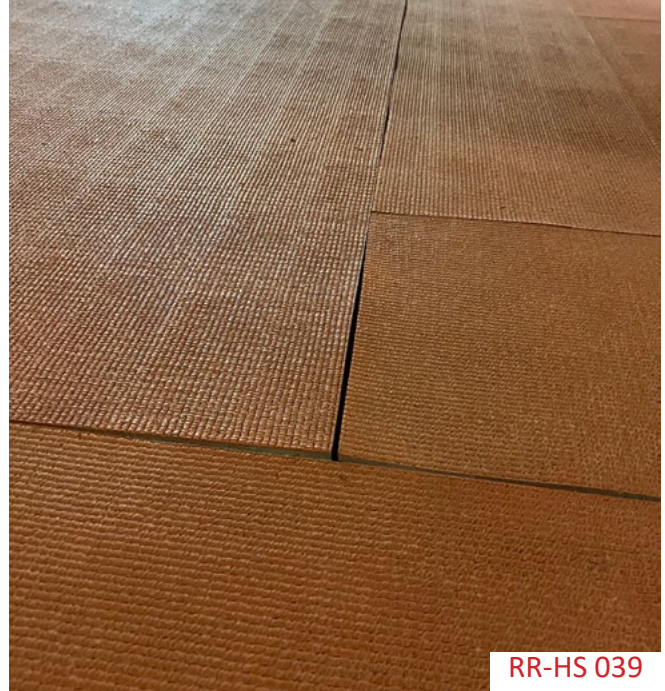
RR-HS 039

The running track material in the basement is lifting up in several spots and needs to be replaced.

Replace the running track in the basement	75	9,877 SF	\$19.94 /SF			\$196,971			\$196,971
Interior Upgrades Subtotal		348,899 SF	\$20.83 /SF						\$7,269,095
Exterior Upgrades									
Replace the damaged sidewalk outside of the school	76	5,600 SF	\$17.56 /SF	\$98,322					\$98,322
Repair the concrete drives and the damaged curbs	77	1 Ea.	\$24,148.04 /Ea.	\$24,148					\$24,148
Replace damaged stoops at doors 9, 10, and 16 that are sinking	78	3 Ea.	\$19,841.24 /Ea.	\$59,524					\$59,524
Add sidewalk that connects doors 7 and 17 to the public walkways in case of an evacuation.	79	2,000 LF	\$17.56 /LF		\$35,120				\$35,120
Replace the roof when it nears the end of its useable lifetime	80	286,964 SF	\$30.58 /SF		\$8,775,359				\$8,775,359
Repaint the green roof and siding near the north entrance of the school	81	348,899 SF	\$0.17 /SF		\$59,313				\$59,313
Exterior Upgrades Subtotal		348,899 SF	\$25.94 /SF						\$9,051,786

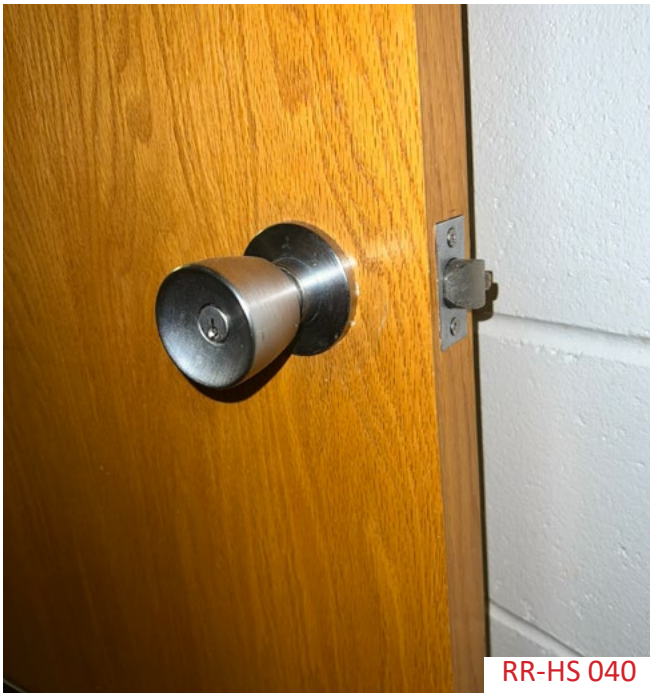
RR-HS 040

Door hardware on numerous doors throughout the building is not accessible

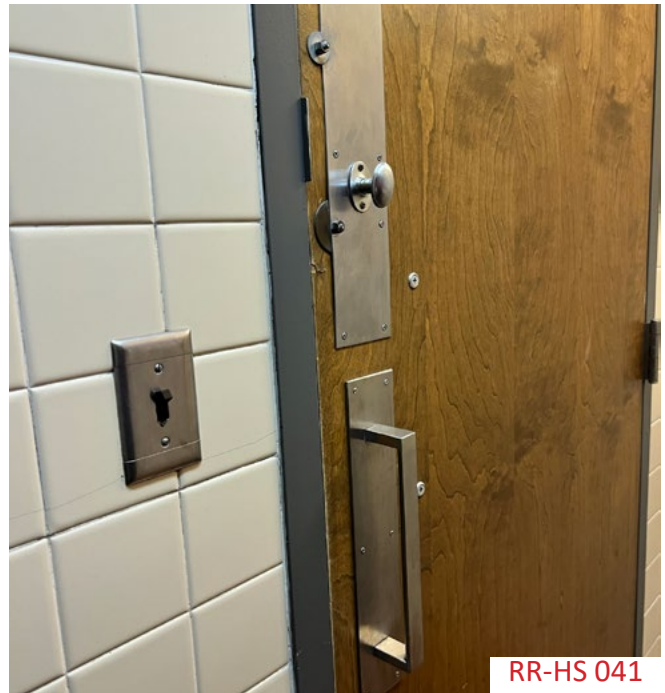
RR-HS 041

Door hardware on numerous doors throughout the building is not accessible

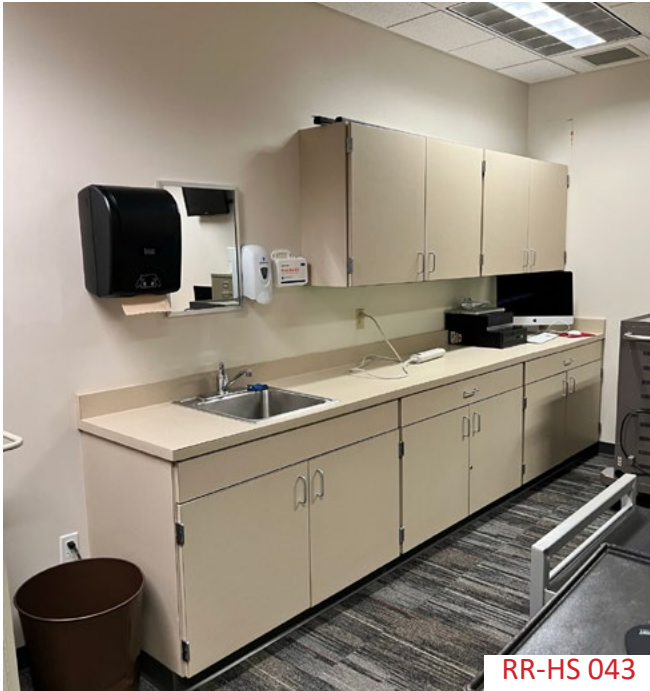
RR-HS 043

Sinks within classrooms and offices are not accessible.

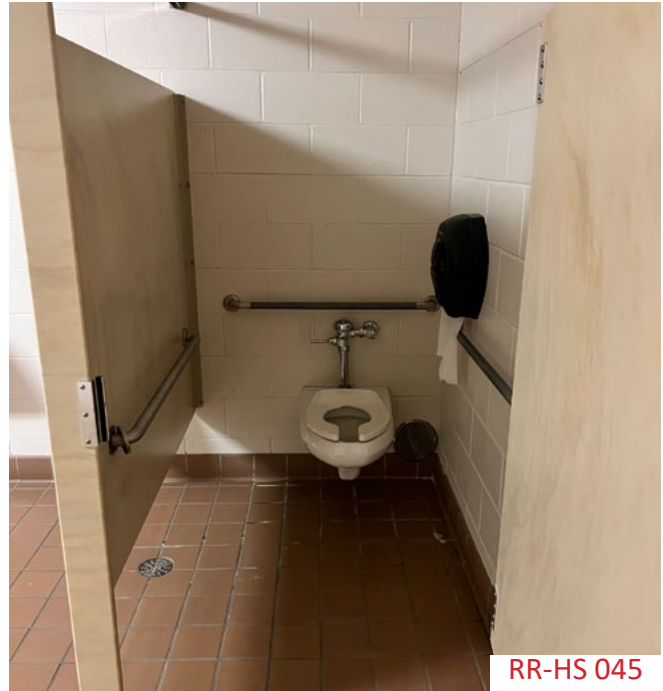
RR-HS 045

All men's and women's locker rooms are not accessible, as they do not have sufficient clearances at the entrances and do not have accessible stalls with the required turning space

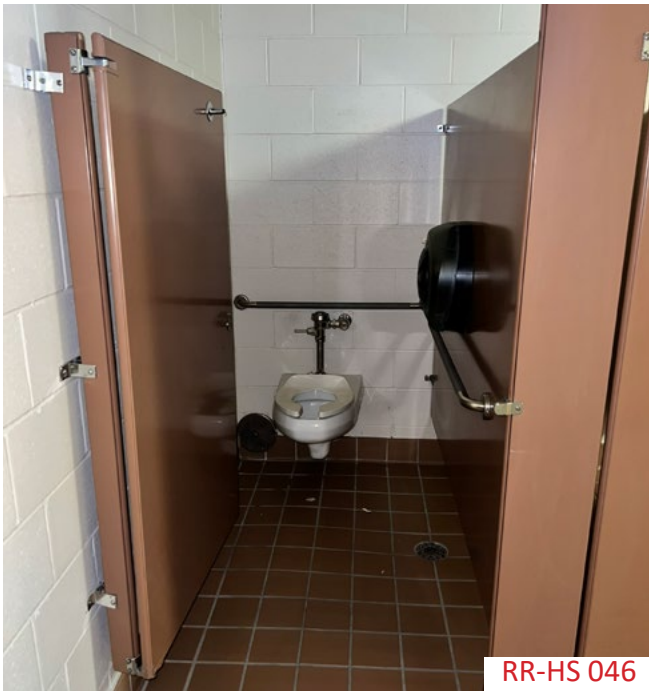
RR-HS 046

All men's and women's locker rooms are not accessible, as they do not have sufficient clearances at the entrances and do not have accessible stalls with the required turning space

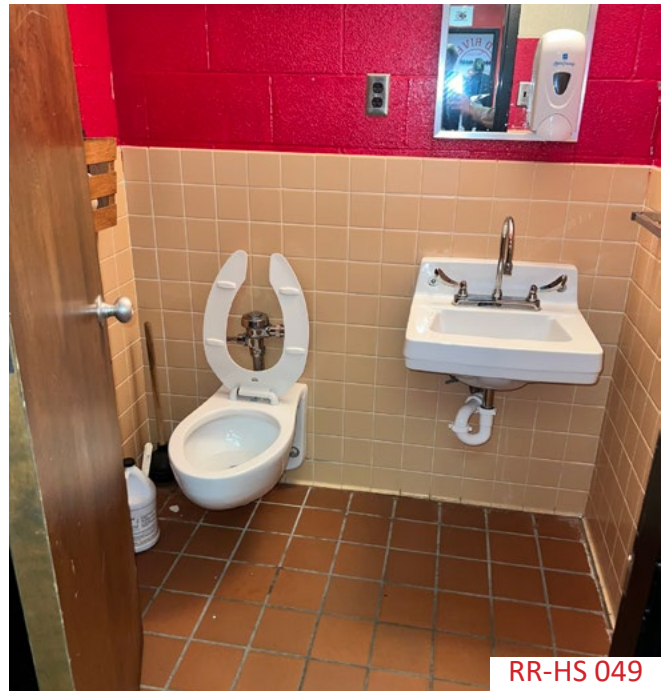
RR-HS 049

The restrooms in the men's and women's physical education staff offices are not accessible as they lack sufficient clearances and handrails.

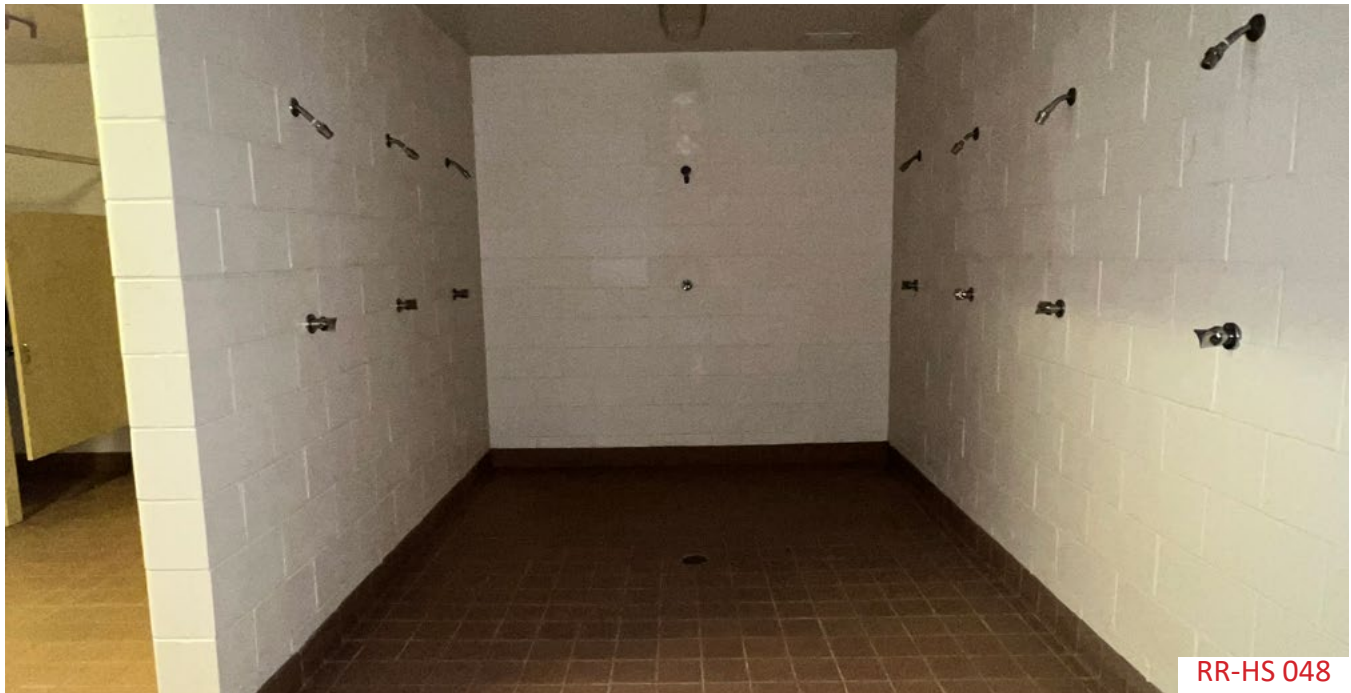
RR-HS 048

Showers in locker rooms do not have sufficient drains as required by code to prevent wastewater from one bather passing over areas occupied by other bathers.

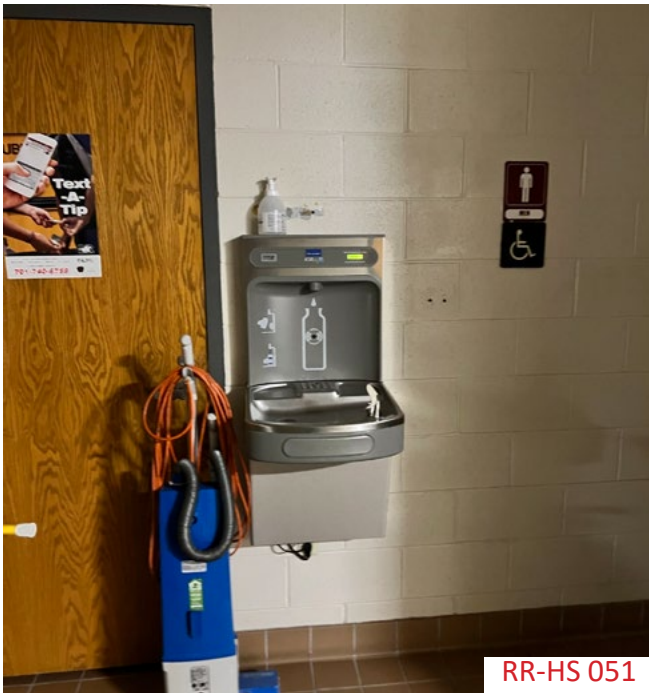
Drinking fountains throughout the building do not meet the required ratio of wheelchair accessible fountains to standing person accessible fountains

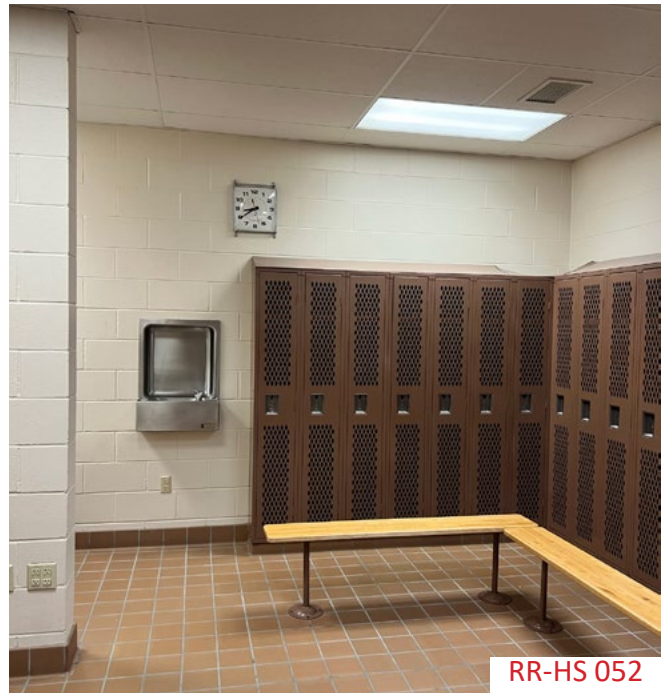
Drinking fountains throughout the building do not meet the required ratio of wheelchair accessible fountains to standing person accessible fountains

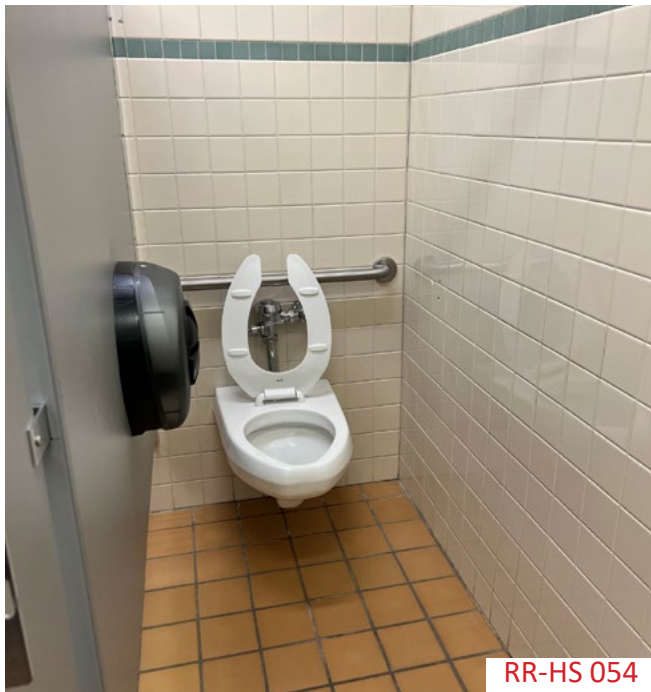
Many restrooms in the building are not accessible. Most restrooms where a larger stall is present do not meet clearance requirements for accessibility.

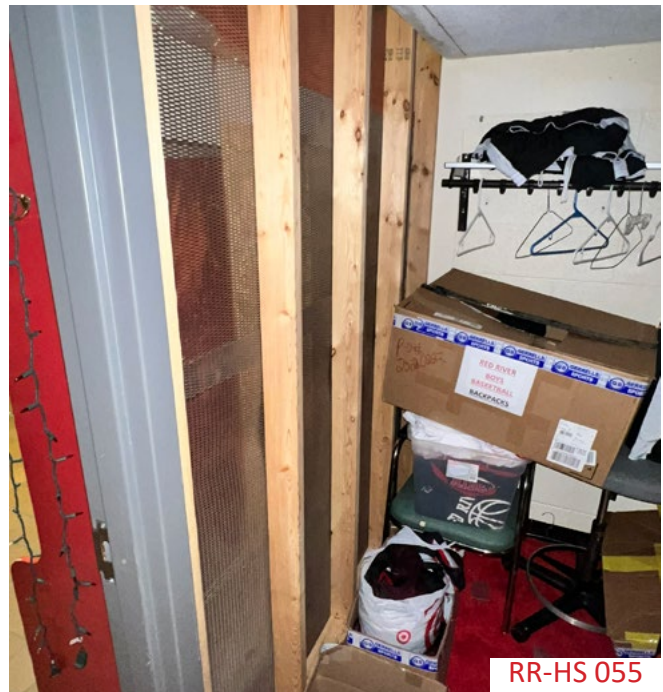
There is exposed wood structure in the storage area in the physical education office that is combustible and should be covered for fire safety.

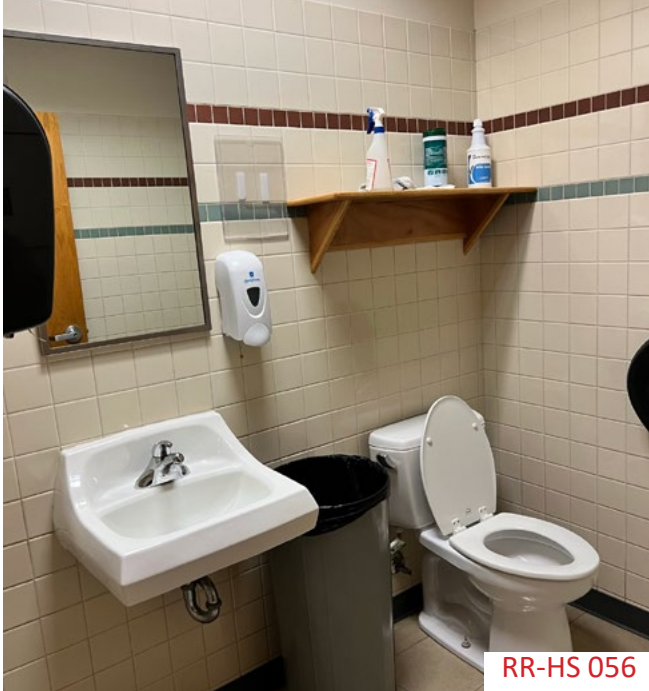
RR-HS 056

The staff lounge restroom is not accessible.

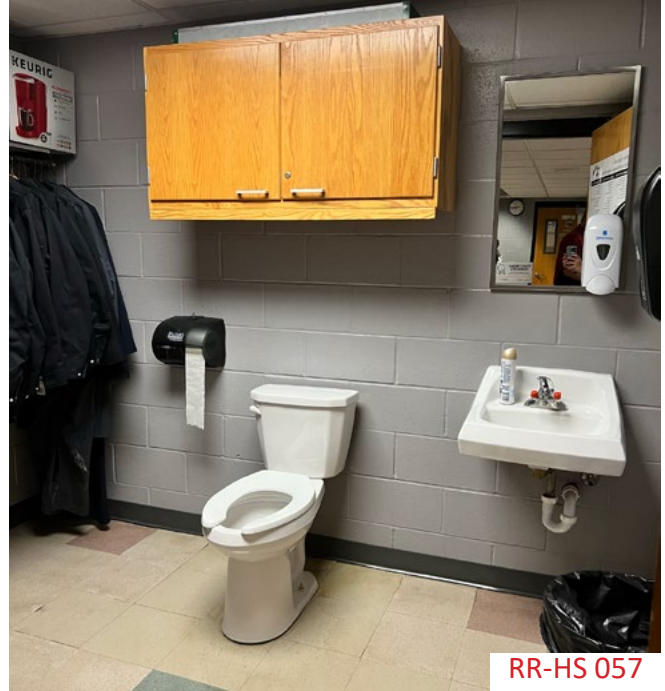
RR-HS 057

The restroom in the technological education office (Room 610) is not accessible.

Remodel the restroom in the technological education office (Rm. 610) to make it accessible and add grab bars	16	1 Ea.	\$37,497.11 /Ea.	\$37,497				X	\$37,497
Replace kitchen ceiling tile with a scrubbable surface.	17	3,282 SF	\$14.75 /SF	\$48,410					\$48,410
Add a corridor since the history classroom on the second floor has divergent path and distance issues because occupants in the room have to pass through multiple rooms before reaching a corridor exit.	18	960 SF	\$65.74 /SF	\$63,110					\$63,110
Change the swing of the doors into the I.D. classrooms (Rooms 102, 104 and 106) since they do not have sufficient push pull clearances	19	3 Ea.	\$3,615.44 /Ea.	\$10,846					\$10,846
Replace the glass in the display cases throughout the school with the required tempered glass	20	10 Ea.	\$4,515.86 /Ea.	\$45,159					\$45,159
Add handrail extensions on the stairs from the original auditorium backstage to the commons	21	8 LF	\$131.89 /LF	\$1,055					\$1,055

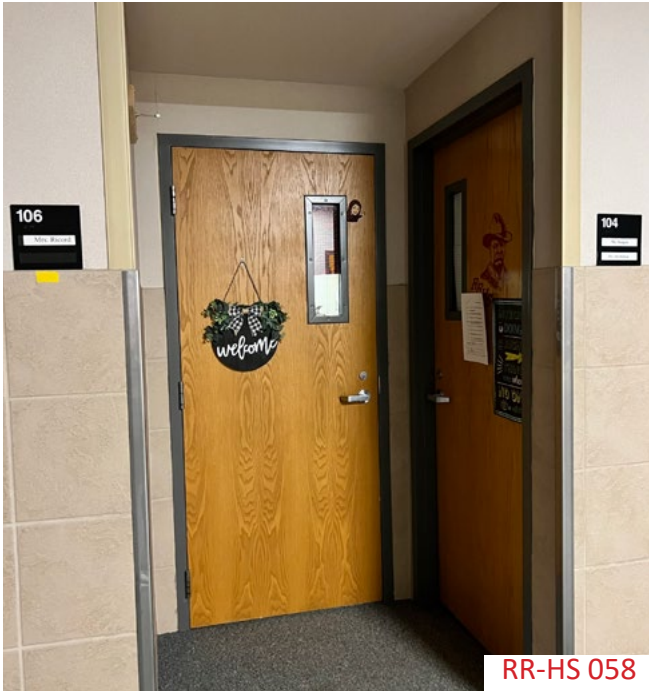
RR-HS 058

- The doors into the I.D. classrooms (Rooms 102, 104 and 106) fail to meet required maneuvering clearances for accessibility. (058)
- Display cases throughout do not have required safety glass. (059)

The doors into the I.D. classrooms (Rooms 102, 104 and 106) fail to meet required maneuvering clearances for accessibility.

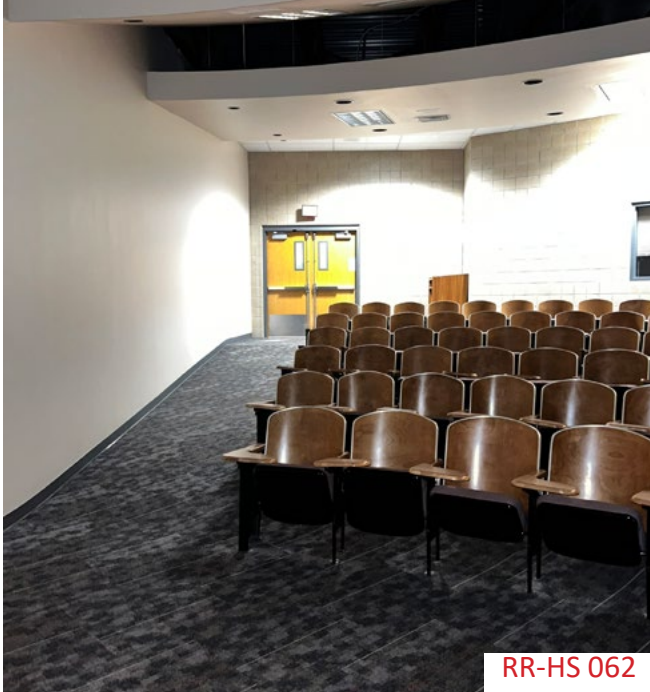
RR-HS 062

The Rider Room is missing handrails on the ramps.
