ICON
ARCHITECTURAL GROUP

FACILITY ASSESSMENT FOR GRAND FORKS PUBLIC SCHOOLS

Grand Forks, ND

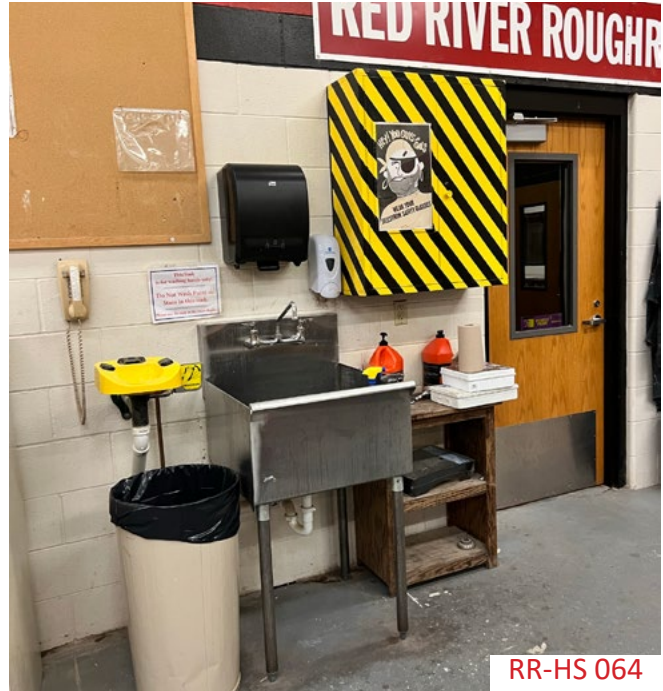
RR-HS 064

Eyewash stations in the automotive and manufacturing/production classrooms (Rooms 608 and 612) are not accessible.

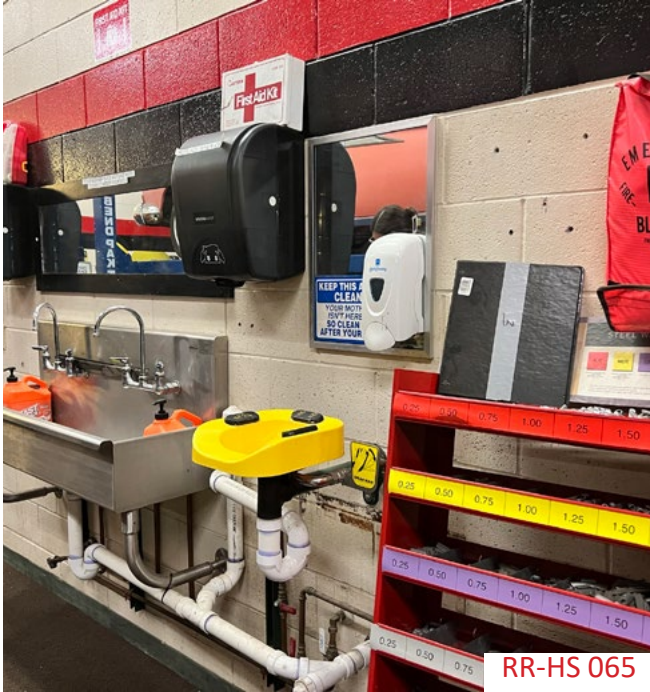
RR-HS 065

Eyewash stations in the automotive and manufacturing/production classrooms are not accessible.

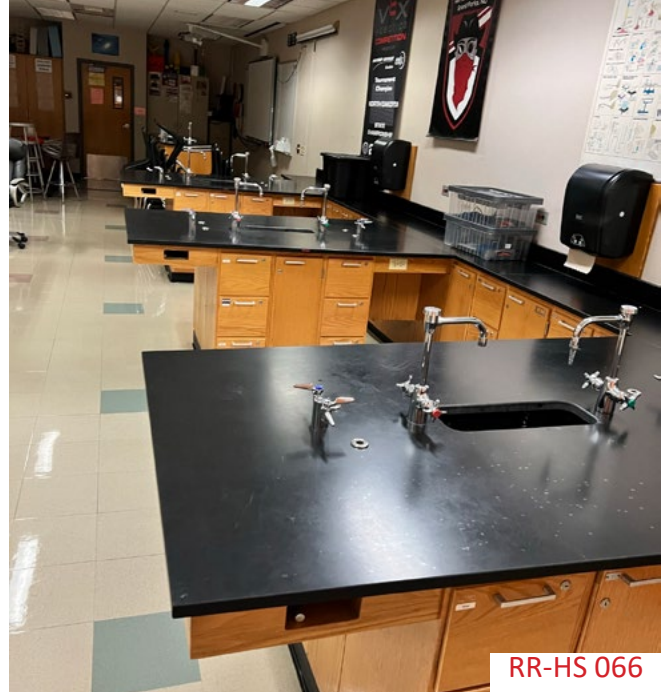
RR-HS 066

Science labs do not have accessible stations.

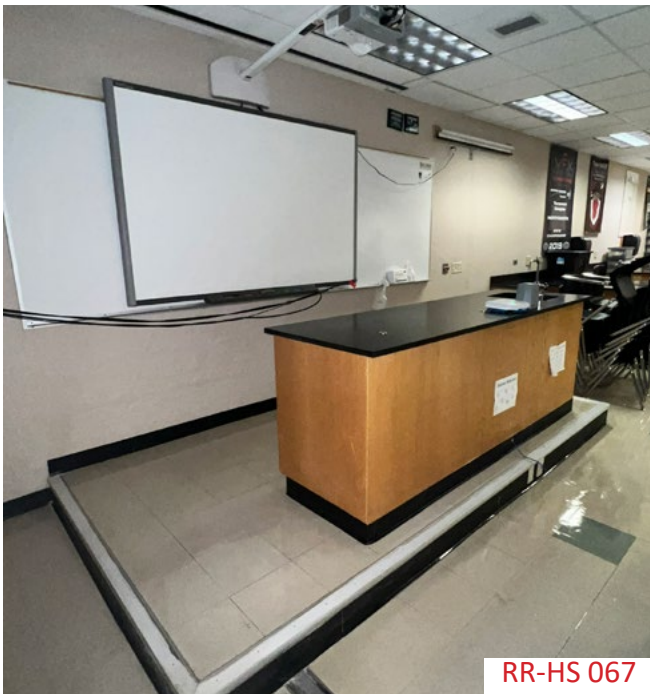
RR-HS 067

Platforms in the science classrooms are not accessible.

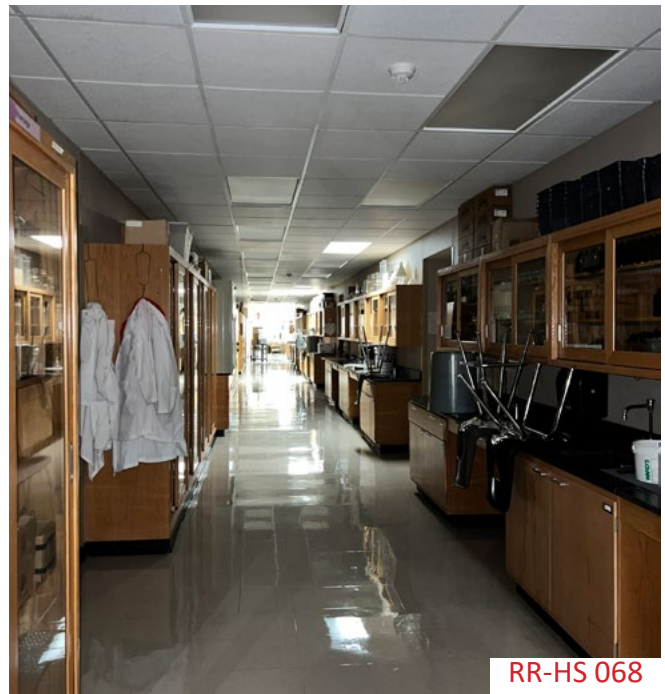
RR-HS 068

Glass within the science storage area is not safety glass, as required by code.

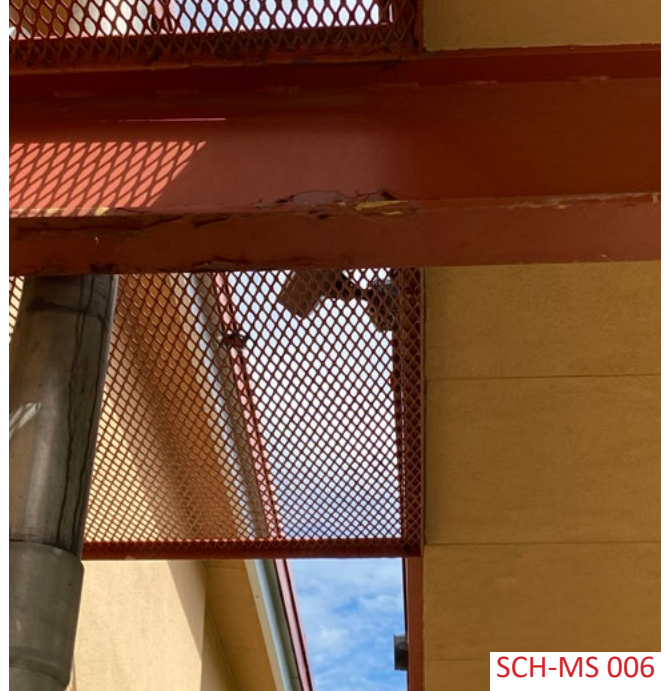
The exterior insulation and finish system (EIFS) is in poor condition with multiple holes seen around the building (004). A canopy repair is needed outside Door 1 (005, 006).

A canopy repair is needed outside door 1.

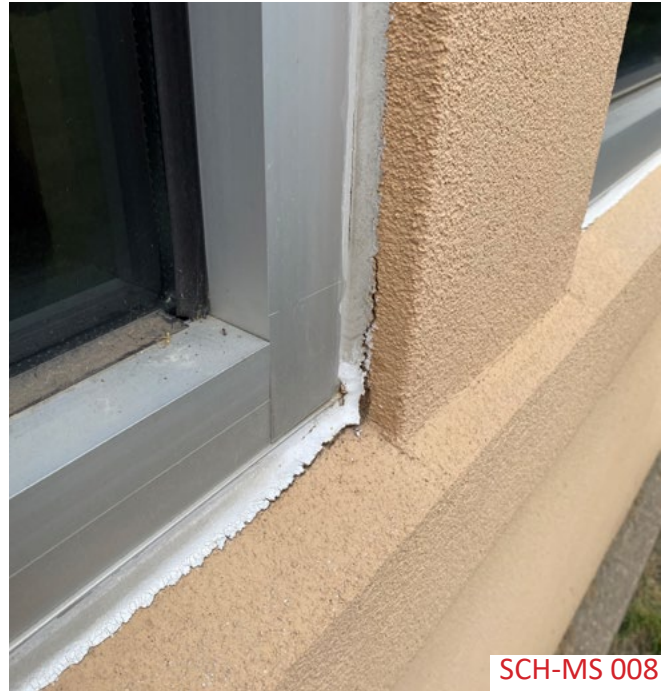
Door openings and windows within the school are in good condition. Window gaskets and caulking are deteriorating and should be replaced (007, 008).

Caulking is worn and should be replaced as well.

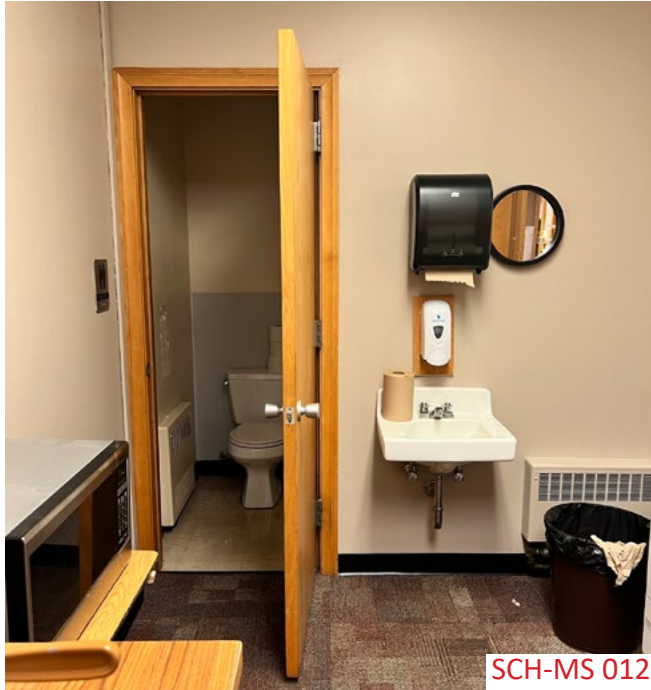
SCH-MS 012

Restrooms within classrooms are not accessible

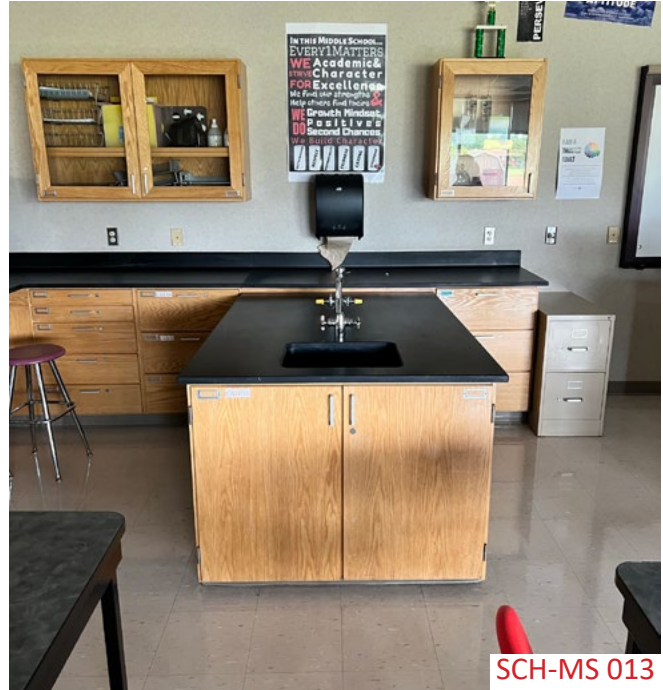
SCH-MS 013

Science labs do not have an accessible sink

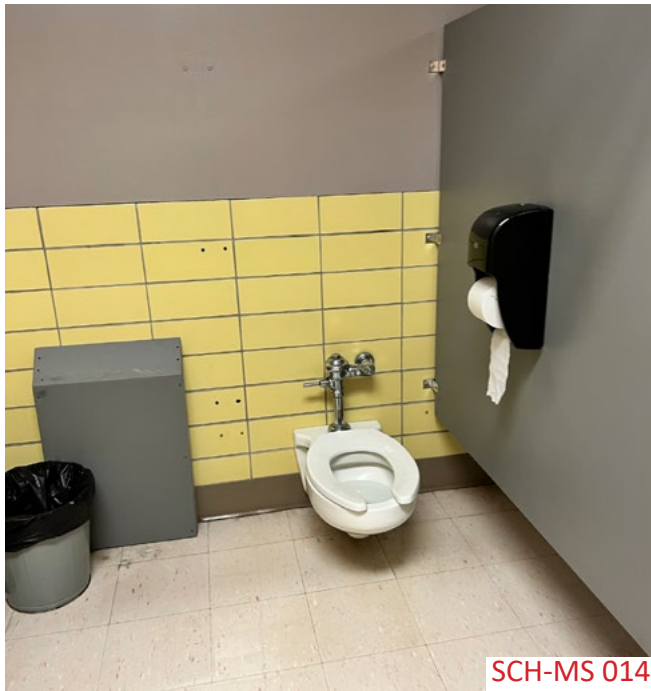
SCH-MS 014

Restrooms throughout the school are not accessible

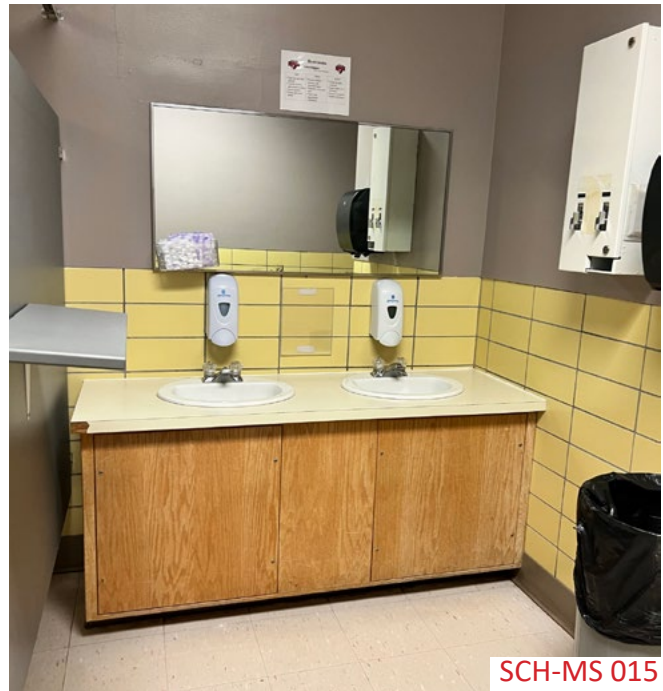
SCH-MS 015

Sinks in restrooms are not accessible

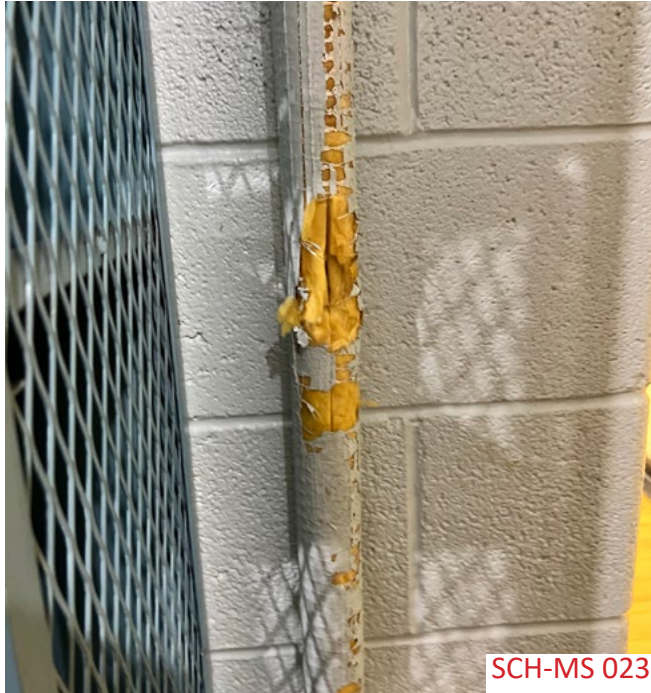
SCH-MS 023

Pipes are exposed throughout the school and should be protected

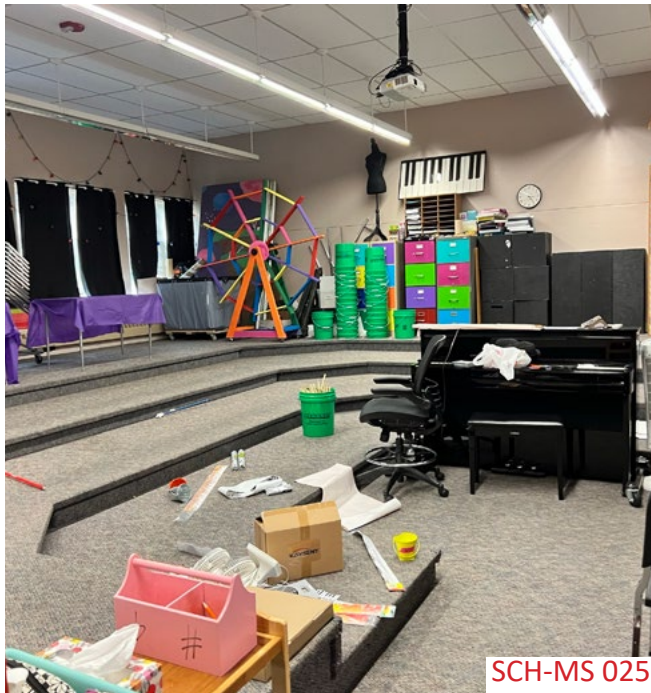
SCH-MS 025

The music room is not accessible

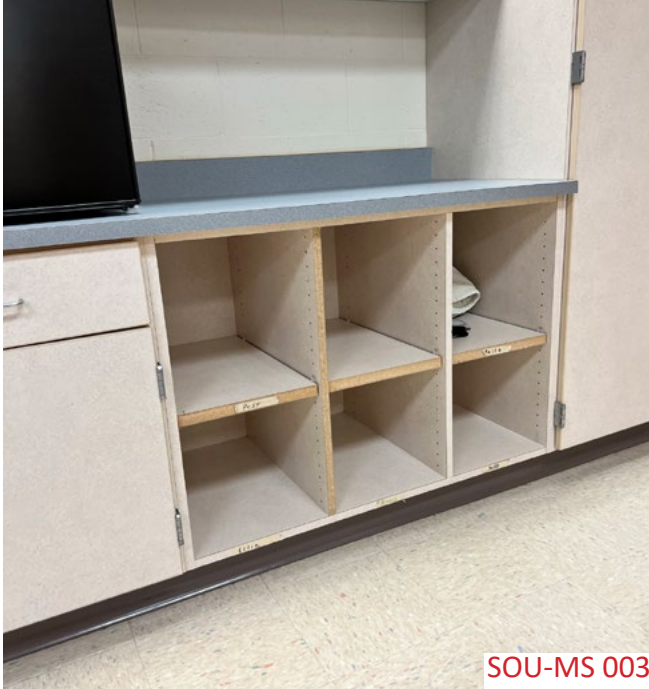
SOU-MS 003

The laminate trim on much of the casework throughout the school is peeling off and needs new adhesion.

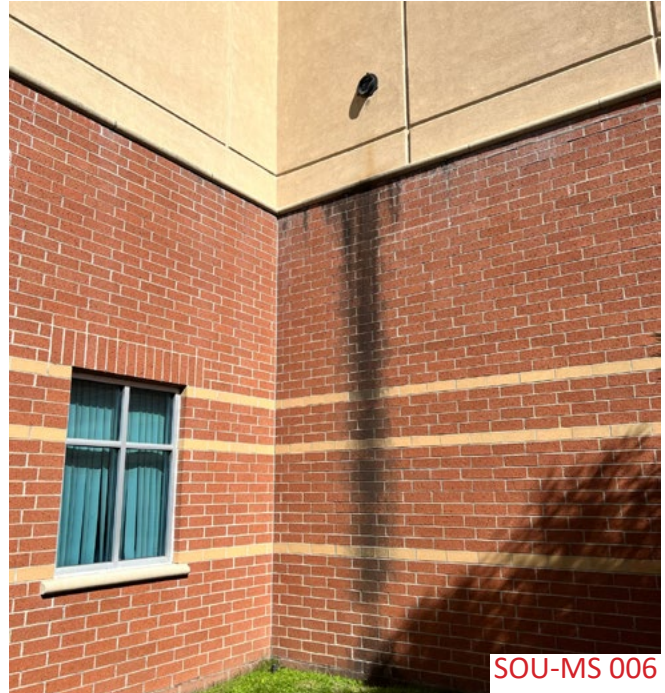
SOU-MS 006

There are exterior drains near Doors 5 and 13 that need to be cleaned so that water can properly drain out as it is currently going onto the brick and creating water spots.

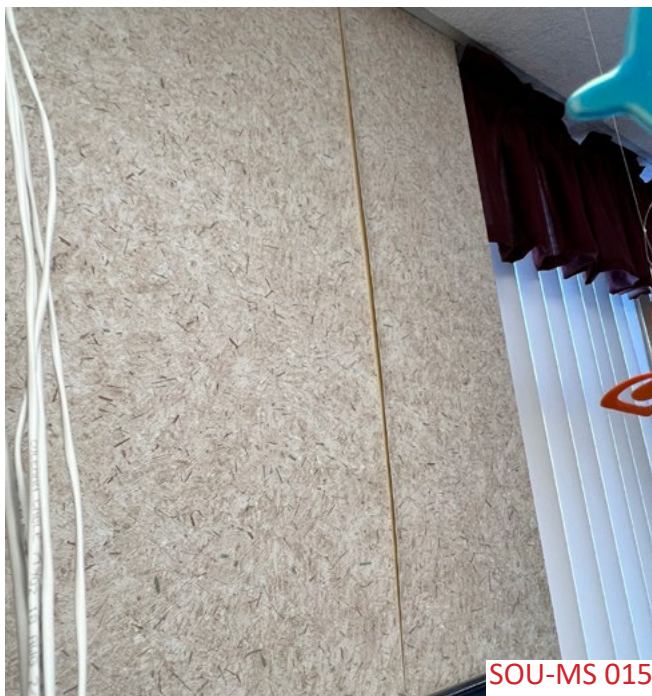
There are several areas where the vinyl wall covering is releasing from the gypsum substrate.

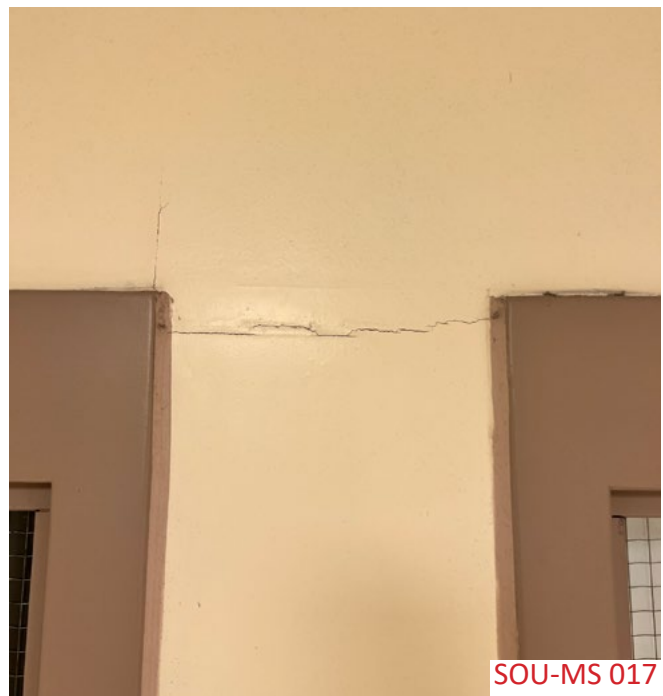
There is horizontal cracking on the dry wall between many of the interior doors.

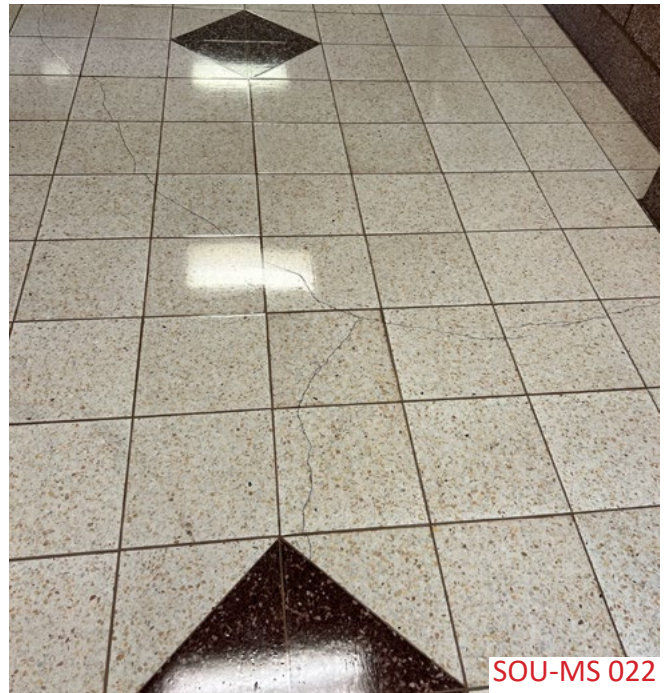
SOU-MS 022

The terrazzo tile in the hallways is beginning to crack

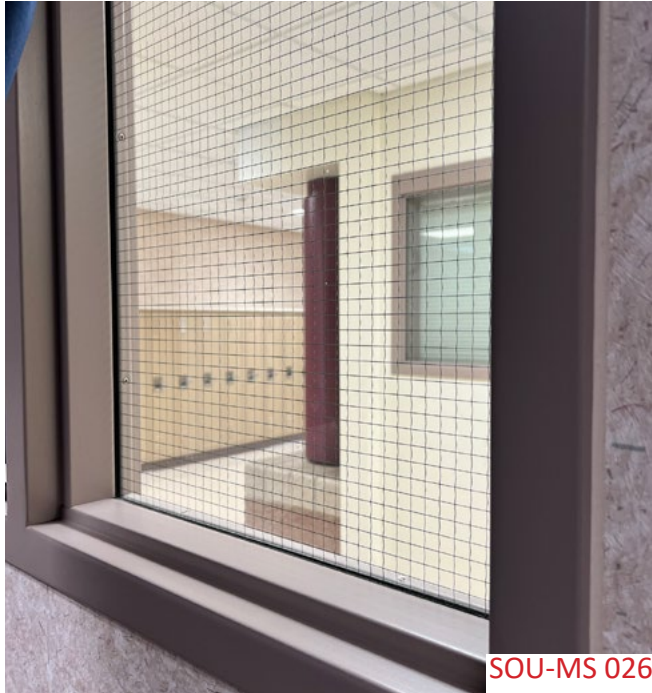
SOU-MS 026

Traditional wire glass throughout the building is no longer to code as an acceptable type of safety glass.

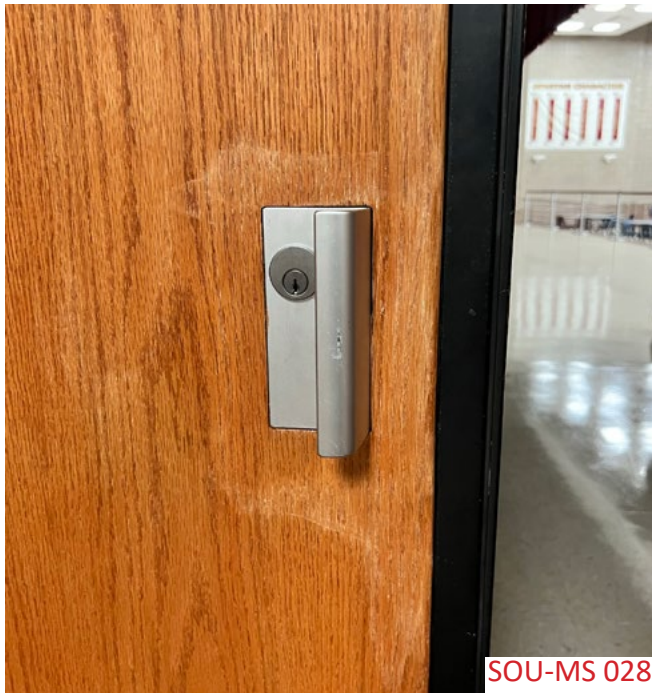
SOU-MS 028

Door 25 is not protected with an enclosed vestibule, as required by energy code.
Door hardware on doors to the stage is not accessible.

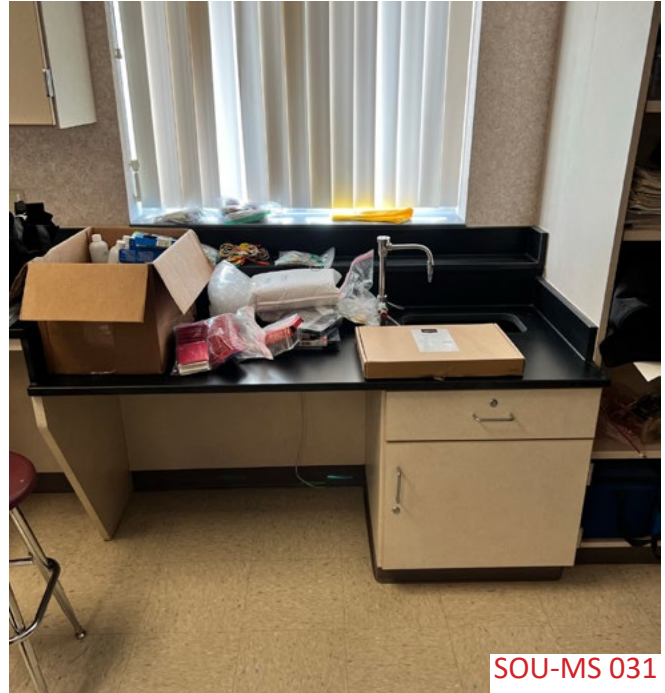
SOU-MS 031

The lower sink in the science lab is not accessible, as it exceeds reach range requirements and has no knee and toe clearance.

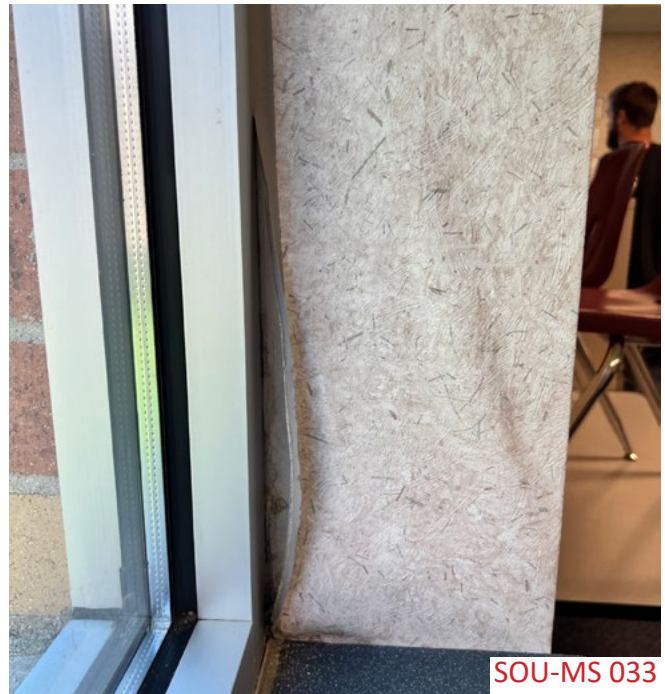
SOU-MS 033

Portions of exterior walls are covered with vinyl wall covering on the interior side, which is not to code.

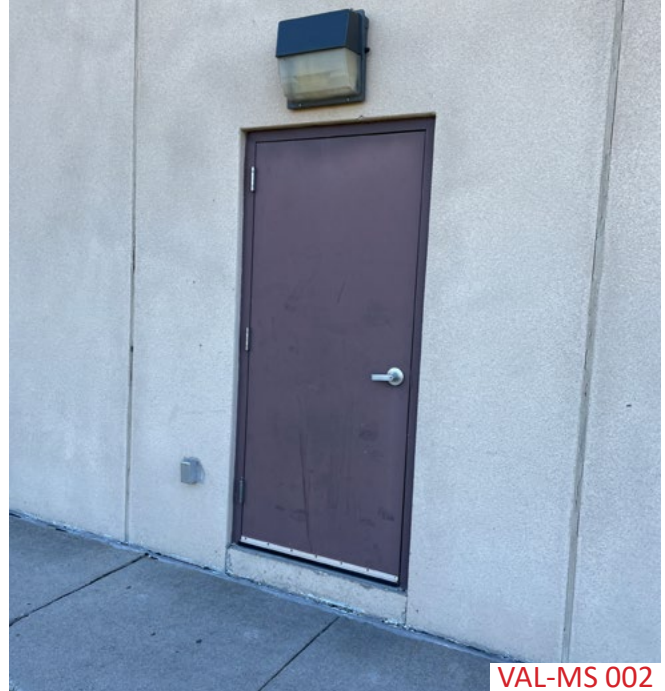
VAL-MS 002

There are accessibility issues at most exterior doors as a step up is required to enter the building.

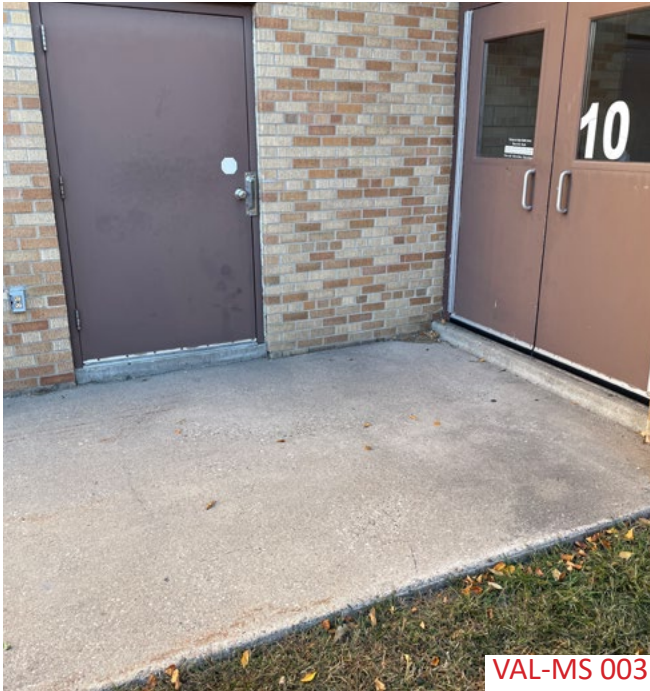
VAL-MS 003

There are accessibility issues at most exterior doors as a step up is required to enter the building.

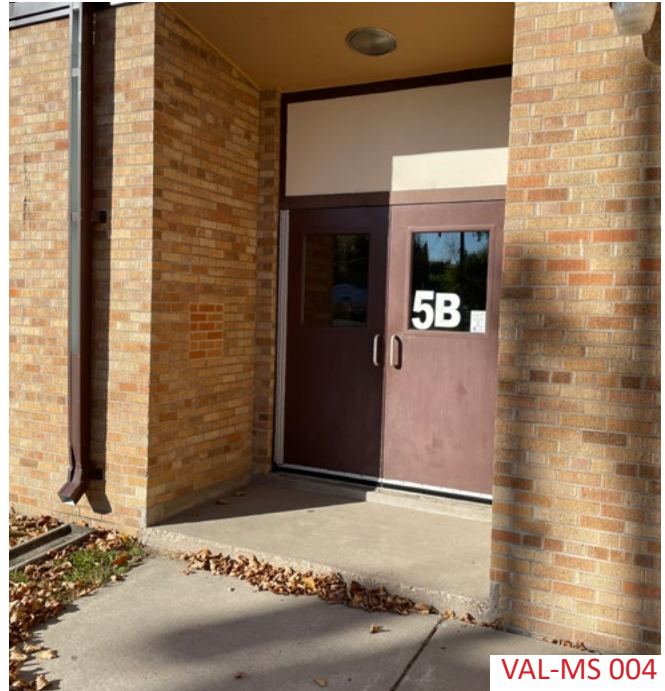
VAL-MS 004

There are accessibility issues at most exterior doors as a step up is required to enter the building.

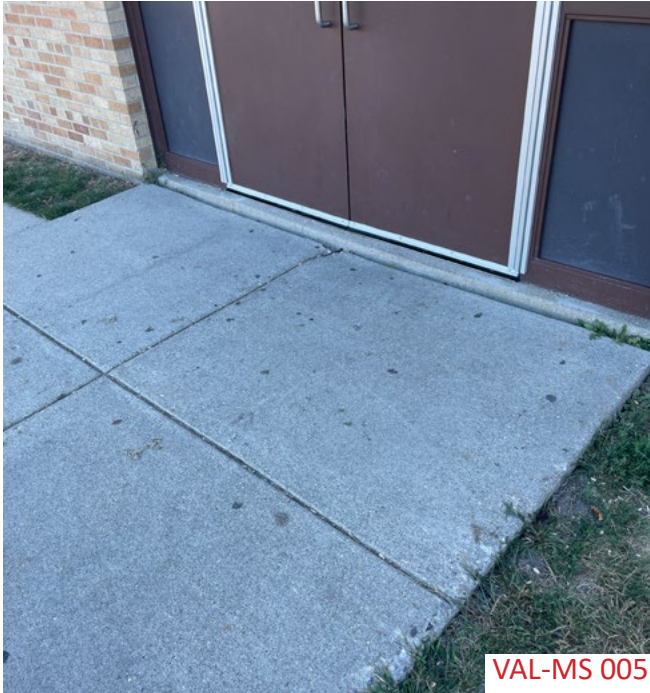
VAL-MS 005

The stoop at the exterior door in the corridor outside the library is sinking and pulling away from the door sill causing gaps at the threshold.

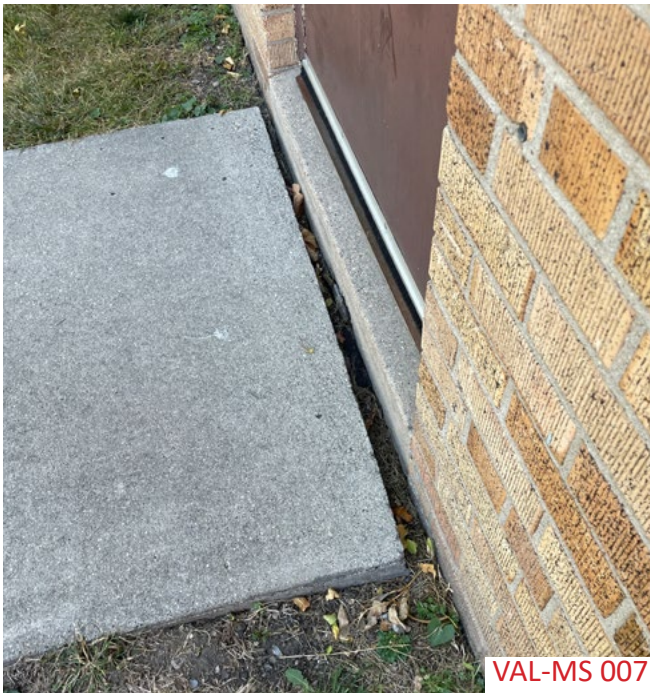
VAL-MS 007

The same issue is apparent at other doors where there isn't a proper stoop tied in.

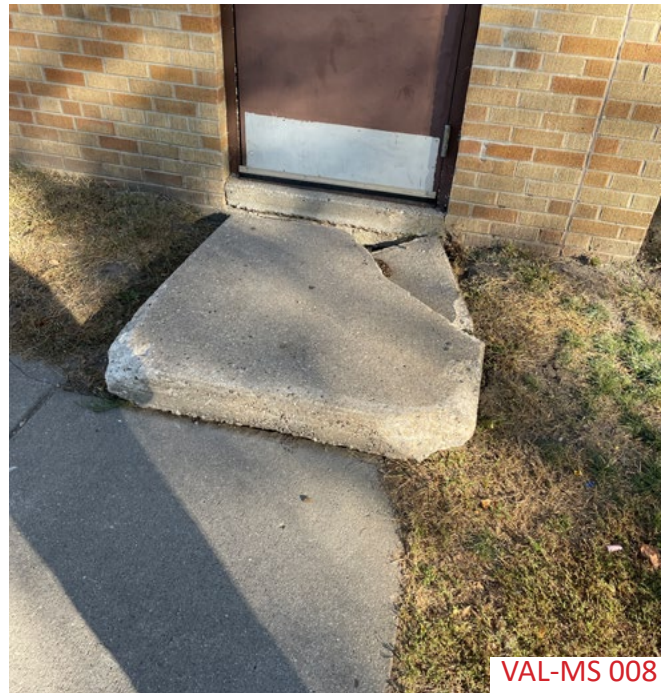
VAL-MS 008

The stoop outside the southeast door of the small gymnasium is in very bad shape and needs to be replaced.

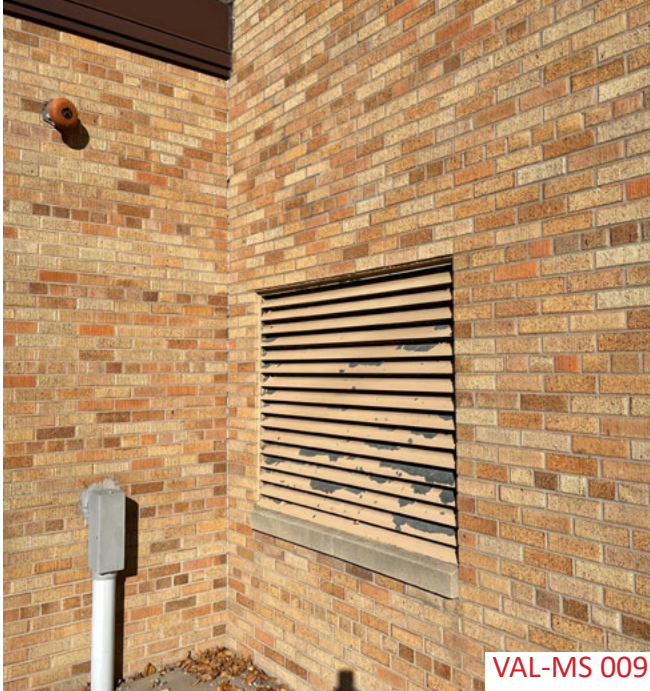
VAL-MS 009

Louvres around the exterior of the building should be repainted.

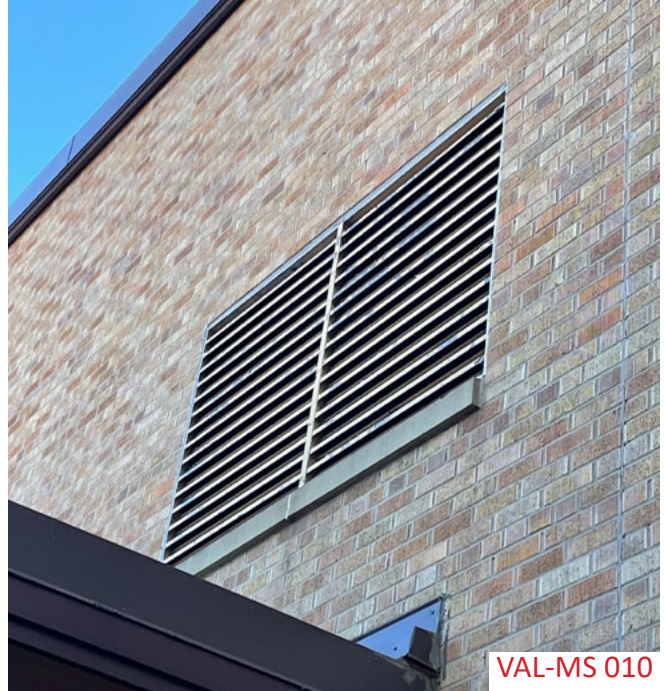
VAL-MS 010

Louvres around the exterior of the building should be repainted.

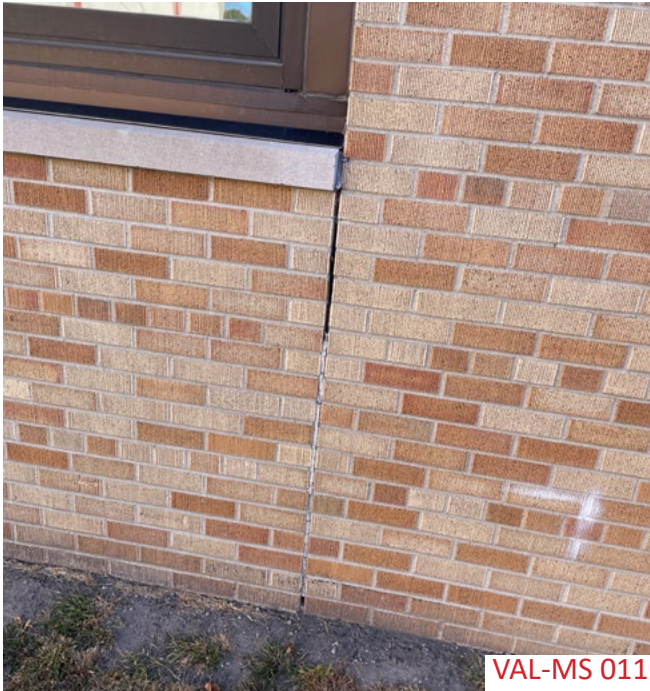
VAL-MS 011

The brick is in good condition overall, but caulking is wearing and needs attention.

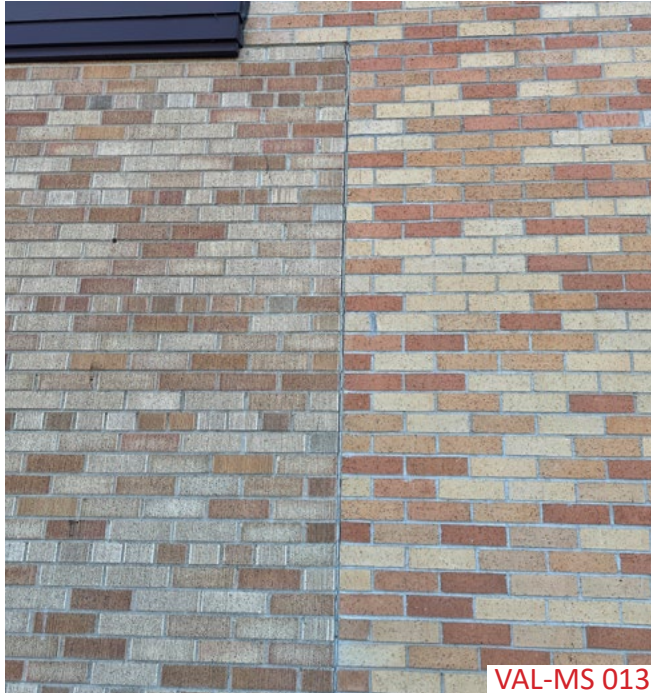
VAL-MS 013

The brick is in good condition overall, but caulking is wearing and needs attention.

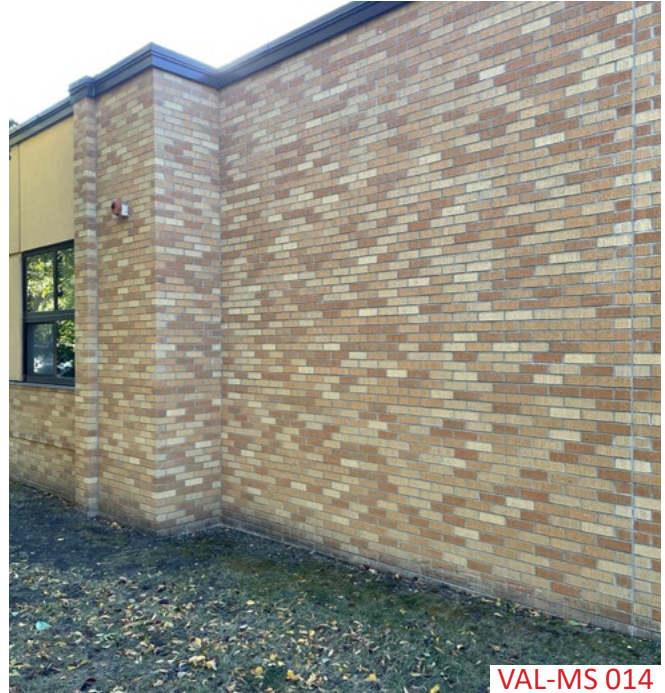
VAL-MS 014

The first few courses of brick around the building are dirty and should be cleaned.

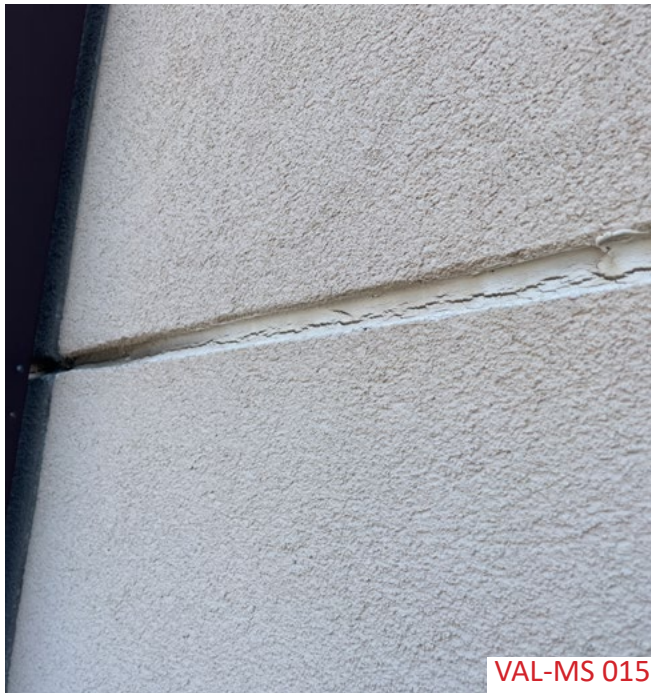
VAL-MS 015

Caulking is wearing and should be redone on EIFS walls.

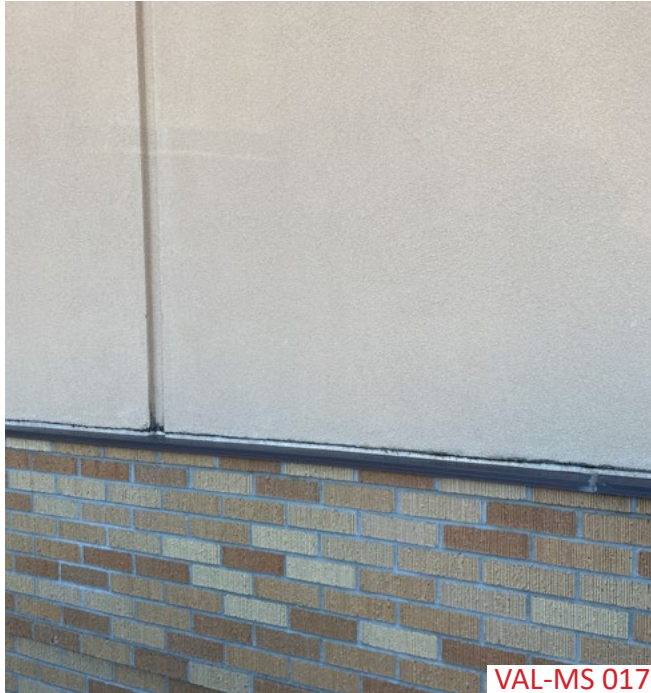
VAL-MS 017

The flashing around the bottom of the EIFS is not sufficiently running away from the wall.

Replace the flashing around the bottom of the EIFS that is not sufficiently running away from the wall	63	1 Ea.	\$76,379.74 / Ea.		\$76,380				\$76,380
Patch and refinish the damaged EIFS band beneath the windows in the north parking lot	64	1 Ea.	\$9,843.64 / Ea.		\$9,844				\$9,844
Paint the exposed trim boards around the top of the brick walls	65	1 Ea.	\$6,417.64 / Ea.		\$6,418				\$6,418
Fill the gaps in the exterior soffit	66	1 Ea.	\$16,743.74 / Ea.		\$16,744				\$16,744
Remove and replace hardboard siding with metal wall panel	67	1 Ea.	\$54,328.23 / Ea.		\$54,328				\$54,328
Exterior Upgrades Subtotal		77,911 SF	\$55.59 / SF						\$4,331,125
Electrical Upgrades									
Replace branch panels throughout building that are noted to be very old that are nearing the end of their useful life	68	77,911 SF	\$3.45 / SF	\$268,702					\$268,702
Add additional outlets throughout the school and upgrade related circuits as needed	69	77,911 SF	\$11.91 / SF	\$928,244					\$928,244

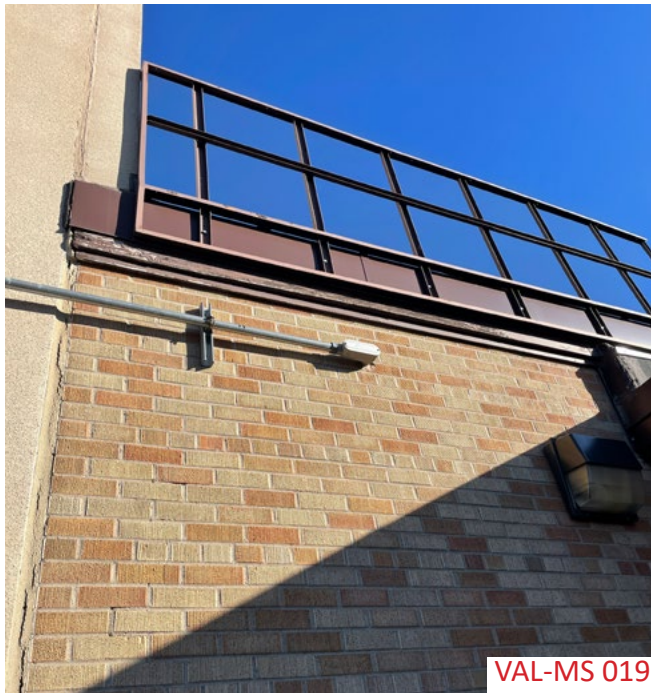
VAL-MS 019

The exposed trim board around the top of the brick walls should be repainted.

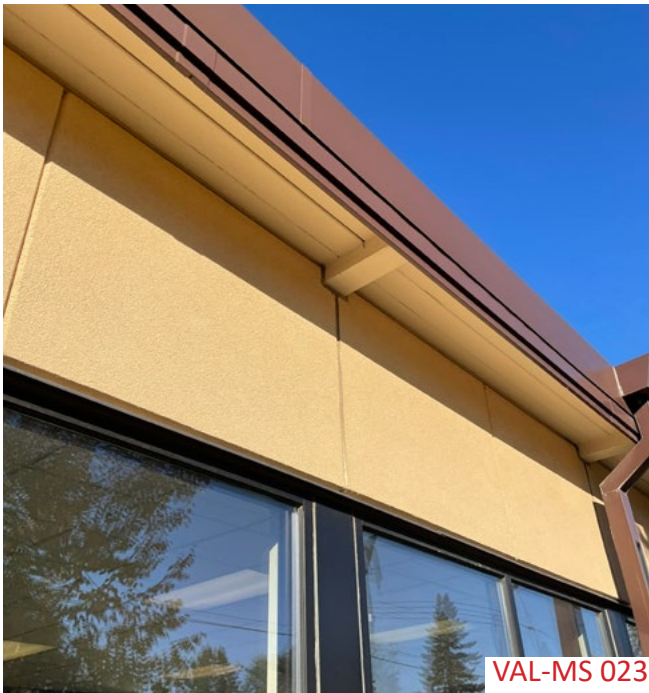
There are gaps in the soffit that need to be addressed.

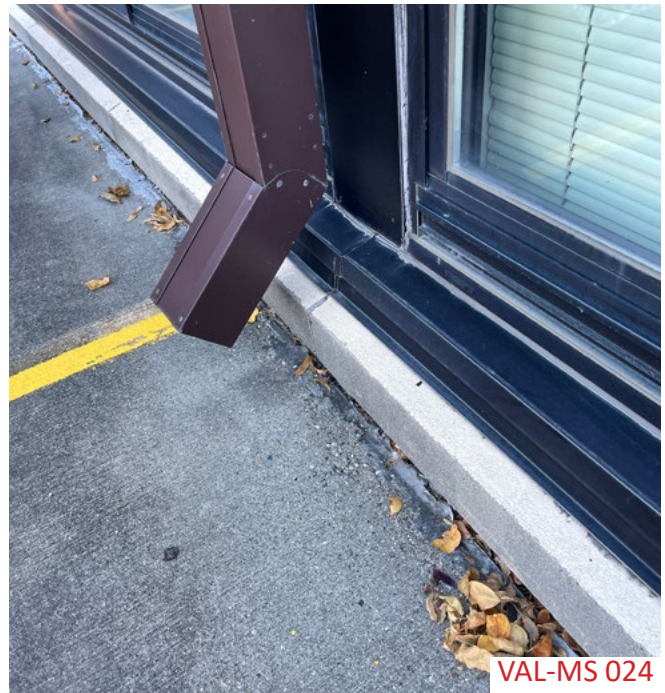
Overall, the windows appear to be in good condition but the sealant and gasketing within the windows are in poor shape and need to be redone.

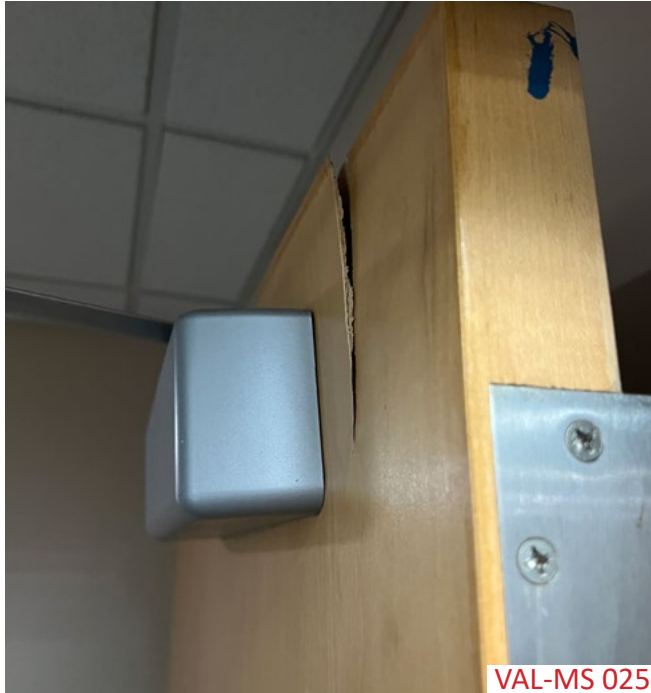
VAL-MS 025

Due to the age of the doors, visible wear and tear is shown on multiple doors.

Capital Maintenance									
Interior Upgrades									
Replace doors throughout the building that are in rough shape due to the age of the doors	50	50 Ea	\$3,780.24 / Ea		\$189,012			X	\$189,012
Replace dated ACT	51	20,000 SF	\$9.14 / SF		\$182,803			X	\$182,803
Further investigation is warranted to determine the cause of the shifting and large cracks in multiple CMU walls throughout the building	52								
Replace dated carpet throughout the school	53	25,000 SF	\$10.51 / SF		\$262,719				\$262,719
Replace old VCT, assumed to be contaminated with asbestos, replace with new flooring including abatement costs	54	5,000 SF	\$24.78 / SF		\$123,898				\$123,898
Interior Upgrades Subtotal		77,911 SF	\$9.73 / SF						\$758,433
Exterior Upgrades									
Add 62 additional parking stalls to the parking lot since it is not large enough	55	15,500 SF	\$14.84 / SF				\$230,020		\$230,020

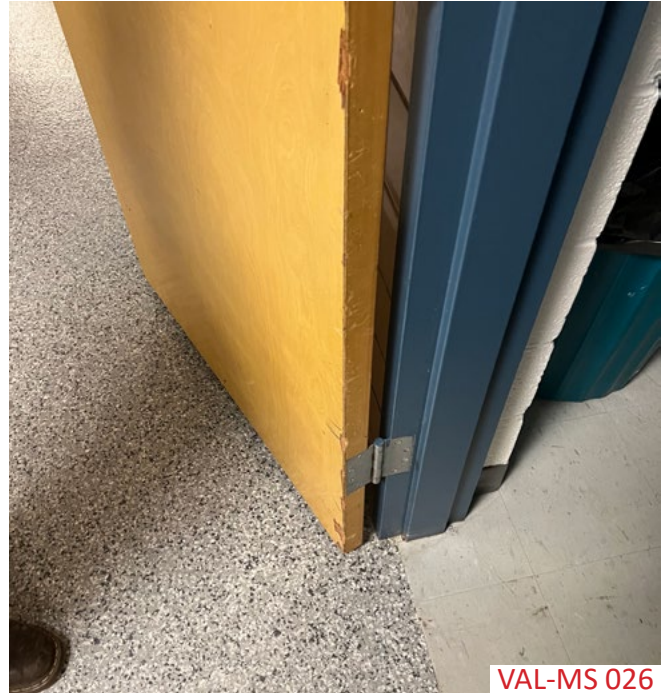
VAL-MS 026

Due to the age of the doors, visible wear and tear is shown on multiple doors.

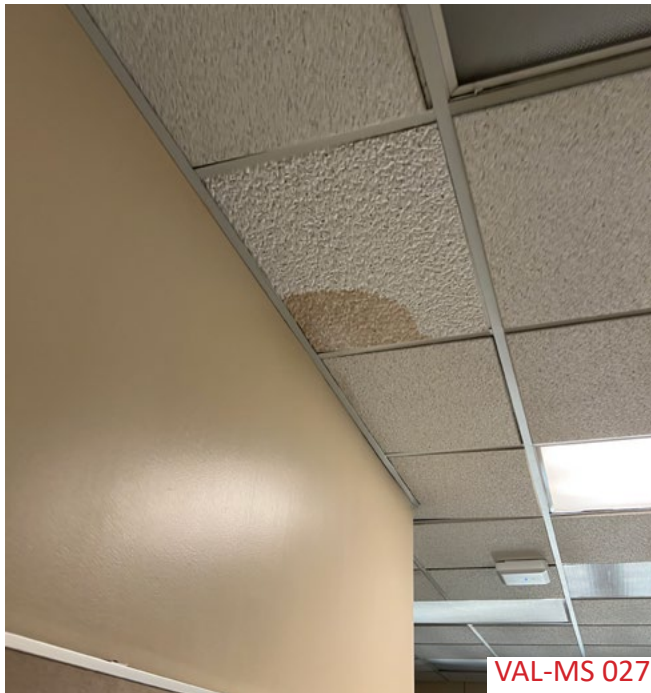
VAL-MS 027

There are some water stains throughout the building.

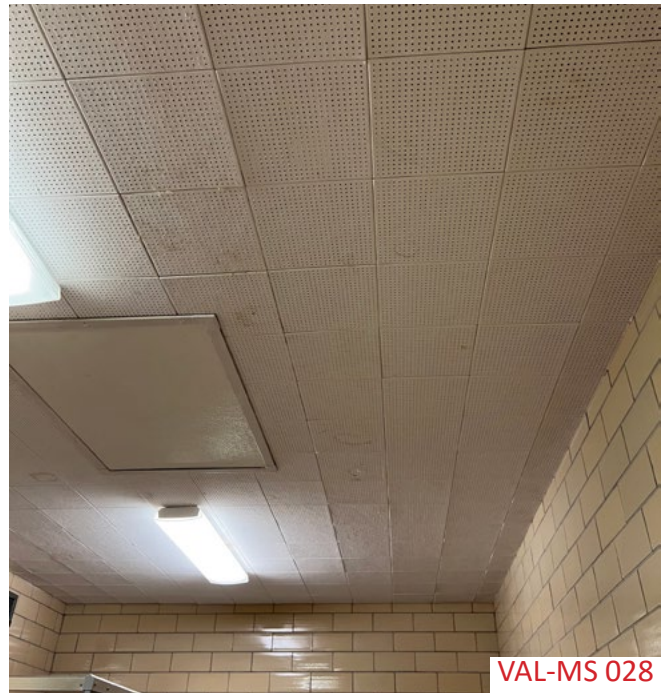
VAL-MS 028

The acoustical panels are dated and showing wear.

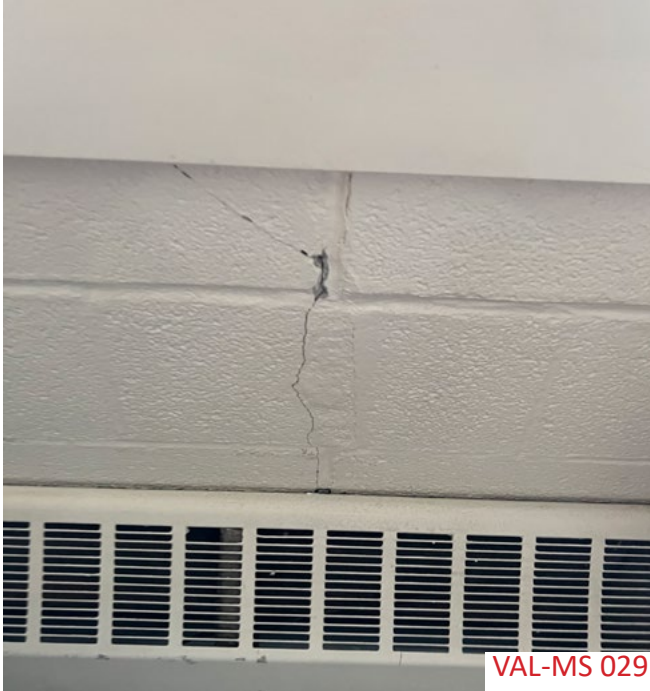
VAL-MS 029

There are notes of shifting and large cracks in multiple CMU walls throughout the building.

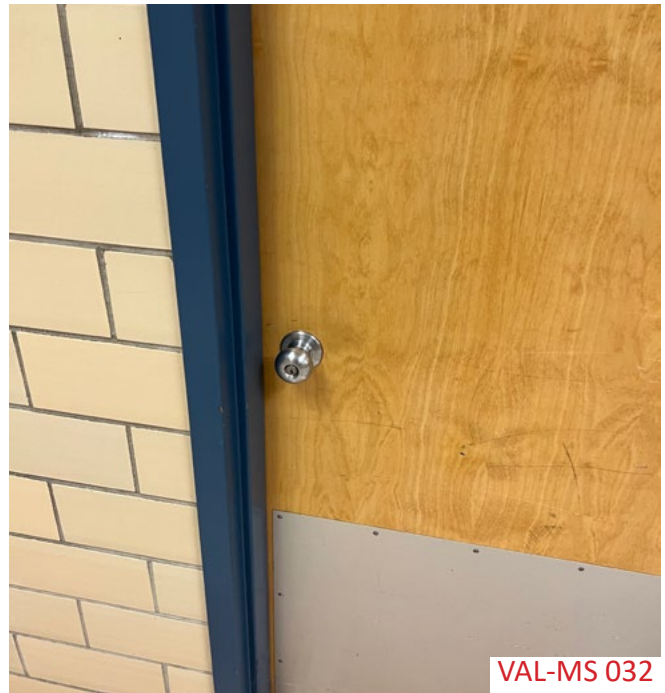
VAL-MS 032

Door hardware on various doors throughout the building is not accessible.

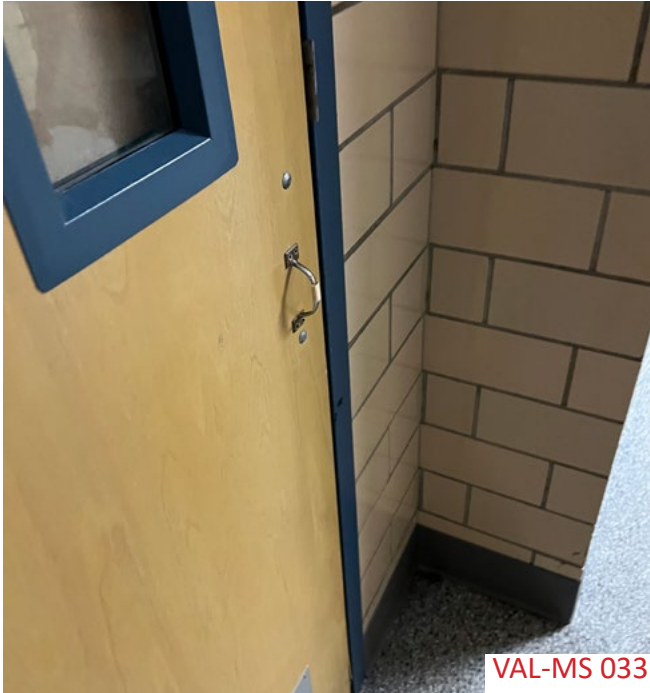
VAL-MS 033

Door hardware on various doors throughout the building is not accessible.

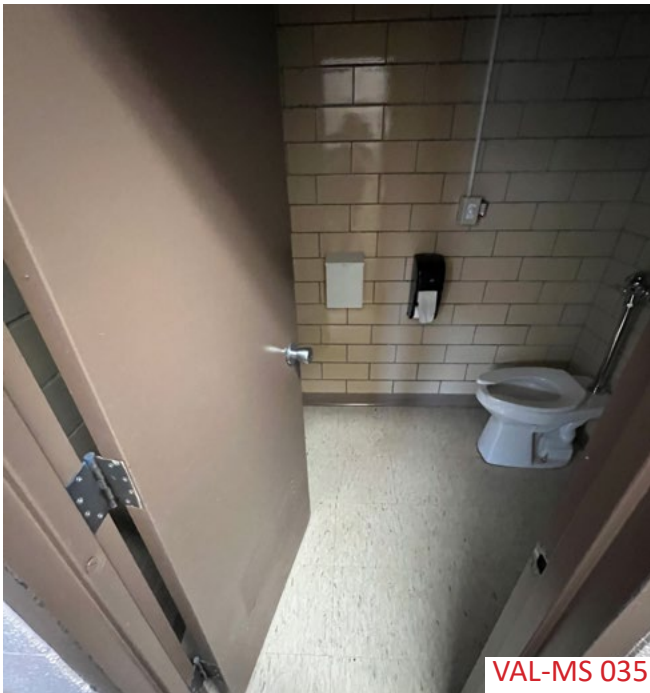
VAL-MS 035

The staff lounge restroom is not accessible.

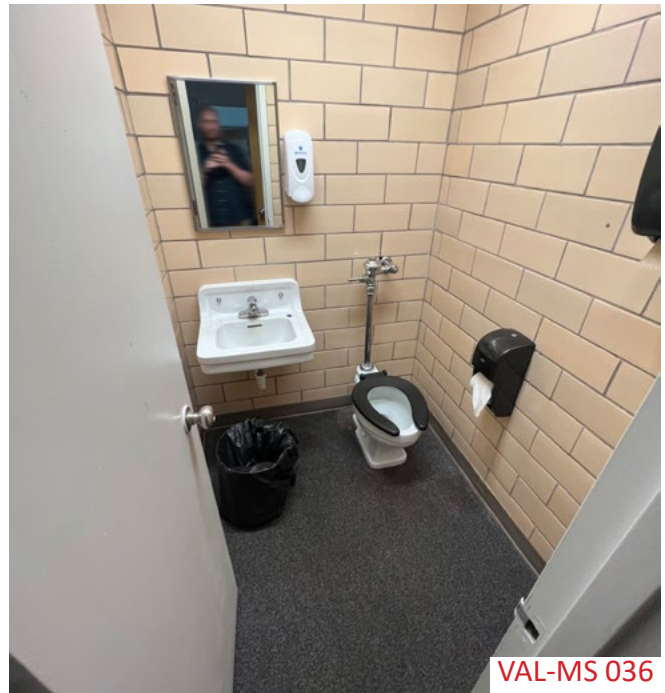
VAL-MS 036

The counseling room restroom is not accessible.
