ICON
ARCHITECTURAL GROUP

FACILITY ASSESSMENT FOR GRAND FORKS PUBLIC SCHOOLS

Grand Forks, ND

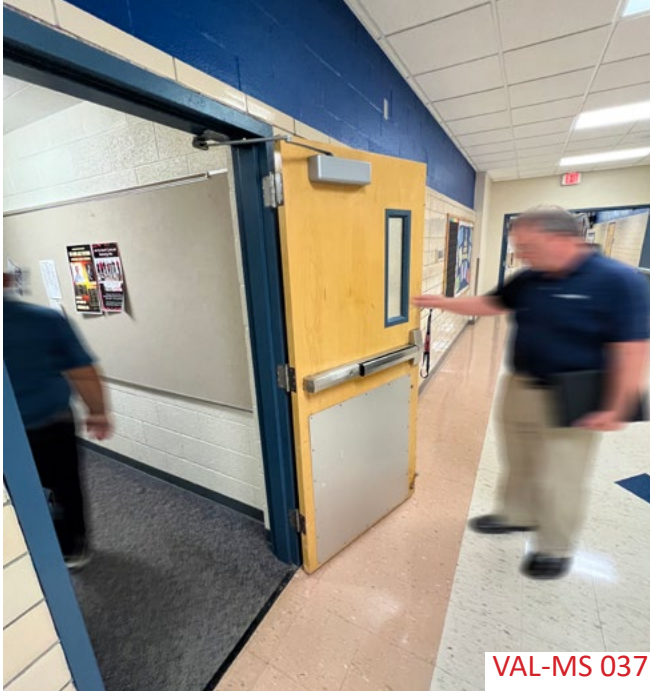
VAL-MS 037

Many interior doors are not fire rated.

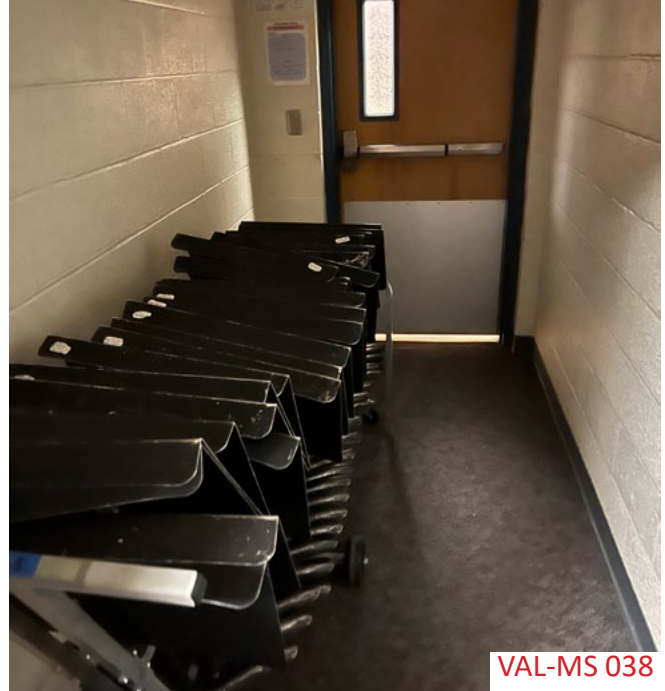
VAL-MS 038

Hallways in the music room do not meet minimum width requirements for accessibility.

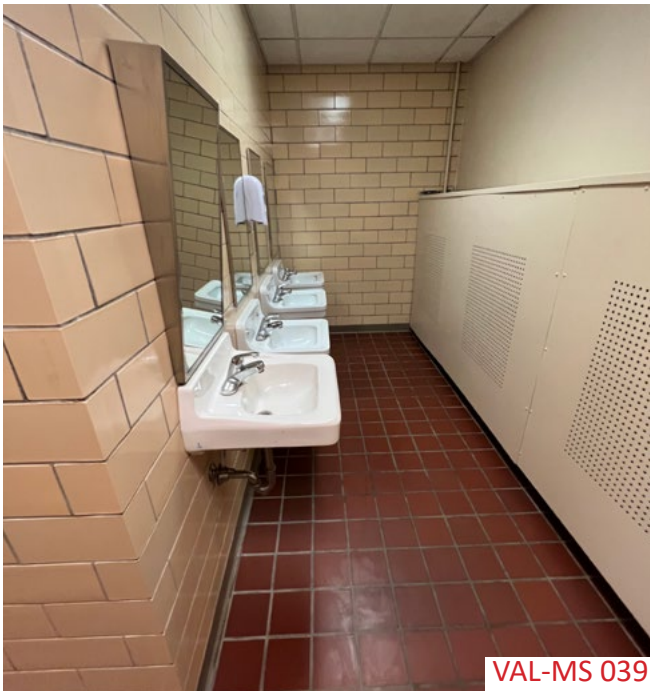
VAL-MS 039

All public restrooms in the building are not accessible.

Remodel all public restrooms in the building within existing space to meet accessibility requirements	6	8 Ea	\$74,350.90 / Ea	\$594,807				X	\$594,807
Remodel the custodial office restroom within the existing space to meet accessibility requirements	7	1 Ea	\$39,917.00 / Ea	\$39,917				X	\$39,917
Replace guardrail and add handrail to the stairwell in three mechanical rooms	8	60 LF	\$212.58 / LF	\$12,755					\$12,755
Remodel all locker rooms do to accessibility requirements, including the related rooms; corridors, storage, offices, showers, bathrooms, weights and fitness	9	4,330 SF	\$359.77 / SF	\$1,557,799				X	\$1,557,799
Remove and replace concrete in 3 locker rooms showers so each individual showerhead can have its own drain per code	10		/						
Remodel will make the weight room is accessible from the gym	11		/						
Change the swing of the door into the weight room that lacks sufficient push/pull clearance	12		/

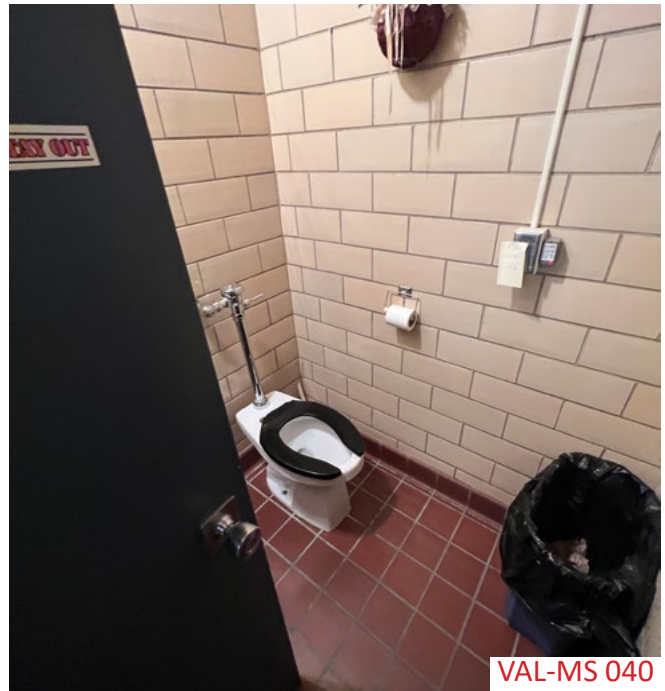
VAL-MS 040

- The custodial office restroom is not accessible (040).
- The stairwell in the mechanical room is missing a handrail (041).
- All locker rooms are not accessible (042, 043).

The custodial office restroom is not accessible.

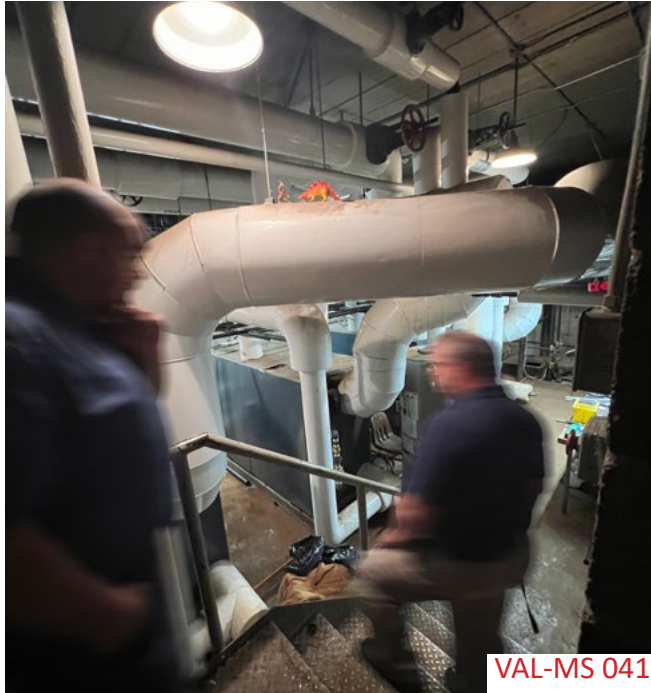
VAL-MS 041

The stairwell in the mechanical room is missing a handrail.

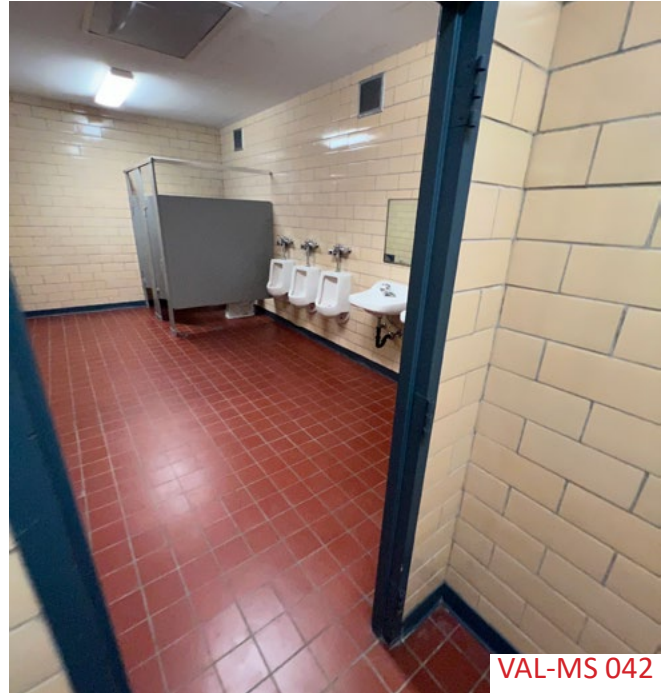
VAL-MS 042

All locker rooms are not accessible.

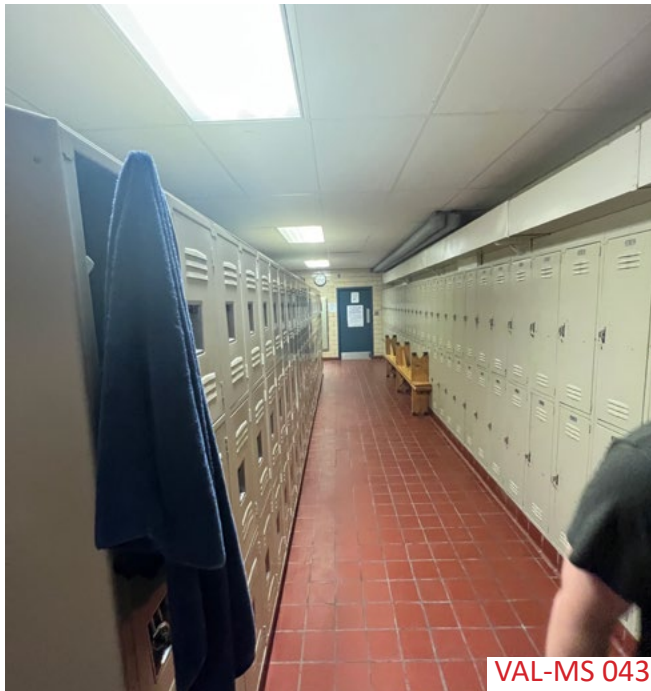
VAL-MS 043

All locker rooms are not accessible.

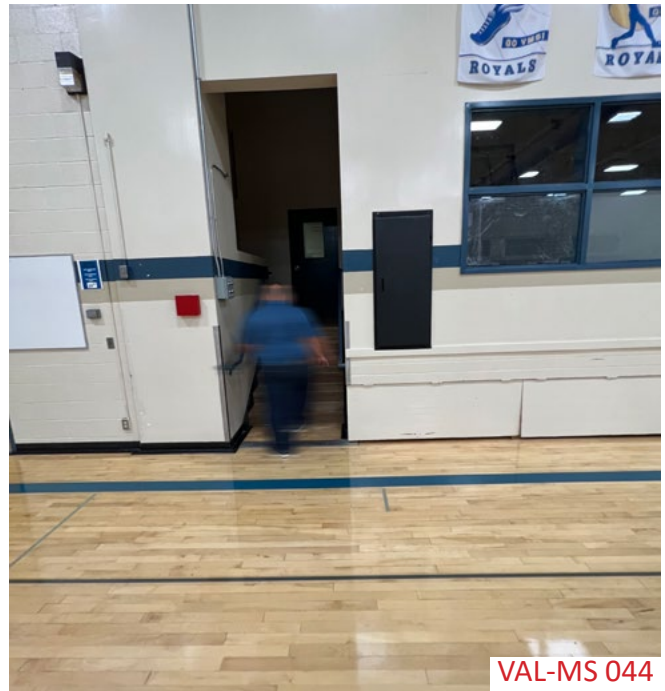
VAL-MS 044

- The weight room is not accessible from the gym (044).
- The door into the weight room fails to meet required maneuvering clearance for accessibility and the door does not swing in the proper direction (045).

The weight room is not accessible from the gym.

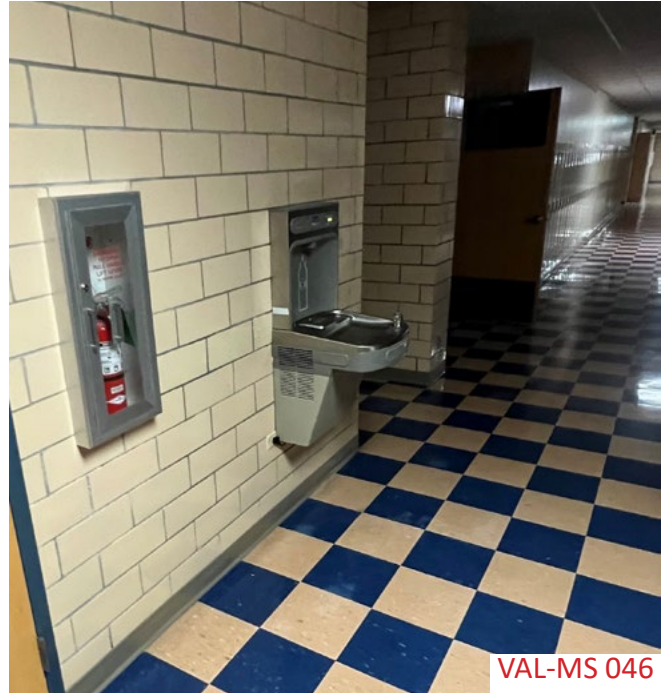
VAL-MS 046

Drinking fountains throughout the building do not meet the required ratio of wheelchair accessible fountains to standing person accessible fountains.

Add handicap accessible water fountains throughout the building	13	16 Ea	\$21,944.54 / Ea	\$351,113					\$351,113
Replace exterior and interior entrance with tempered glass at the main south entrance, the east entrance by the gym, and the west entrance by the library.	14	3 Ea	\$42,899.62 / Ea	\$128,699					\$128,699
Remove combustible material from ceilings and walls in the music area, replace with acoustical wall coverings and ACT	15	1,500 SF	\$53.84 / SF	\$80,764					\$80,764
Replace room signage that is missing brail with ADA compliant signs	16	185 Ea	\$128.26 / Ea	\$23,729					\$23,729
Replace all guardrails and handrails in public stairwells that do currently meet code (60 lf guardrail and 240 lf handrails)	17	300 LF	\$199.43 / LF	\$59,829					\$59,829
Add handrails extensions to the to and bottom of the stairs	18		/						
Add a separate handrail to the guardrail as required in the stairwell in the middle of the school	19		/

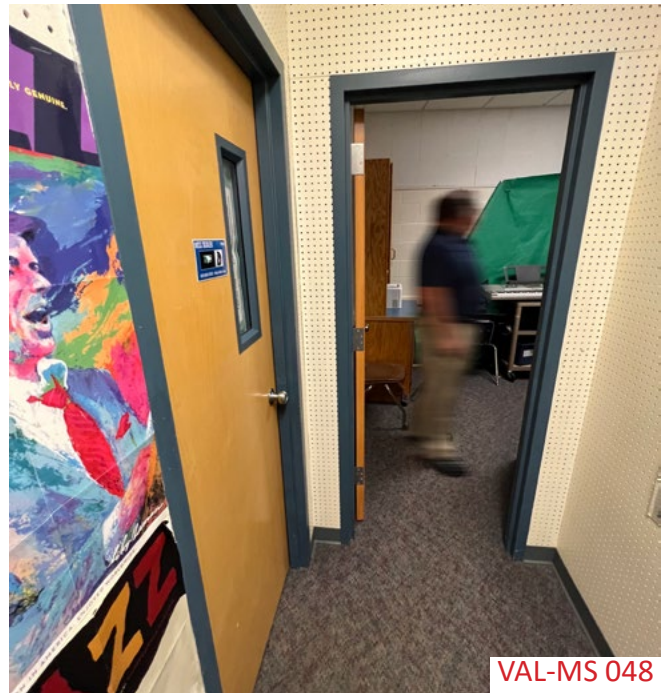
VAL-MS 048

- Most entrances to the school do not have the required safety glass (047).
- Combustible material is found in corridors that are non-sprinklered (048).

Combustible material is found in corridors that are non-sprinklered.

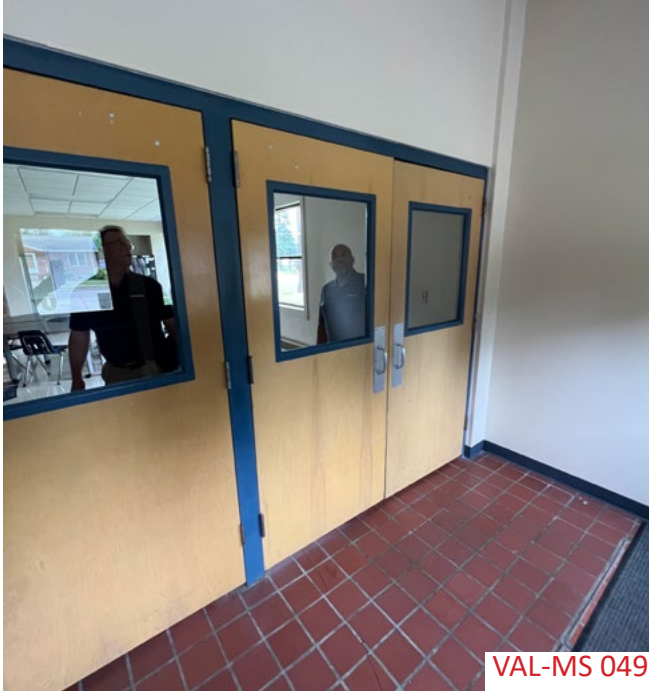
VAL-MS 049

Exit doors do not have the required safety glass.

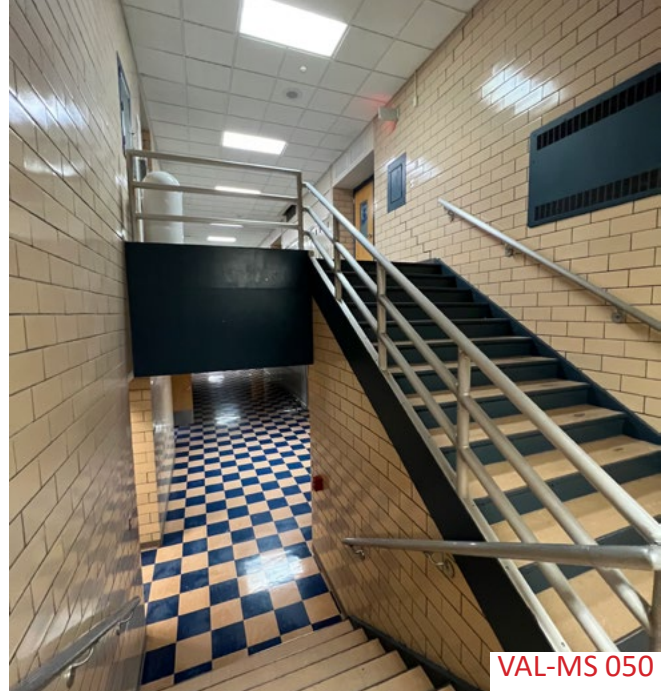
VAL-MS 050

The stairwell in the middle of the school is lacking a separate handrail from the guardrail and spaces between the railings exceed the maximum size of 4".

Replace guardrail where the spaces between railings exceed the maximum size of 4"	20		/						
Change the swing of the door to the electrical meter room	21	1 Ea	\$3,561.29 / Ea	\$3,561					\$3,561
Replace wire glass throughout the building that is no longer up to code (frame to remain)	22	3,200 SF	\$33.65 / SF	\$107,683				X	\$107,683
Protect sink plumbing in restrooms throughout the building that are exposed	23	18 Ea	\$940.48 / Ea	\$16,929				X	\$16,929
Replace casework (20lf of base, top, and upper per classroom) and sinks in 40 classrooms that are not accessible	24	40 Ea	\$26,939.88 / Ea	\$1,077,595					\$1,077,595
Create a second exit in computer room 3	25	1 Ea	\$3,508.52 / Ea	\$3,509					\$3,509
Create a second exit in the art room	26	1 Ea	\$3,508.53 / Ea	\$3,509					\$3,509
Create a second exit in room B-5	27	1 Ea	\$3,508.52 / Ea	\$3,509					\$3,509
Create an ADA workstation at the desk in the main office	28	1 Ea	\$7,855.41 / Ea	\$7,855					\$7,855

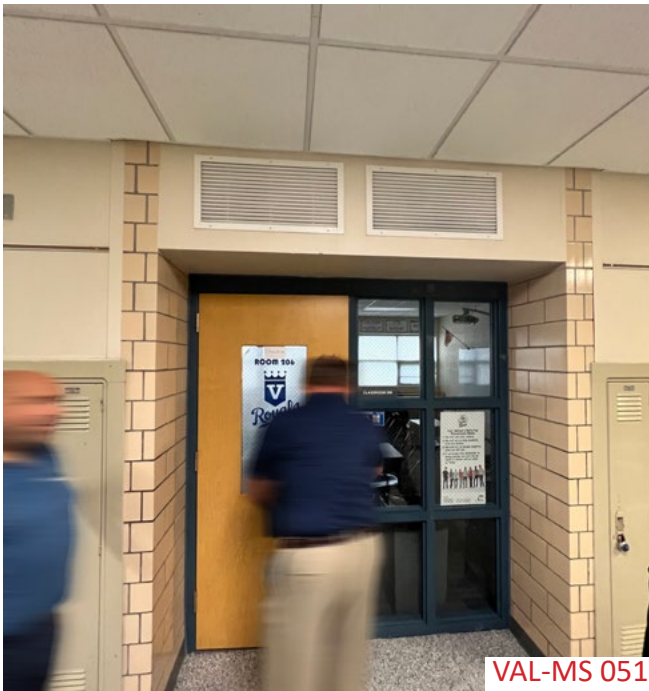
VAL-MS 051

Wire glass is seen throughout the building.

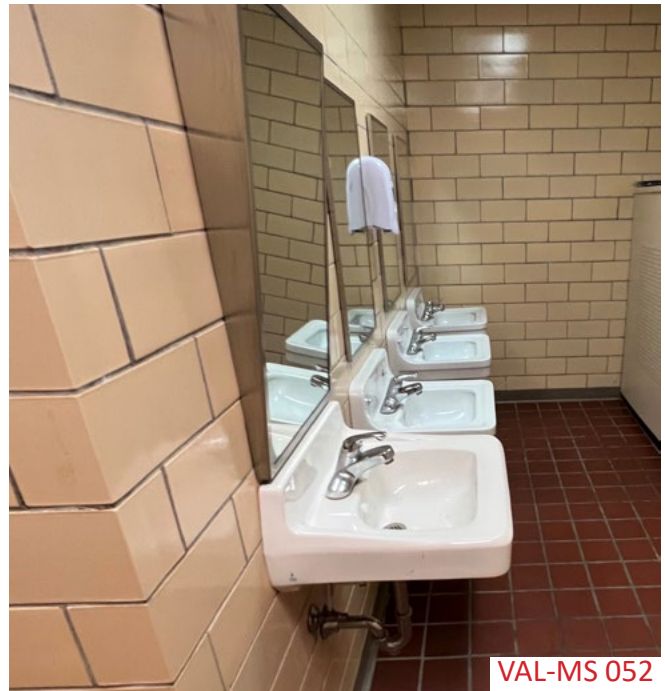
VAL-MS 052

Pipes throughout the building are exposed and should be protected.

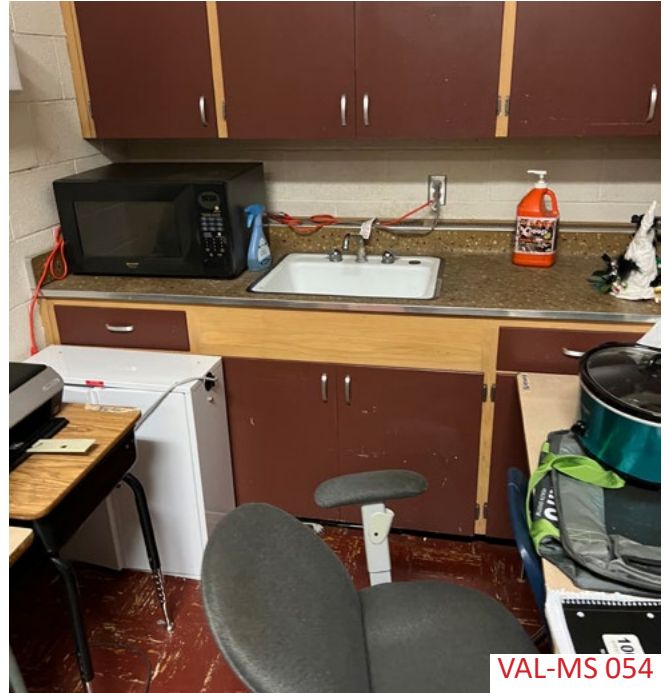
Sinks in classrooms are not accessible.

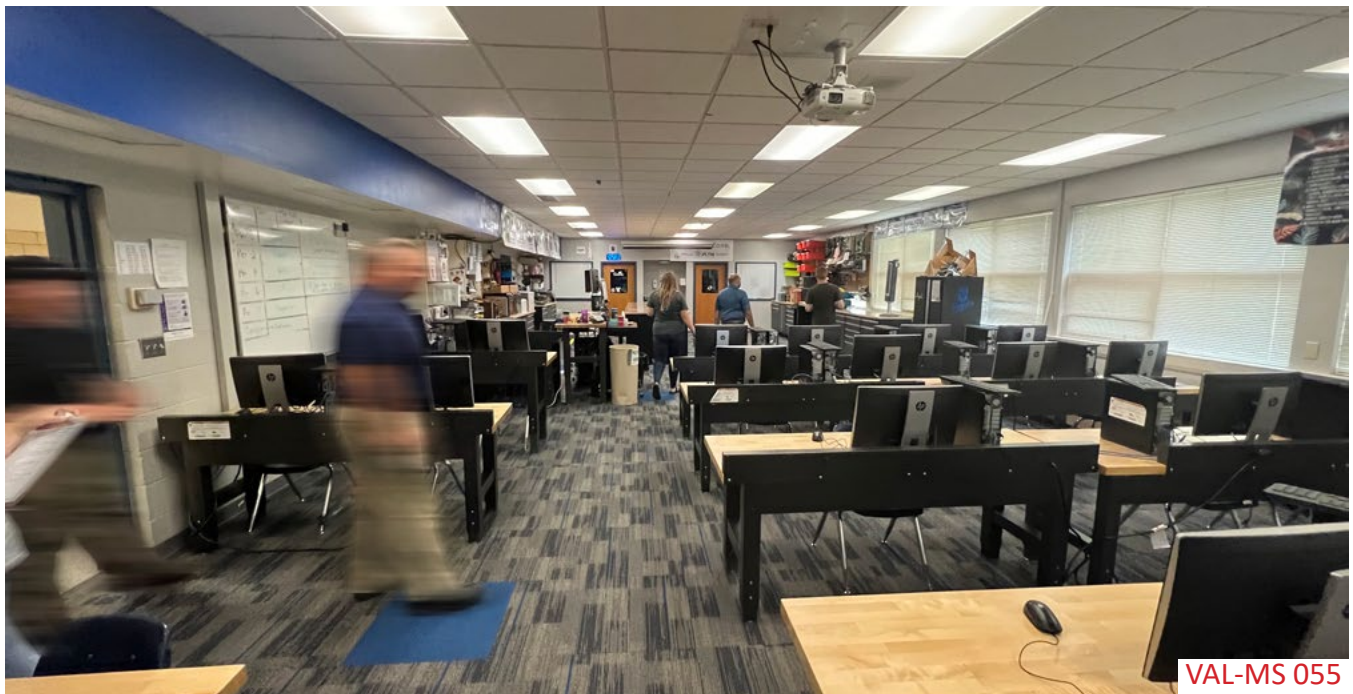
Room B-5 needs an additional exit.

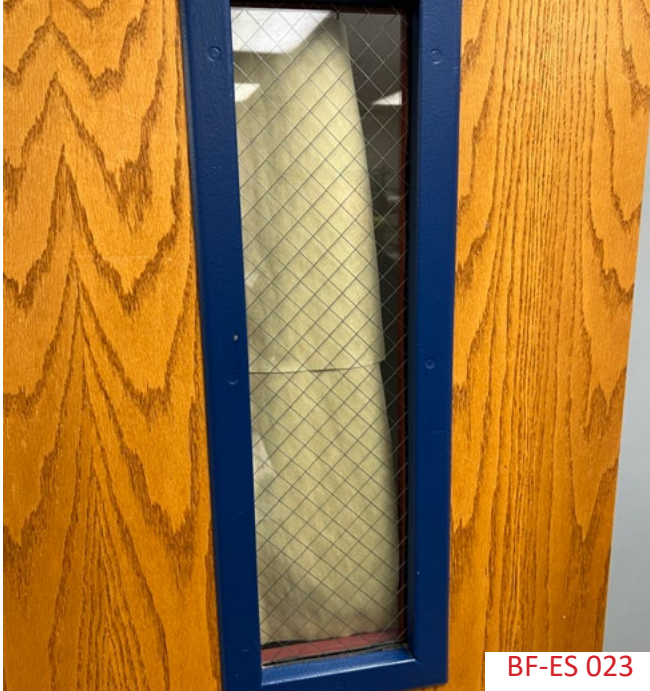
Traditional wire glass throughout the building is no longer to code as an acceptable type of safety glass.

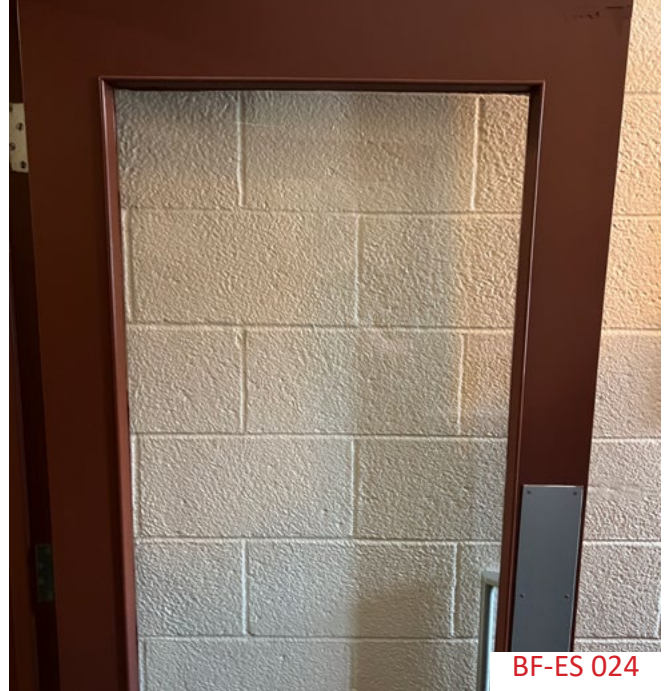
Glass in display cases and doors is not the required safety glass.

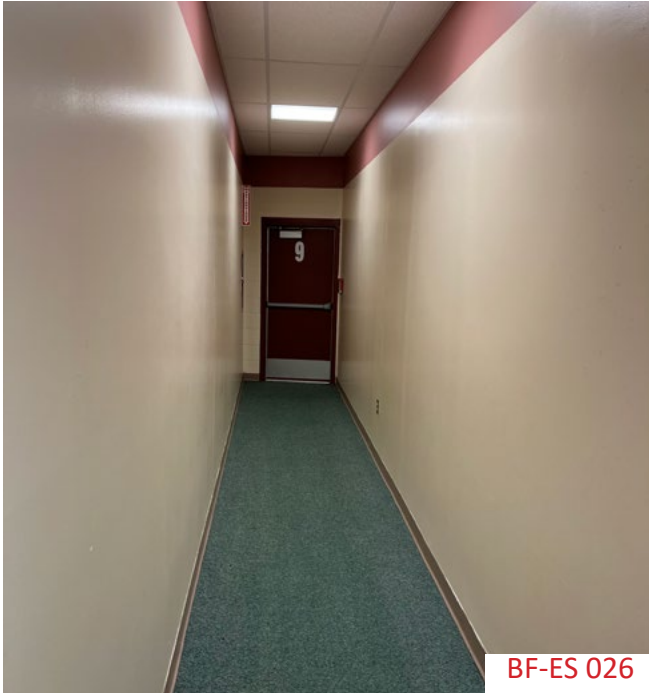
The slanted corridors in the west wing of the building do not have an adequate turn radius and the doors fail to meet required maneuvering clearances for accessibility.

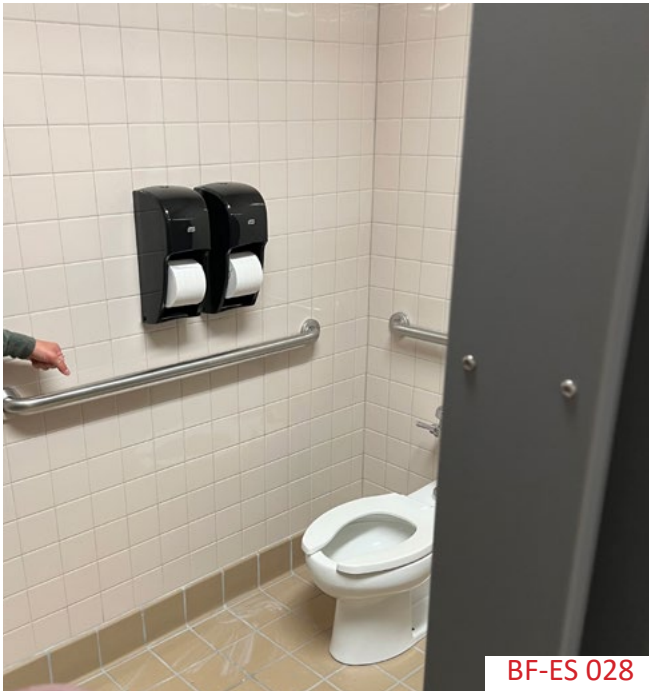
Boys' and girls' restrooms near the gym are not accessible. Grab bars and toilet paper dispensers exceed height limitations

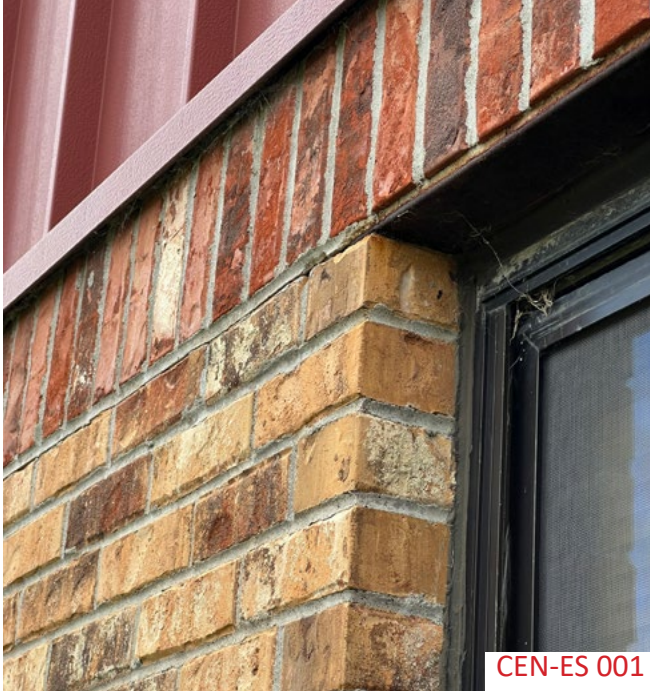
CEN-ES 001

Mortar could be repaired in some areas as it is cracking and wearing, especially outside of the music room window.

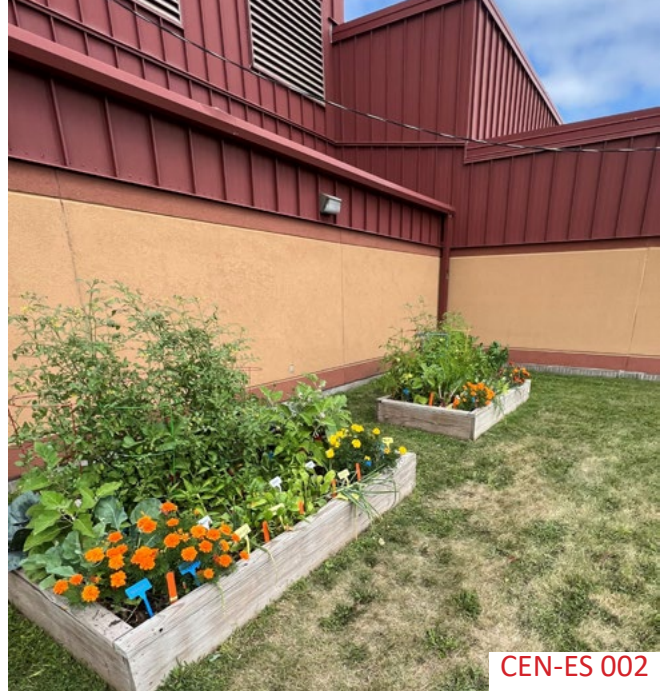
CEN-ES 002

In addition to masonry, the exterior façade also consists of EIFS and metal siding.

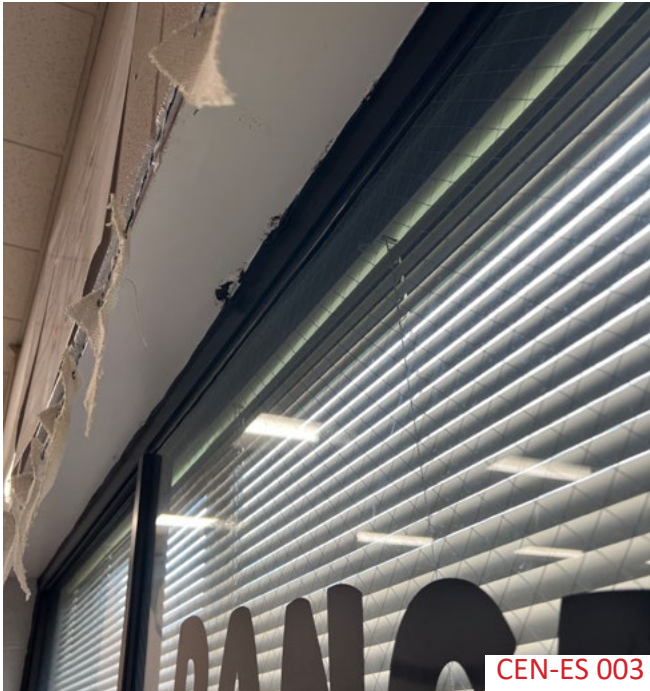
CEN-ES 003

Windows are in good condition as well, but there has been water leakage above the window in the music room.

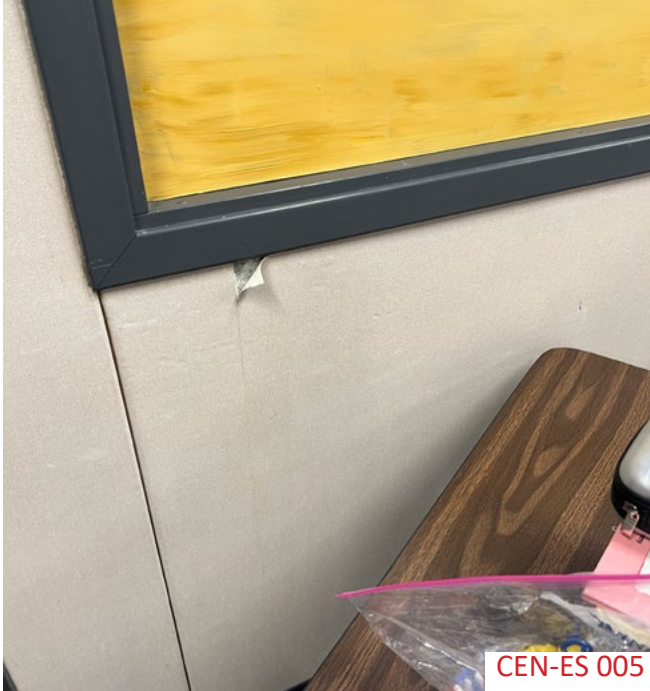
CEN-ES 005

Some areas where the vinyl wall covering is releasing from the gypsum substrate.

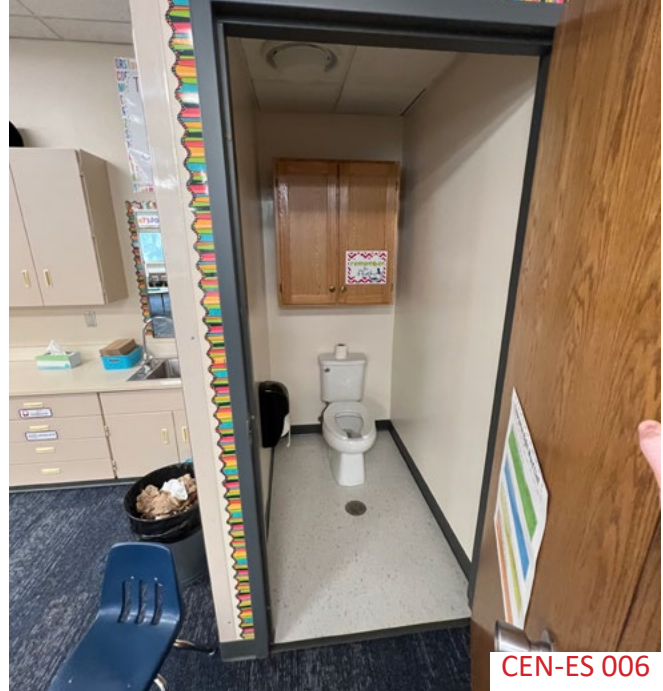
CEN-ES 006

Restrooms in the building are not accessible. This includes restrooms in classrooms

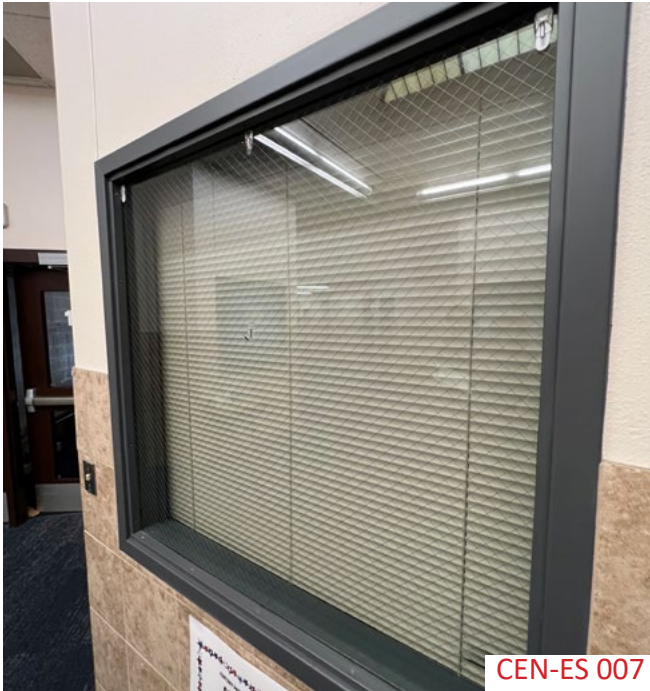
CEN-ES 007

Traditional wire glass throughout the building is no longer to code as an acceptable type of safety glass

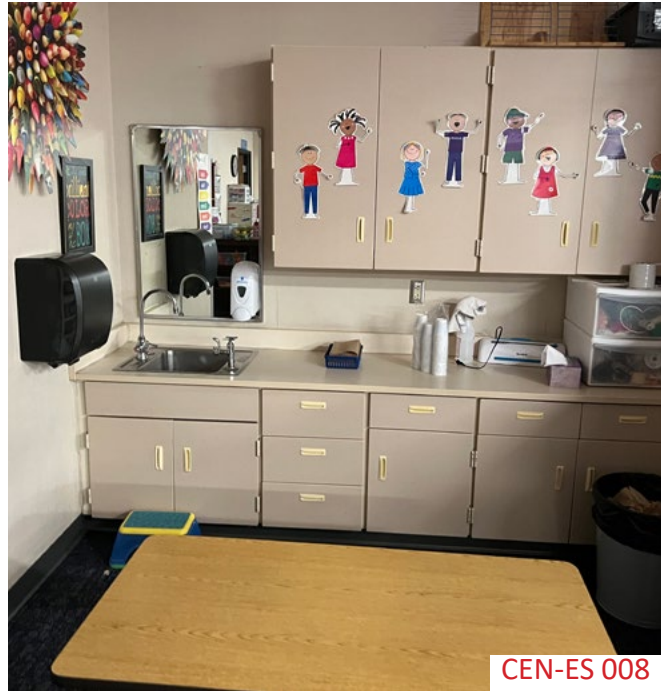
CEN-ES 008

Several sinks in the building are not accessible, specifically in the resource room, library work room, lounge, sick room, classrooms, and restrooms.

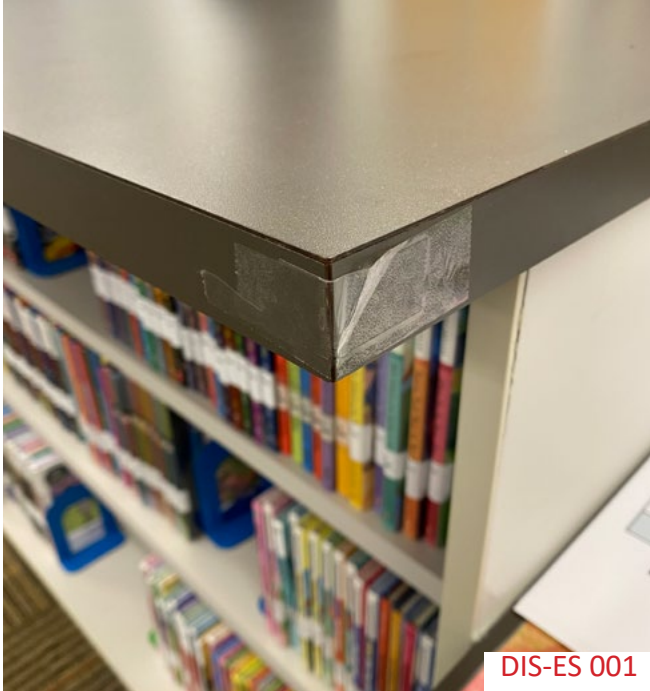
DIS-ES 001

The original casework of the building is low quality and damages easily. The laminate is peeling on the counters .

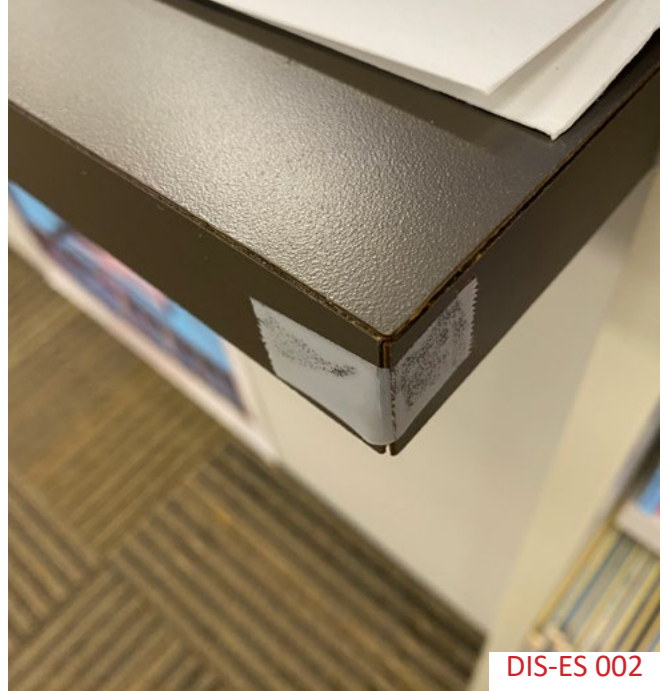
DIS-ES 002

Replacement should be considered; damage is especially apparent in library islands.

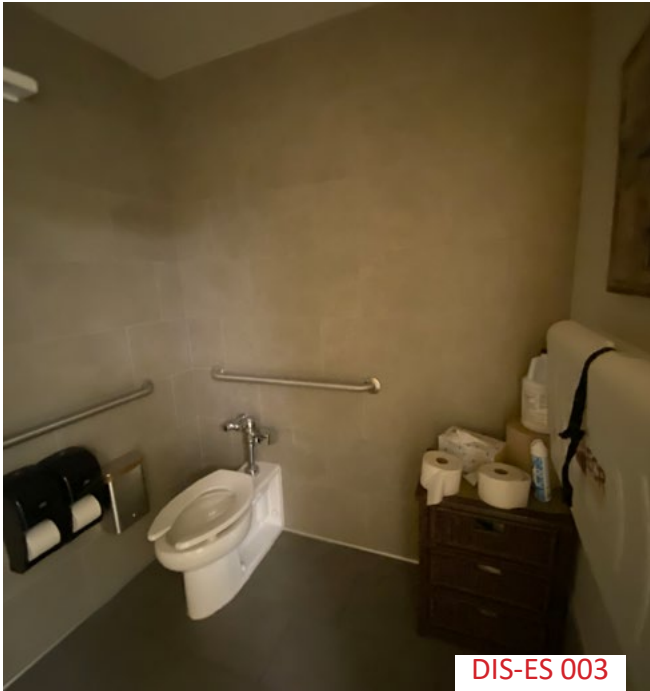
DIS-ES 003

Another concern is the lack of storage in restrooms.

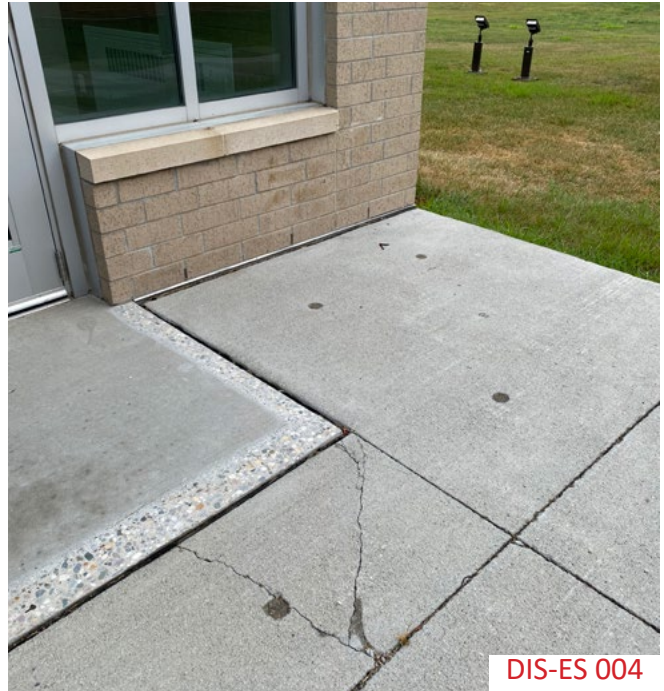
DIS-ES 004

The slab is sagging and sinking around the stoop at door 7.

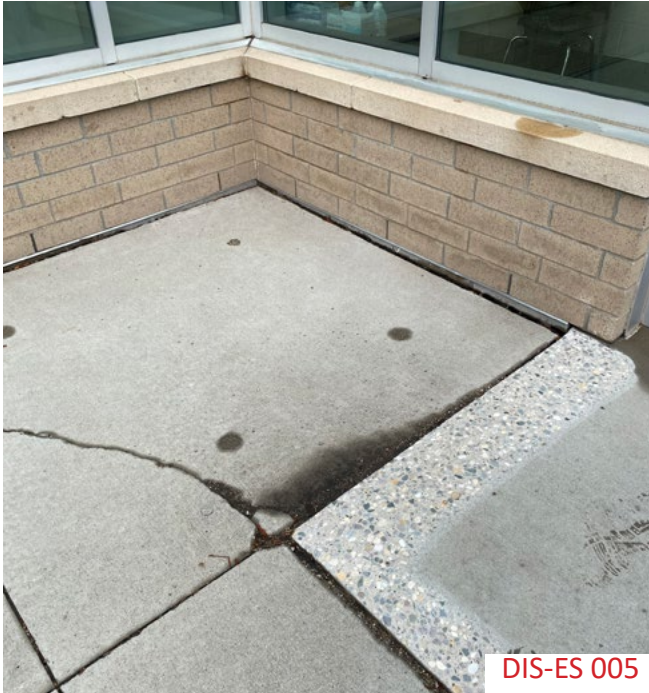
DIS-ES 005

The slab is sagging and sinking around the stoop at door 7.

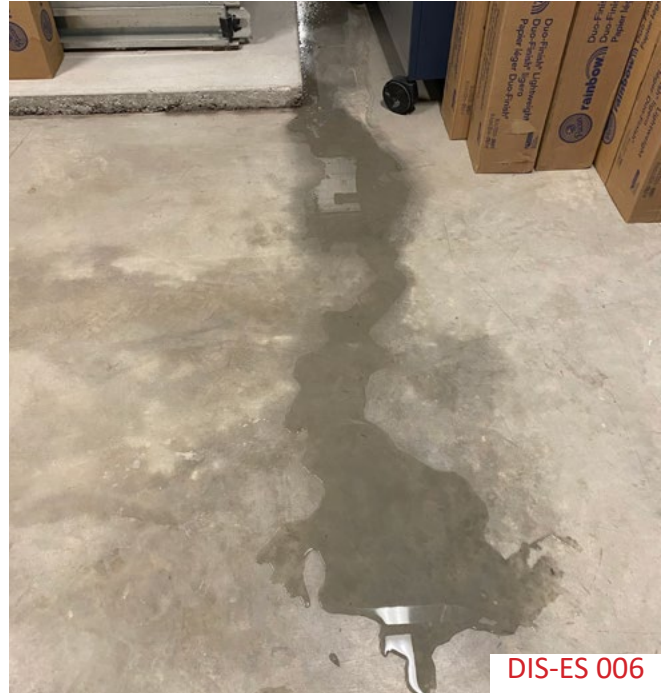
DIS-ES 006

Water is leaking and pooling in the 2nd floor mechanical room.

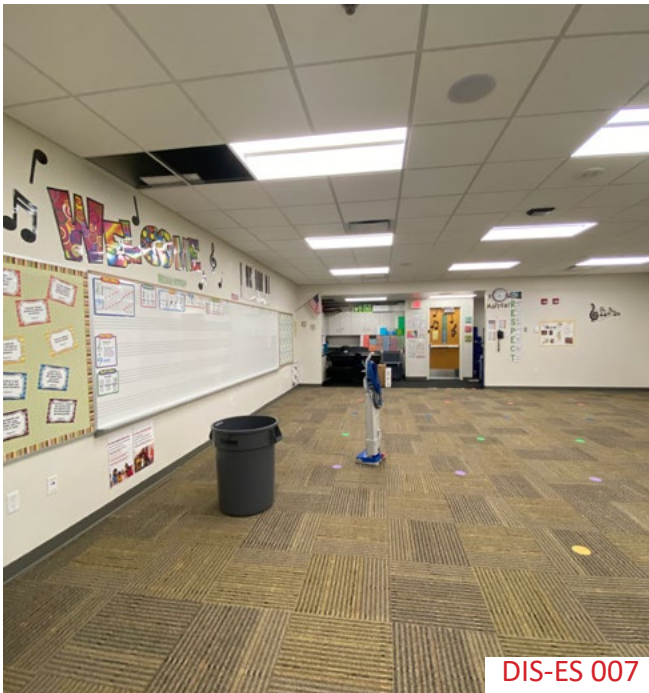
DIS-ES 007

Water is leaking and pooling in the 2nd floor mechanical room which is resulting in ceiling leaks into the music and band rooms below.

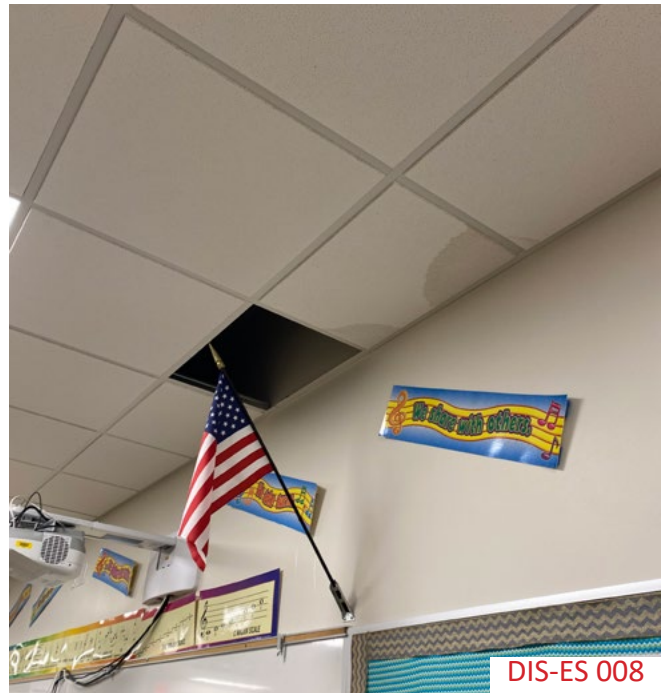
DIS-ES 008

Water is leaking and pooling in the 2nd floor mechanical room which is resulting in ceiling leaks into the music and band rooms below.

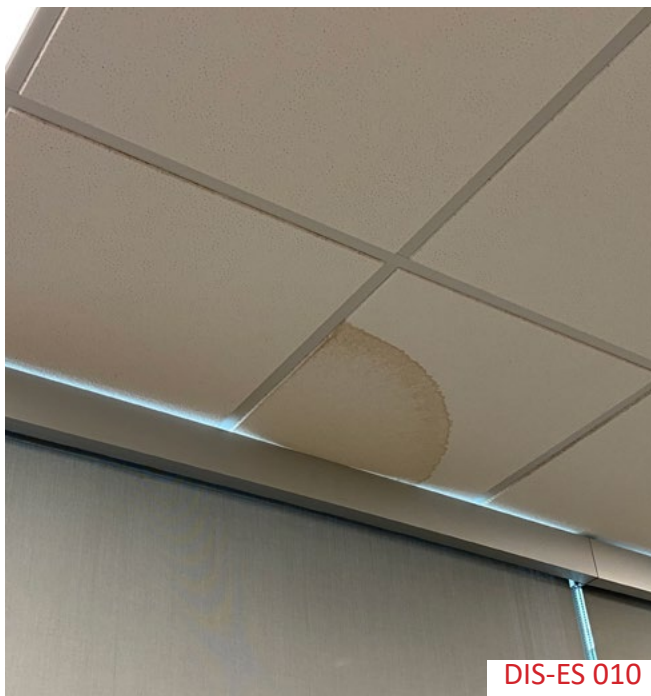
There are also several ceiling tiles throughout the school that have water damage.

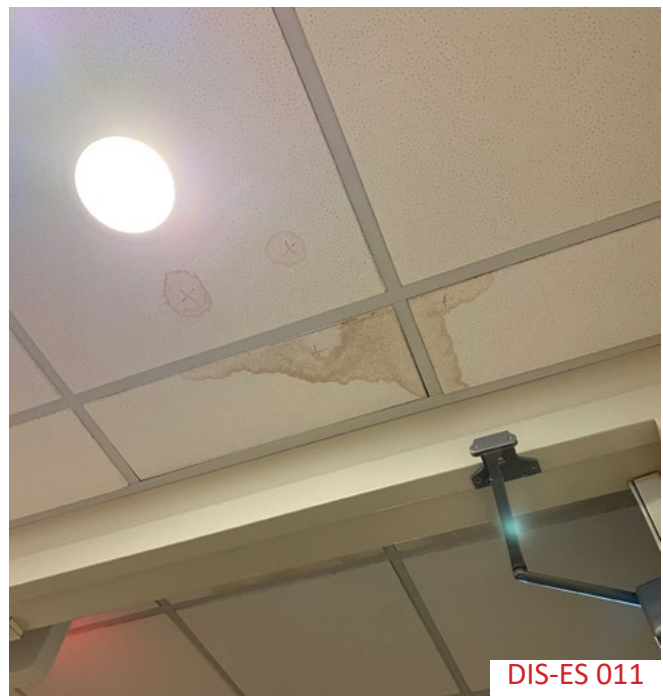
There are also several ceiling tiles throughout the school that have water damage.

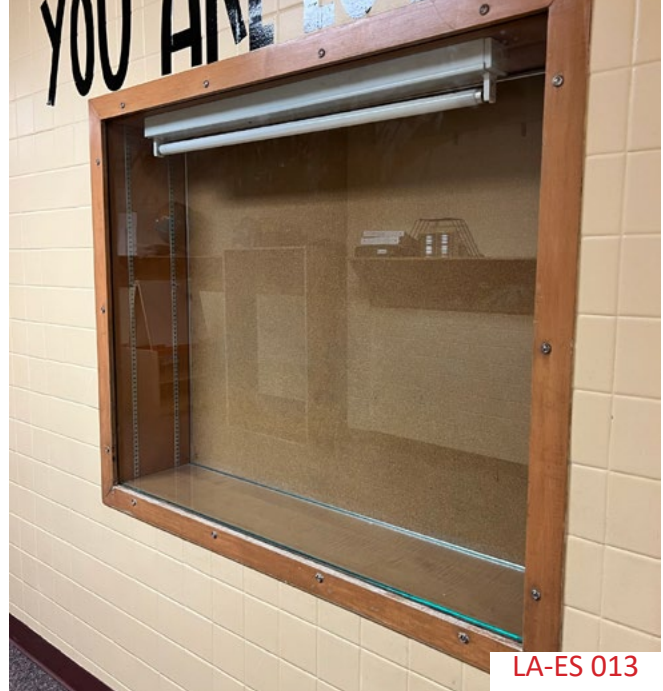
LA-ES 013

Display case does not have required safety glass.

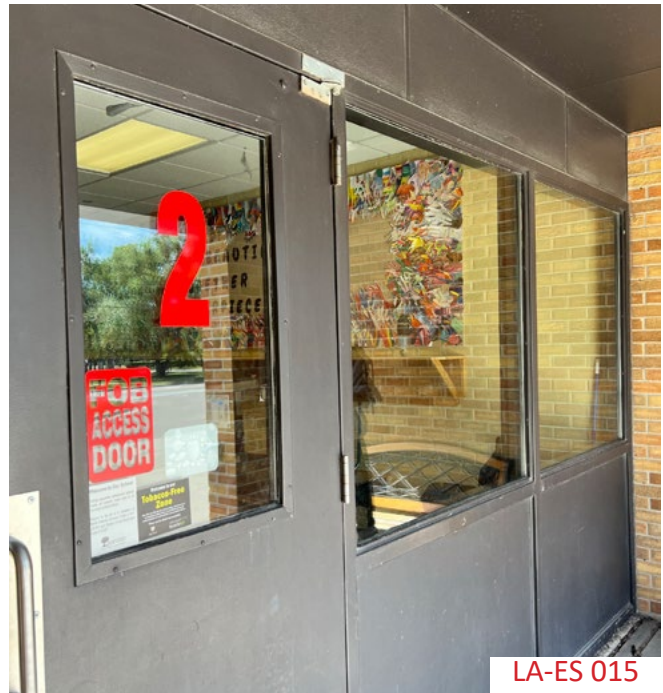
LA-ES 015

Doors 1,2, and 10 are not protected with an enclosed vestibule, as required by energy code.

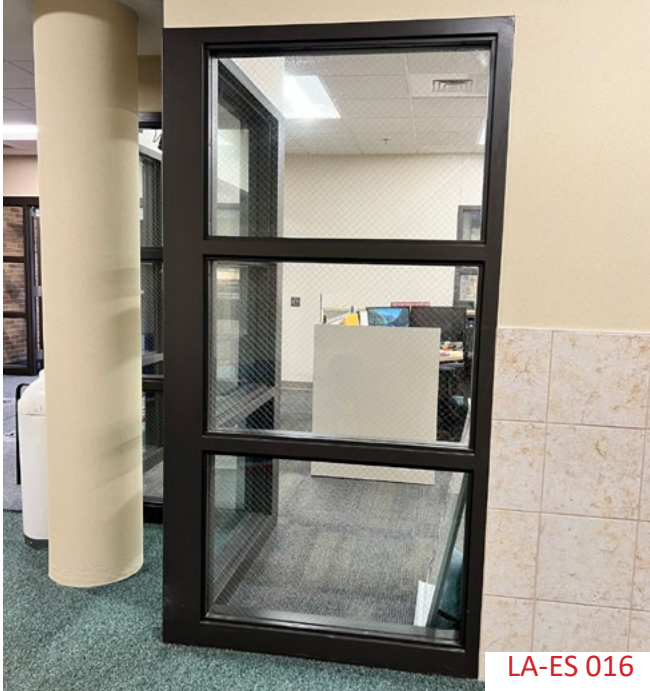
LA-ES 016

Traditional wire glass throughout the building is no longer to code as an acceptable type of safety glass.

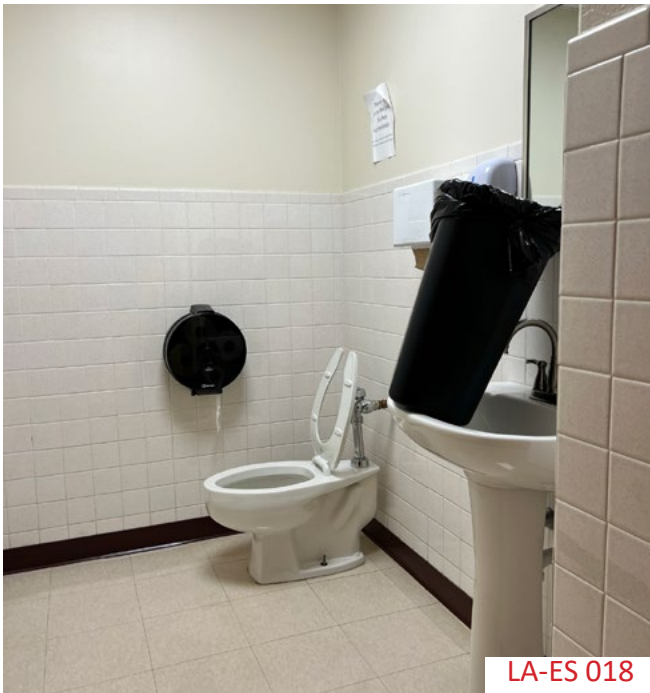
LA-ES 018

The restrooms near the first-grade classrooms are not accessible due to the absence of grab bars.

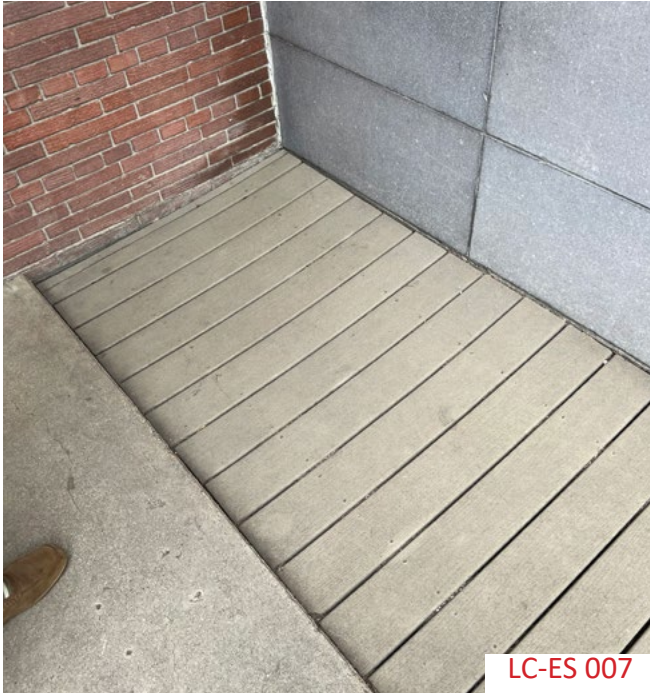
LC-ES 007

There are some site concerns with parking and accessibility. Accessible parking spots are located next to a non-accessible building entrance (004). Not all entrances are accessible, and several exterior ramps and stairs lack required railings. Water leaks into the lower-level crawl space from the exterior (005). The rim board should be painted and repaired. Boards on the platform outside of Door 7 are sagging and the platform should have a railing (006, 007).

Boards on the platform outside of door 7 are sagging and the platform should have a railing.

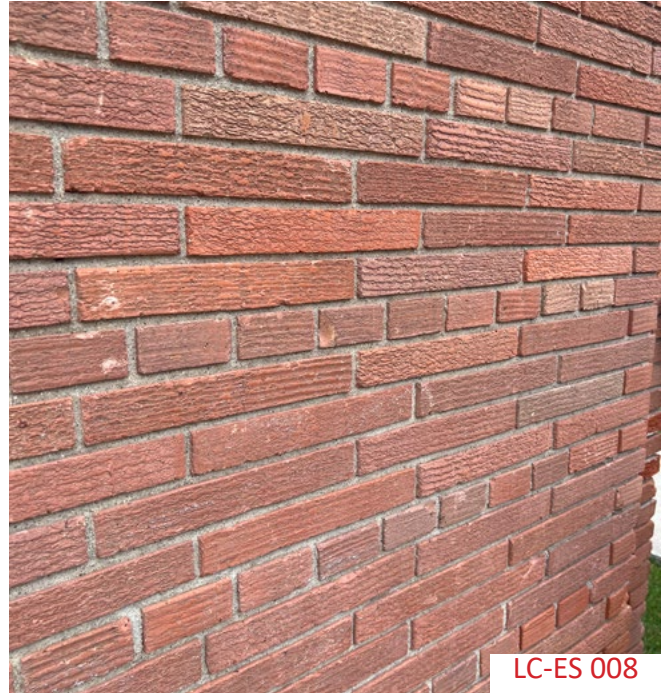
LC-ES 008

The exterior brick is in decent condition. Tuckpointing is wearing (008) and there are signs of moisture at the bottom of exterior brick walls (009).

Tuckpointing is wearing.

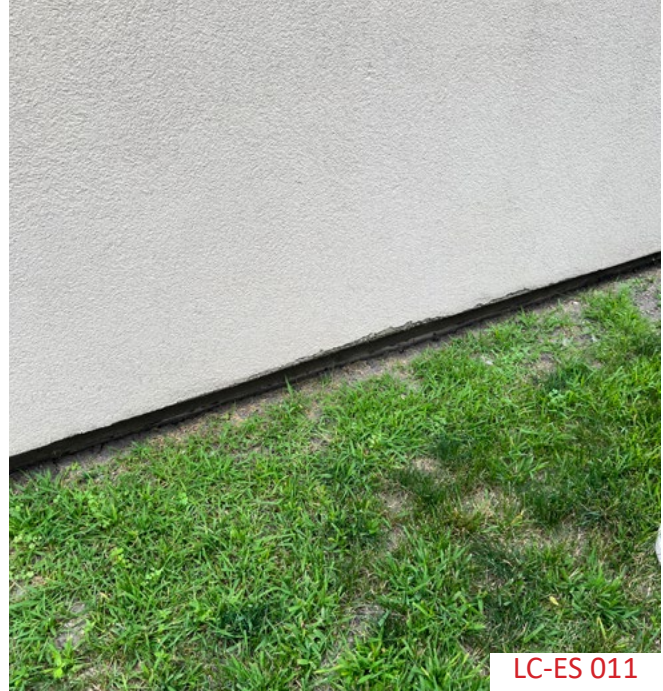
The exterior of the building consists of masonry and exterior insulation and finish systems (EIFS). Caulking should be redone as it is worn and deteriorating (010). There is damage to the bottom edge of the EIFS around the perimeter (011).

There is damage to the bottom edge of the EIFS around the perimeter.
