ICON
ARCHITECTURAL GROUP

FACILITY ASSESSMENT FOR GRAND FORKS PUBLIC SCHOOLS

Grand Forks, ND

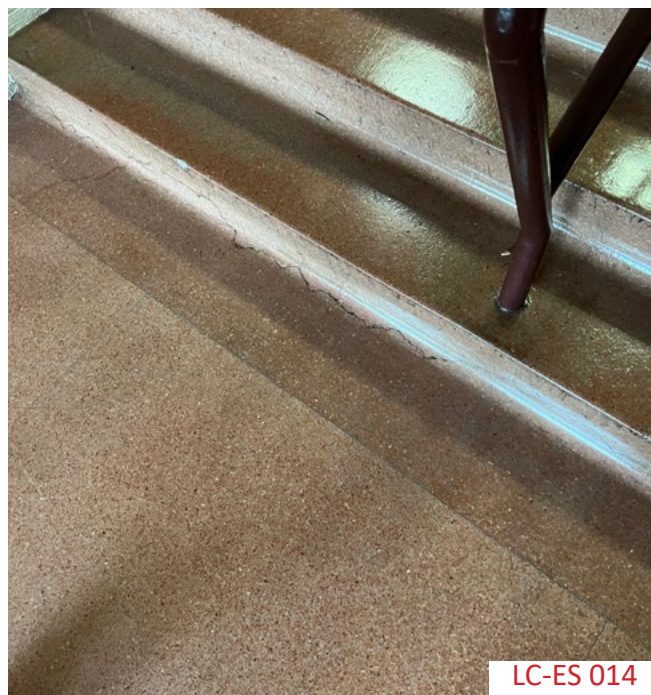
The flooring is cracked by door 1 and there are cracks in the flooring of several staircases.

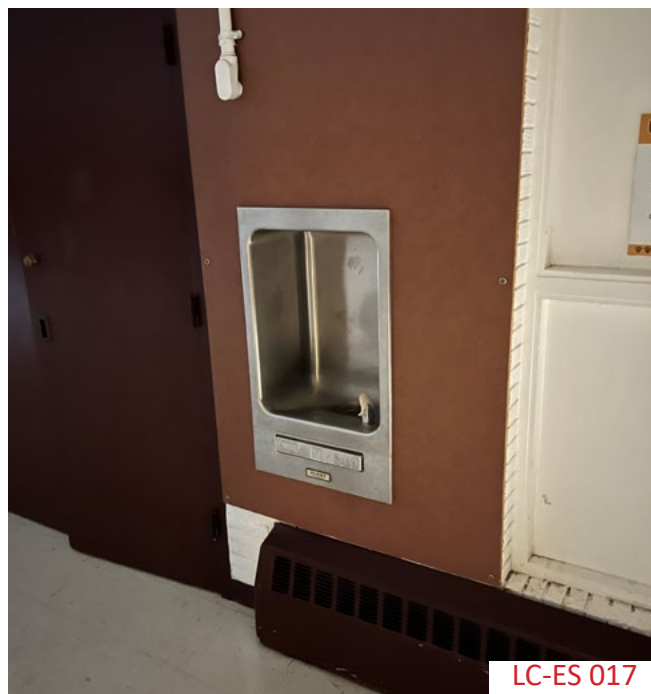
Drinking fountains throughout the building do not meet the required ratio of wheelchair accessible fountains to standing person accessible fountains

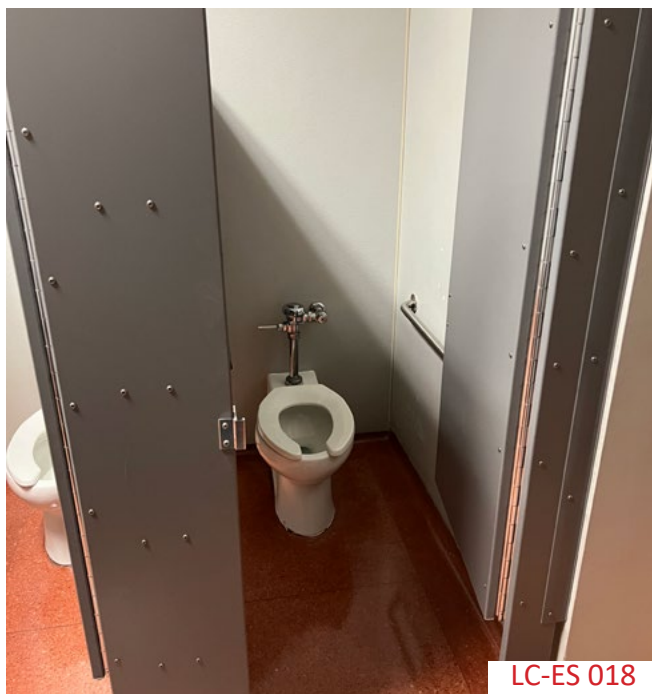
Public restrooms are not accessible

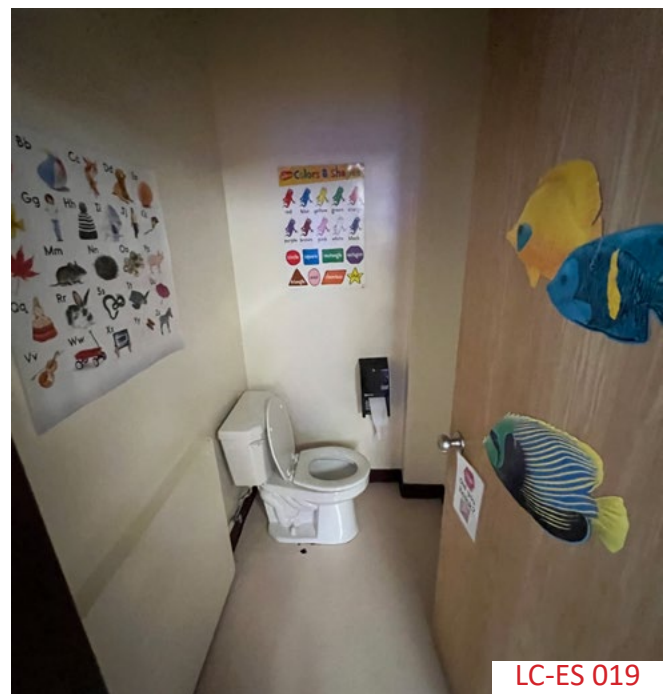
Restrooms in classrooms are not accessible

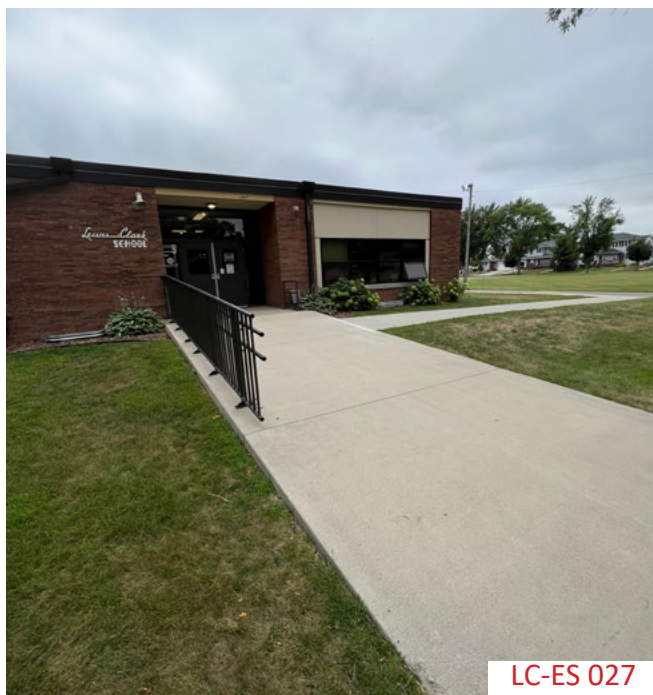
LC-ES 027

Ramp outside of Door 5 does not have a railing on both sides as required by code. The railings should extend the full length of the ramp

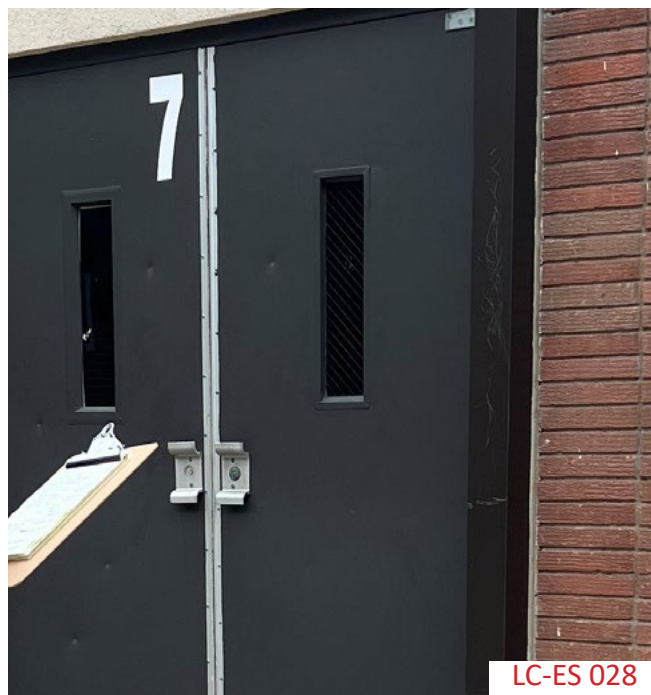
LC-ES 028

Various doors throughout the building have door hardware that is not accessible

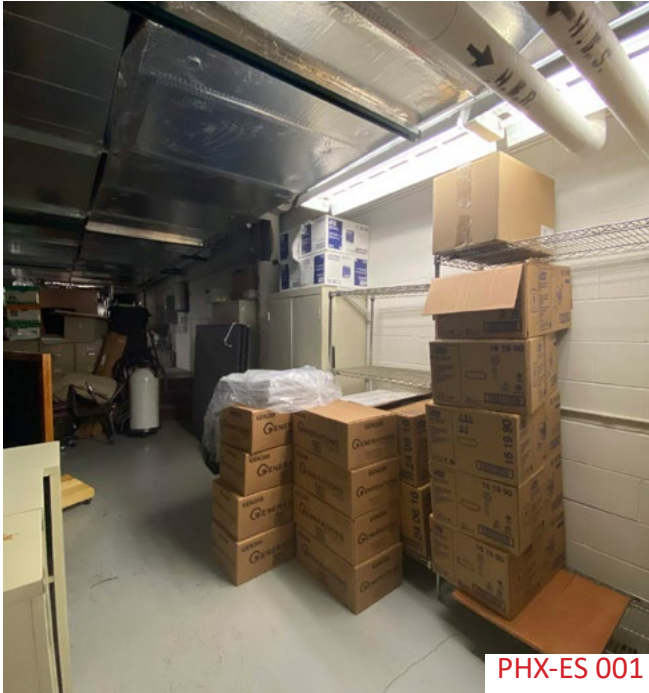
PHX-ES 001

The school, in general, lacks storage space as many of the restrooms, electrical closets, and mechanical rooms double as storage.

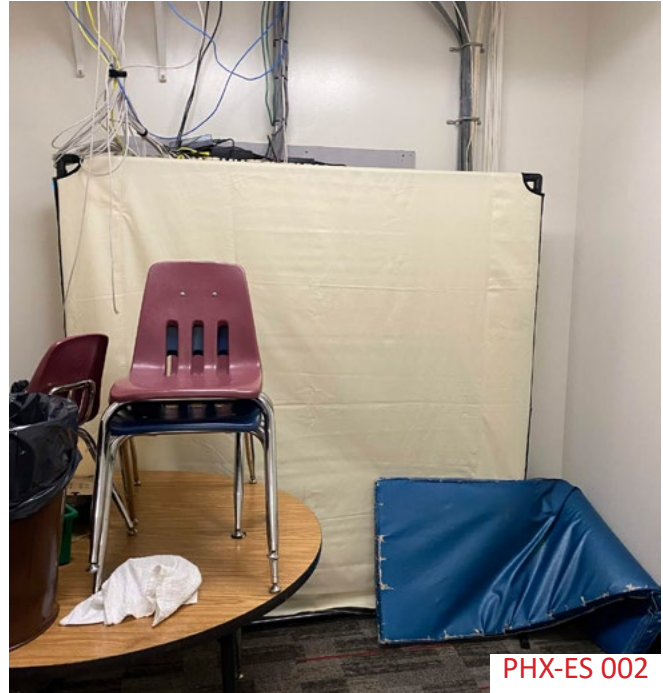
PHX-ES 002

Many individual learning spaces have had to move to spaces that are not optimal for learning. For example, there is a one-on-one learning space inside of an electrical closet.

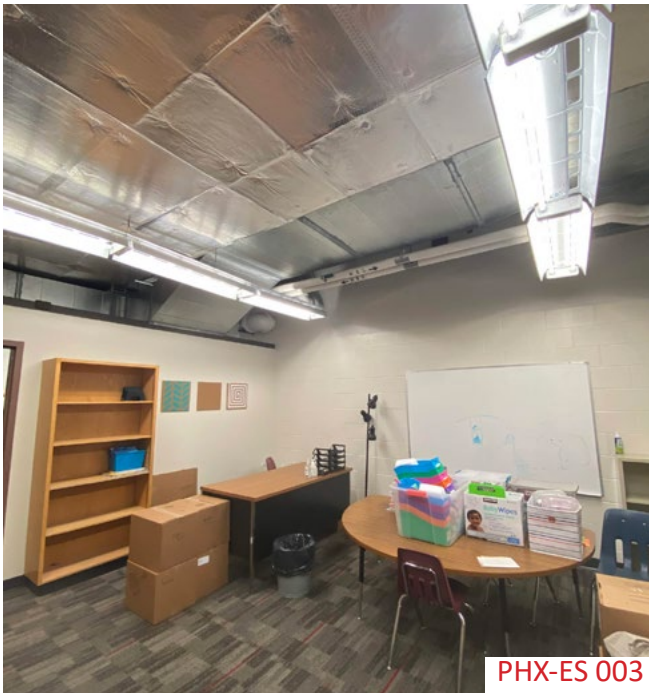
PHX-ES 003

Many individual learning spaces have had to move to spaces that are not optimal for learning. For example, there is a specialized learning space within the mechanical and janitorial area of the building.

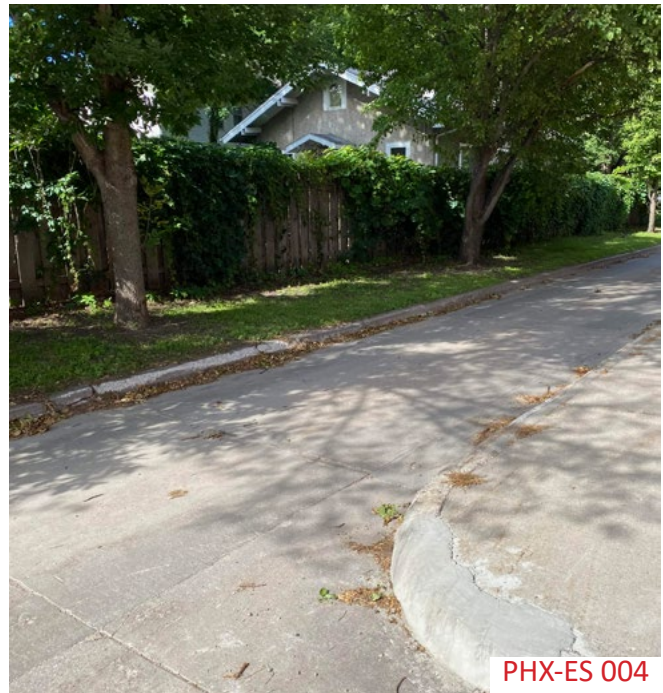
PHX-ES 004

This causes drivers to circumvent the one-way and cross over a crosswalk to connect to 5th Avenue South, creating concern for the safety of the children who utilize the crosswalk.

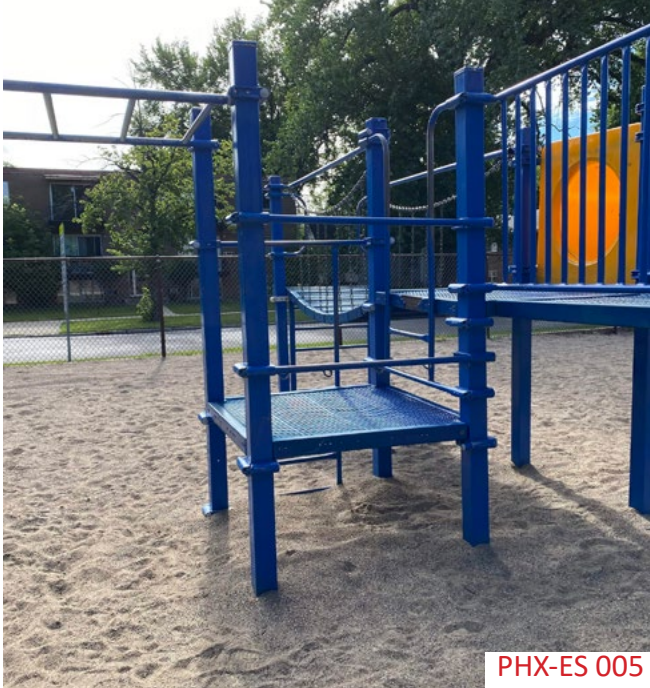
The playground directly outside the building is outdated, broken, and inaccessible and should be replaced.

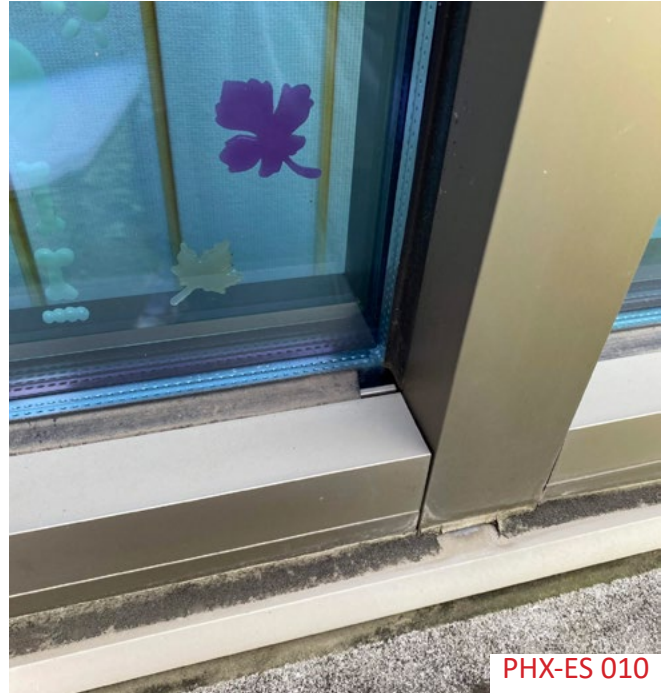
PHX-ES 010

Due to the age of the windows, the sealant/gasket has shrunk and no longer runs the entire width of the glass panels.

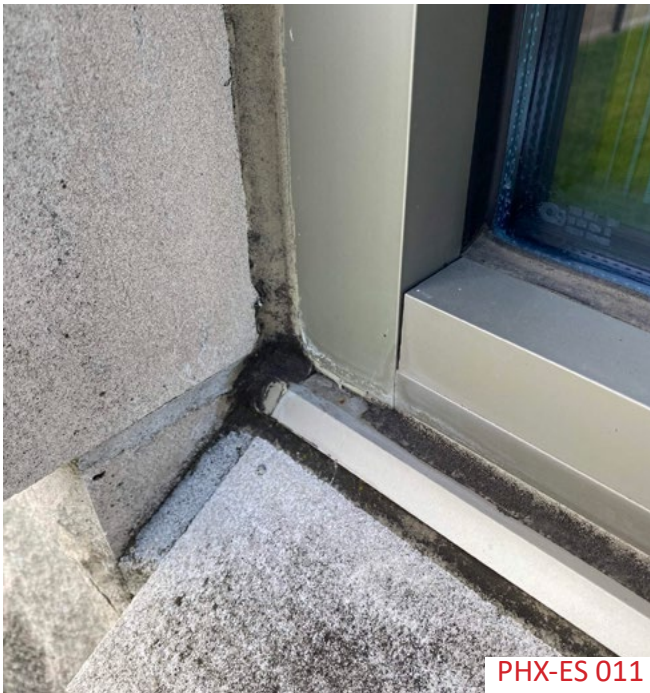
PHX-ES 011

Due to the age of the windows, the sealant/gasket has shrunk and no longer runs the entire width of the glass panels.

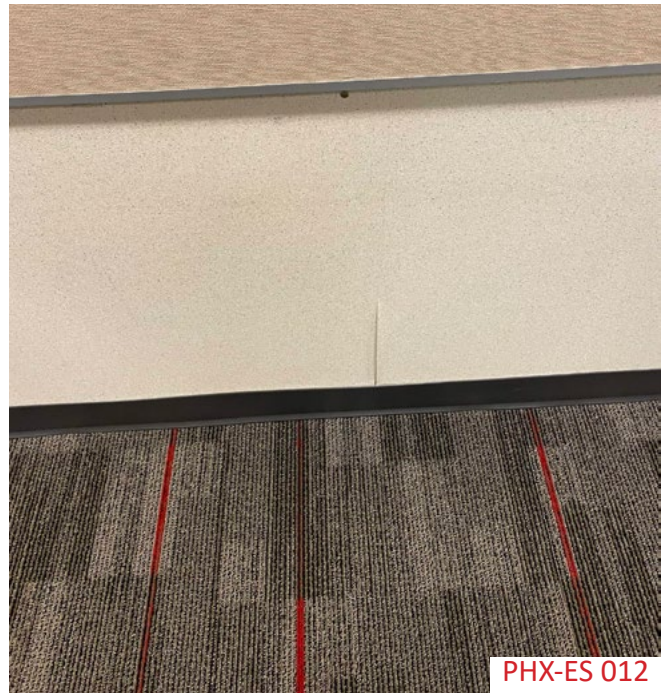
PHX-ES 012

There are several areas where the vinyl wall covering is releasing from the gypsum wall board substrate

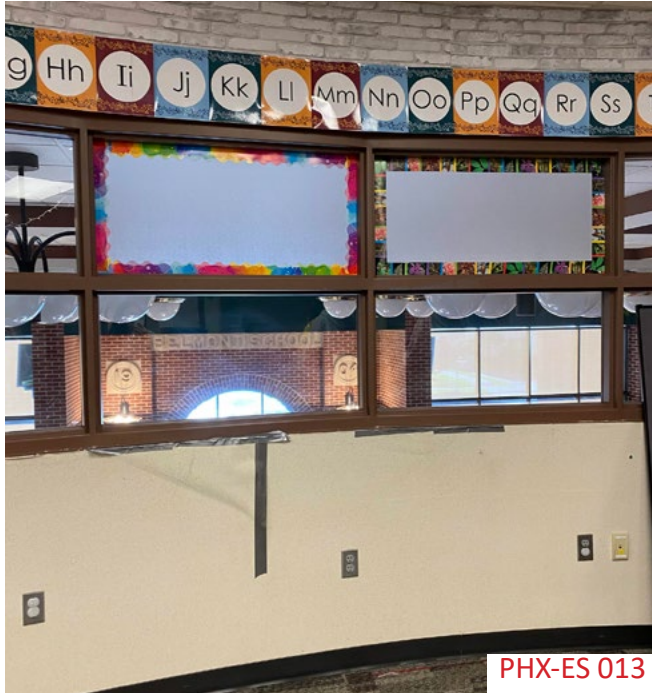
Other areas have signs of wear and tear and could use wall and corner guards to protect from future damage

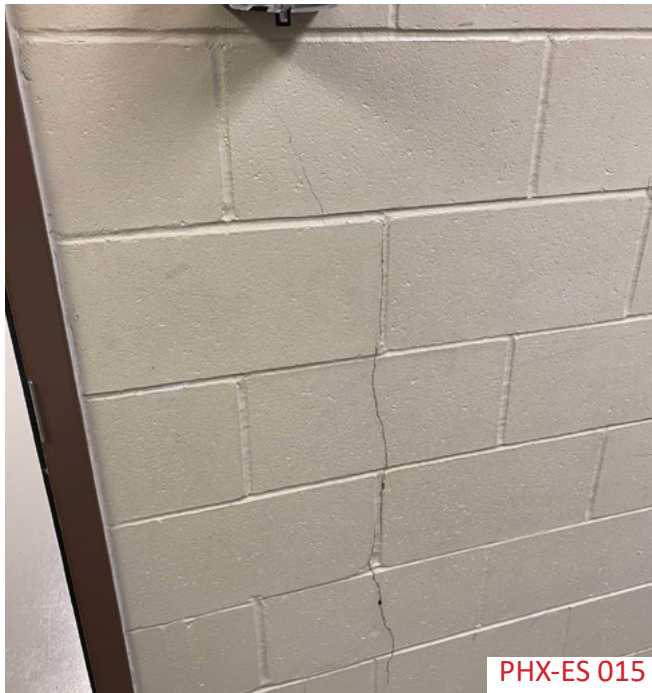
There is cracking in a CMU wall adjacent to a steel column that can be seen from the mechanical room and the hallway.

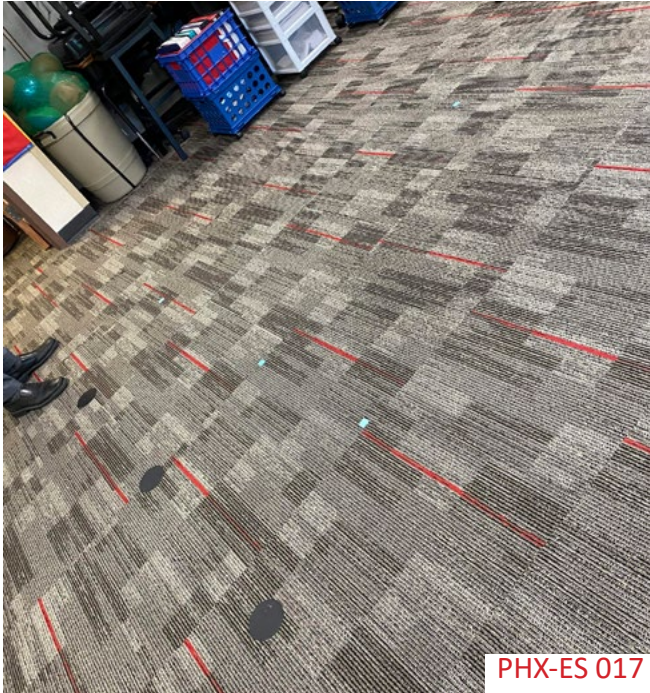
PHX-ES 017

There is an area in Room B235 where the precast concrete underneath the carpet has inconsistencies in its seams. Because of this, there is an uneven and sloped portion of the floor in the classroom.

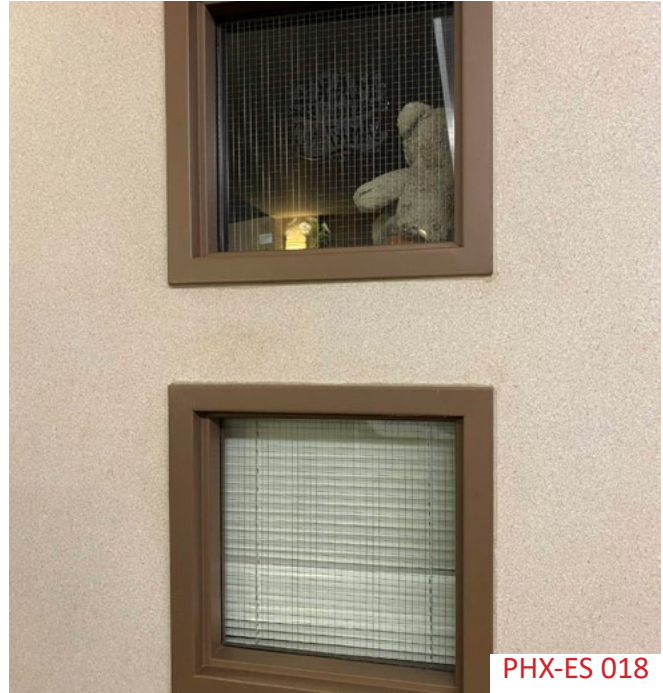
PHX-ES 018

Traditional wire glass throughout the building is no longer to code as an acceptable type of safety glass

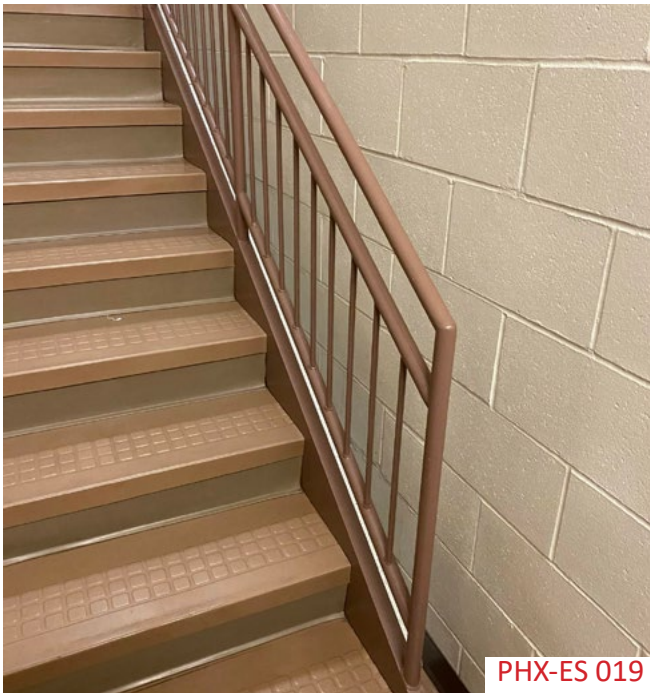
PHX-ES 019

Both stairwells are lacking a separate handrail from the guardrails and existing guardrails do not meet height requirements

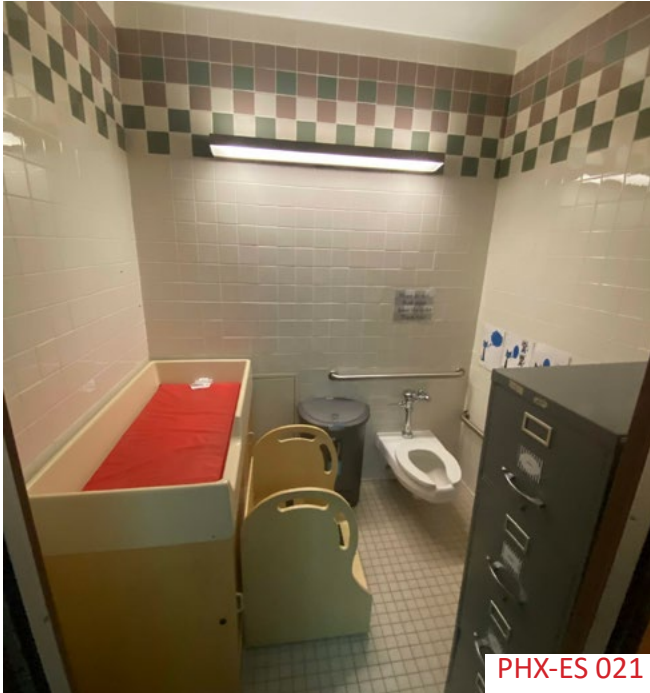
PHX-ES 021

Numerous single restrooms throughout the school are accessible, but with all the extra items stored there, are no longer accessible

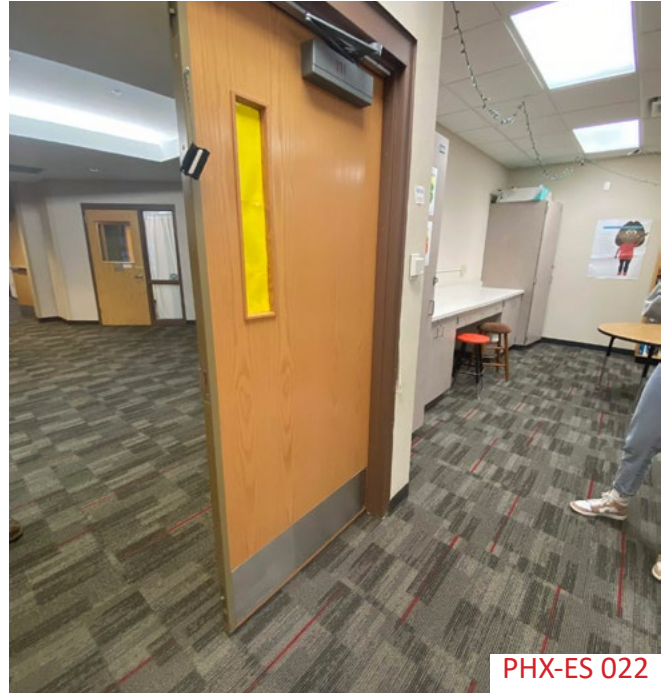
PHX-ES 022

Double doors in the Title 1 classroom (Room 171) do not have required panic hardware

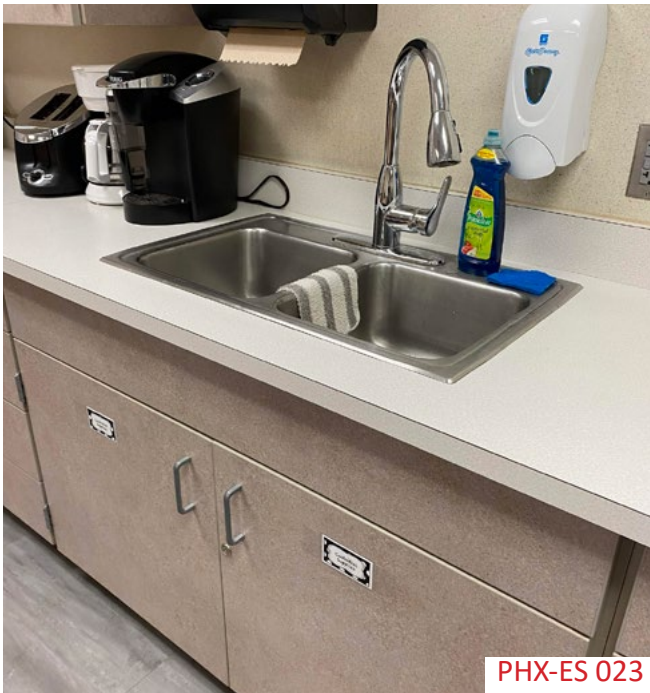
PHX-ES 023

Sinks in the staff lounge, main office, nurse's office, and library office (Rooms A136, A137, B145 and no corresponding room number) are not accessible

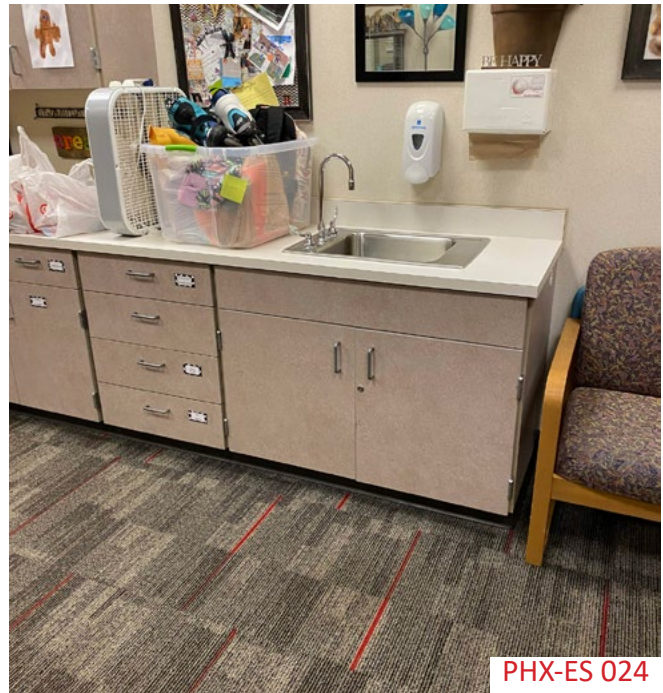
PHX-ES 024

Sinks in the staff lounge, main office, nurse's office, and library office (Rooms A136, A137, B145 and no corresponding room number) are not accessible

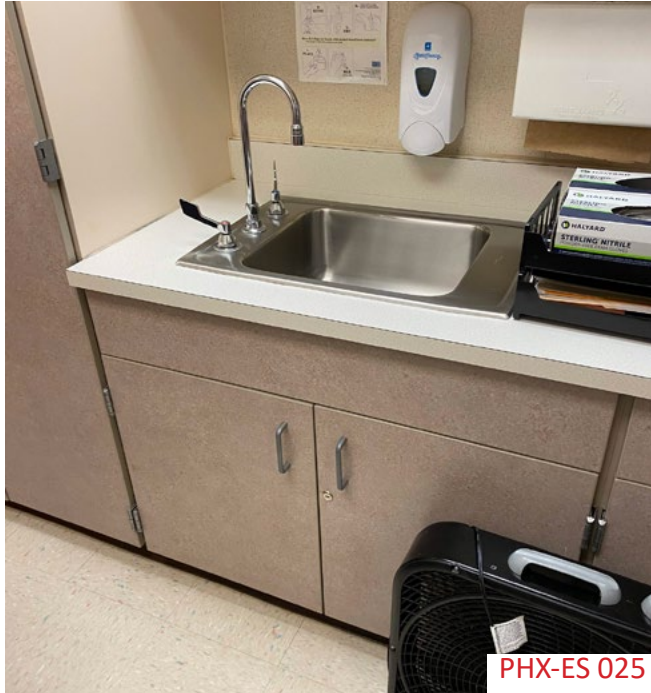
PHX-ES 025

Sinks in the staff lounge, main office, nurse's office, and library office (Rooms A136, A137, B145 and no corresponding room number) are not accessible

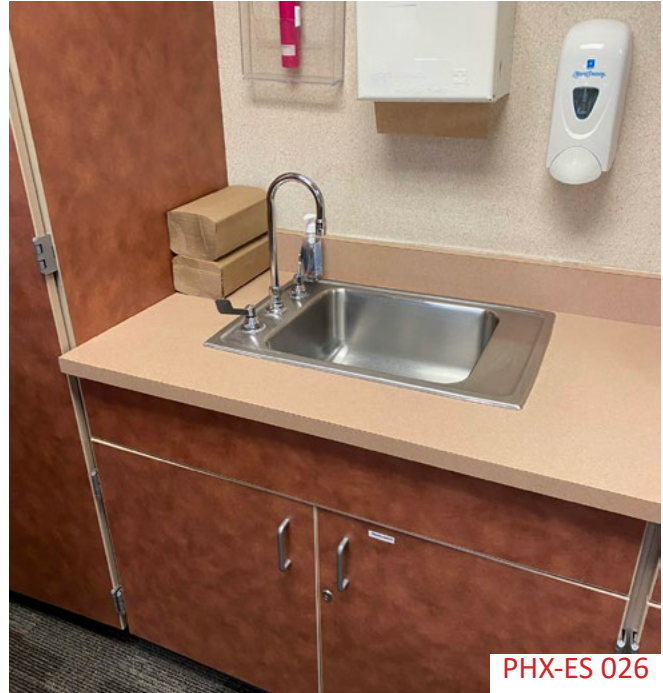
PHX-ES 026

Sinks in the staff lounge, main office, nurse's office, and library office (Rooms A136, A137, B145 and no corresponding room number) are not accessible

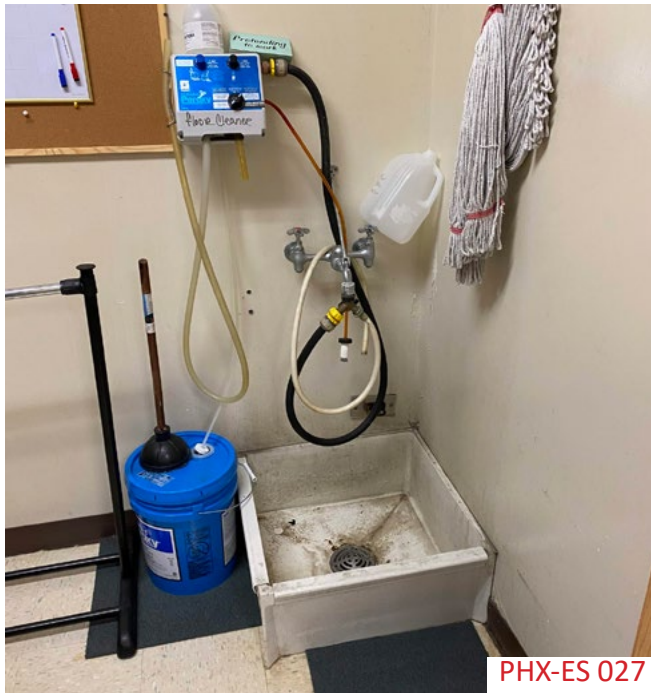
PHX-ES 027

Mop sink in the second-floor janitorial closet (Room A214) needs fiber-reinforced panels on the adjacent walls

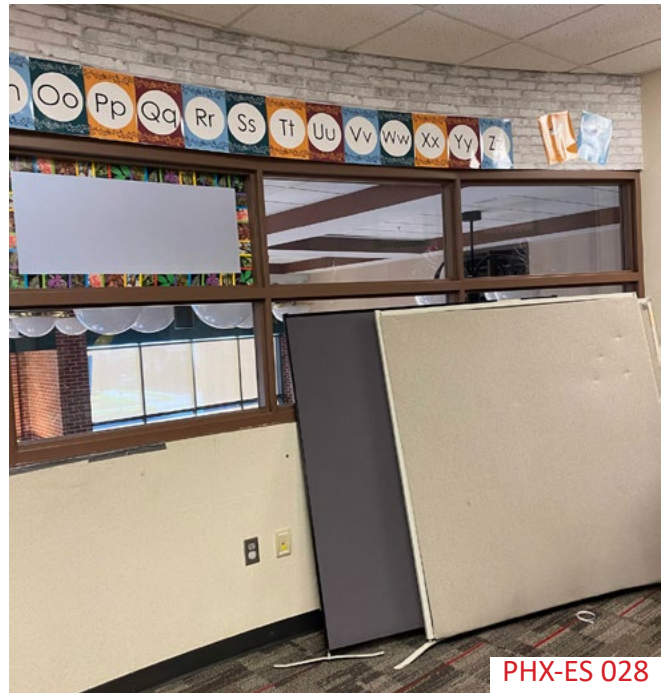
PHX-ES 028

All classrooms with interior windows facing the atrium are missing sprinklers 4"-12" from the windows for fire protection

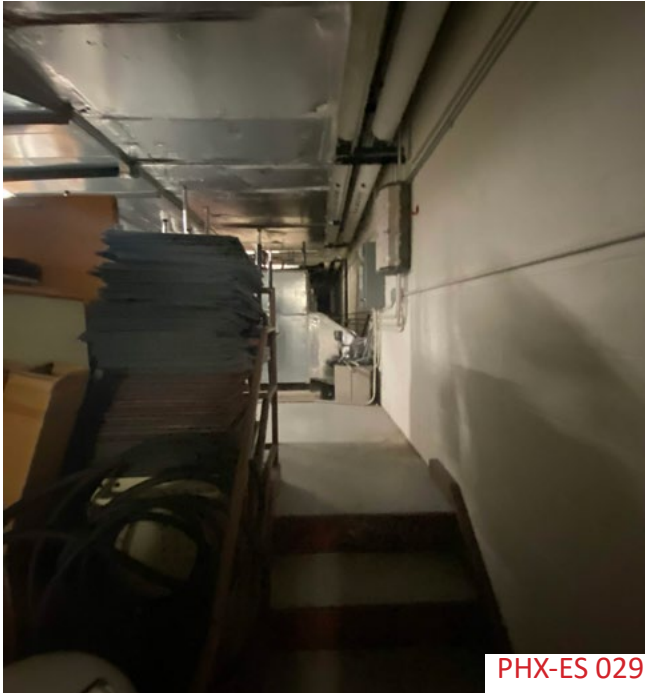
PHX-ES 029

The guardrail in the mechanical room does not meet height requirements and appropriate handrails are missing

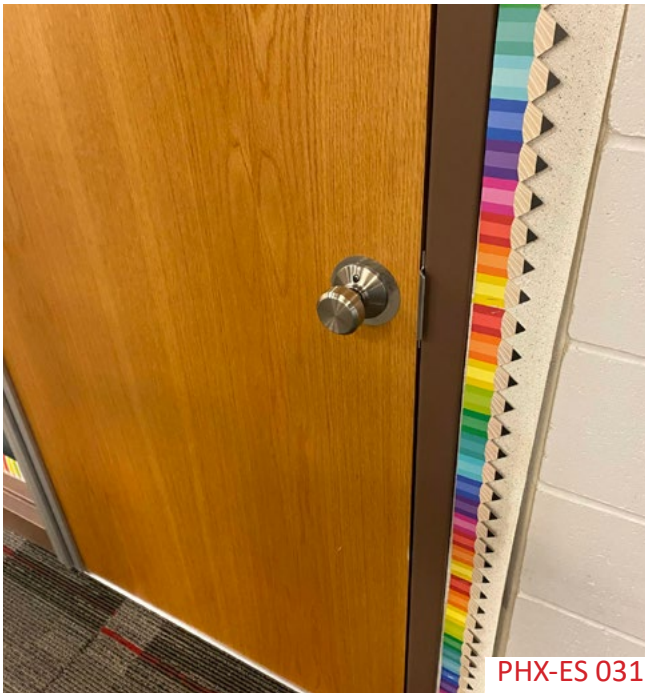
PHX-ES 031

Door hardware, on the door to the STAR room in Room 229, is not accessible

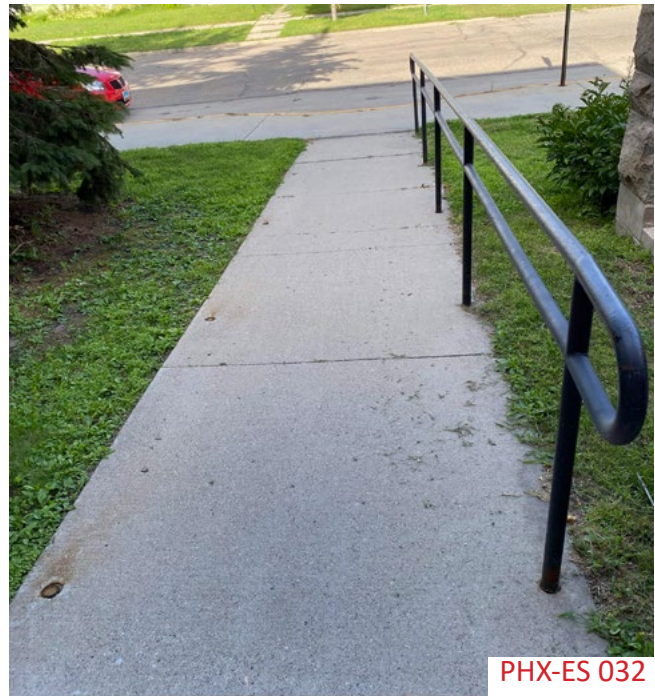
PHX-ES 032

Due to the incline of the southernmost exterior ramp outside of the cafeteria, handrails are required on both sides of the ramp

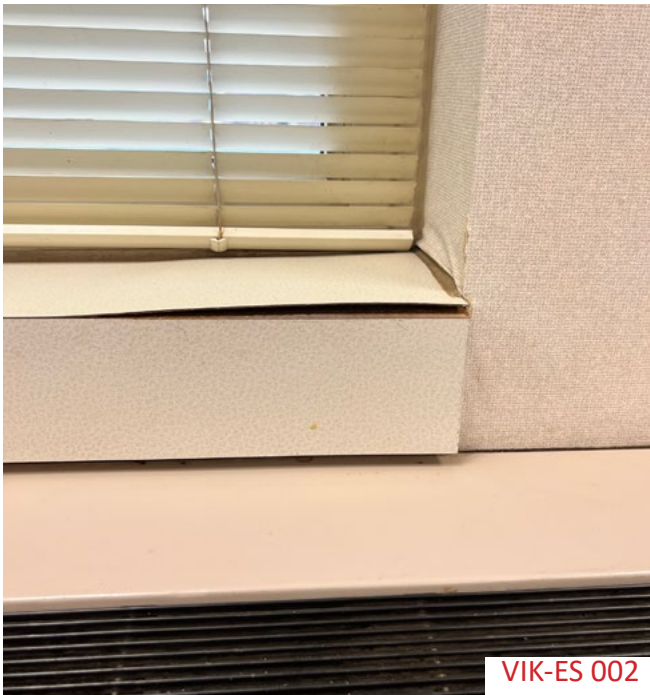
VIK-ES 002

Some laminate under windows in the cafeteria is lifting.

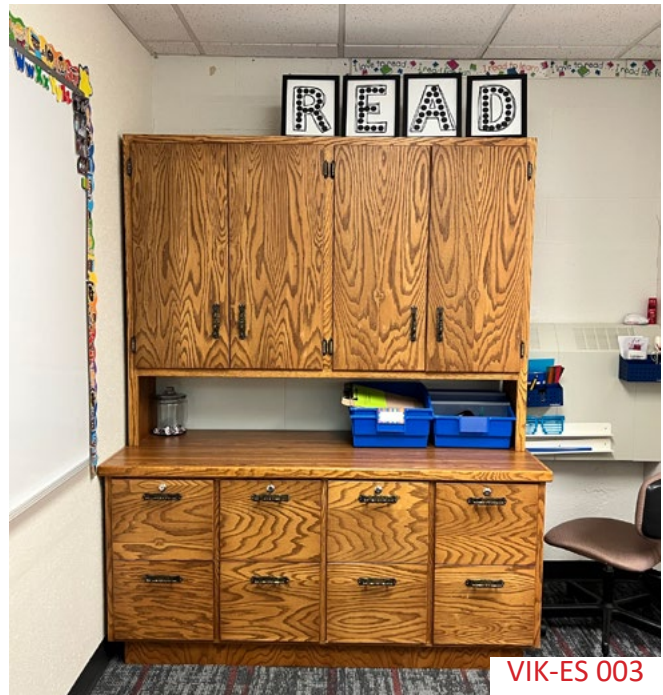
VIK-ES 003

Casework in classrooms is dated, but functional.

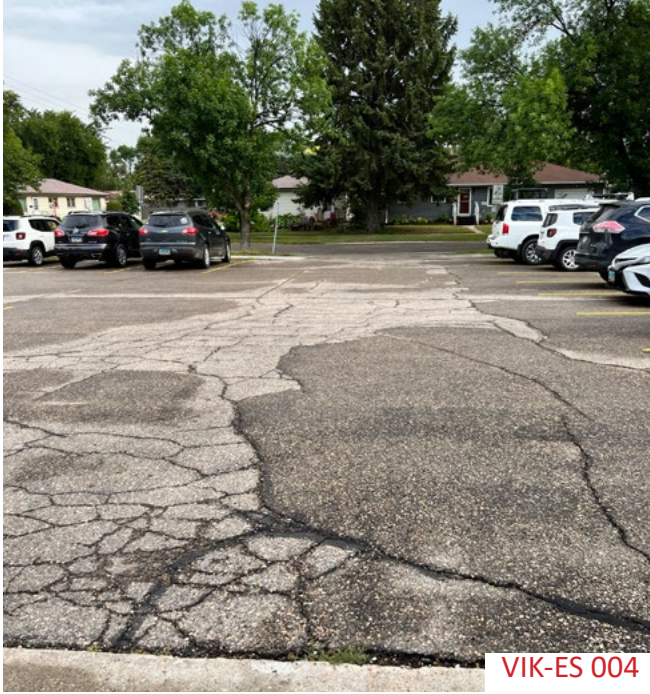
VIK-ES 004

The asphalt on the site has some cracking (004). Several entrances to the school have uneven concrete which creates issues for accessibility. The school's parking lot is not large enough and could use more stalls. Two portable classrooms are located on the south side of the building (005).

The asphalt on the site has some cracking.

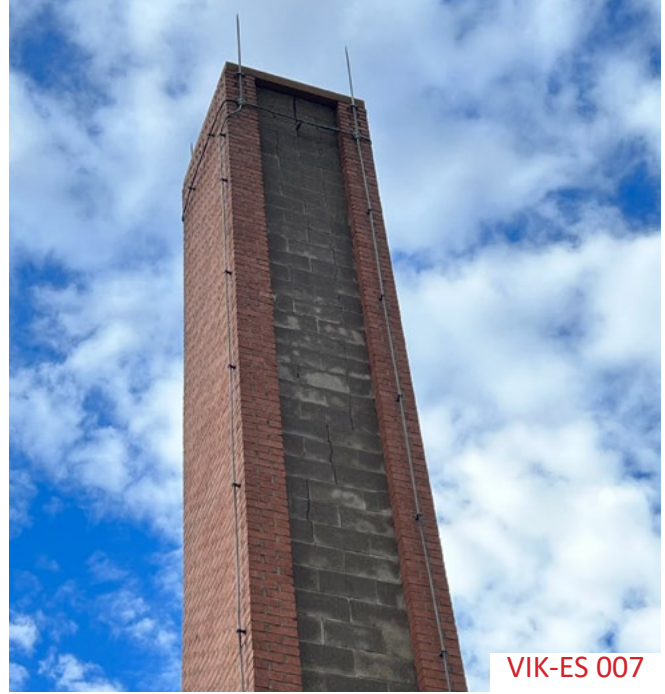
VIK-ES 007

The exterior brick is in overall good condition. The brick mortar and caulking are in good condition. There is some cracking on exterior CMU brick (006), including up the chimney (007).

There is some cracking on exterior CMU brick, including up the chimney.

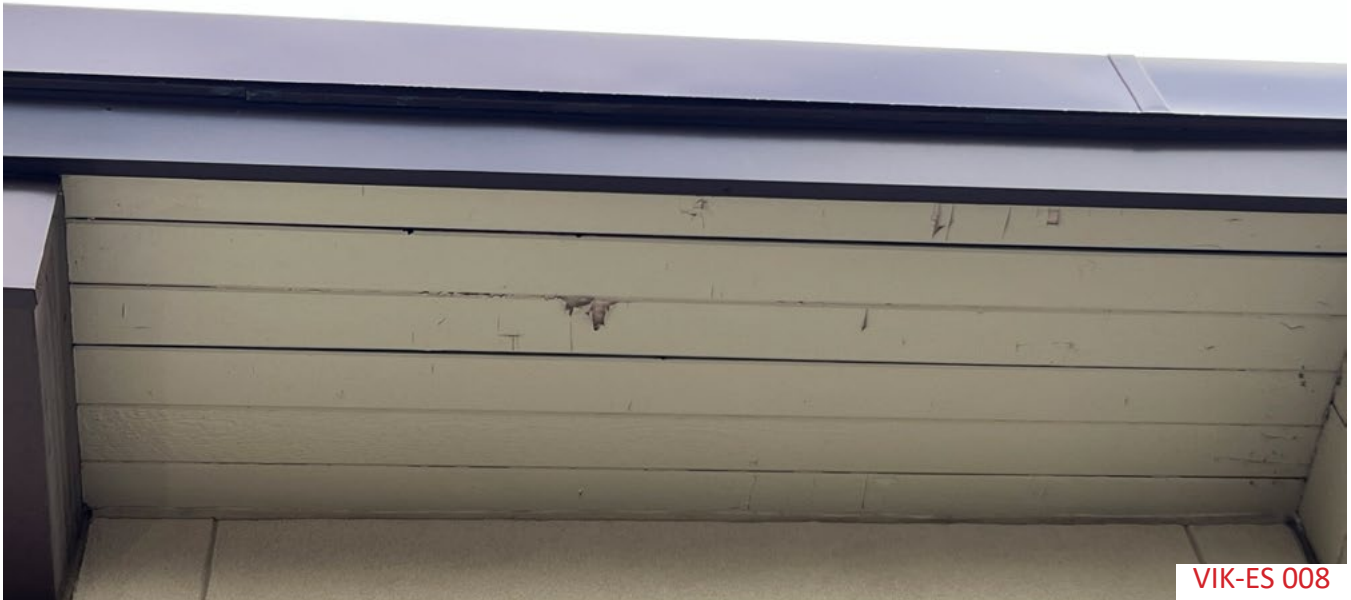
Plaster is cracking in some areas. Paint is peeling off the wood on the underside of overhangs around the building (008). Exterior overhangs consist of combustible material and may require sprinklers.

In areas of overhangs around the building, paint is peeling underneath the wood.

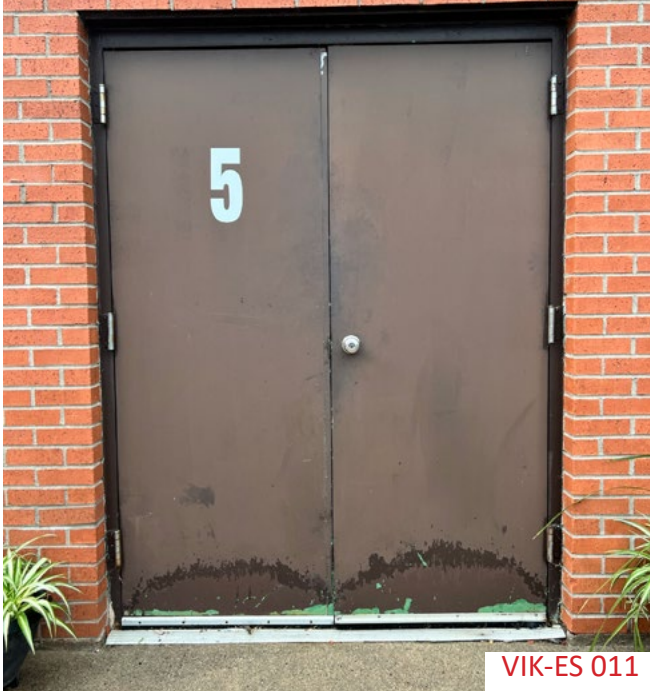
VIK-ES 011

The door openings and windows within the school are in good condition. Weather stripping could be replaced (009) and potentially door hardware (010). Paint on exterior doors is deteriorating and in poor condition (011). Entrances are not protected with an enclosed vestibule.

Paint on exterior doors is deteriorating and in poor condition.

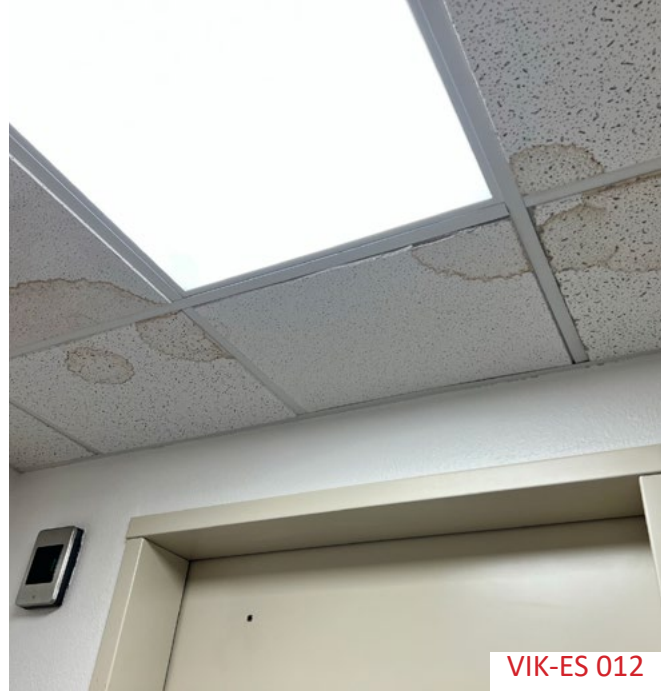
VIK-ES 012

The ceilings within the school are mostly comprised of acoustical ceiling tiles (ACT). The ACT is generally in good condition, but there are some areas with water damage (012).

The ACT is generally in good condition, but there are some areas with water damage.

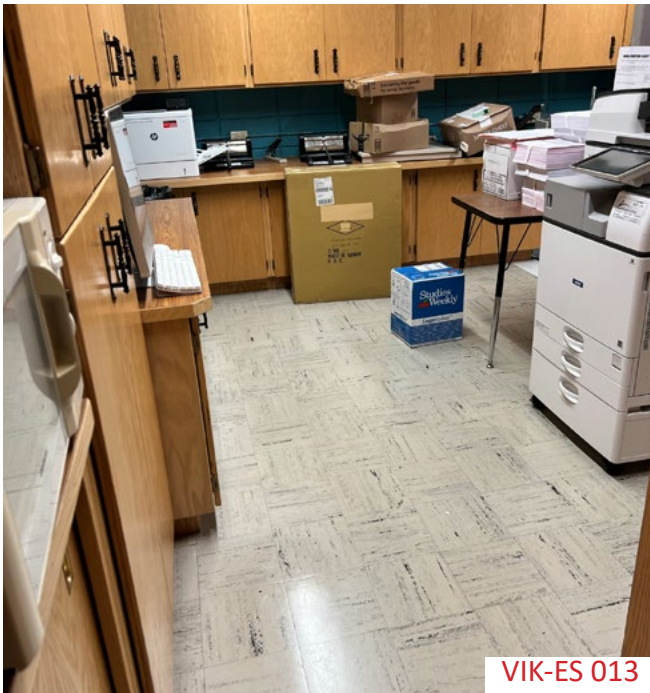
VIK-ES 013

The floors in the school are either carpeting or various types of tiling. The carpet is 9-10 years old, but in overall good condition. Some portions of the original tile are dated, but still in good condition. There is potential asbestos in portions of older tile (013).

There is potential asbestos in portions of older tile.

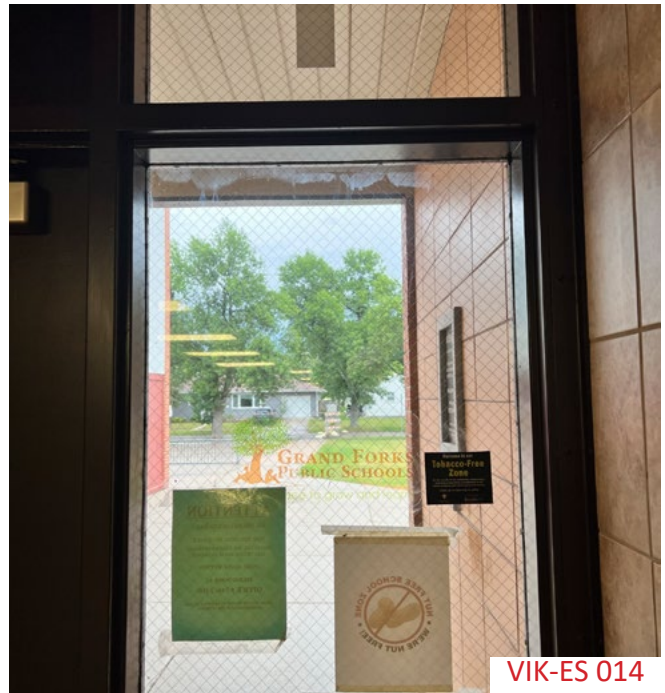
VIK-ES 014

Traditional wire glass throughout the building is no longer to code as an acceptable type of safety glass.

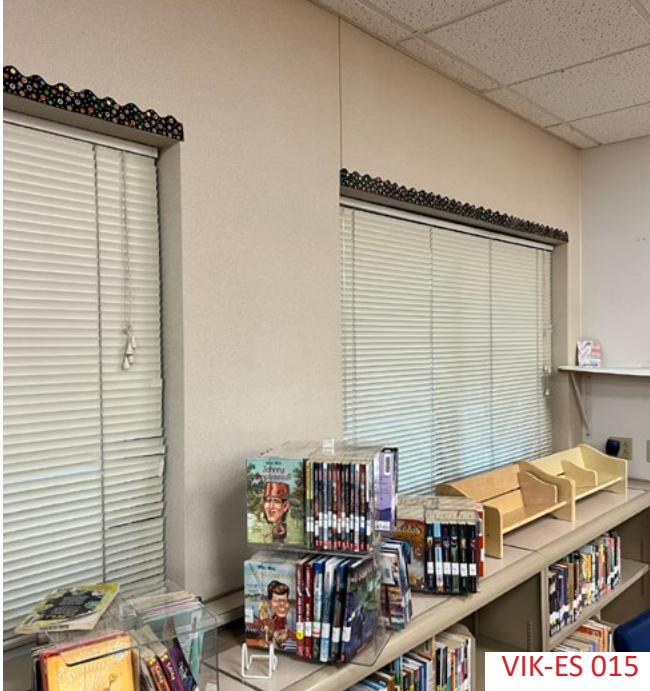
VIK-ES 015

The interior walls are either painted masonry, painted gypsum board, have vinyl wall coverings, or have tiling. Large portions of exterior walls are covered with vinyl covering on the interior side. It is recommended the vinyl wall covering be removed from the interior surface of exterior walls, as this could potentially create a double vapor barrier and trap moisture within the walls. Current code does not permit the use of vinyl wall covering on outside walls for this reason.

Portions of exterior walls are covered with vinyl wall covering on the interior side, which is not to code.

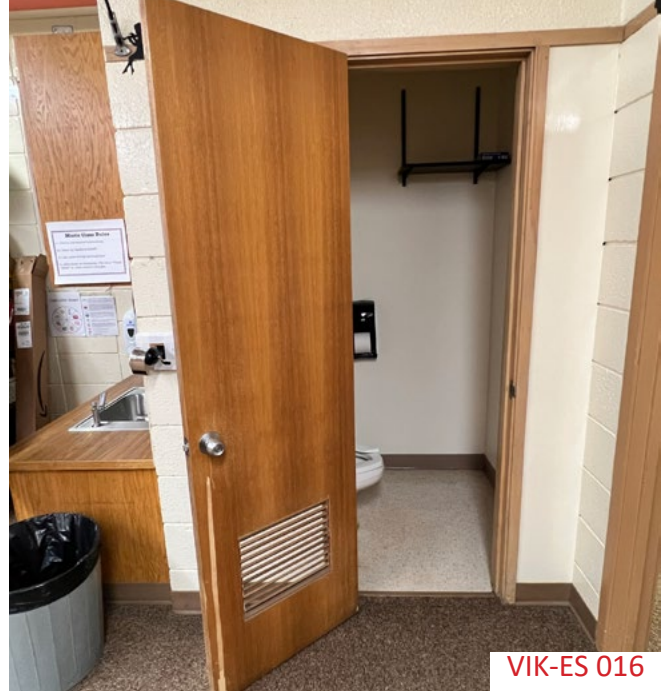
VIK-ES 016

Multiple classrooms have restrooms that are not accessible.

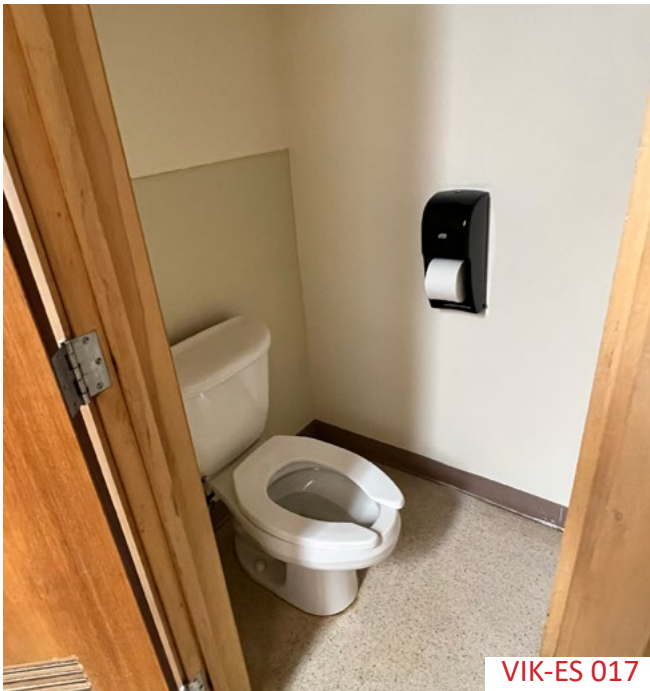
VIK-ES 017

Multiple classrooms have restrooms that are not accessible.

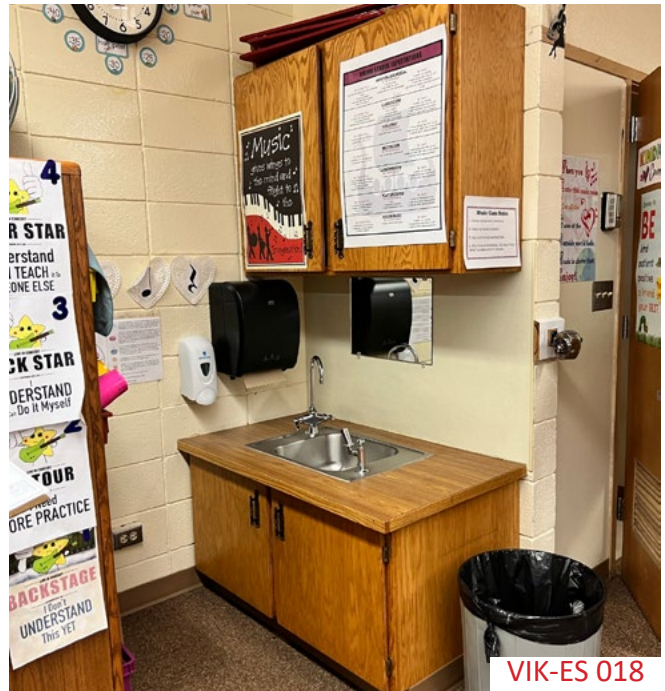
VIK-ES 018

Sinks in classrooms are not accessible.

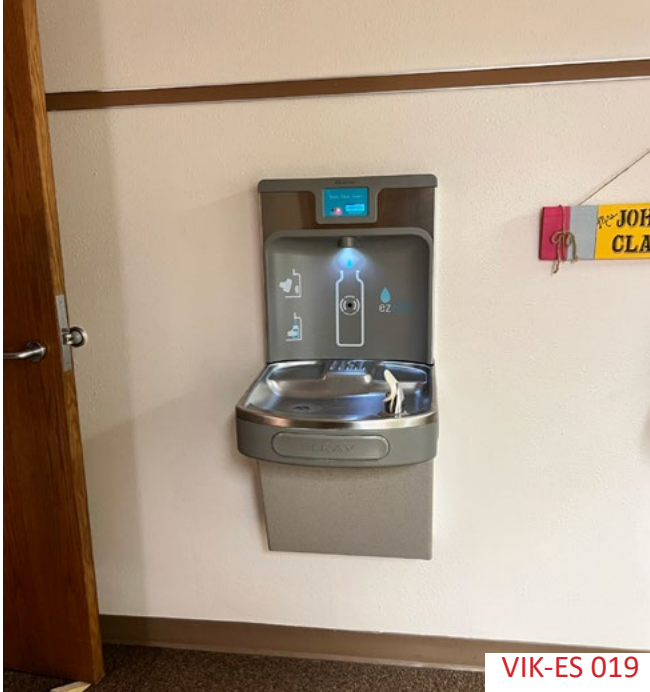
VIK-ES 019

Drinking fountains throughout the building do not meet the required ratio of wheelchair accessible fountains to standing person accessible fountains.

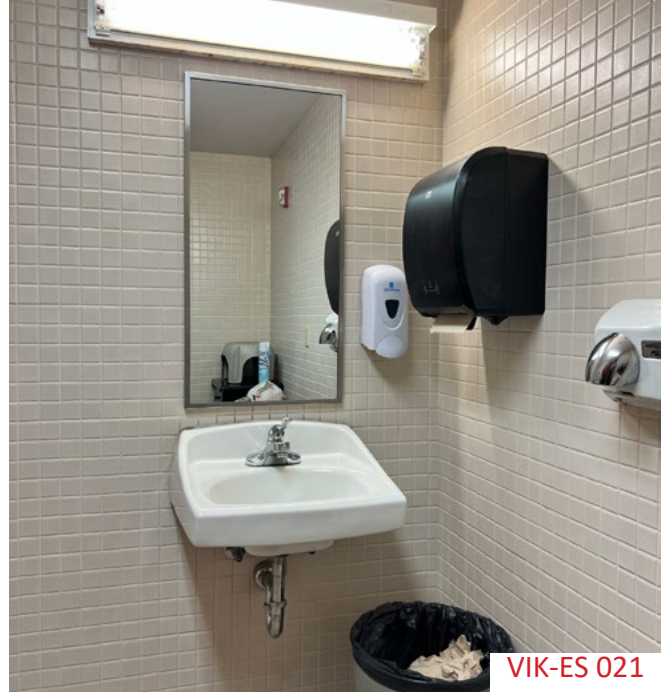
VIK-ES 021

Pipes in restrooms are exposed and should be protected.
